Subject: BBC Brown Boveri
HK Control Device

Subject BELLEFONTE NUCLEAR STATION
A.O. 33-51014 & 33-54753

INSTRUCTIONS FOR INSPECTING, ADJUSTING AND/OR REPLACEMENT
OF PARTS FOR OBTAINING LIMIT SWITCH ADJUSTMENTS
ON BROWN BOVERI 7.5KV THRU 15KV, 500 THRU 750 MVA;
5HK350, 3000; ALL HKV BREAKERS

IB-8303

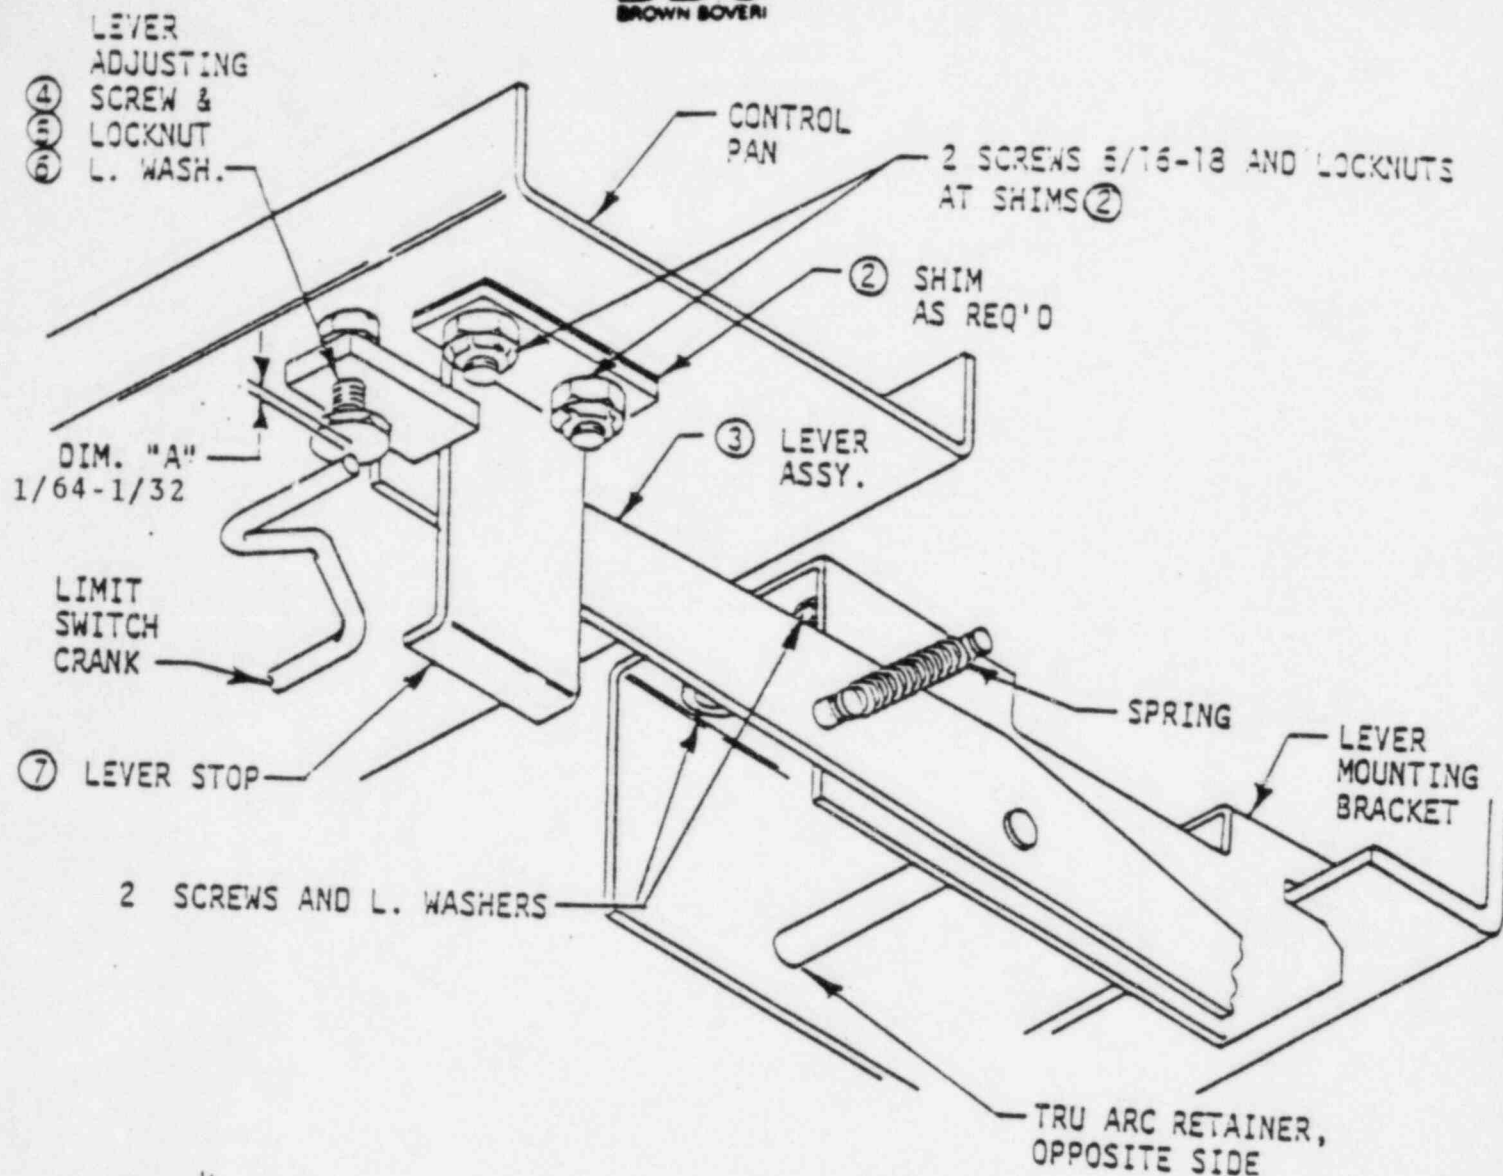
FIG. 1

2. INSPECTION AND ADJUSTMENT FOR DIM. "A" (See Fig. 1)

- 2.1 Charge the closing springs electrically or manually.
- 2.2 Check Dim. "A" with feeler or pin gages.
- 2.3 If required, readjust the screw (4) to Dim. "A" after first loosening the jam nut (5) and then retightening the jam nut after the adjustment.
- 2.4 Close and open the breaker to discharge the closing springs.

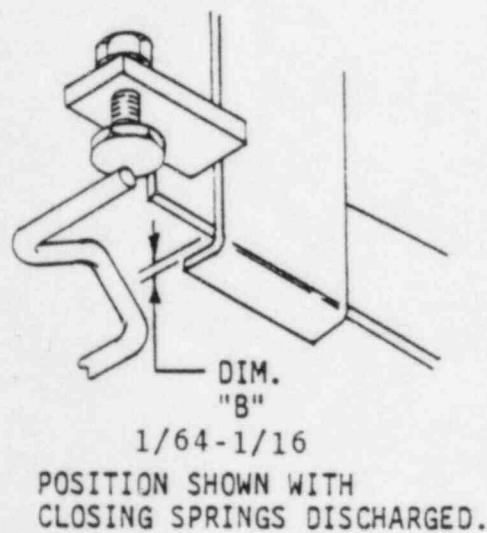
FIG. 2

3. INSPECTION AND ADJUSTMENT FOR DIM. "B" (See Fig's 1 and 2)

- 3.1 For this procedure, the breaker is to be open and the closing springs discharged.
- 3.2 Check Dim. "B" with feeler or pin gages. (See Fig. 2)
- 3.3 If Dim. "B" is not within dimensions, it is necessary to shim the lever stop(7) up or down as required. This is done by adding or removing shims(2) at the lever stop. (See Fig. 1) Note that if all shims are removed and the Dim."B" still exceeds the max. allowed, the length of the lever stop should be checked. The lever stops made after July 1978 are $2 \frac{17}{32}$ long. Previous to this, the length was $2 \frac{25}{32}$. If required, install the shorter lever stop (7).
