October 14, 1996

1CAN109608

Subject: Arkansas Nuclear One - Unit 1
Docket No. 50-313
License No. DPR-51
Special Report - Once Through Steam Generator Tubing Surveillance -
Category C-3 Results

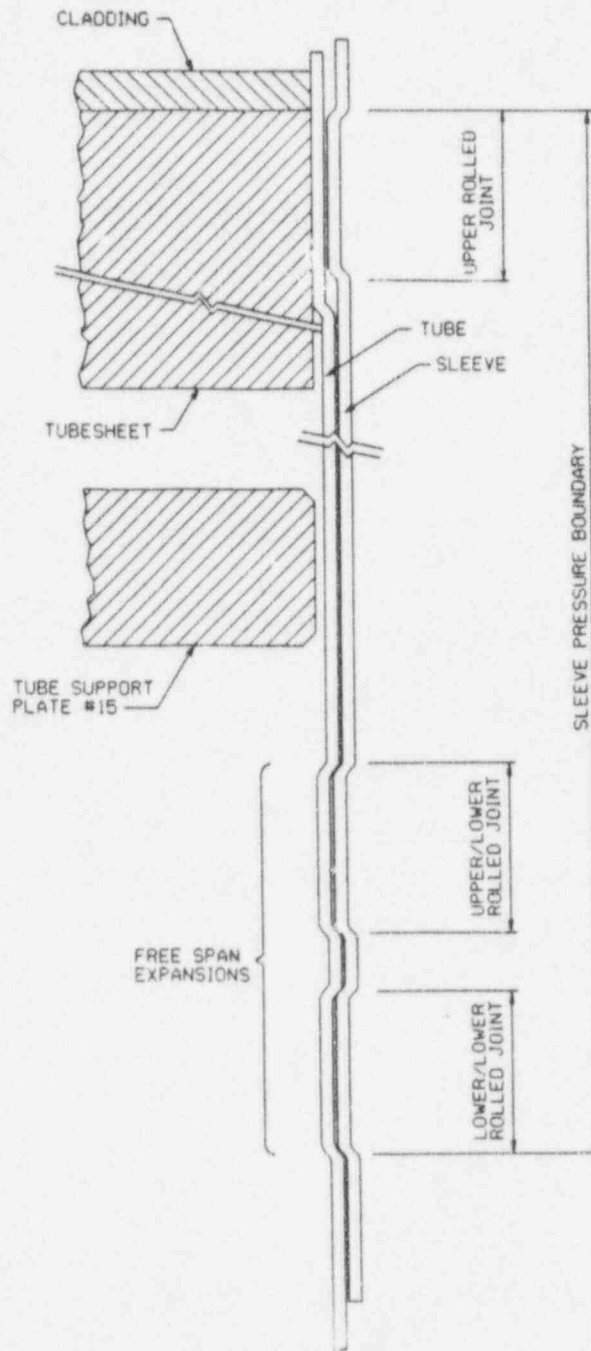
OTSG MECHANICAL SLEEVE

A list of the tubes and their associated indications is summarized below. Figure 1, "OTSG Mechanical Sleeve" is provided as a representation of the subject tube/sleeve configuration.

Row	Tube	Call	Location	Characterization	Sleeve Material
75	17	SCI ¹	15S ² - 4.40"	Upper Lower Roll Upper Transition	690
79	1	MAI ³	UTE ⁴ - 0.53"	Upper Roll Upper Transition	690
79	5	SVI ⁵	UTE - 2.14"	Upper Roll Lower Transition	690
79	5	SCI	UTE - 1.31"	Upper Roll Expansion	690
81	1	MAI	UTE - 0.55"	Upper Roll Upper Transition	690
82	3	SCI	UTE - 1.47"	Upper Roll Expansion	690
102	4	SCI	UTE - 1.44"	Upper Roll Expansion	600

The seven (7) indications listed above all occur in the parent tube and are considered to be non-service induced. Due to their location and small size, the cause of the indications is attributed to either scratches associated with sleeve installation which are within the detectability of the Plus Point probe, or to inspection anomalies associated with the use of the Plus Point probe.

All sleeve/tube joints were inspected with a Plus Point probe. The sleeve freespan area was inspected with a bobbin probe. No indications were reported in the freespan area of the sleeves. The above listed tubes have been removed from service by plugging.
