TITLE: AFPT Overspeed Trip Throttle Valve Problem

REPORT BY: R. J. Gradowski

DATE PREPARED: 6/20/85

I. INTRODUCTION

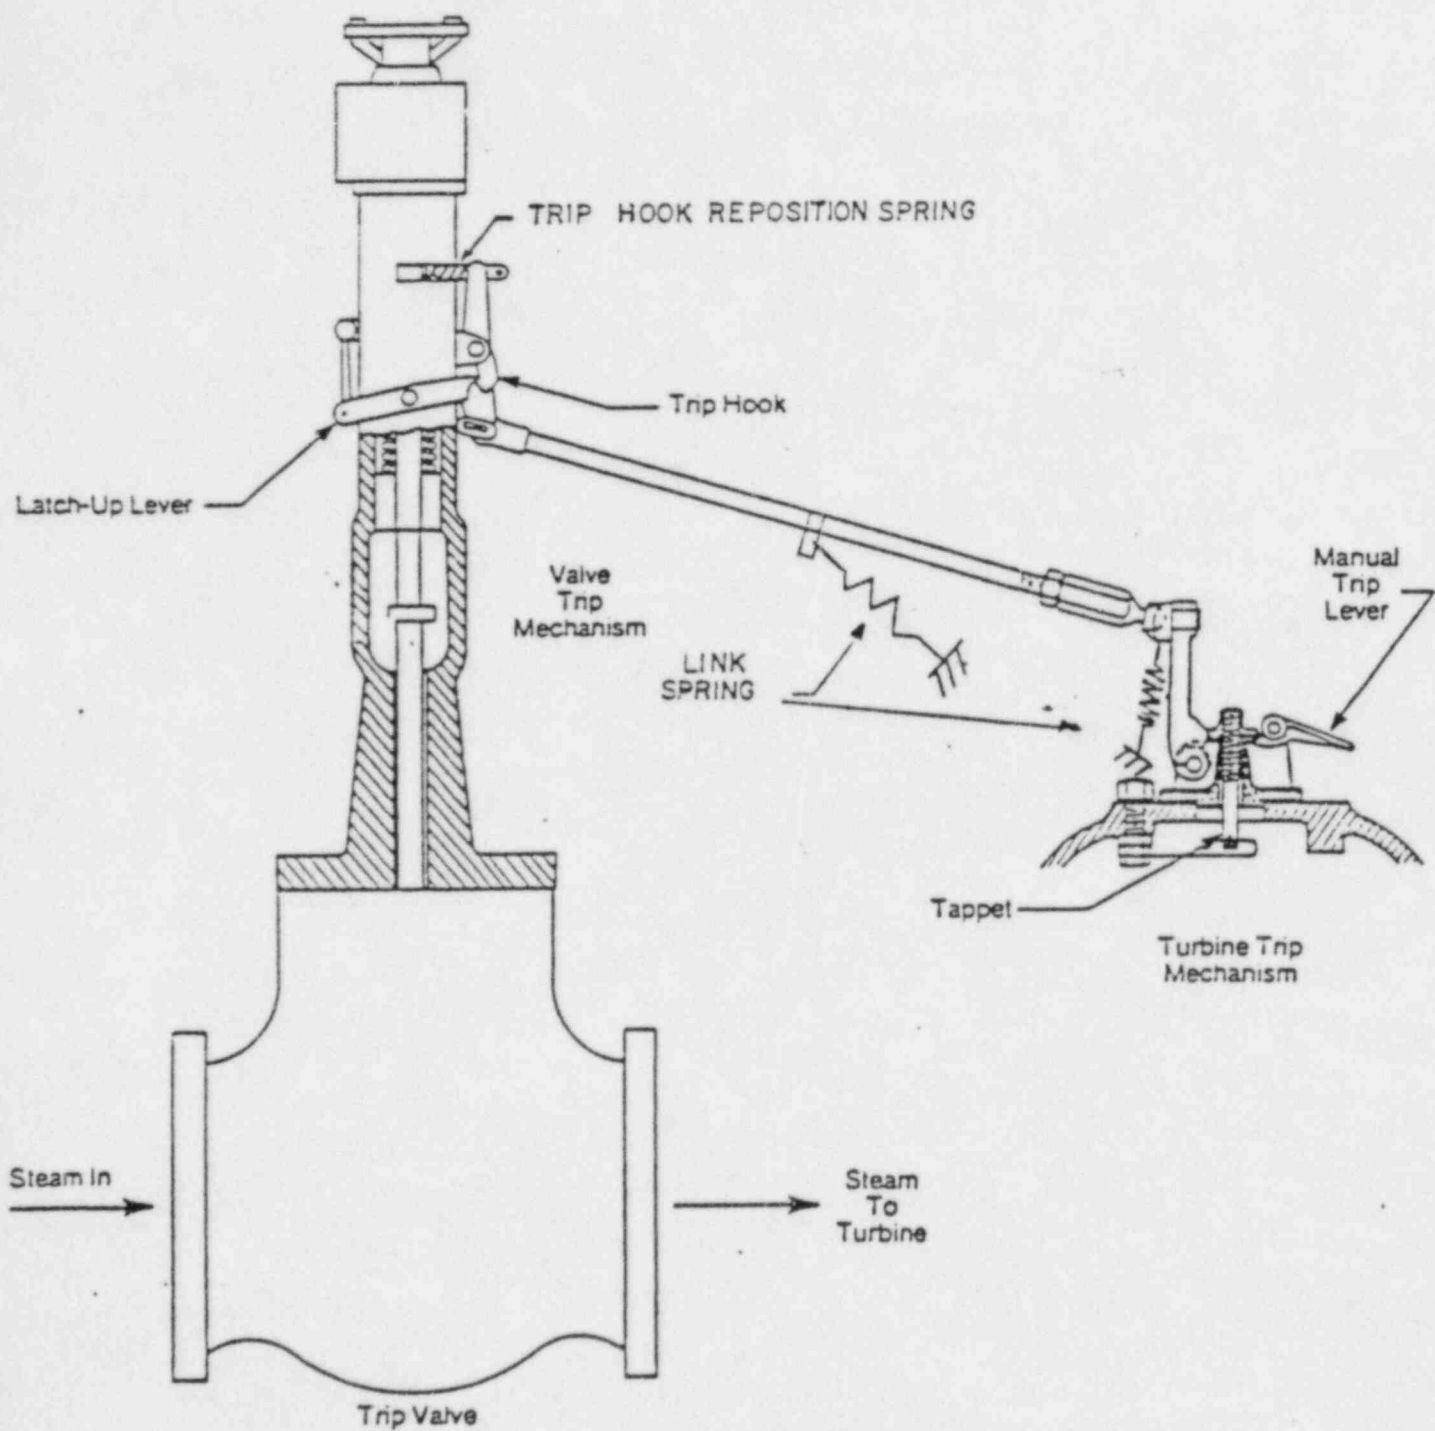
Figure 1

1) The tappet* of the turbine trip mechanism did not return to its normal position while attempting the relatch evolution, 2) The spring that provides the relatching force for the trip hook is defective or inadequate, 3) The pivot point of the trip hook is not sufficiently free to assure proper engagement of trip hook to latch-up lever, and/or 4) The linkage mechanism may not be adjusted correctly.

Latching AFW Turbine Trip Valve (Typical Sketch)
