WCAP-10453

METALLURGICAL INVESTIGATION OF
THE RECORDED UT INDICATIONS IN THE
STEAM GENERATOR STUB BARREL
TO LOWER SHELL WELD AT
BYRON 1 STATION

December, 1983

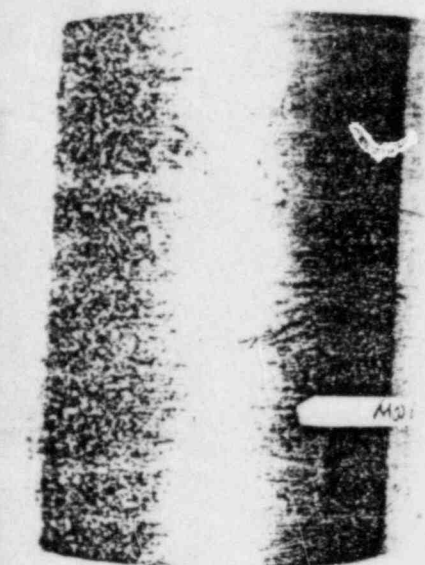
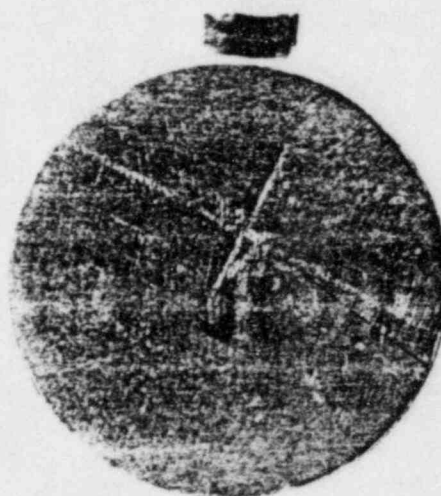
FIGURE 2-1.

The results of the surface examinations on the two plugs (Plug Nos. 93 CCW and 113 CCW) are illustrated in Figures 2-1 through 2-4. Examination of the Plug 93 CCW in the as-received and slightly polished condition showed no evidence of cracks, voids or discontinuities on the outside diameter surface. Examination of the surface condition of the end face of the plug (which corresponded to the inside diameter surface of the steam generator outer shell), however, showed some evidence of what appeared to be isolated inclusion sites along the weld line (Figure 2-3). Similar examinations on Plug 113 CCW showed evidence of a deep void on the outside diameter surface of the plug, at a location approximately 0.37 inches below the end face (shell ID surface). The appearance of the void is illustrated by the light optical macrograph in Figure 2-4. No evidence of any abnormal surface condition was seen on the end face of Plug 113 CCW. The end faces of both the plugs corresponding to the ID surface of the steam generator outer shell, showed presence of grinding marks, presumably introduced during surface cleaning subsequent to welding.

AS-RECEIVED SURFACE APPEARANCE OF PLUG NO. 93 CCW
 (a) CYLINDRICAL SURFACE APPEARANCE.
 (b) END VIEW SHOWING SG SHELL ID SURFACE. THE WHITE
 LONGER CHALK MARK INDICATES THE ORIENTATION AND
 LOCATION OF REPORTED INDICATION.

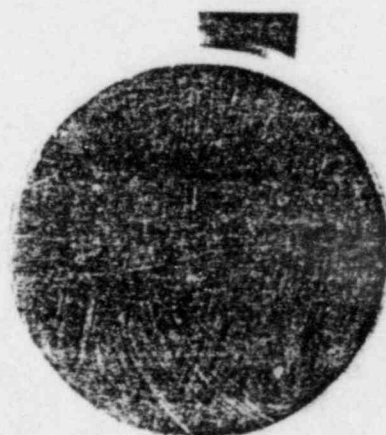
FIGURE 2-2.

AS-RECEIVED SURFACE APPEARANCE OF PLUG NO. 113 CCW

(a) CYLINDRICAL SURFACE SHOWING THE
LOCATION OF VOID.

(b) END VIEW OF THE PLUG SHOWING THE STEAM
GENERATOR SHELL ID SURFACE.

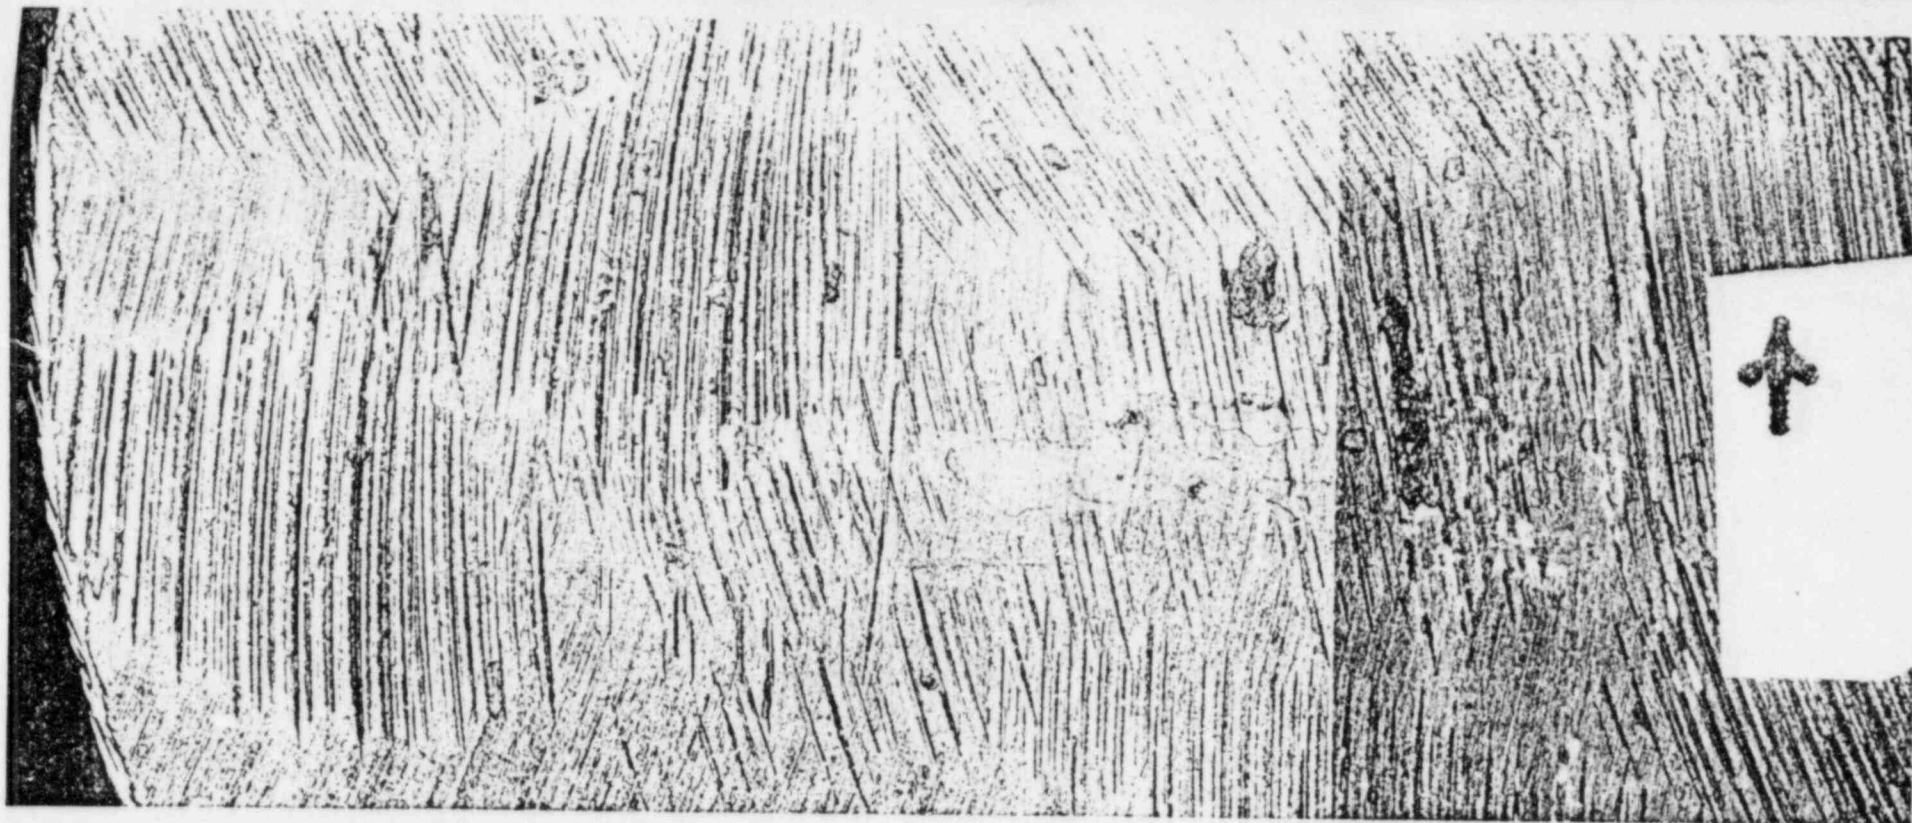
FIGURE 2-3. LIGHTLY POLISHED APPEARANCE OF THE ID SURFACE OF THE STEAM GENERATOR SHELL (PLUG NO. 93 CCW). (ARROW INDICATES SG TOP DIRECTION, AND THE LONG CHALK MARK CORRESPONDS TO THE ORIENTATION OF REPORTED INDICATION AND CIRCUMFERENTIAL WELD.)

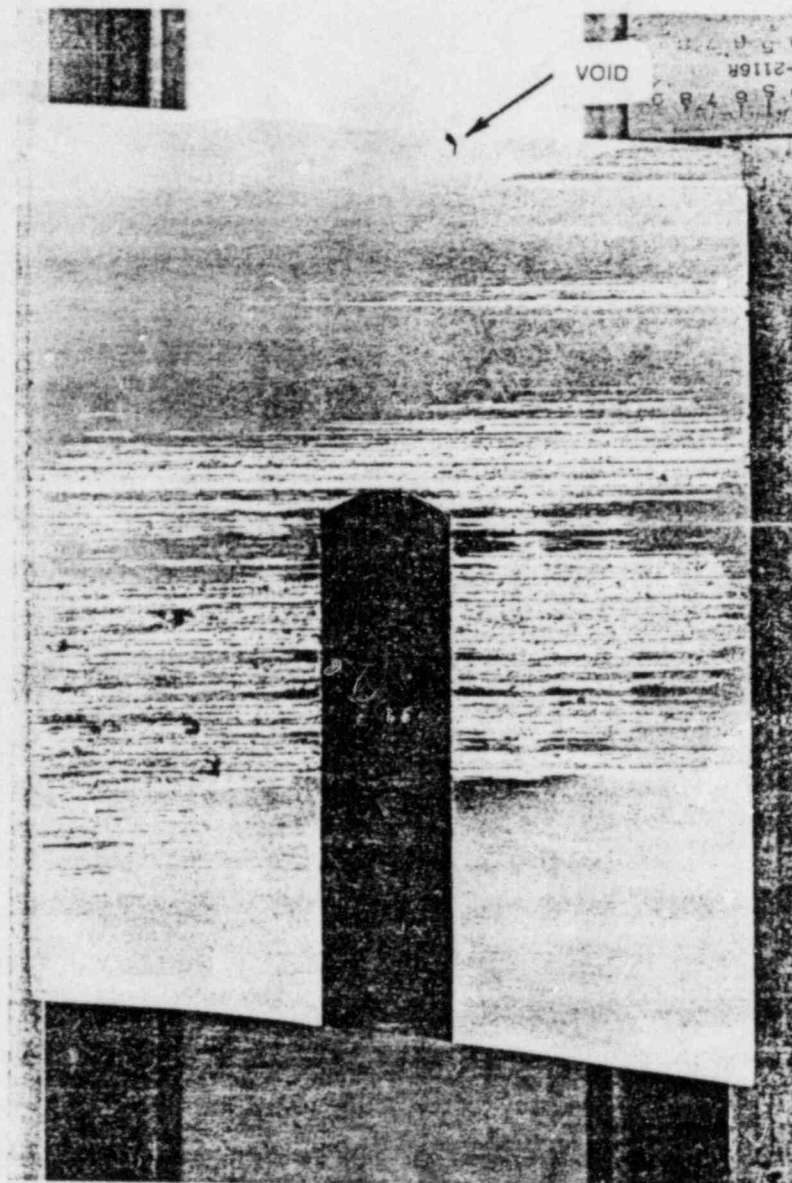
FIGURE 2-5.

APPEARANCE OF THE AS-POLISHED SECTION TAKEN
DIAMETRICALLY THROUGH THE PLUG NO. 93 CCW.
THE SECTION IS TAKEN TRANSVERSE TO THE INDICATION
(AS MARKED ON THE PLUG) AT ITS MID-LENGTH LOCATION.

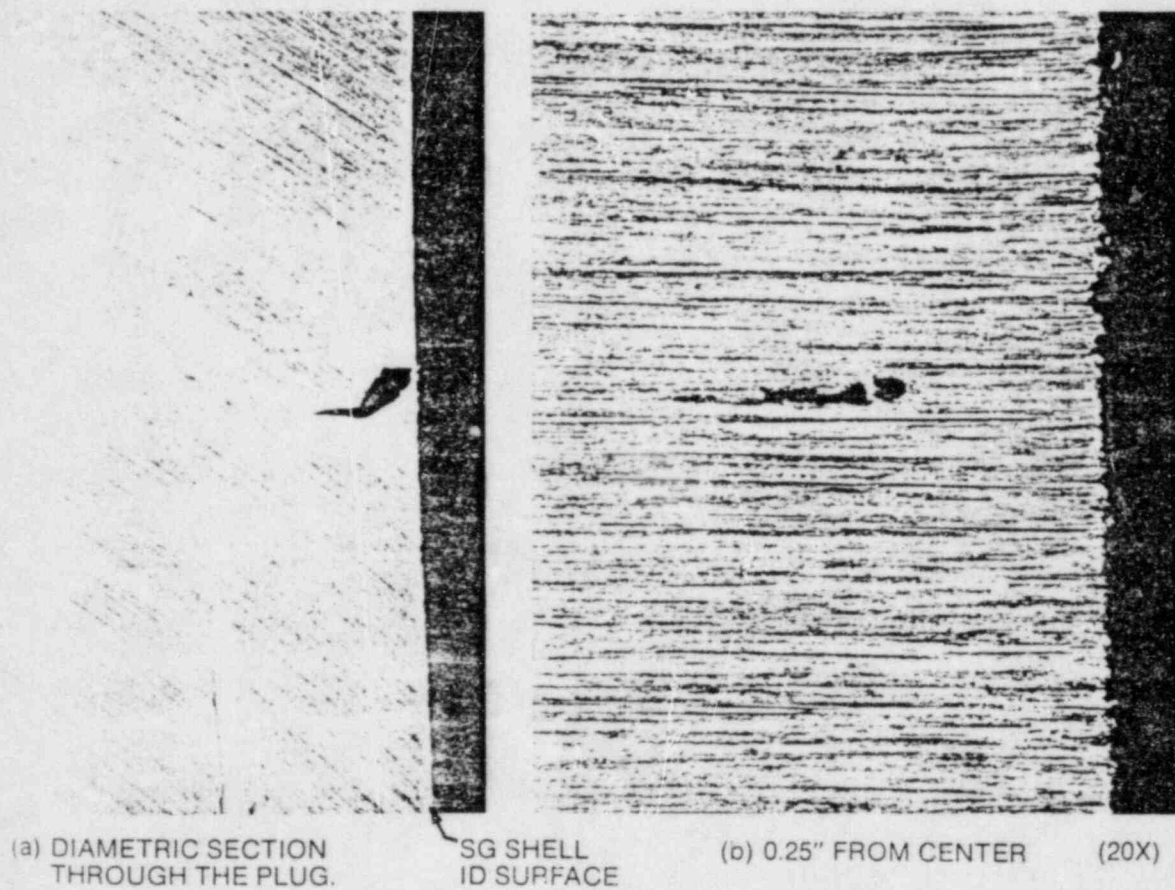
below the surface at one of its termination, 0.5" away from the mid-section. The depth and width of the discontinuity itself, however, appeared maximum at its mid-section (Figure 2-6a) measuring approximately 0.09 inches deep and 0.01 inches wide. Metallographic examination results of the polished and etched sections of Plug 93 CCW are illustrated in Figure 2-8 through 2-10. The morphology of the discontinuity and its relationship to the local microstructure are clearly illustrated here in the micrographs. The morphology of the discontinuity varied from approximately a tear drop shape at its mid-length to a planar shape, which then turned into two isolated voids as it approached its termination. The discontinuity is located at the weld metal to base metal interface at the root gap of the weld. Figure 2-10 clearly illustrates that the two voids connected to the discontinuity are located at the weld metal-to-base metal interface. Evidence of trapped slag inclusion in one of the voids can also be seen here. Examination of a number of sections taken along the weld line confirmed that the total length of the discontinuity in Plug 93 CCW is approximately 1.15 inches. Figure 2-11 illustrates the morphology of the discontinuity in Plug 113 CCW on an axial section transverse to the weld and at 0.325 inches from the outside diameter surface of the plug. The morphology here consists of three isolated voids connected with a thin crack-like opening. Light optical metallographic examination results of the polished and etched section 0.125 inches from the OD surface of the plug are illustrated in Figure 2-12. As can be seen here the discontinuity is located at the weld bead interface and evidence of slag inclusion associated with the discontinuity can be seen here (Figure 2-12b). The discontinuity measured a maximum of 0.02 inches in width and 0.07 inches in depth. Examinations on sections taken progressively along the weld confirmed that the discontinuity is approximately 0.45 inches long. The overall results of the metallographic examinations on the two plugs showed that the observed discontinuities are located at the weld metal-to-base metal interface and that they are often associated with slag inclusions.

FIGURE 2-6.

APPEARANCE OF AS-POLISHED SECTIONS TAKEN AXIAL TO
THE PLUG NO. 93 CCW ILLUSTRATING THE MORPHOLOGY
OF VOIDS AT VARIOUS LOCATIONS.

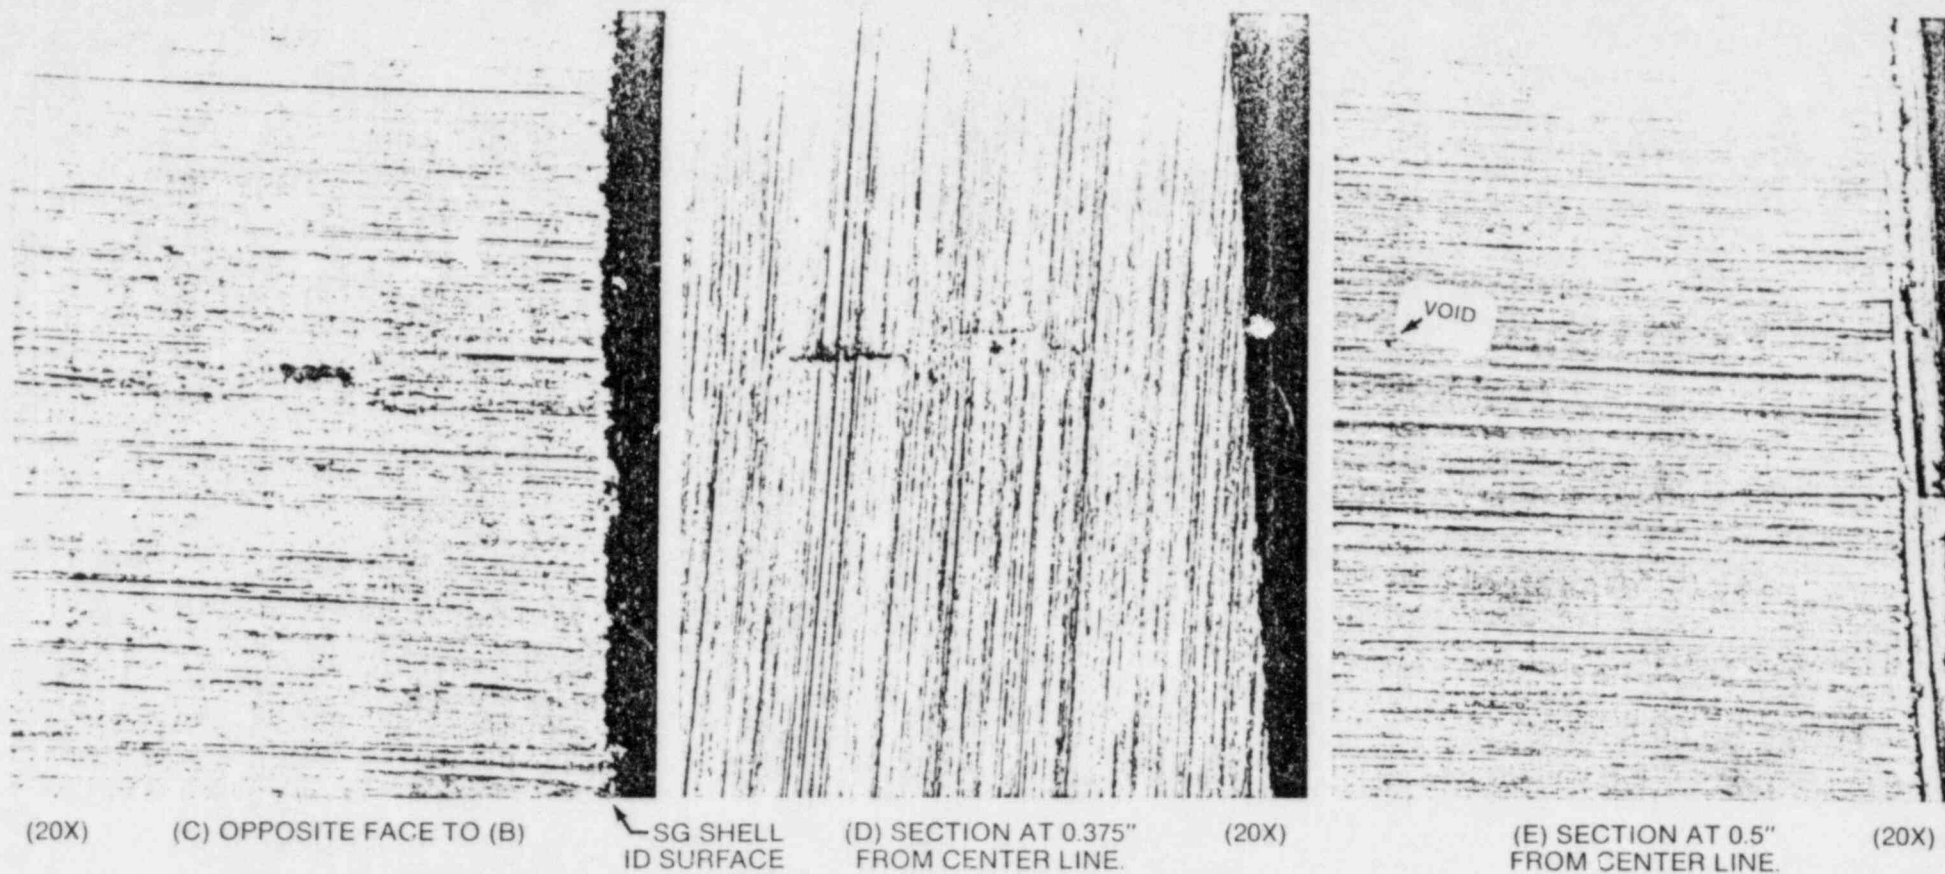
FIGURE 2-7. APPEARANCE OF AS-POLISHED SECTIONS TAKEN AXIAL TO THE PLUG NO. 93 CCW ILLUSTRATING THE MORPHOLOGY OF VOID AT VARIOUS LOCATIONS.

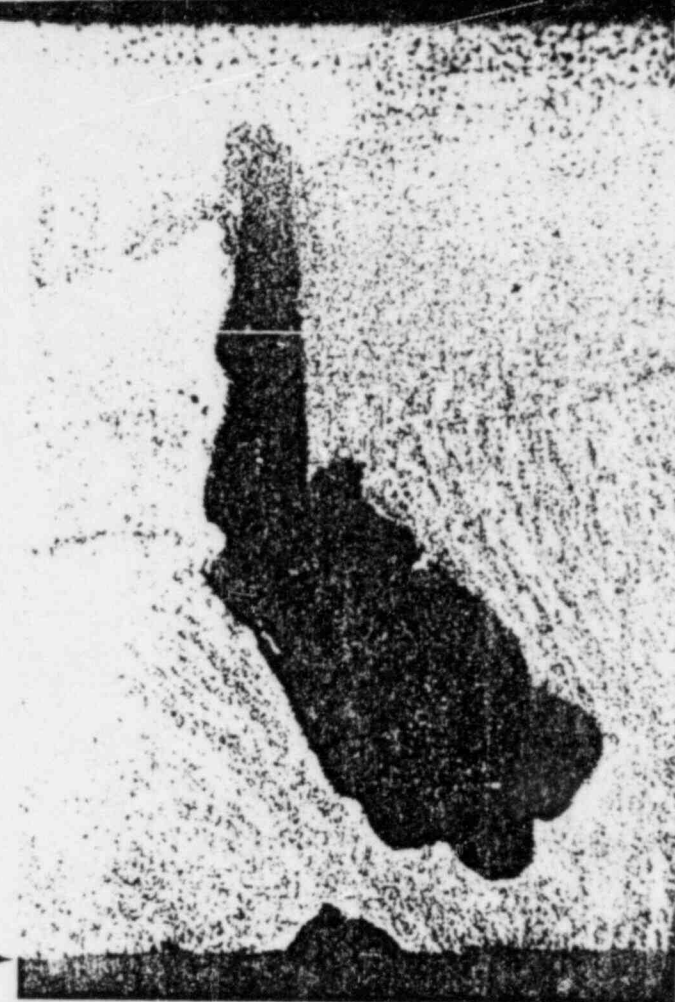
FIGURE 2-8.

LIGHT OPTICAL METALLOGRAPHY RESULTS, ILLUSTRATING THE VOID MORPHOLOGY AND ITS RELATION TO THE LOCAL WELD MICROSTRUCTURE. PLUG NO. 93 CCW, SECTION AT THE MID-LENGTH LOCATION OF REPORTED INDICATION.

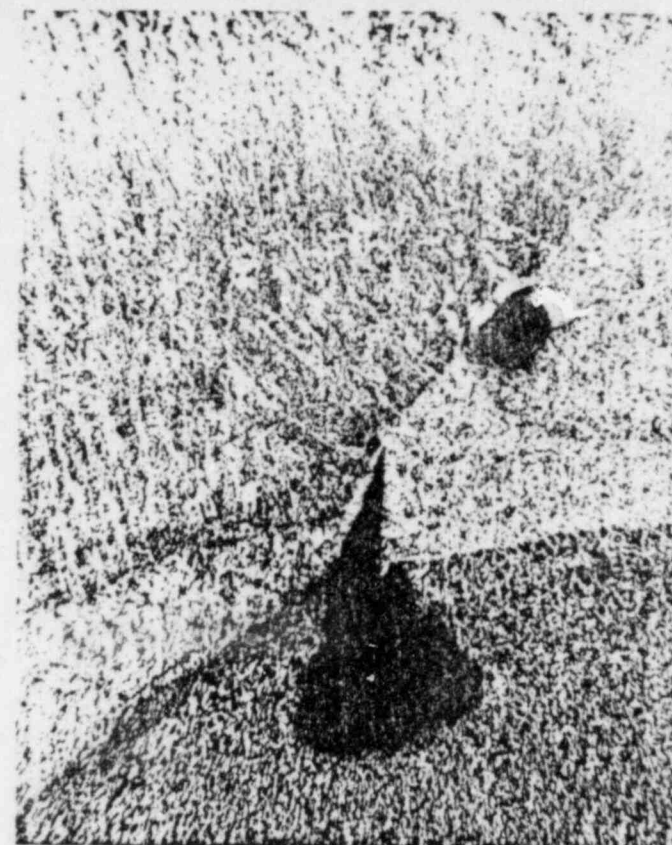
FIGURE 2-10. LIGHT OPTICAL METALLOGRAPHY RESULTS, ILLUSTRATING THE MORPHOLOGY OF THE VOID AND ITS RELATION TO THE LOCAL (WELD) MICROSTRUCTURE. PLUG NO. 93 CCW, SECTION AT 0.375" FROM THE MID-LENGTH LOCATION OF REPORTED INDICATION.

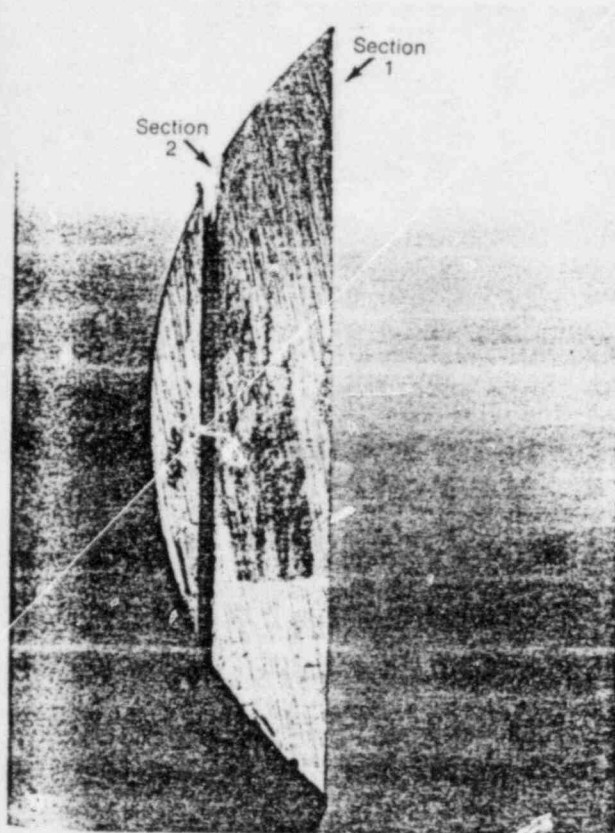
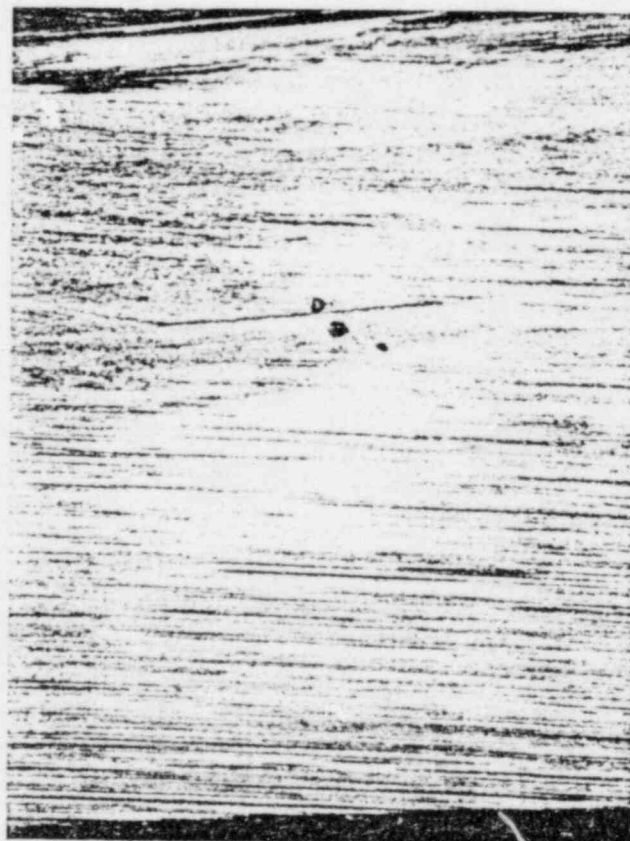
FIGURE 2-11.

APPEARANCE OF THE VOID ON A SECTION TAKEN AT
0.325" FROM THE OD SURFACE ON PLUG NO. 113 CCW.

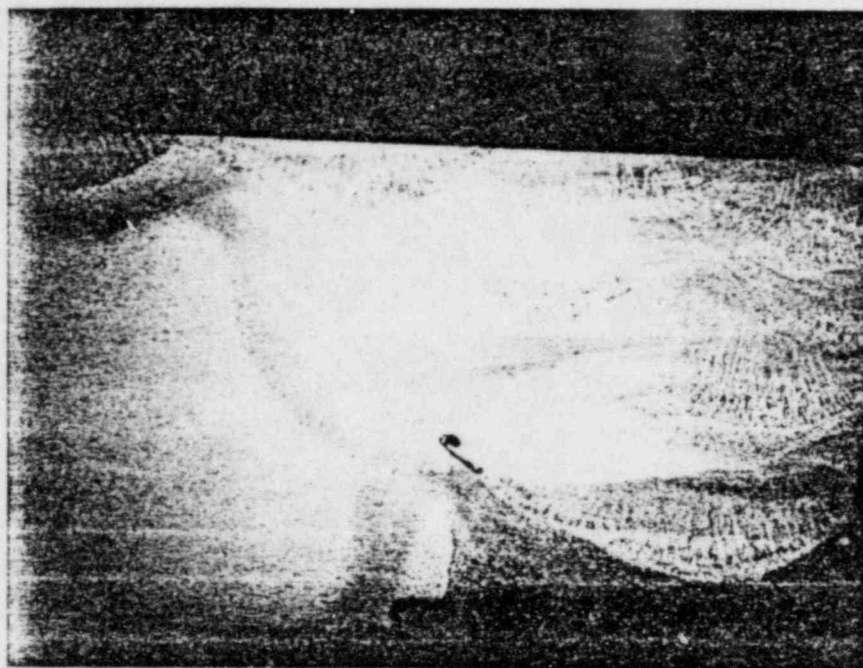
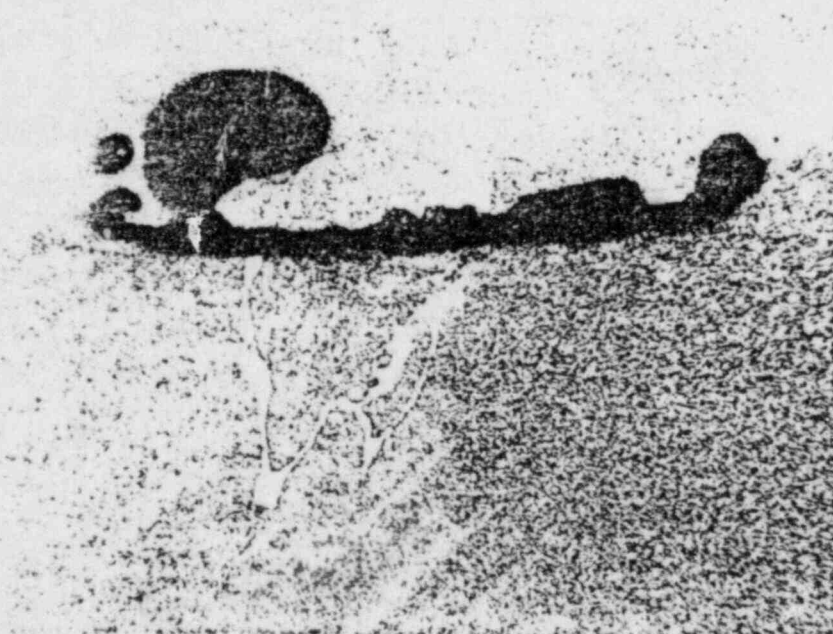
FIGURE 2-12. LIGHT OPTICAL METALLOGRAPHY RESULTS ILLUSTRATING THE MORPHOLOGY OF VOID AND SLAG INCLUSION AT THE WELD INTERFACE. (SECTION AT 0.125" FROM OD SURFACE OF PLUG NO. 113 CCW)

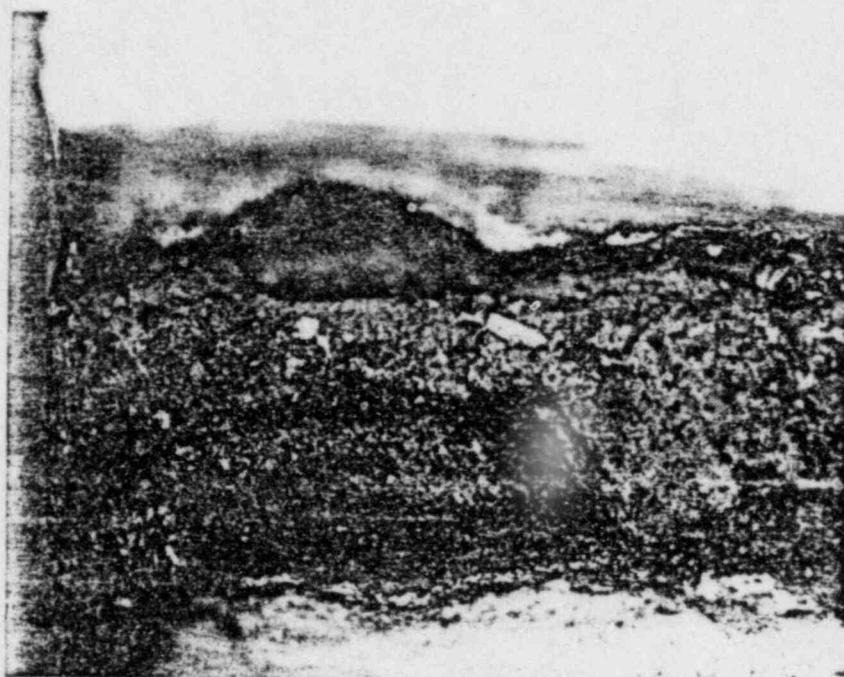
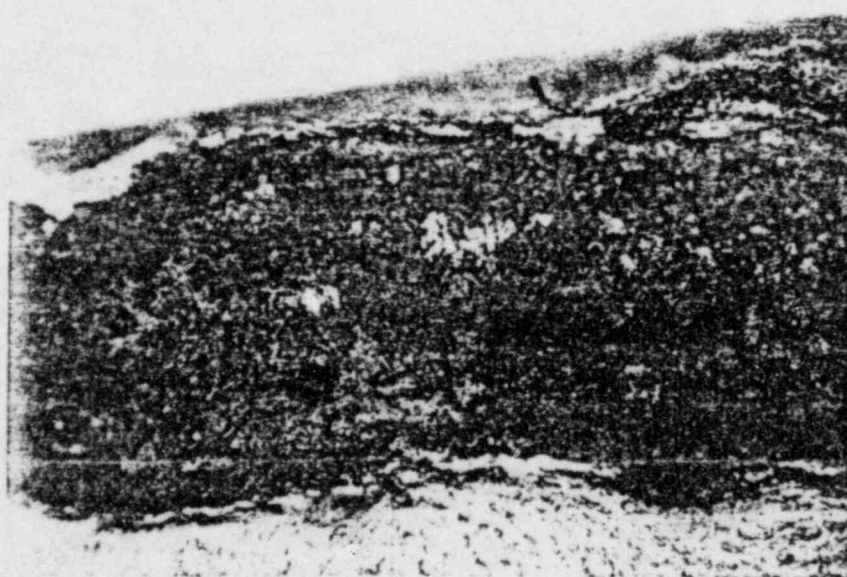
The results of the fractographic examinations are illustrated in Figures 2-13 through 2-17. Figure 2-13 illustrates light optical fractographs of a freshly opened (dry) discontinuity from Plug 93 CCW. The fractographs show evidence of dark colored oxide or slag deposits on the inside surface of the discontinuity. Higher magnification scanning electron fractographs of both freshly opened and endoxed discontinuity faces are illustrated in Figures 2-14 through 2-17. Figure 2-14 is a lower magnification scanning electron fractograph of a freshly opened discontinuity showing an overview of the discontinuity face and laboratory induced fracture. Figure 2-15 illustrates higher magnification fractographs of the discontinuity face and the laboratory frac-

FIGURE 2-13. LIGHT OPTICAL FRACTOGRAPHS OF FRESHLY OPENED INCLUSION VOID IN PLUG NO. 93 CCW SHOWING THE DARK DEPOSITS ON THE VOID ID SURFACE.

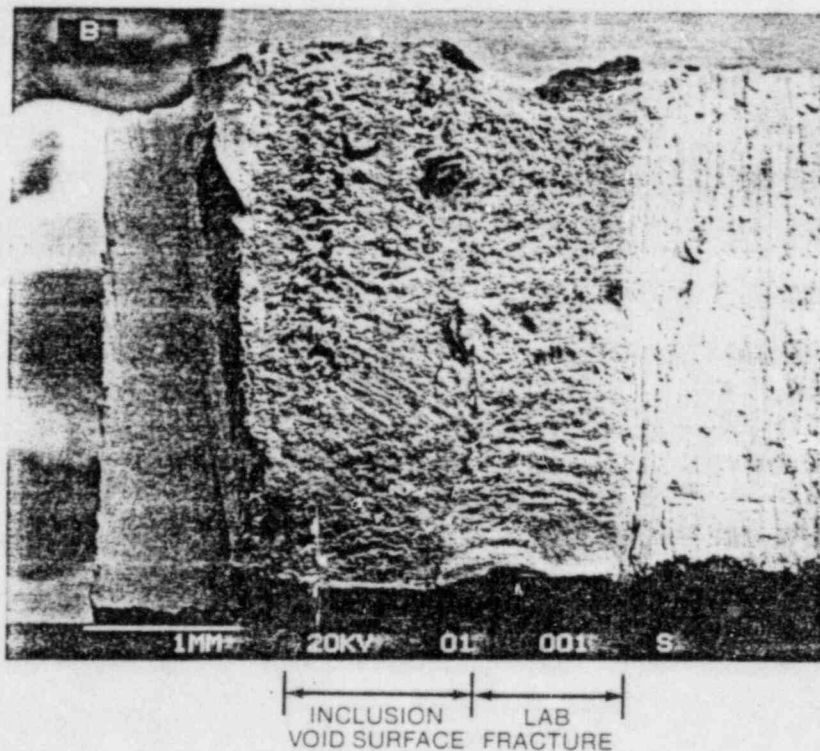
FIGURE 2-14.

SCANNING ELECTRON FRACTOGRAPH OF FRESHLY
OPENED VOID SURFACE FROM SAMPLE 93 CCW.

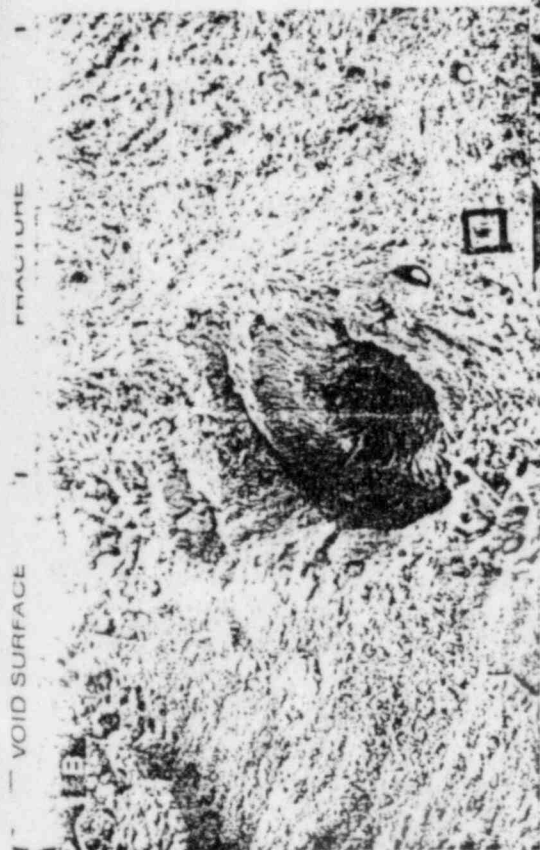
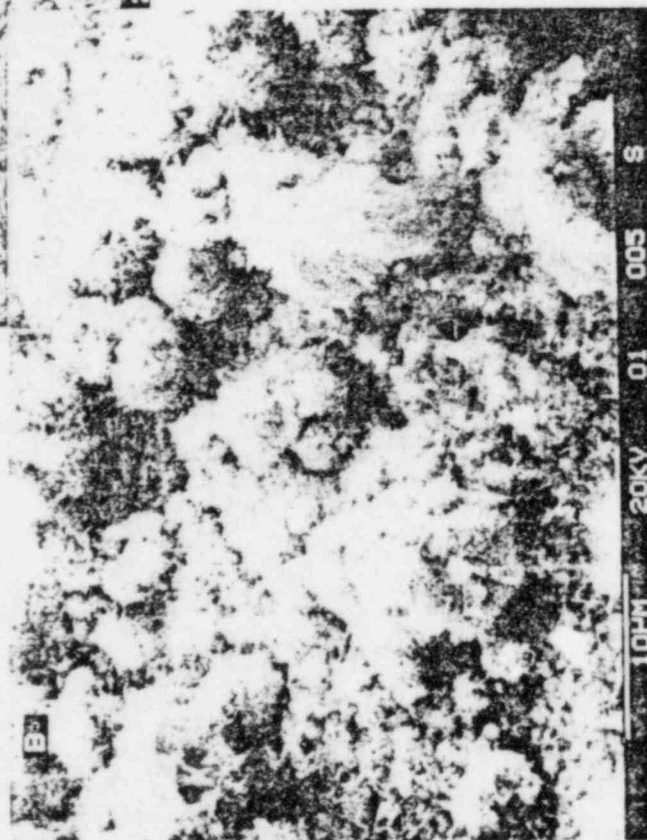
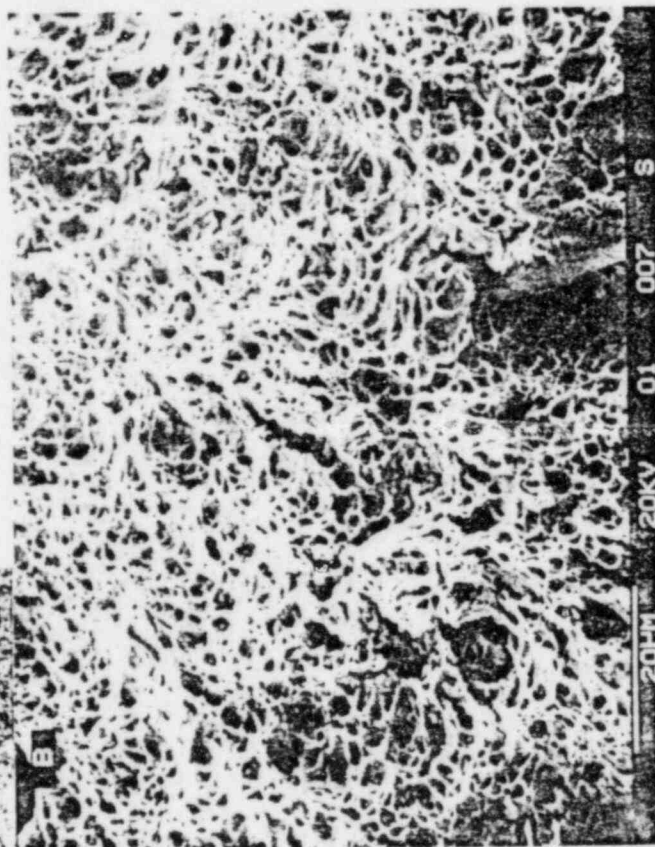
ture. As can be seen here, the discontinuity face showed presence of oxide or other slag deposits while the laboratory fracture is made of dimpled morphology. Figure 2-16 shows fractographs of the laboratory opened discontinuity in the freshly opened and endoxed conditions respectively.

(a) OVERALL VIEW OF FRACTURE SURFACE

(b) DEPOSITS AT THE INCLUSION SITE.

(c) LABORATORY INDUCED DIMPLED FRACTURE.

FIGURE 2-15. SCANNING ELECTRON FRACTOGRAPHS OF THE FRESHLY OPENED VOID IN PLUG NO. 93 CCW.

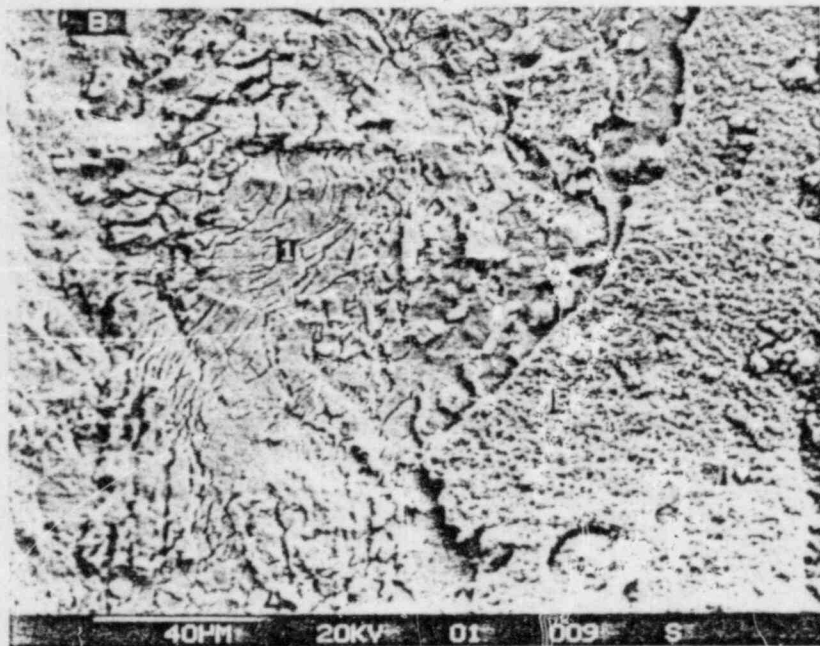
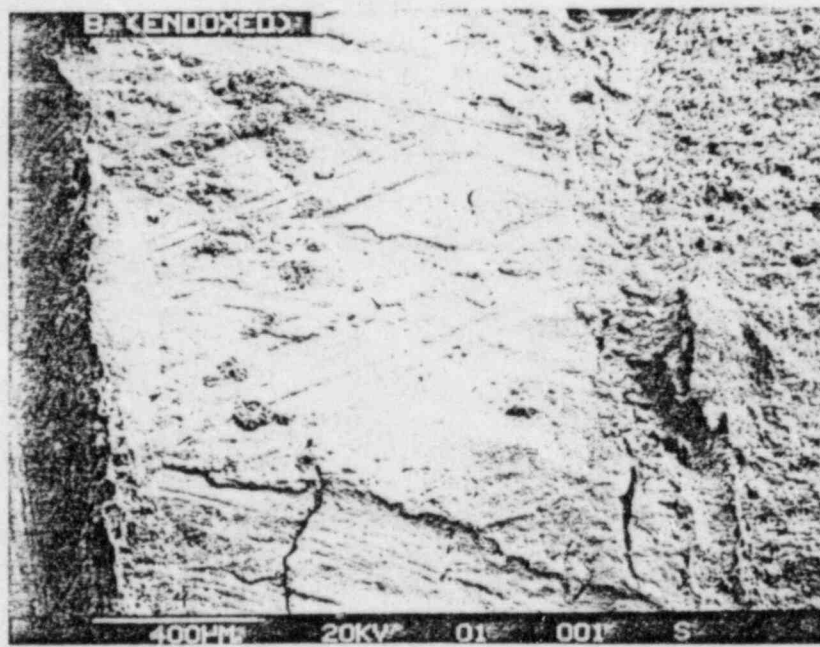
FIGURE 2-16. SCANNING ELECTRON FRACTOGRAPHS OF (a) AS-OPENED, AND (b) ENDOXED FRACTURE FACES. (PLUG NO. 93 CCW)

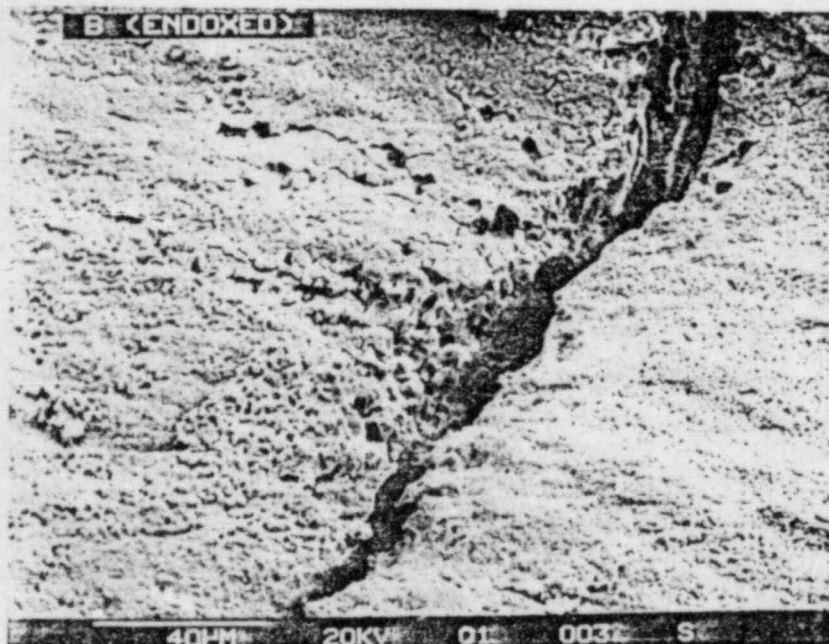
FIGURE 2-17.

Figure 2-17 is a higher magnification scanning electron fractograph of endoxed discontinuity face showing evidence of surface crazing presumably caused by the inclusion-base metal interactions at the interface. The crazing appearance was seen occasionally on the endoxed discontinuity faces at isolated local regions.

SCANNING ELECTRON FRACTOGRAPH SHOWING THE
CRAZING APPEARANCE AT THE INCLUSION SITE.
(ENDOXYD, PLUG NO. 93 CCW)

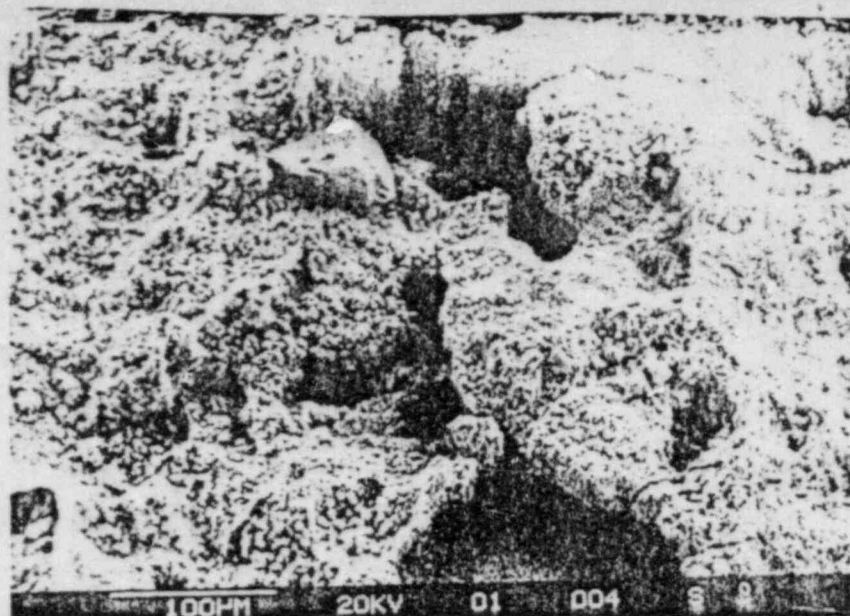
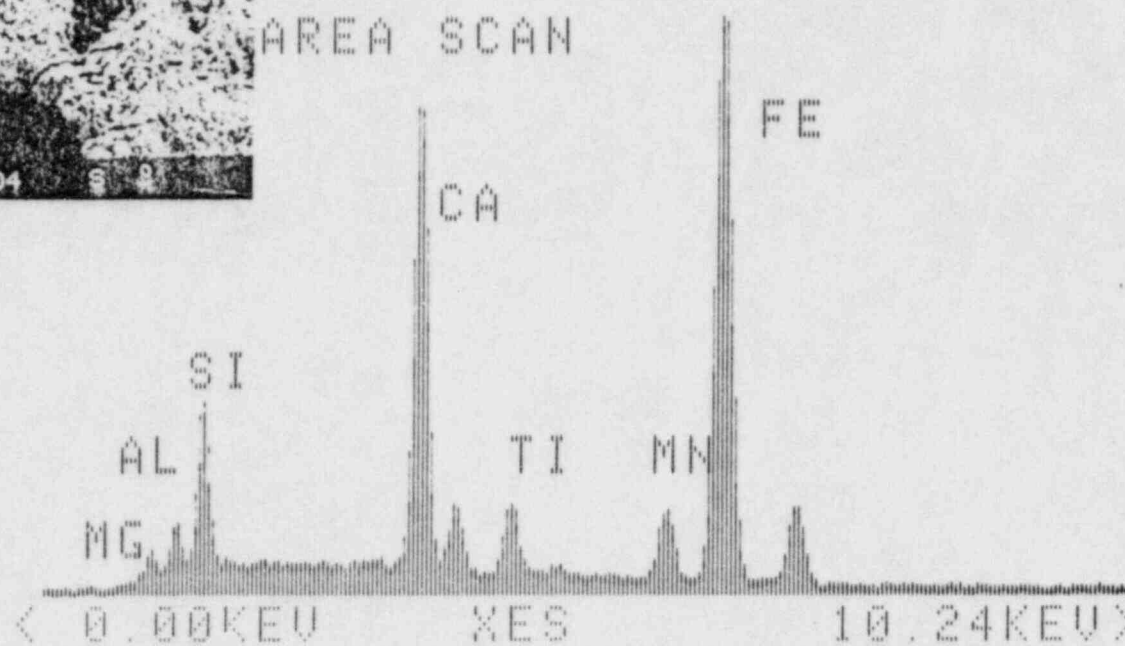
The results of the wet chemistry analysis of the weld metal are listed in Table 1. The results show that the weld metal contained significantly higher amounts of silicon and "sum of other elements" as compared to the specification requirements for SFA 5.17 Type EH14, Modified Flux Linde 0091. Chemistry evaluation results of the discontinuity deposits by energy dispersive x-ray analysis, illustrated in Figure 2-18 showed evidence of a number of elements such as magnesium, aluminum, silicon, calcium, titanium, that can be normally found in slag inclusion.

FIGURE 2-18. ENERGY DISPERSIVE X-RAY (EDAX) ANALYSIS RESULTS OF THE FRESHLY OPENED VOIDS IN PLUG NO. 93 CCW (AREA SCAN) (A) SCANNING ELECTRON FRACTOGRAPH. (B) EDAX SPECTRUM.
