UNITED STATES OF AMERICA
NUCLEAR REGULATORY COMMISSION

BEFORE THE FACT-FINDING TASK FORCE

RE: Davis-Besse Event of June 9, 1985

This report documents the review of data from previous unit trips, the 6/9/85 trip, AFPT testing, and other utility overspeed trips to determine possible causes of the overspeed trips which occurred at Davis-Besse on 6/9/85. Based on this review, this report presents hypothesized causes of the observed overspeed.

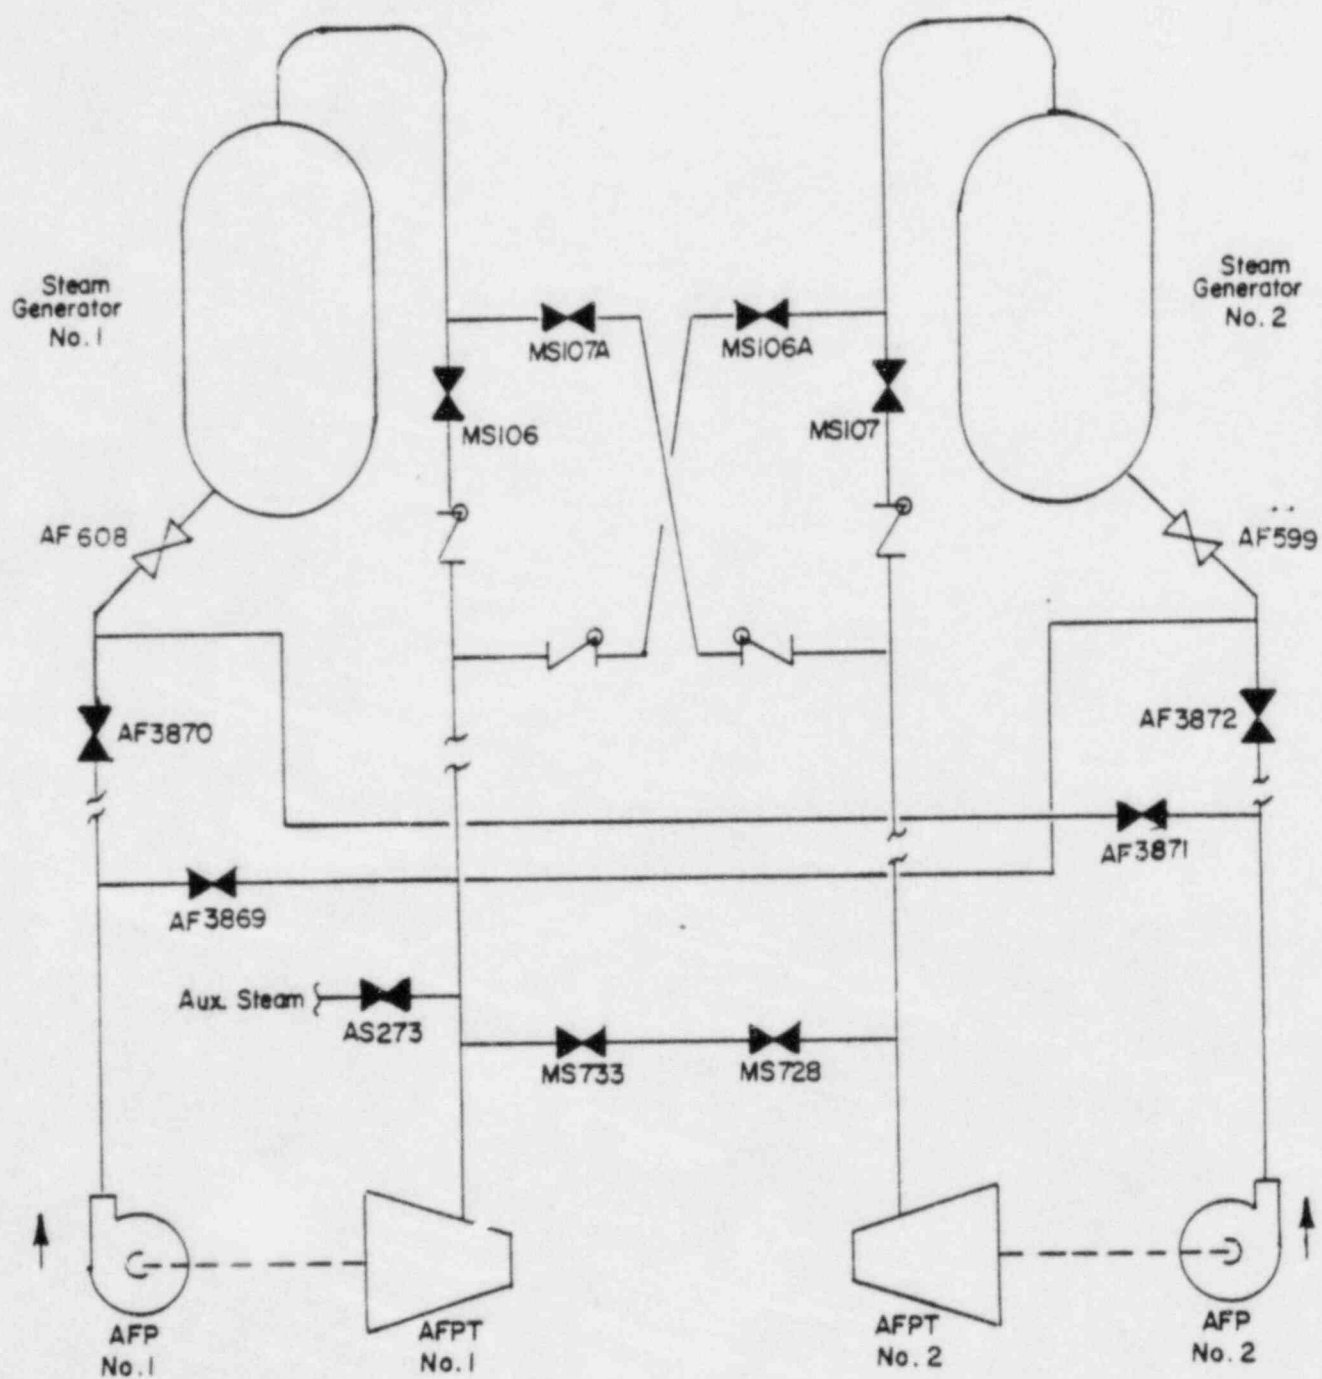
Figure 1

3. MS 107 (SG #2 feed to AFPT #2) - The pipe length of this run is approximately 125 feet. Immediately downstream of MS 107 is a downhill run. The total length of the pipe run has an almost continual downhill flow (i.e., very few long lengths of horizontal pipe) dropping from elevation 623 to elevation 565. Any condensation is expected to become entrapped in the steam flow or be carried as small slugs.

4. MS 107A (SG #1 feed to AFPT #2) - The pipe length of this run is approximately 375 feet. Immediately downstream of MS 107A is a 250 foot length of essentially horizontal pipe except for a 7 foot rise near the end of the run. After the rise is a short horizontal run and then the steam supply line has a 14 foot drop and is tied to the steam supply pipe described in item 3 above, immediately downstream of MS 107. The rise, after a long horizontal run, will enable water slugs to form at the bottom of the rise and be carried downstream after filling the pipe.

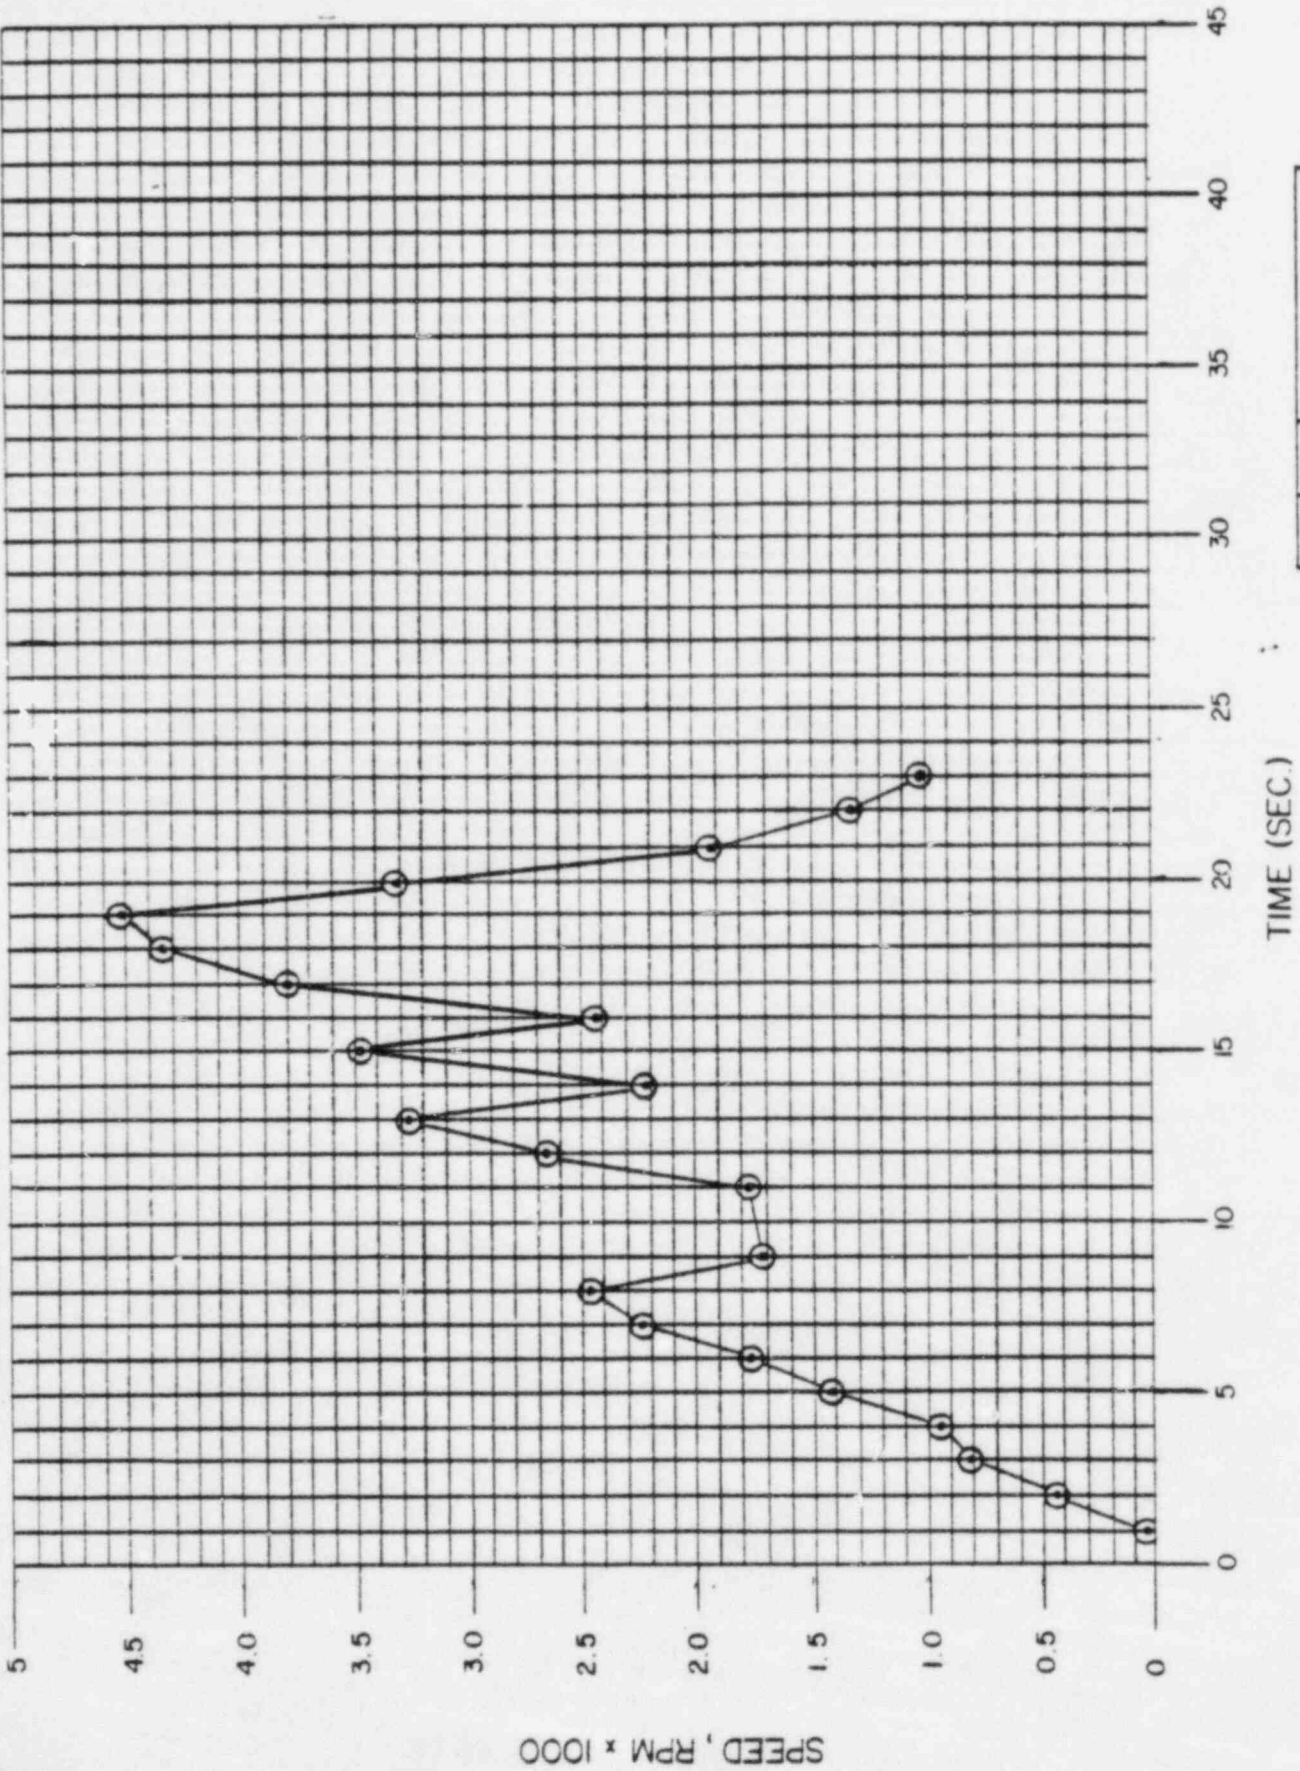
Figure 2

AUX.-FEED PUMP # 1
DATE: 6/9/85 TRIP

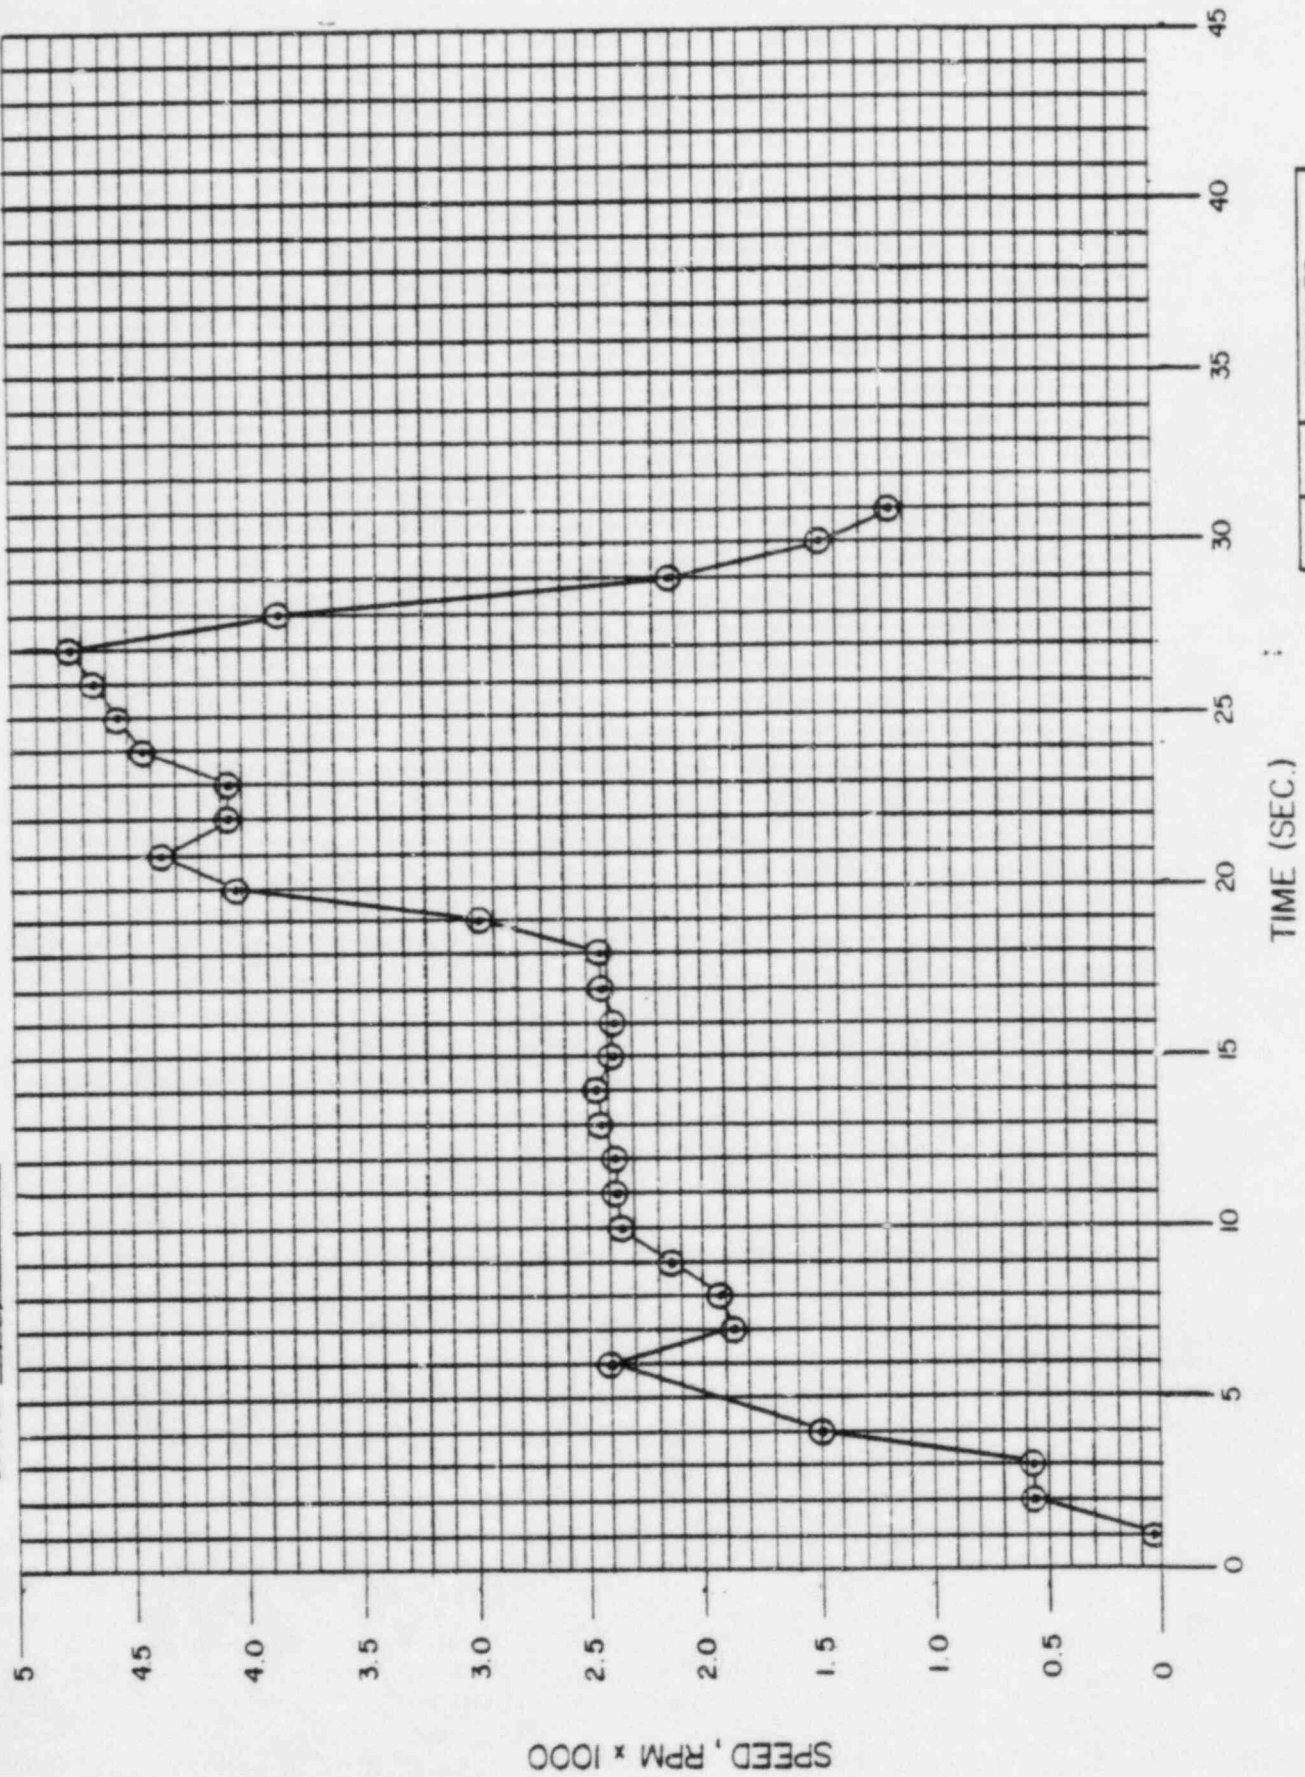
Figure 3

AUX.-FEED PUMP # 2
DATE: 6/9/85 TRIP

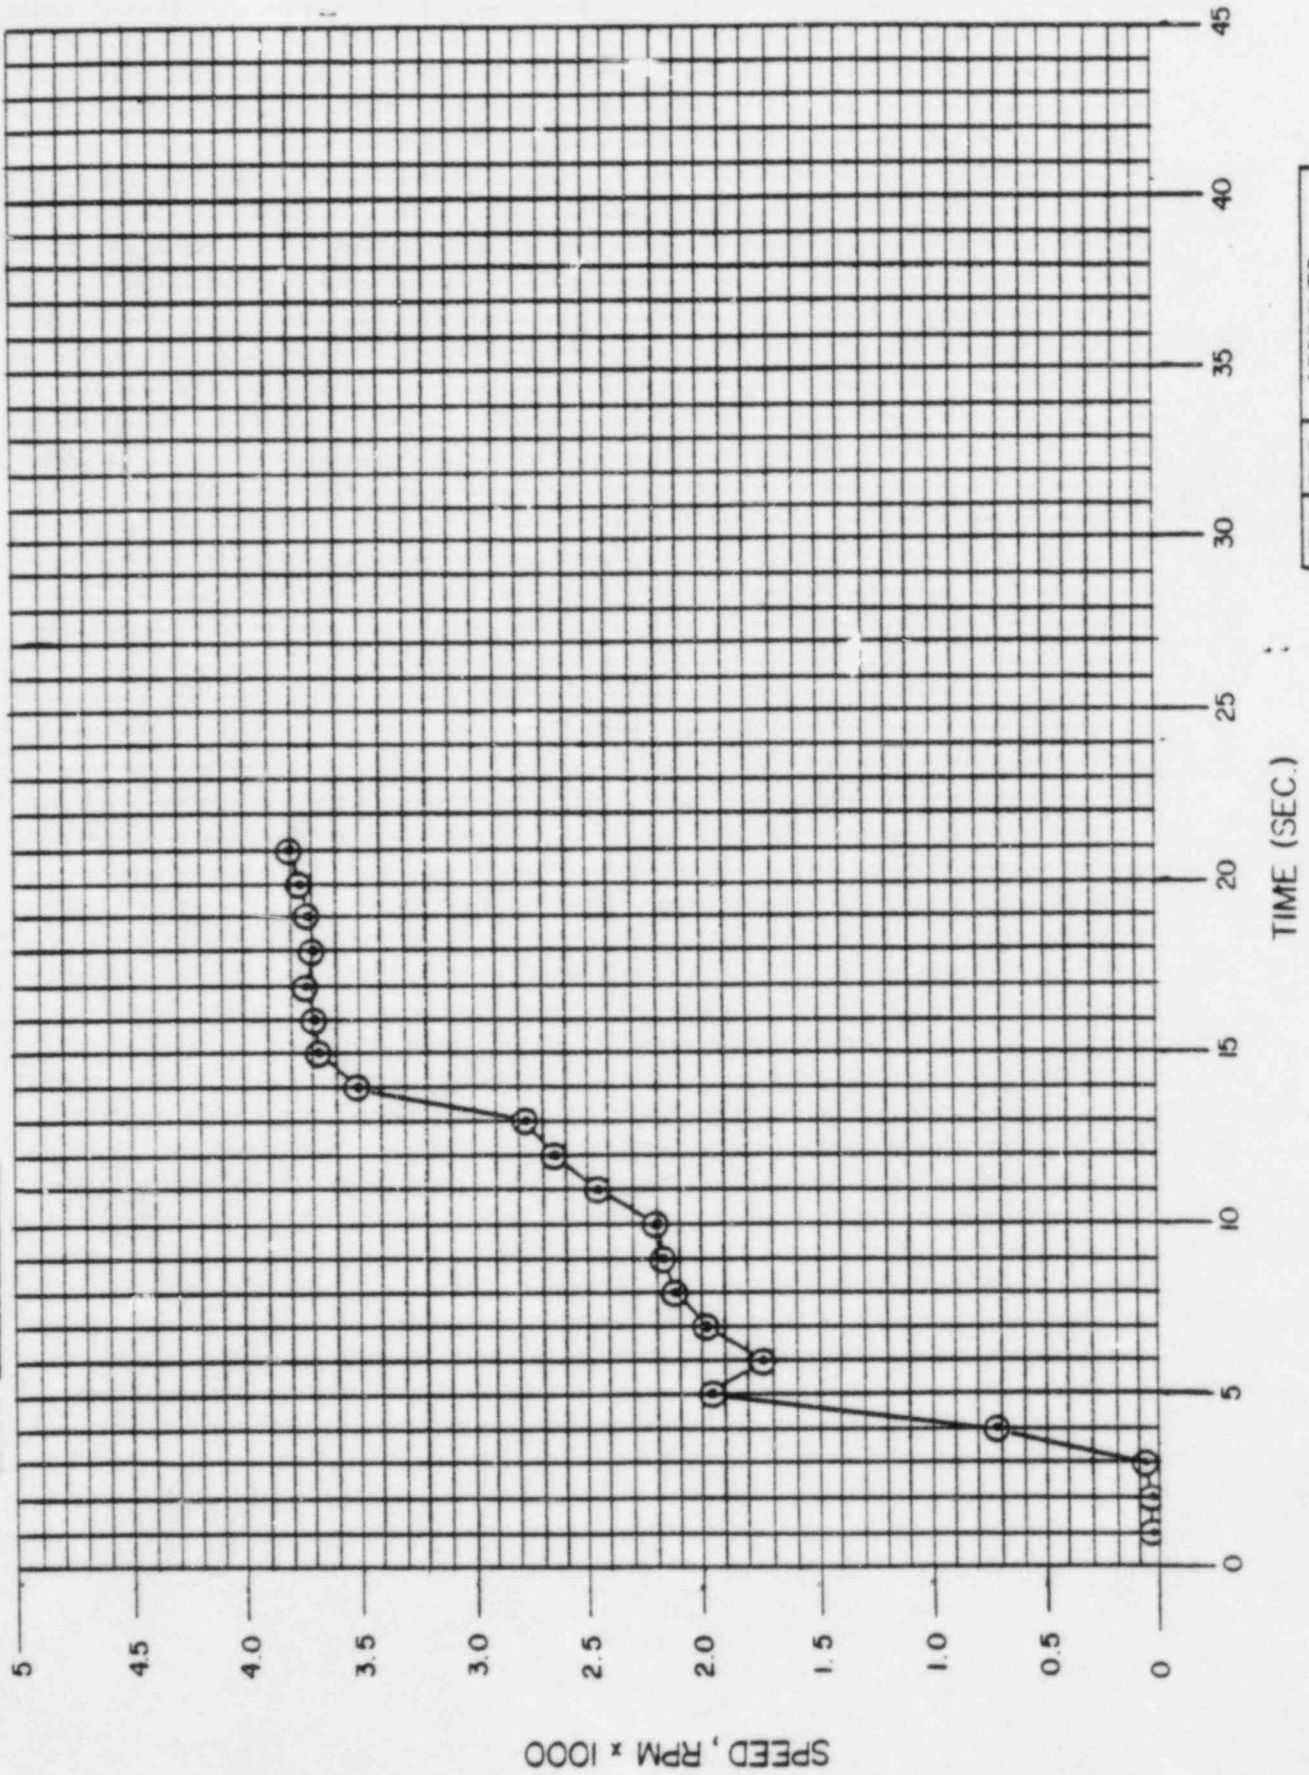
Figure 10

Technical Specifications. These tests were run on the normal steam supply path via MS 107 and with the pump discharge valves closed (i.e., min-recirc path open). Less than 24 hours prior to these two (2) tests some additional testing was done on this same turbine using the same valve line-ups. This prior testing was performed for trouble-shooting. Due to the prior testing, the steam lines may not have been cooled to ambient conditions prior to the two (2) operability tests being run. The speed characteristics are shown in Figures 10 and 11 of Attachment 2.

AUX.-FEED PUMP # 2
DATE: 4/12/85 TESTING, FIRST RUN

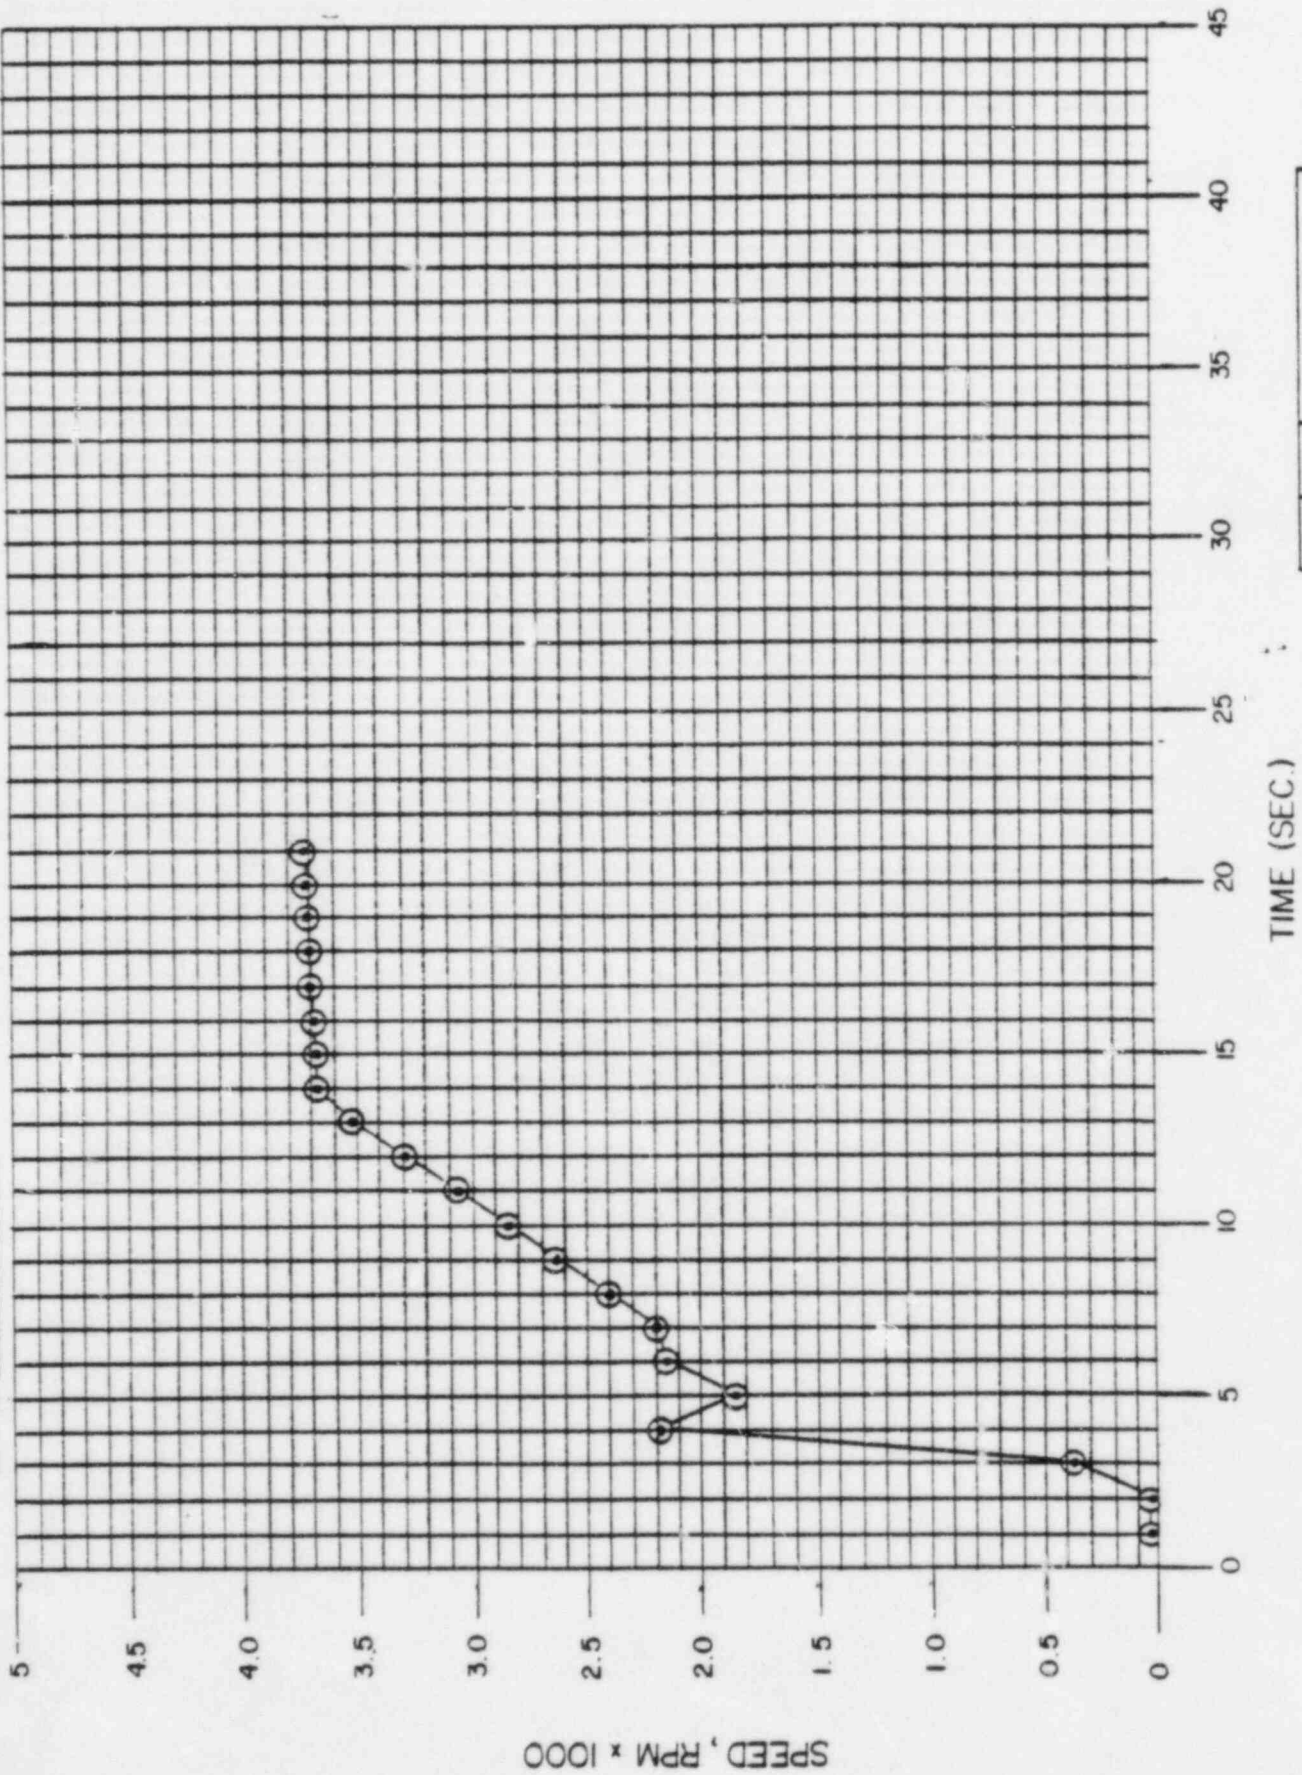
Figure 11

AUX.-FEED PUMP # 2
DATE: 4/12/85 TESTING, SECOND RUN

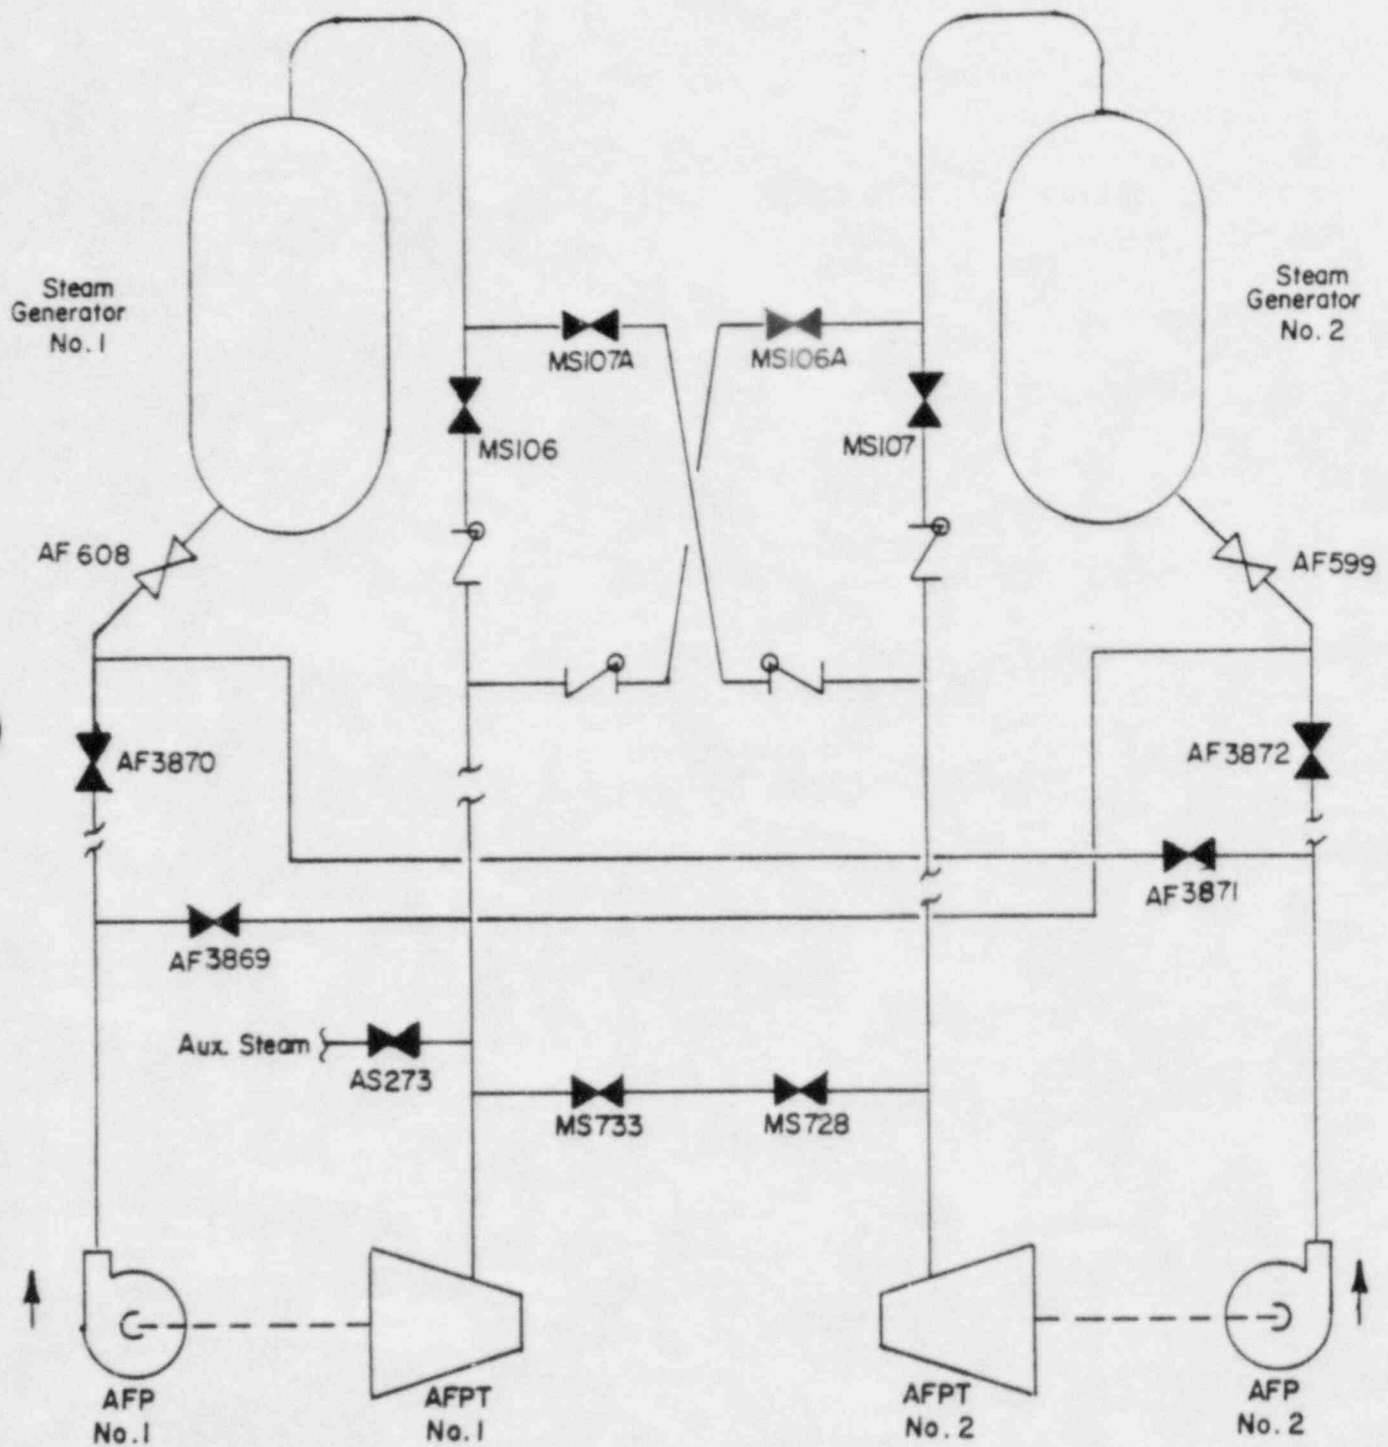
Figure 1

4. MS 107A (SG #1 feed to AFPT #2) - The pipe length of this run is approximately 375 feet. Immediately downstream of MS 107A is a 250 foot length of essentially horizontal pipe except for a 7 foot rise near the end of the run. After the rise is a short horizontal run and then the steam supply line has a 14 foot drop and is tied to the steam supply pipe described in item 3 above, immediately downstream of MS 107. The rise, after a long horizontal run, will enable water slugs to form at the bottom of the rise and be carried downstream after filling the pipe.

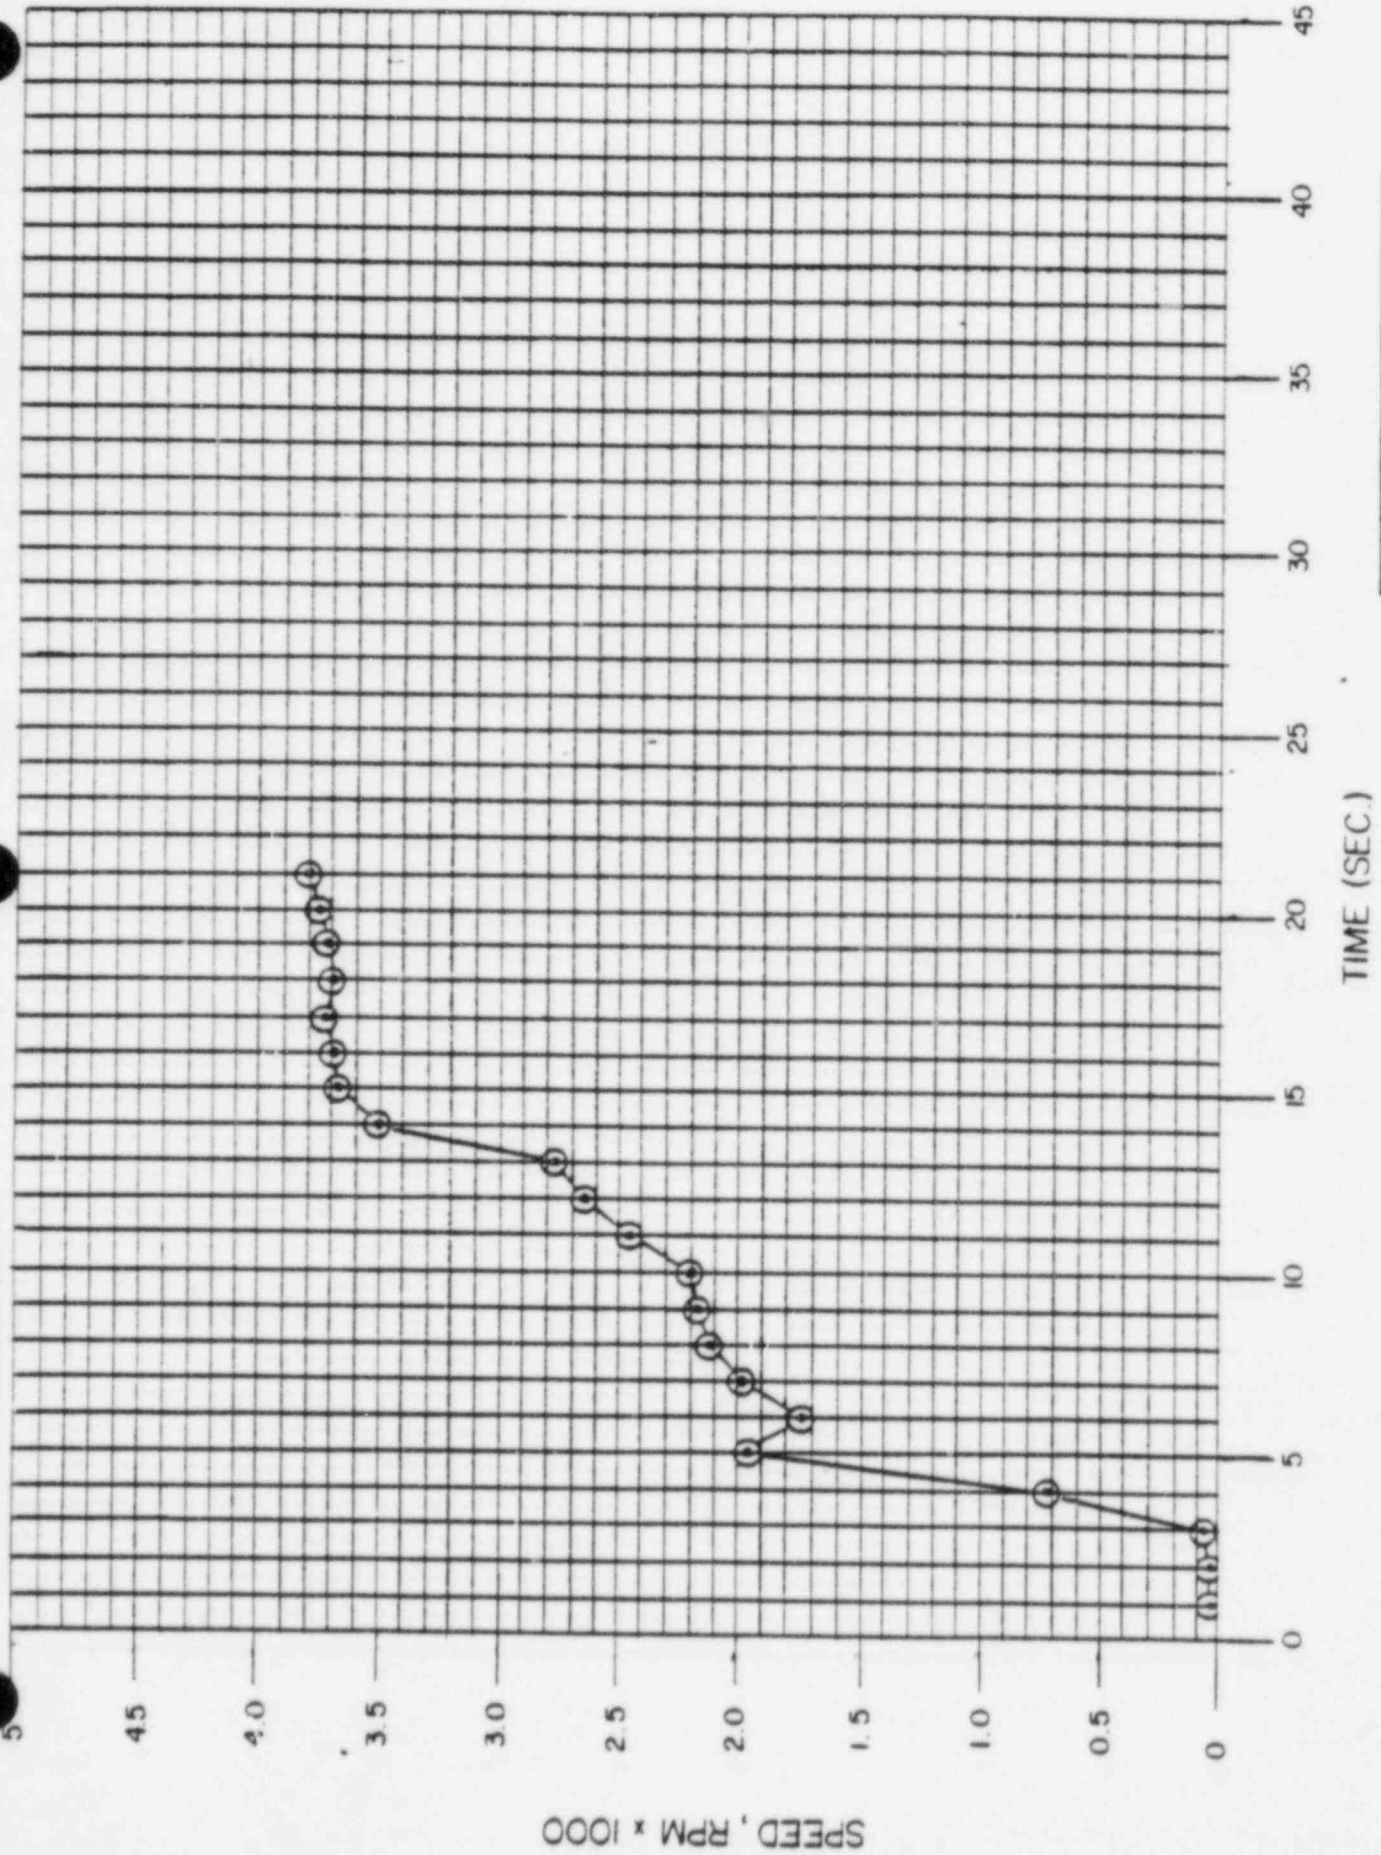
Figure 10

AUX.-FEED PUMP
DATE: 4/12/85 TESTING, FIRE RUN

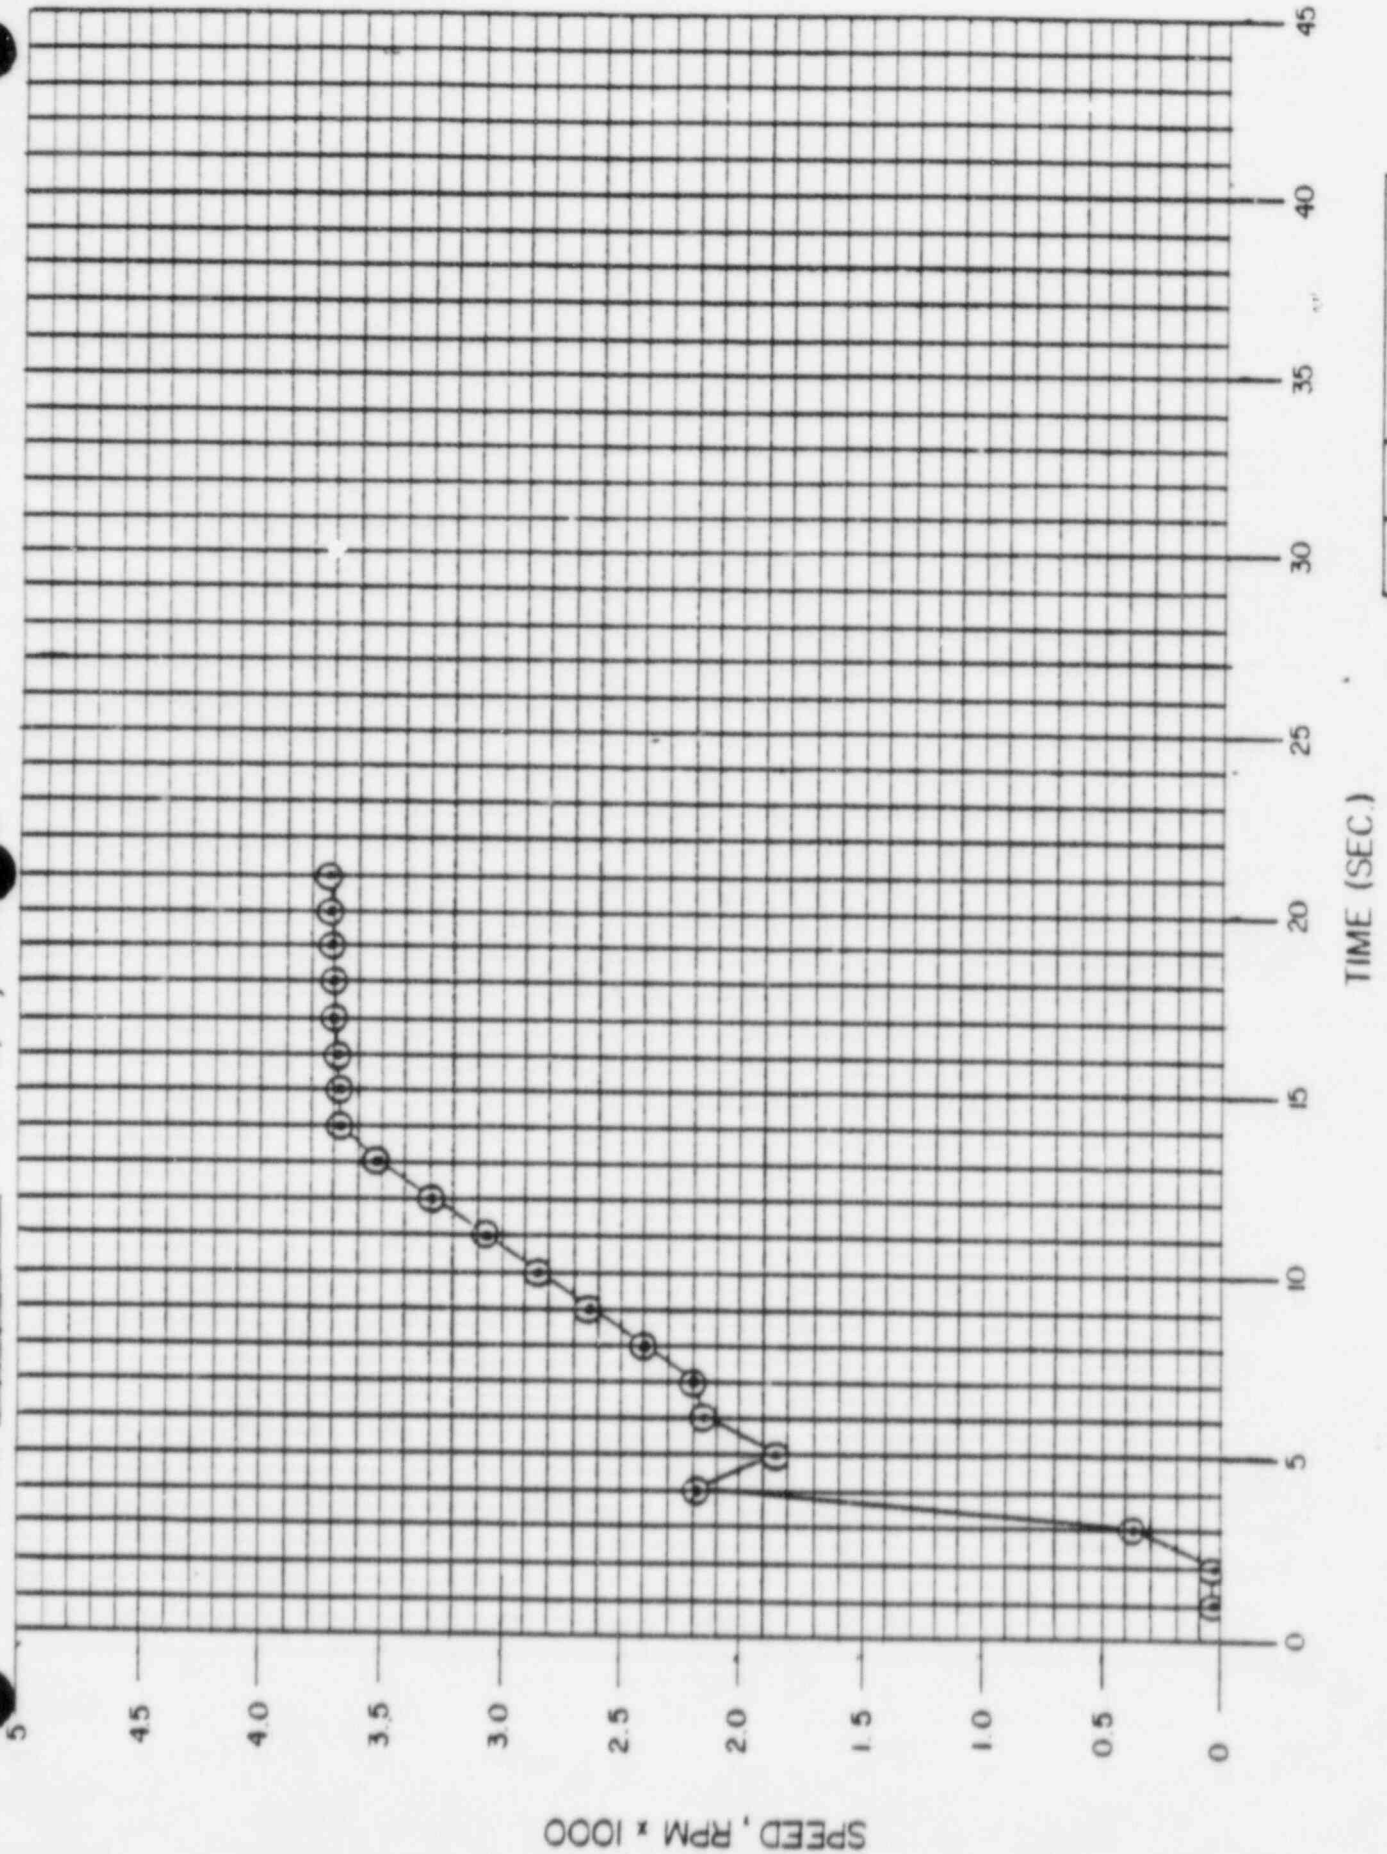
Figure 11

AUX.-FEED PUMP # 2
DATE: 4/12/85 TESTING, SECOND RUN
