# REACTOR TRIP

## ROOT CAUSE DETERMINATION

2. UNIT 1 Time and Date of Trip 1335 4-10-85

Shutdown bank A Group 1, Rods D02 and B12 dropped initiating a Rx Trip on Negative Rate. (See computer print outs.)

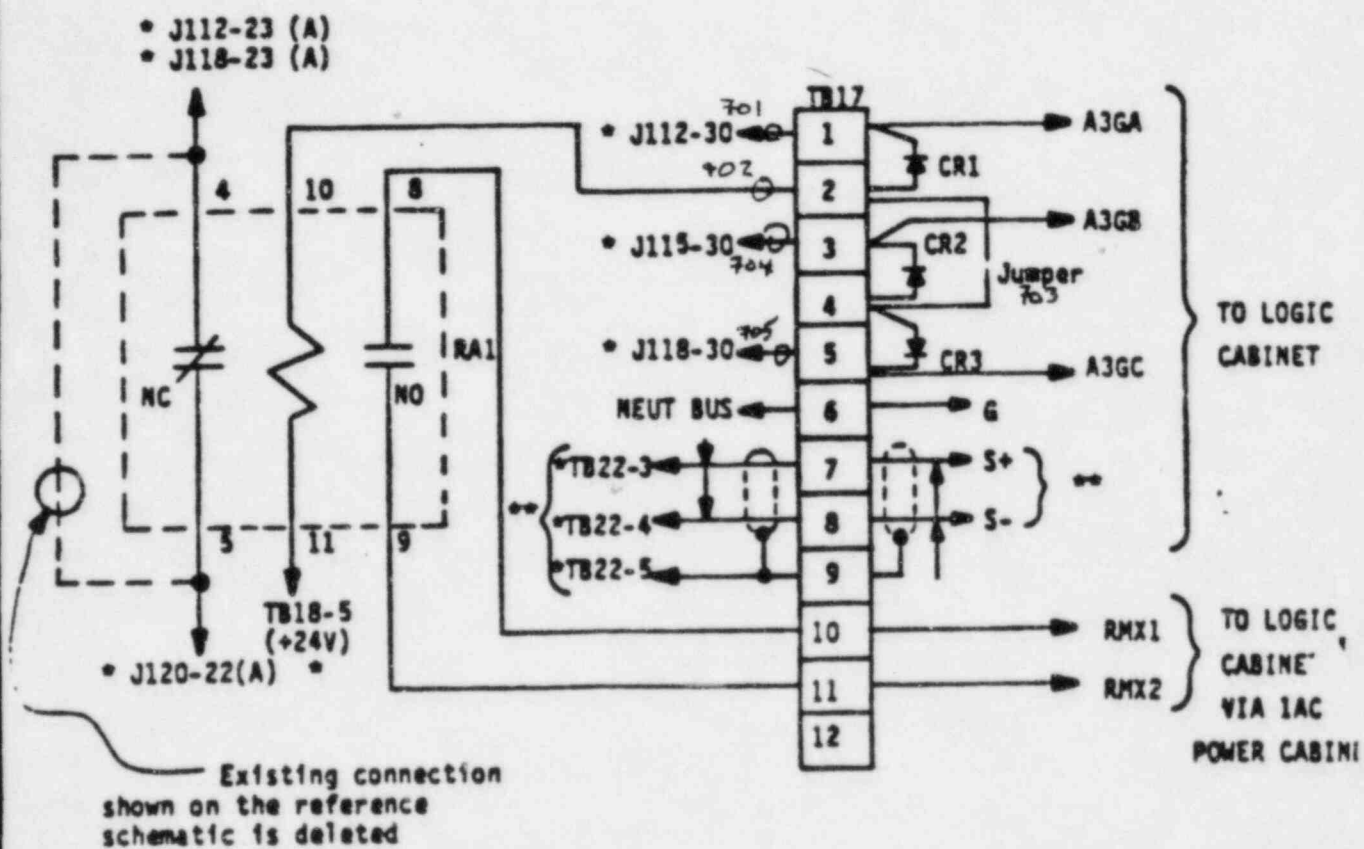
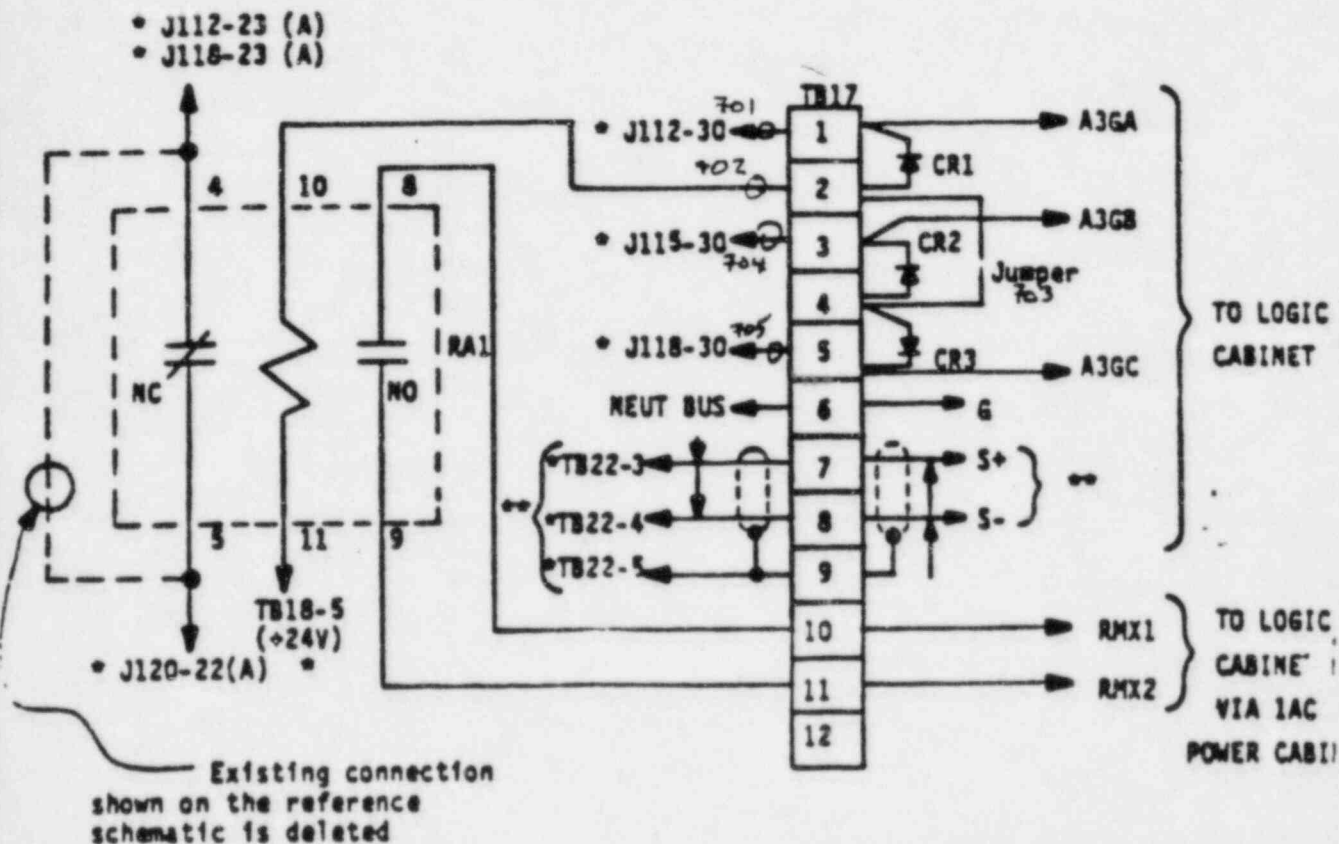
### III.B Power Cabinet Schematic Modifications

*I/O card A803 was bad and this resulted  
in problems with auto rod drop relay circuit used  
for rod drop testing see IM fireman descriptions  
on attached sheets*

All Urgent alarm conditions held rods in place except for a zero current order being generated out of sequence specifically a ground applied on pin 30 of the stationary Reg card.

Fuses and power sources had been previously checked. Investigation of the Rod Drop modification showed a relay coil connected to the stationary Reg cards via pin 30. The intent of the relay is to interrupt reduced ~~to~~ current orders AI when the Rod Drop computer is connected and a zero current order is applied to intentionally drop rods for testing. Under normal operations this relay would not be energized but the possibility of

may not have been considered when the mod was designed.

As corrective action the wires associated with the stationary regulator cards and the Rod Drop test relay are going to be lifted and isolated, and the stationary reg card group C will be replaced.
