UNION ELECTRIC COMPANY
CALLAWAY PLANT

DOCKET NUMBER 50-483
CALLAWAY PLANT UNIT 1
FACILITY OPERATING LICENSE NPF-30
SPECIAL REPORT 85-04
LOOSE PARTS MONITORING SYSTEM

SPECIAL REPORT 85-04
LOOSE PARTS MONITORING SYSTEM ALARM

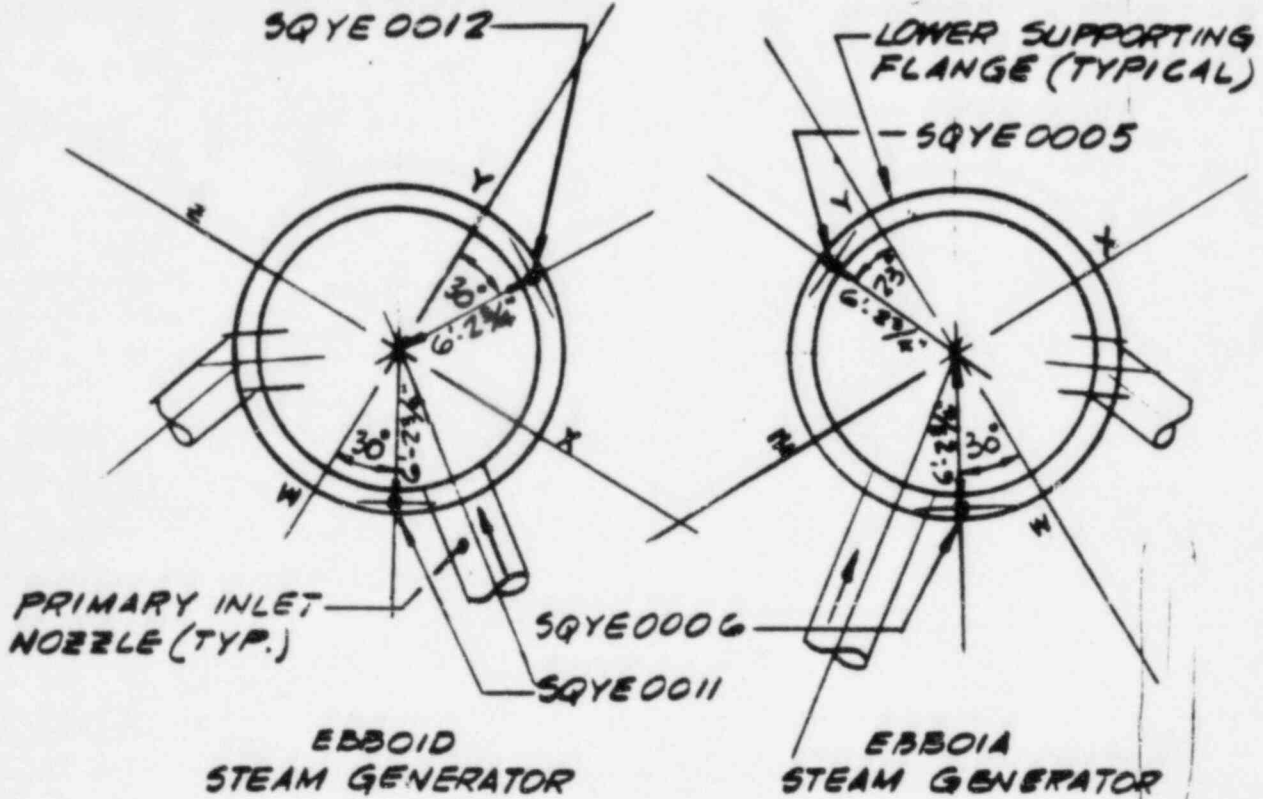
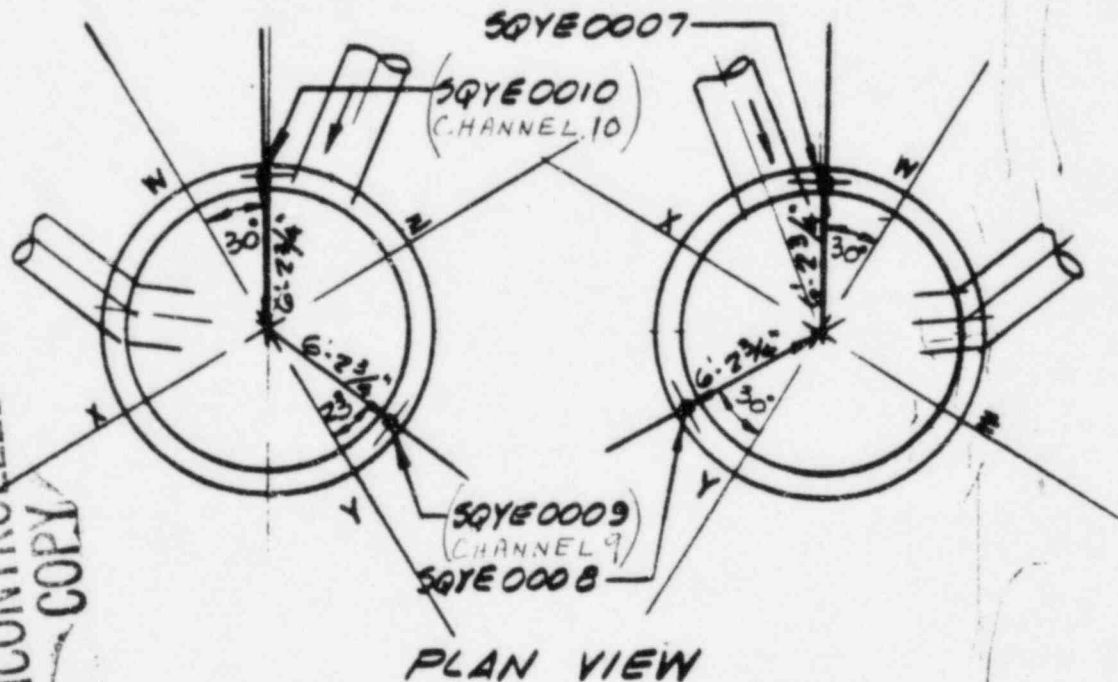
LOOSE PARTS MONITORING
SYSTEM

The Channel 9 accelerometer is located on Steam Generator C near inlet A on the lower supporting flange. An additional accelerometer (Channel 10) is also located on Steam Generator C on the lower supporting flange approximately 120° clockwise from Channel 9 (see attached sketch). Upon discovery of Channel 9 in an alarm state, Channel 10 was verified to be reading normal. Investigation revealed that Channel 9 had failed and was thereby giving a false reading.

A Work Request was initiated to troubleshoot Channel 9. Technicians verified circuitry from the Control Board to the Bio-shield and found no indication of a cause of the malfunction. Due to the radiation level inside the Bio-shield, no further investigation has been done.

At the first outage of sufficient duration, additional investigation inside the Bio-shield will be conducted. Channel 9 will be returned to an operable state no later than the restart following the first refueling.
