PDR

TITLE: AUXILIARY FEED PUMPS OVERSPEED TRIPS

REPORT BY: Dan Wilczynski, Chuck Rupp

DATE PREPARED: 6/24/85

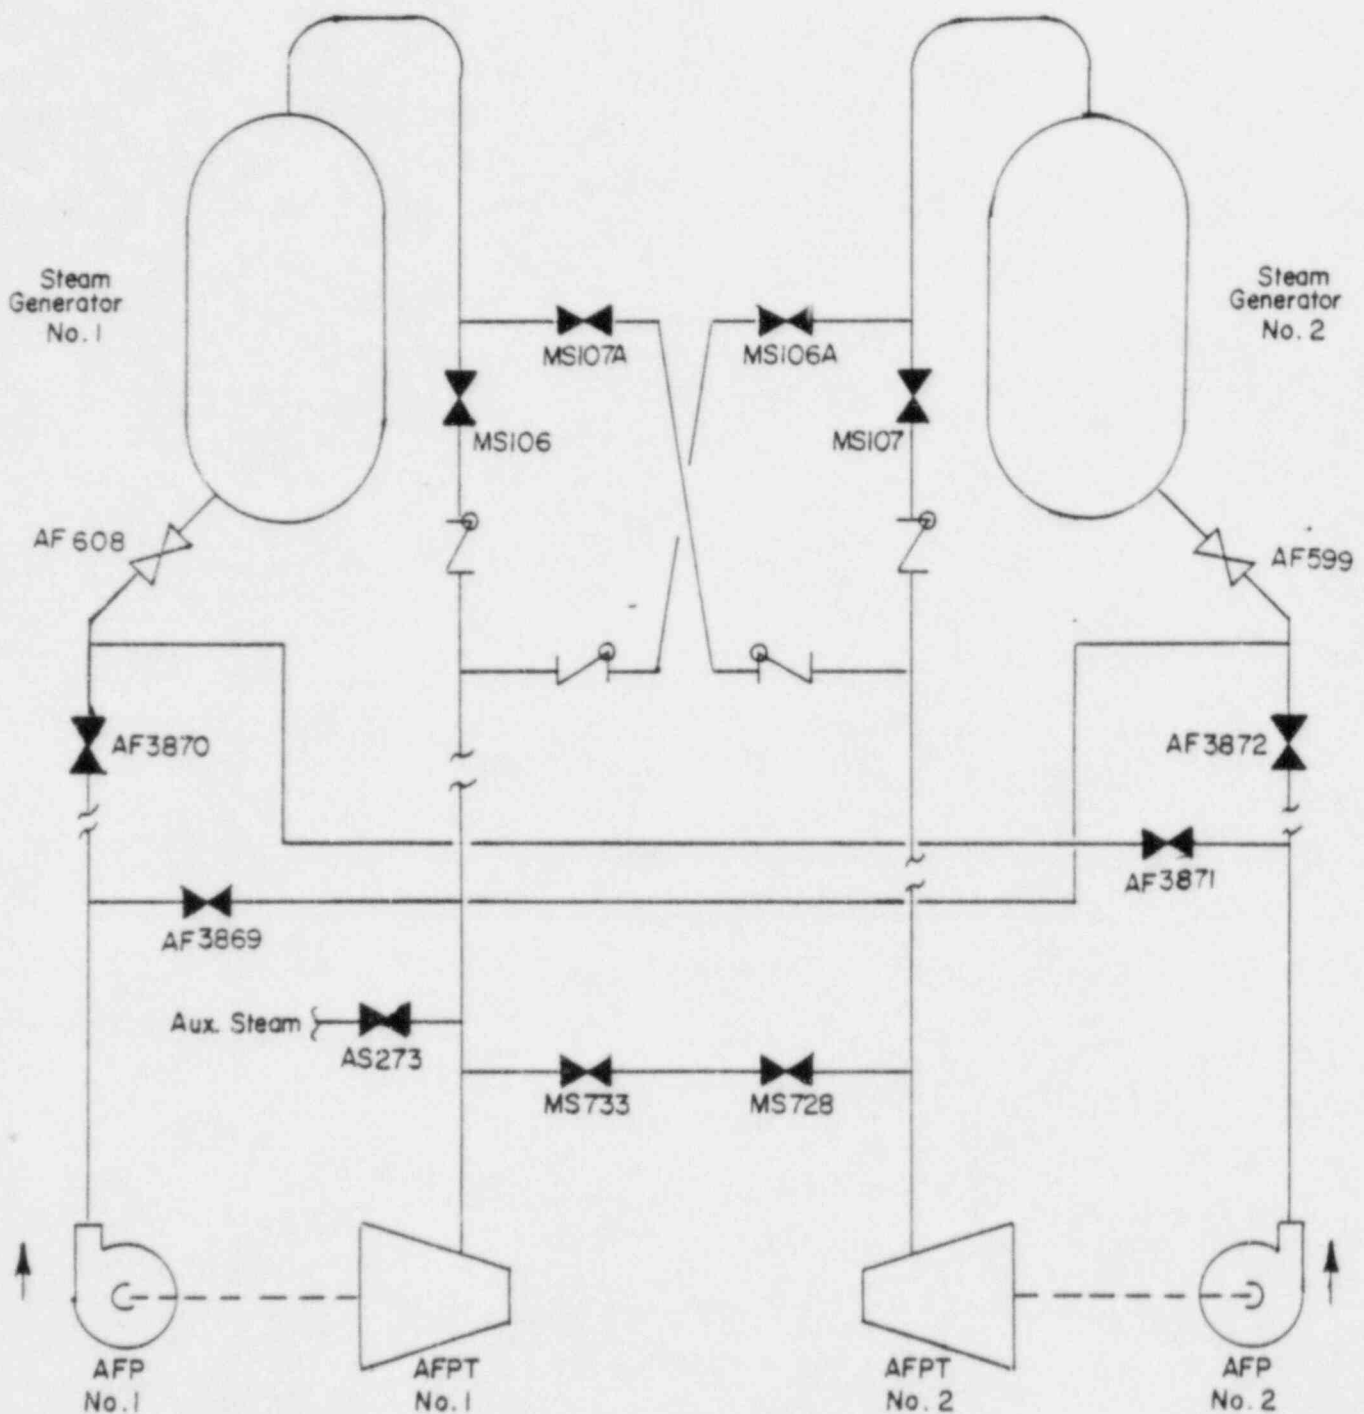
Figure 1

3. MS 107 (SG #2 feed to AFPT #2) - The pipe length of this run is approximately 125 feet. Immediately downstream of MS 107 is a downhill run. The total length of the pipe run has an almost continual downhill flow (i.e., very few long lengths of horizontal pipe) dropping from elevation 623 to elevation 565. Any condensation is expected to become entrapped in the steam flow or be carried as small slugs.

4. MS 107A (SG #1 feed to AFPT #2) - The pipe length of this run is approximately 375 feet. Immediately downstream of MS 107A is a 250 foot length of essentially horizontal pipe except for a 7 foot rise near the end of the run. After the rise is a short horizontal run and then the steam supply line has a 14 foot drop and is tied to the steam supply pipe described in item 3 above, immediately downstream of MS 107. The rise, after a long horizontal run, will enable water slugs to form at the bottom of the rise and be carried downstream after filling the pipe.

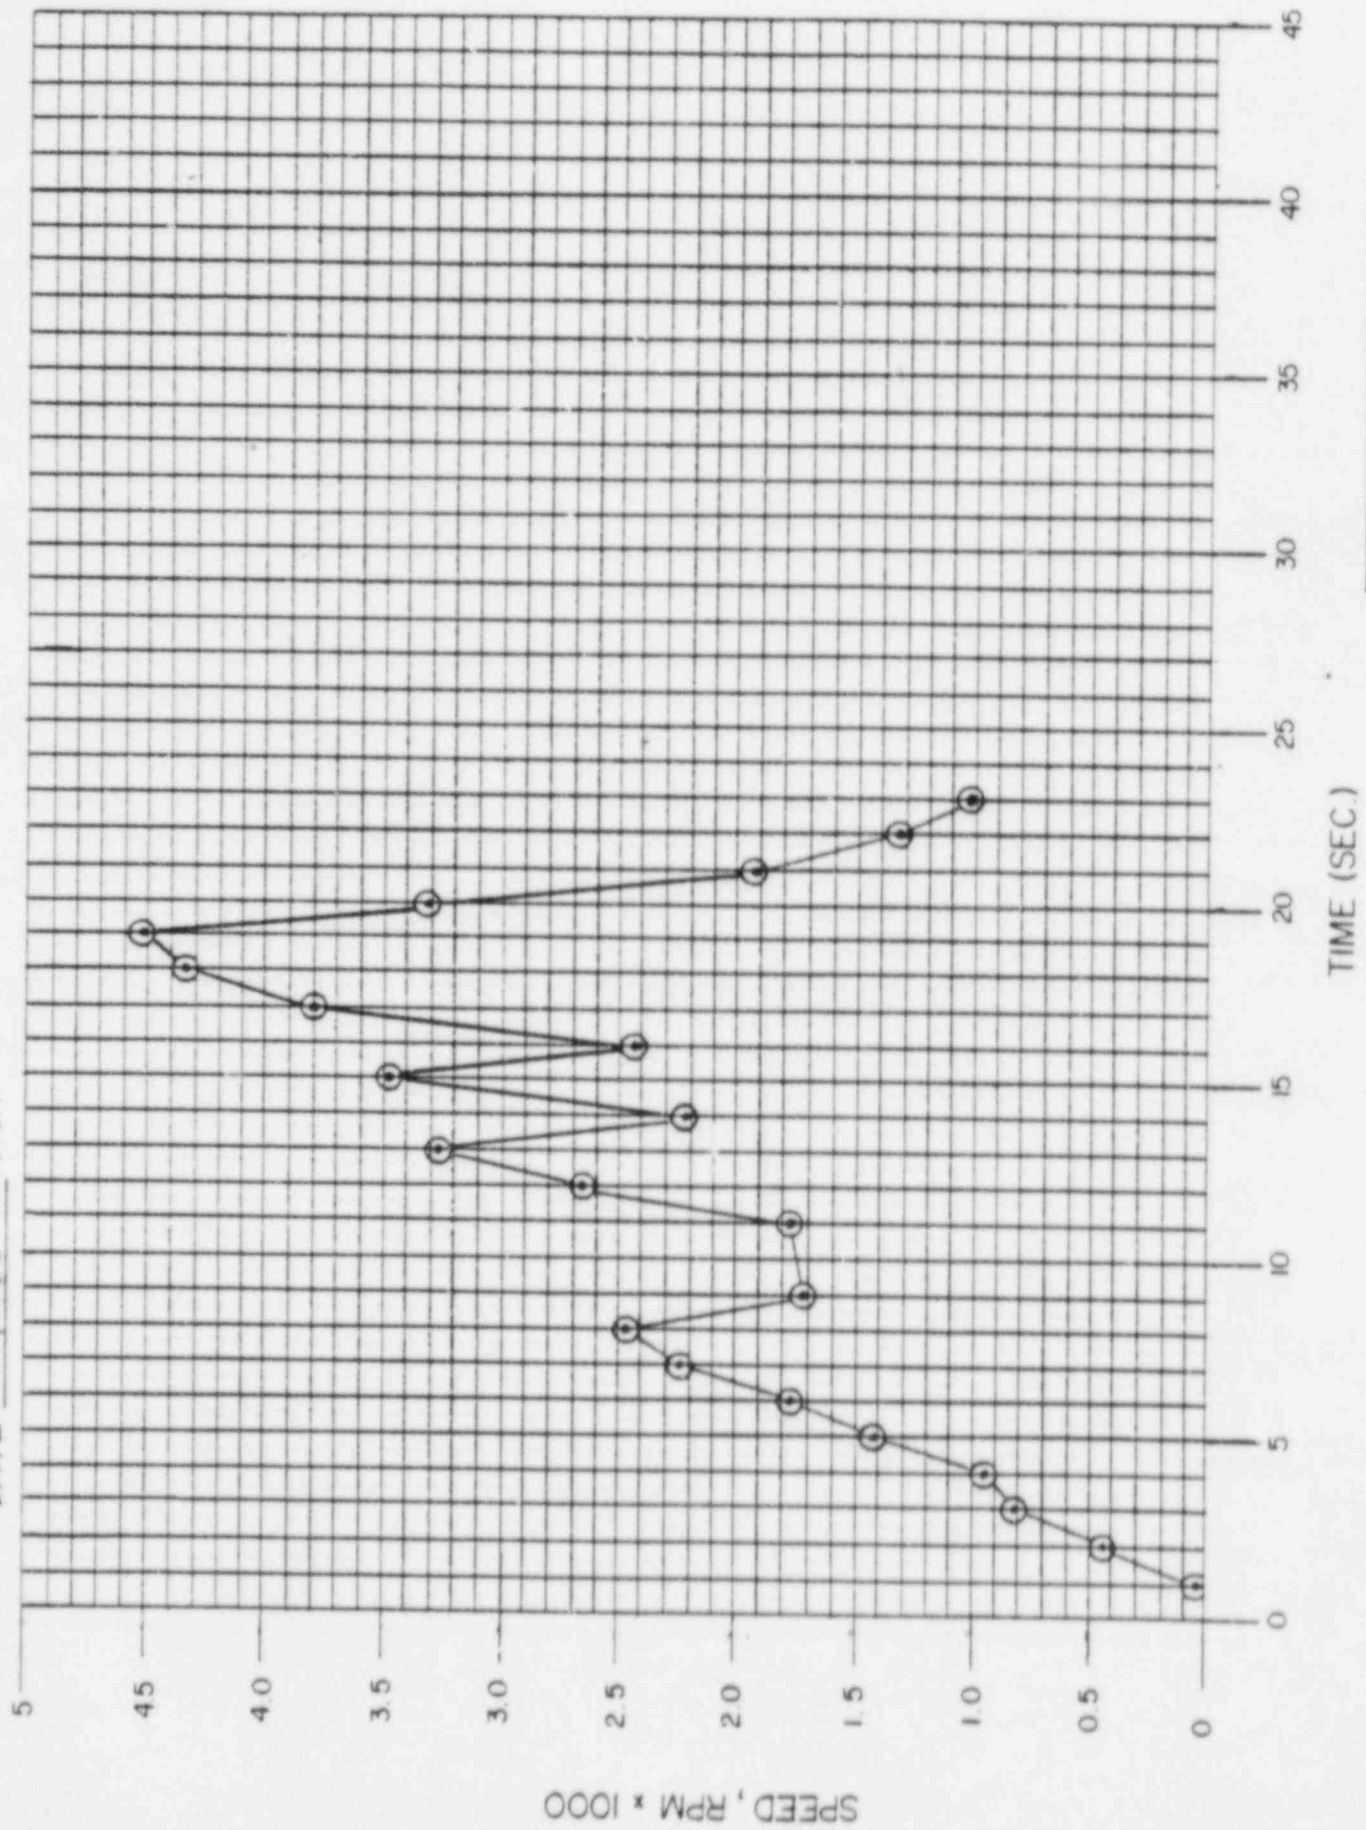
Figure 2

A review of the speed vs. time characteristics for AFPT #1 shows the typical characteristics of several oscillations prior to reaching rated speed but the final oscillation was uncontrolled and increased turbine speed to the overspeed trip setpoint. The speed characteristics are shown on Figures 2 and 3 of Attachment 2.

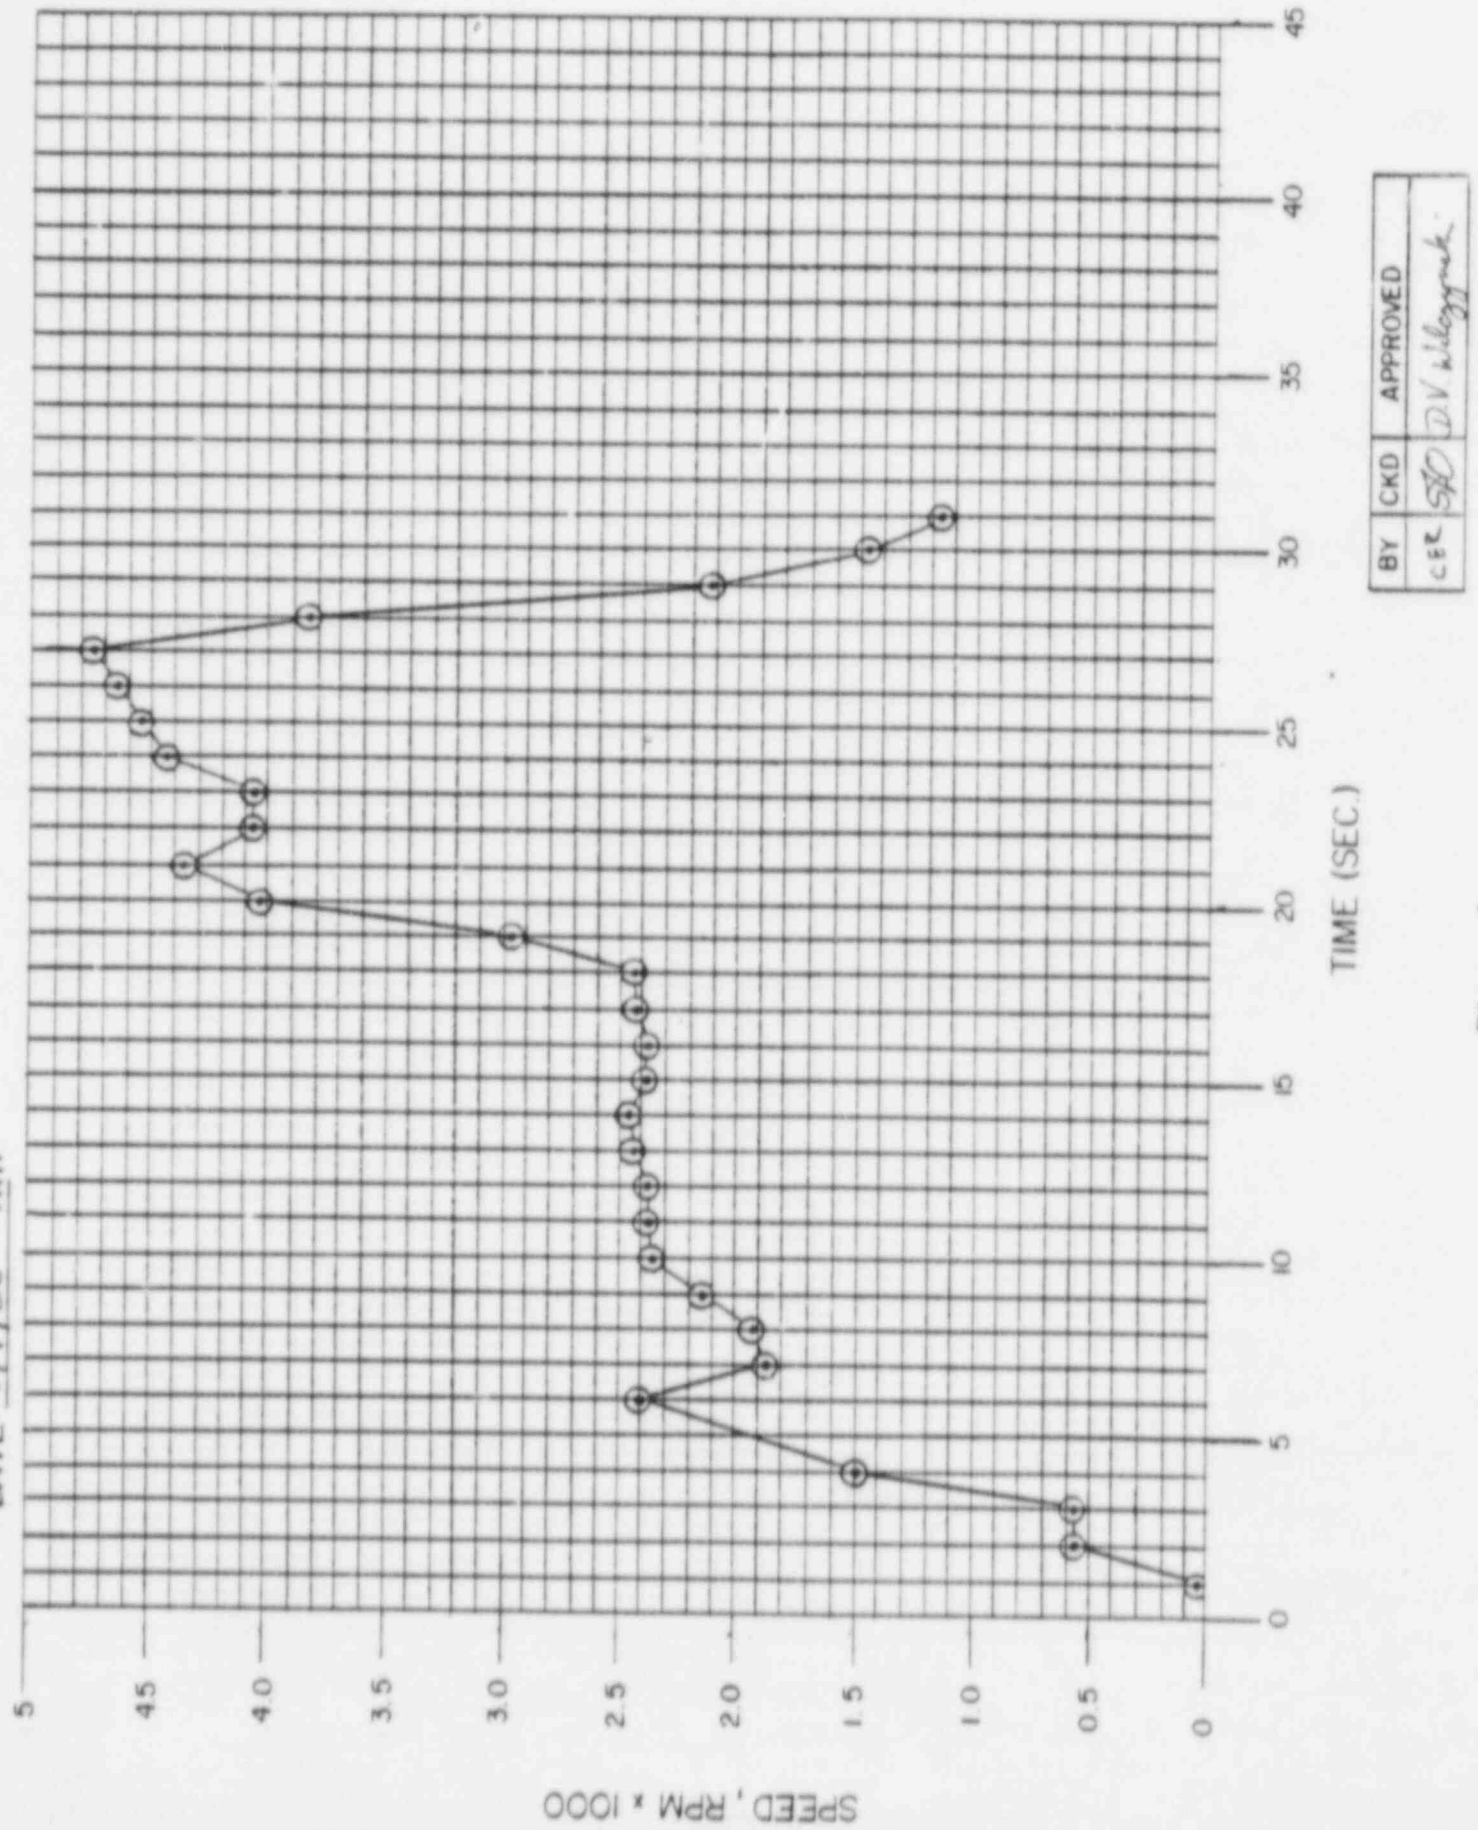
Figure 3

A review of the speed characteristics for AFPT #2 shows an uncharacteristic leveling off at approximately 2500 RPM for about eight (8) seconds from which point turbine speed quickly increases to above 4100 RPM, decreases slightly and then continues to increase to the overspeed trip setpoint. The pause at 2500 RPM could be due to excessive water induction into the turbine.

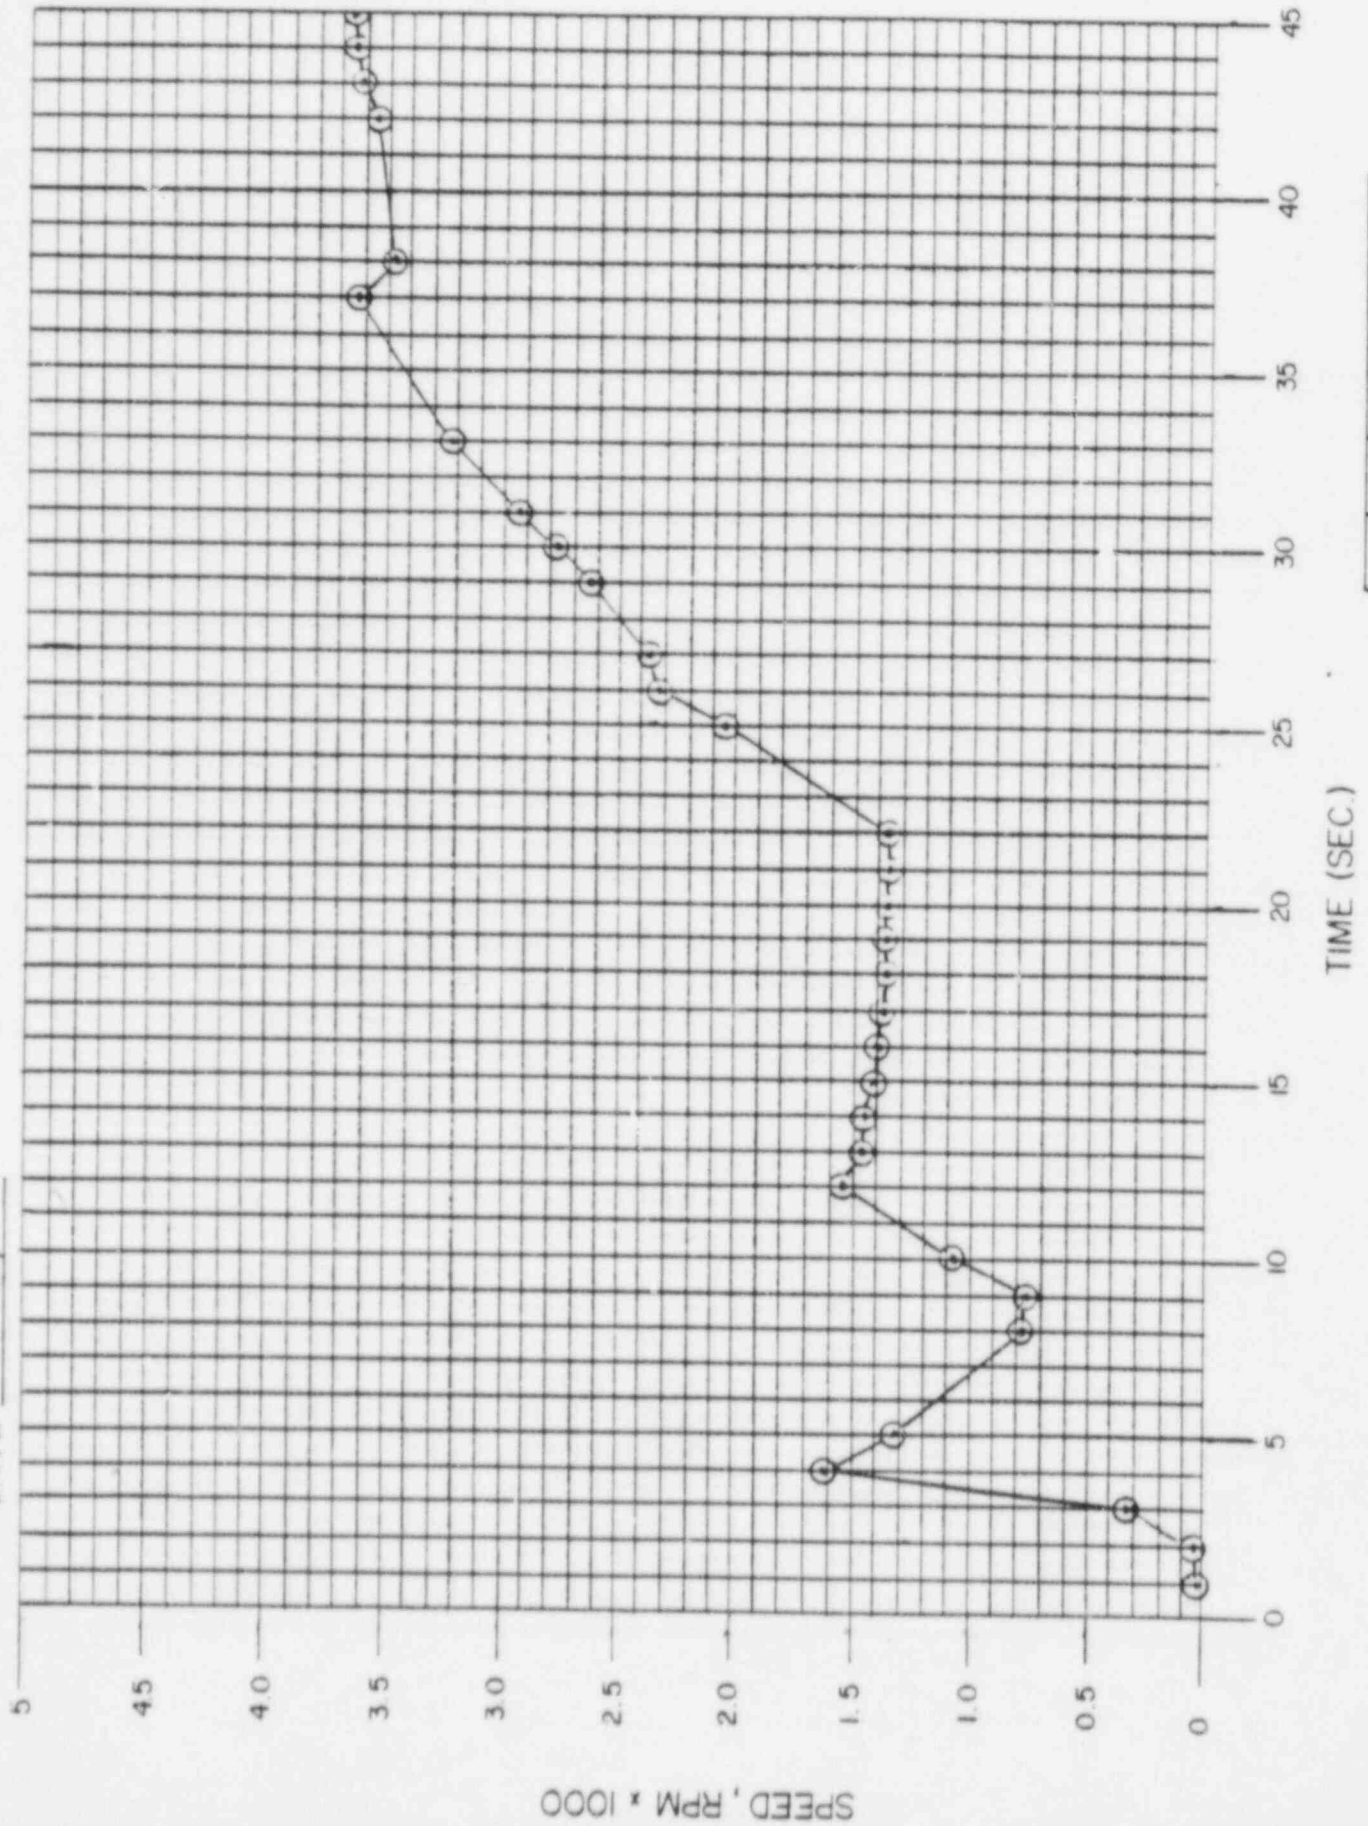
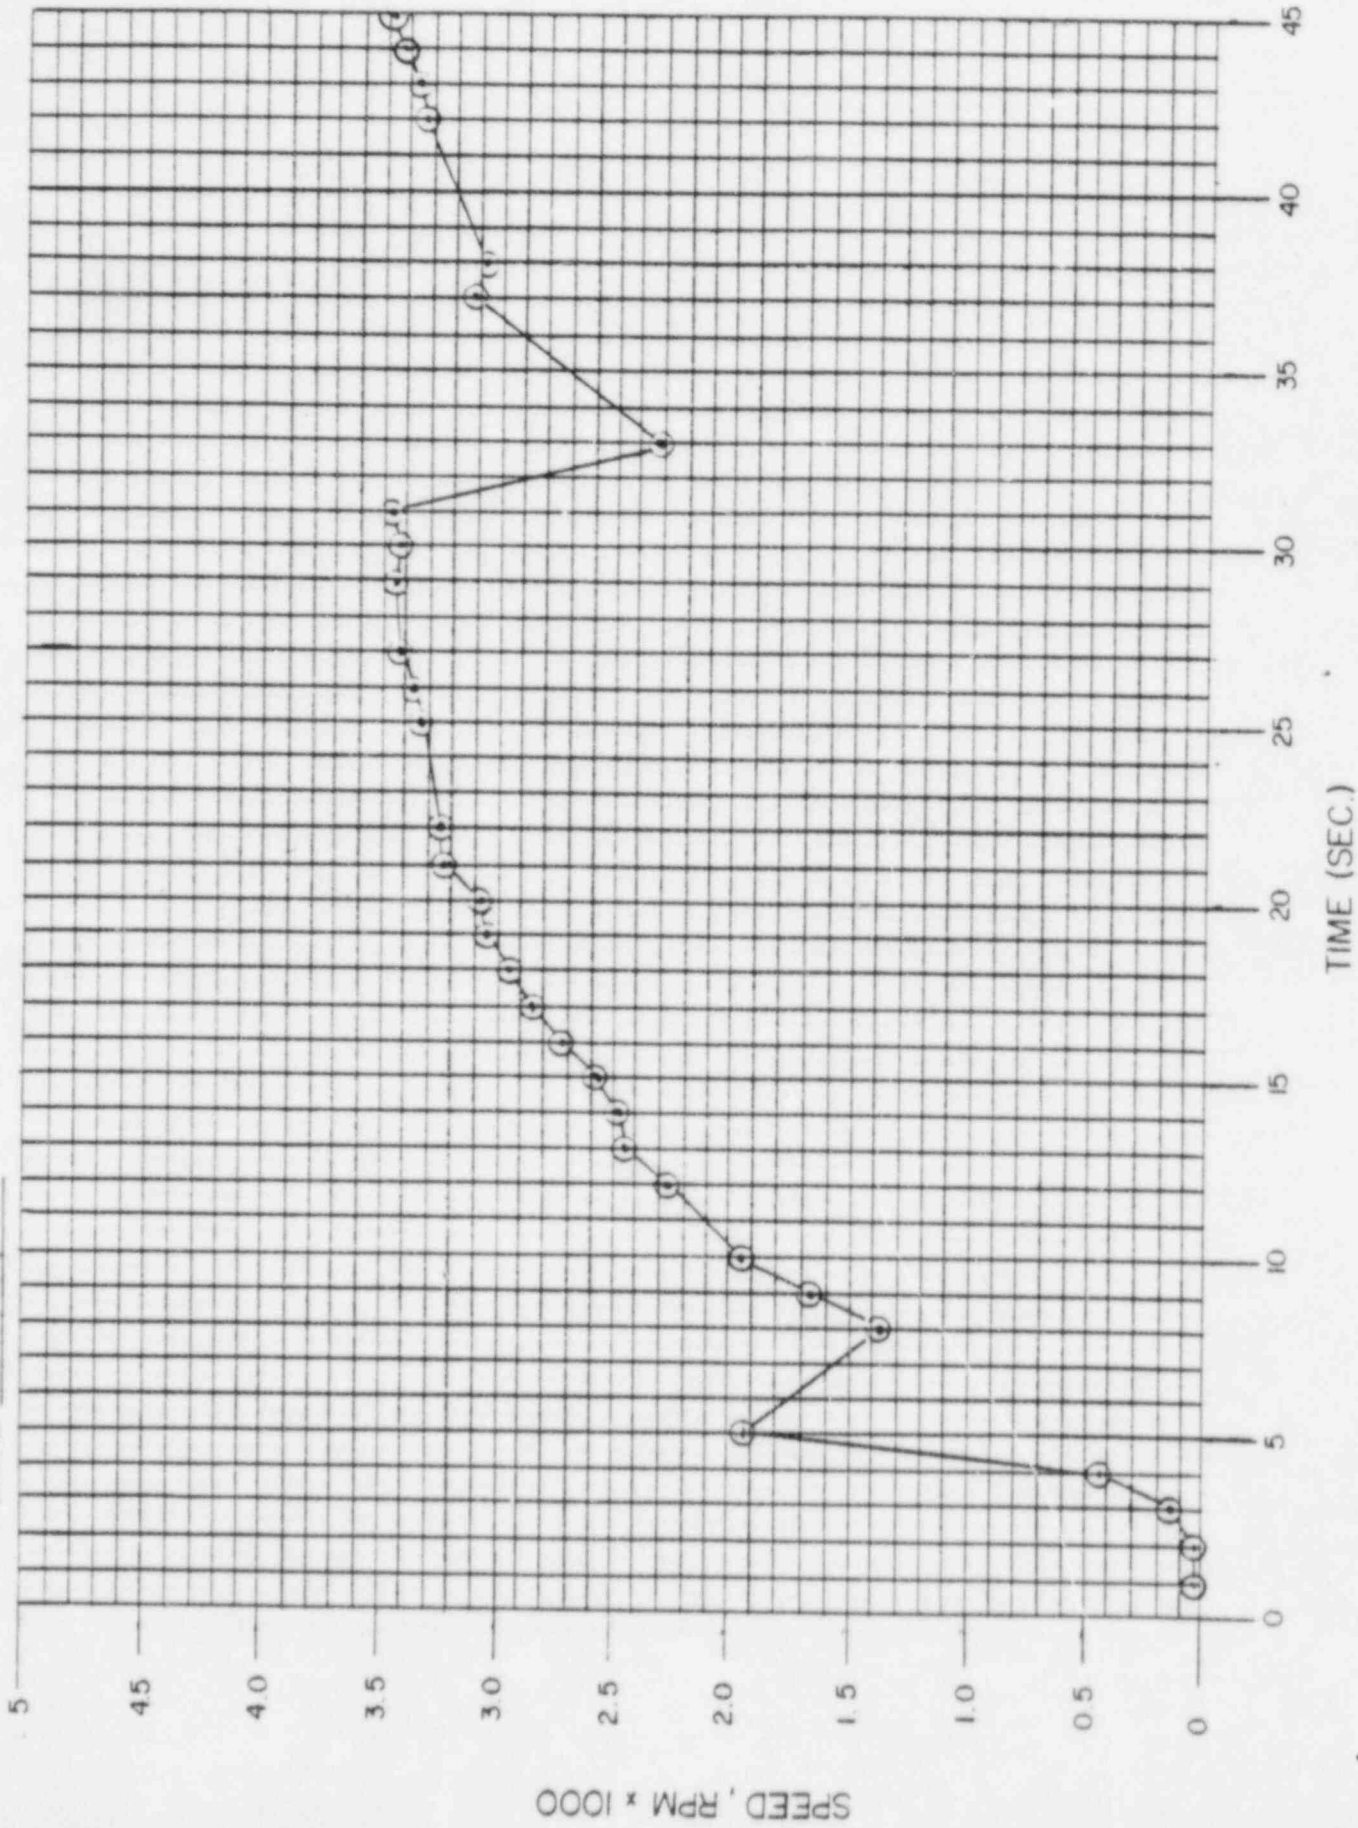
the steam supply valve (MS 107) from SG #2 to AFPT #2 and opened the cross connect valve MS 107A to supply steam to AFPT #2 from SG #1. This switch of steam supply occurred 21 seconds (12:37:55) after both AFPTs had been started via MS 106 and MS 107. A review of the speed vs. time characteristics (see Figures 4 and 5 of Attachment 2), show that AFPT #2 experienced a decrease of approximately 1000 RPM at sixteen (16) seconds after the SFRCS low pressure trip. This speed decrease may be attributed to excessive water being picked up from the MS 107A line and being carried to the turbine.

- On 3/2/84, since MS 107 was open and heating the line, opening MS 107A introduced only 250' of cold piping, thereby reducing the amount of water introduced to the turbine.
- On 3/2/84, additional water may have been introduced by opening MS 107A because the steam lines were not drained periodically at this time.
- On 3/2/84, since AFPT #2 was pumping approximately 1000 GPM, if a slug of water occurred from opening of MS 107A, there would have been more resistance to a speed increase as compared to the 6/9/85 event when only a min-recirc flow path was available.
- On 3/2/84, both AFPTs had the Woodward PG-PL governors installed.

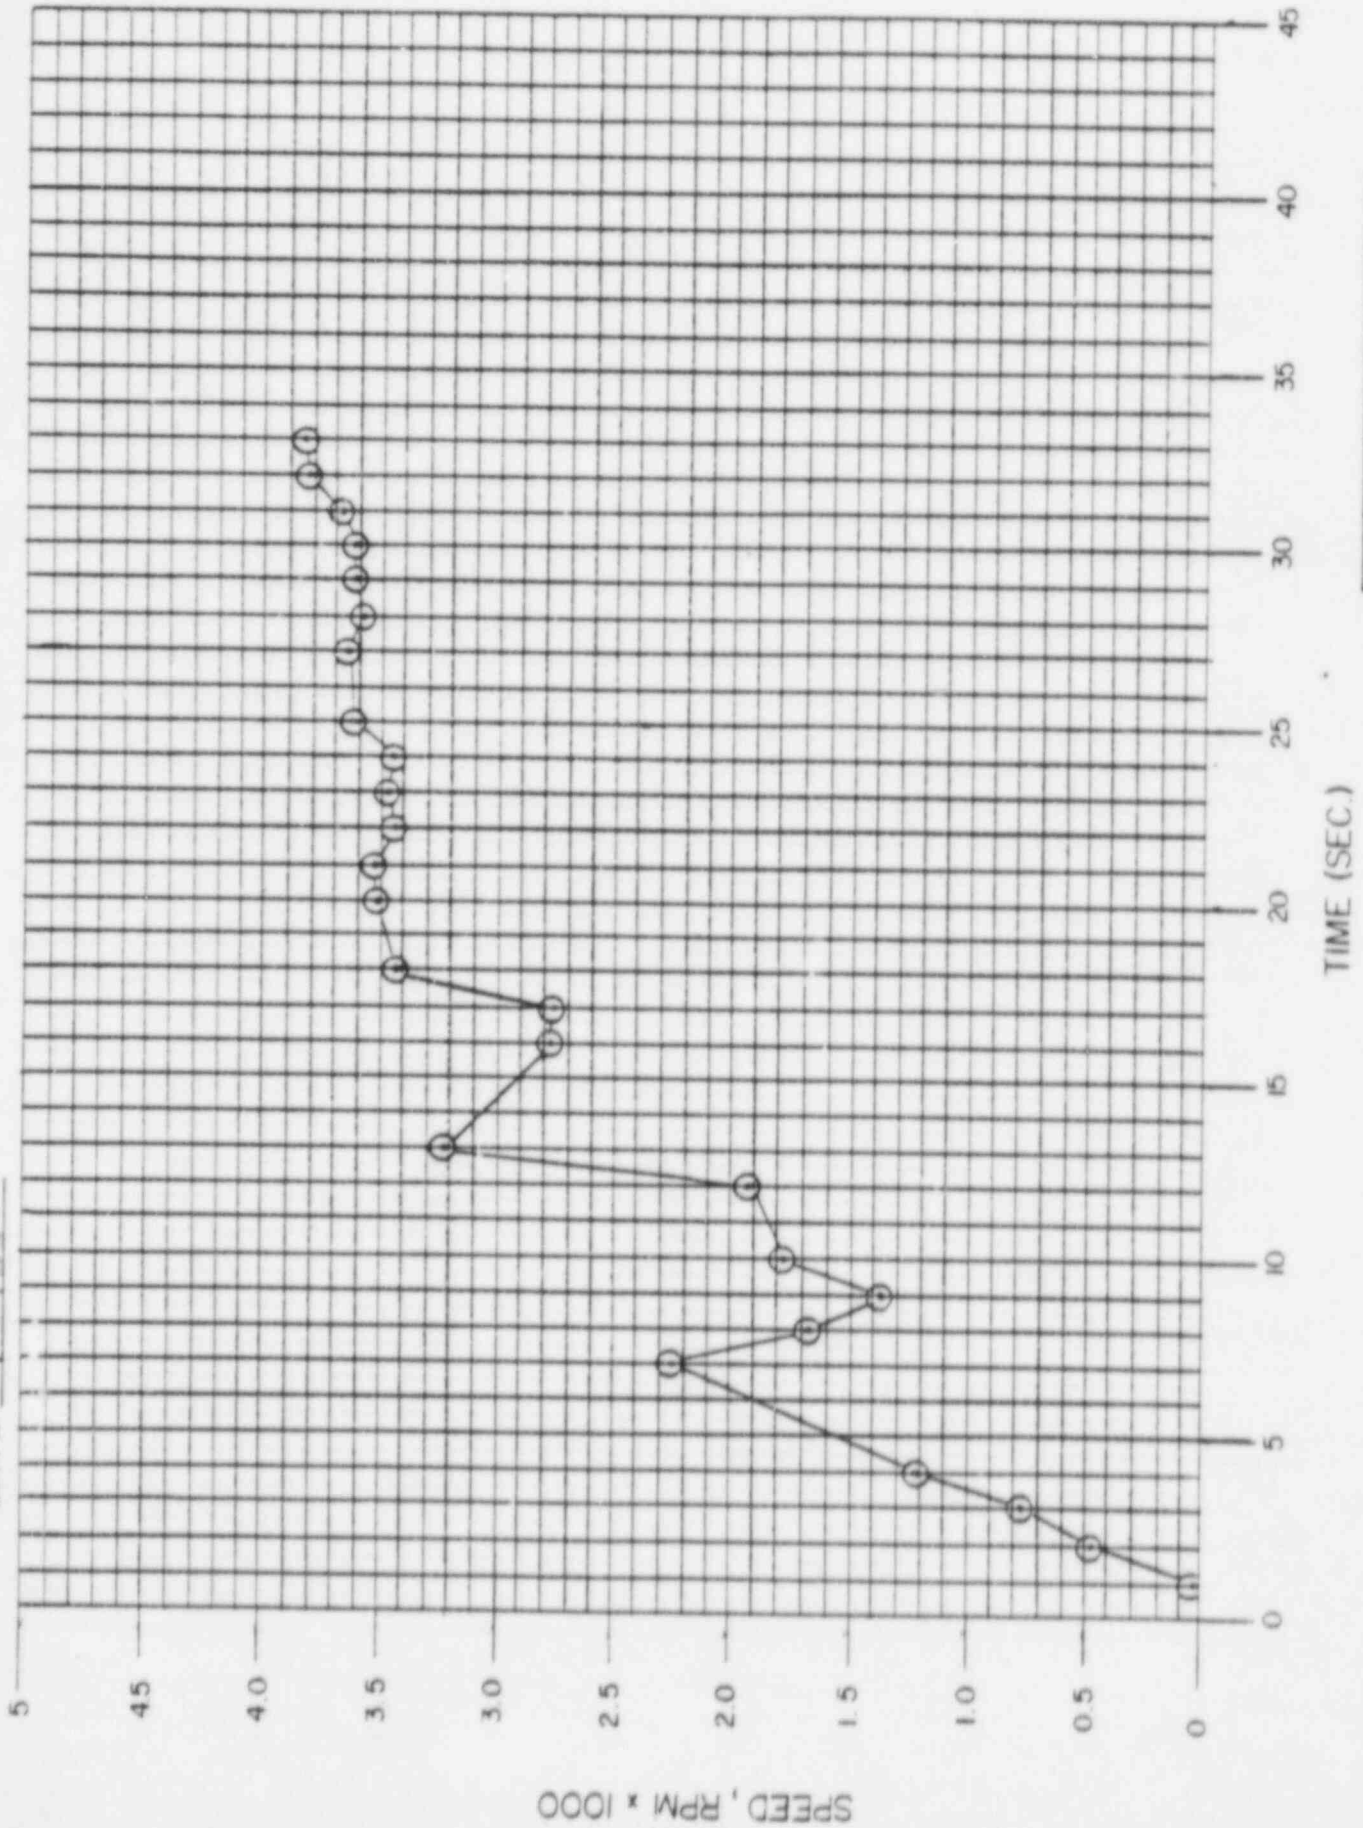
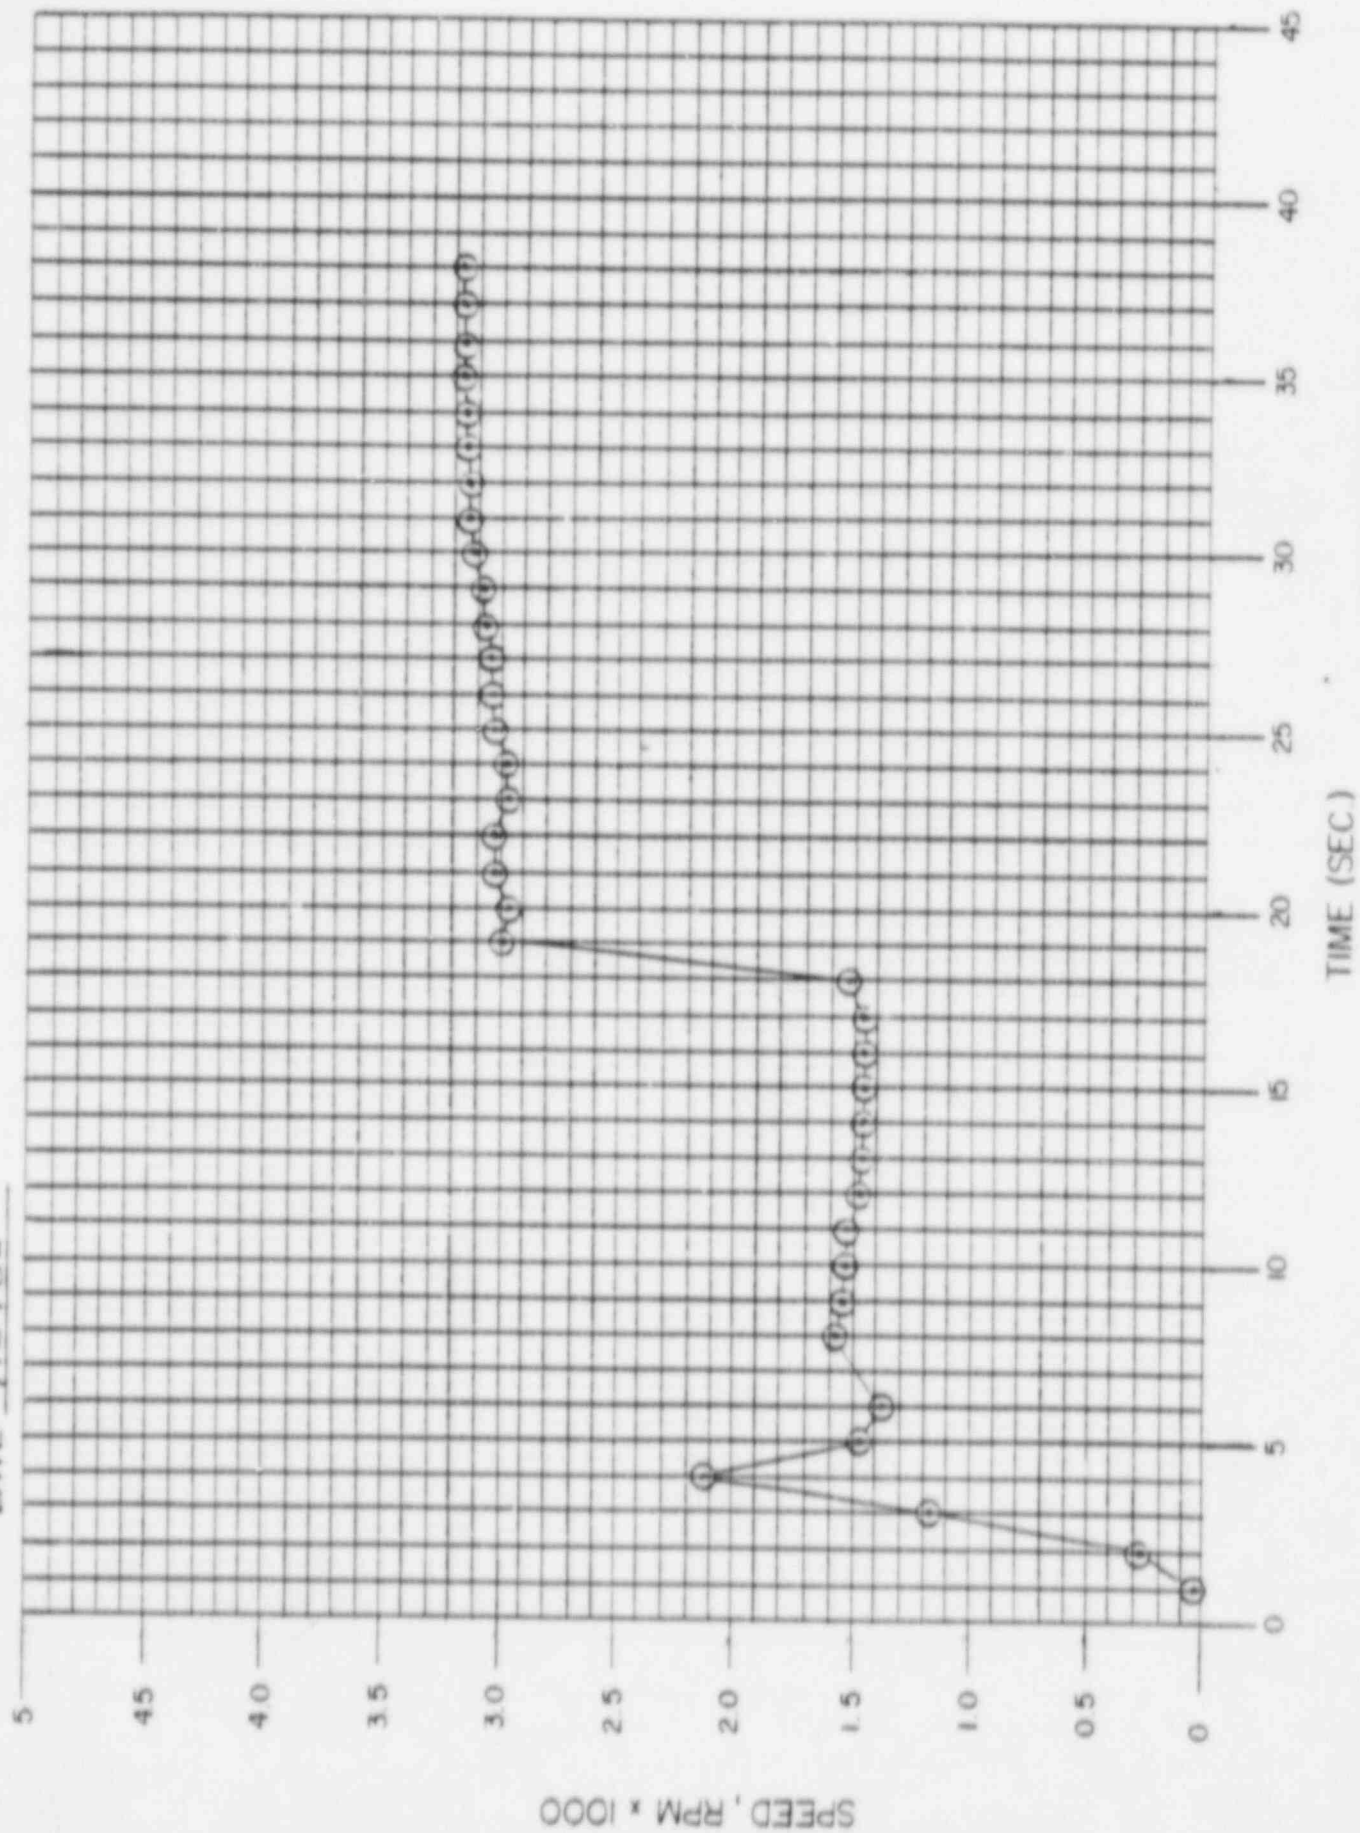
This event initiated a SFRCS trip on low SG level which, due to valve control changes made during the 1984 refueling outage, opened all four steam supply valves to the AFPTs. Also, AFPT #2 had the new PGG governor installed during the 1984 refueling outage. The speed characteristics are shown on Figures 6 and 7 of Attachment 2.

- On 1/15/85, due to the pipe configuration, initial steam flow to both turbines would have been via the normal flow paths, MS 106 and MS 107. Therefore, initial heating of the respective lengths (360' and 125') may have occurred prior to steam flow through the cross connects resulting in less total mass of

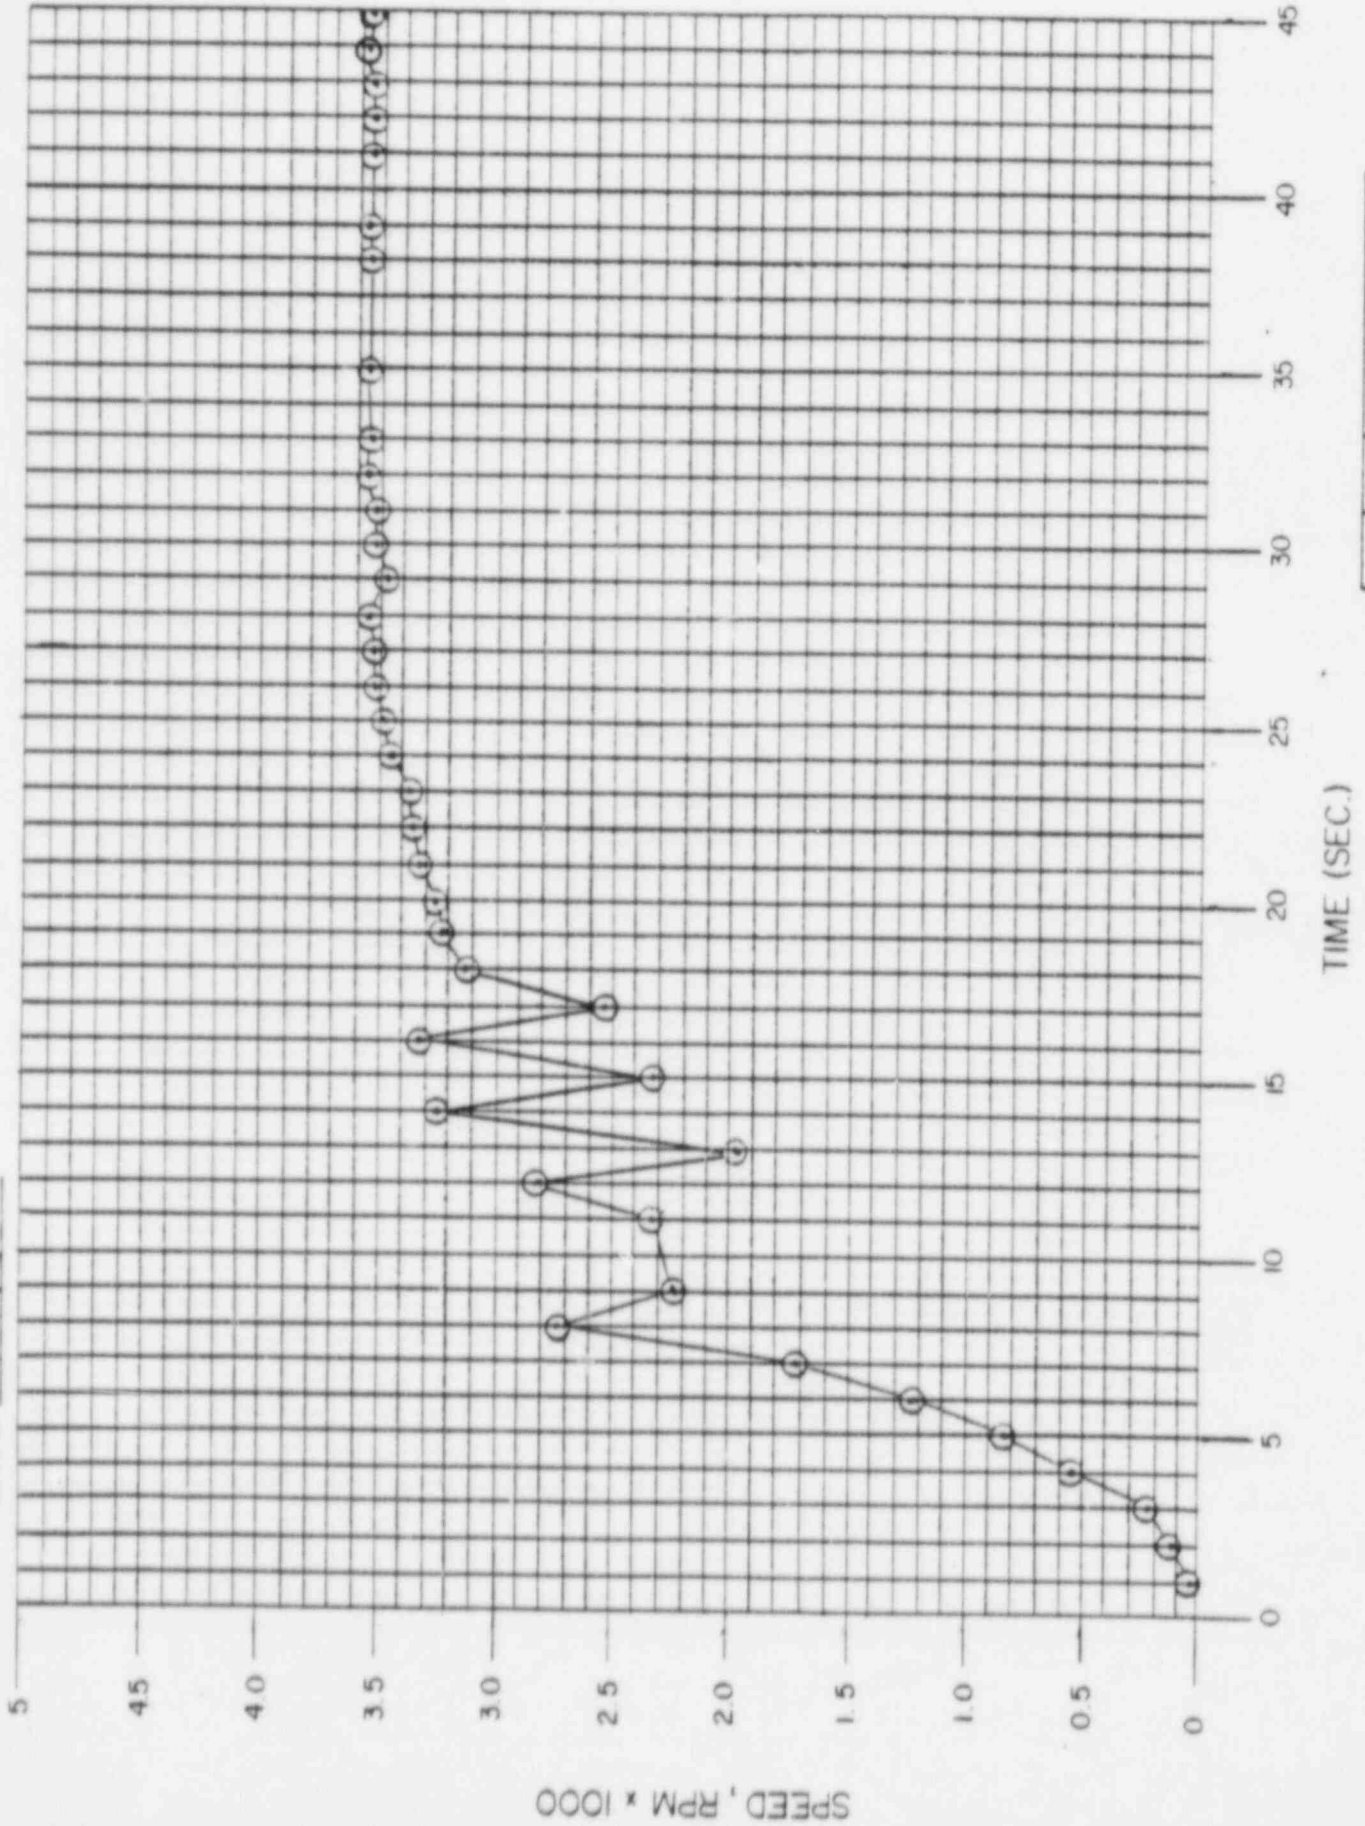
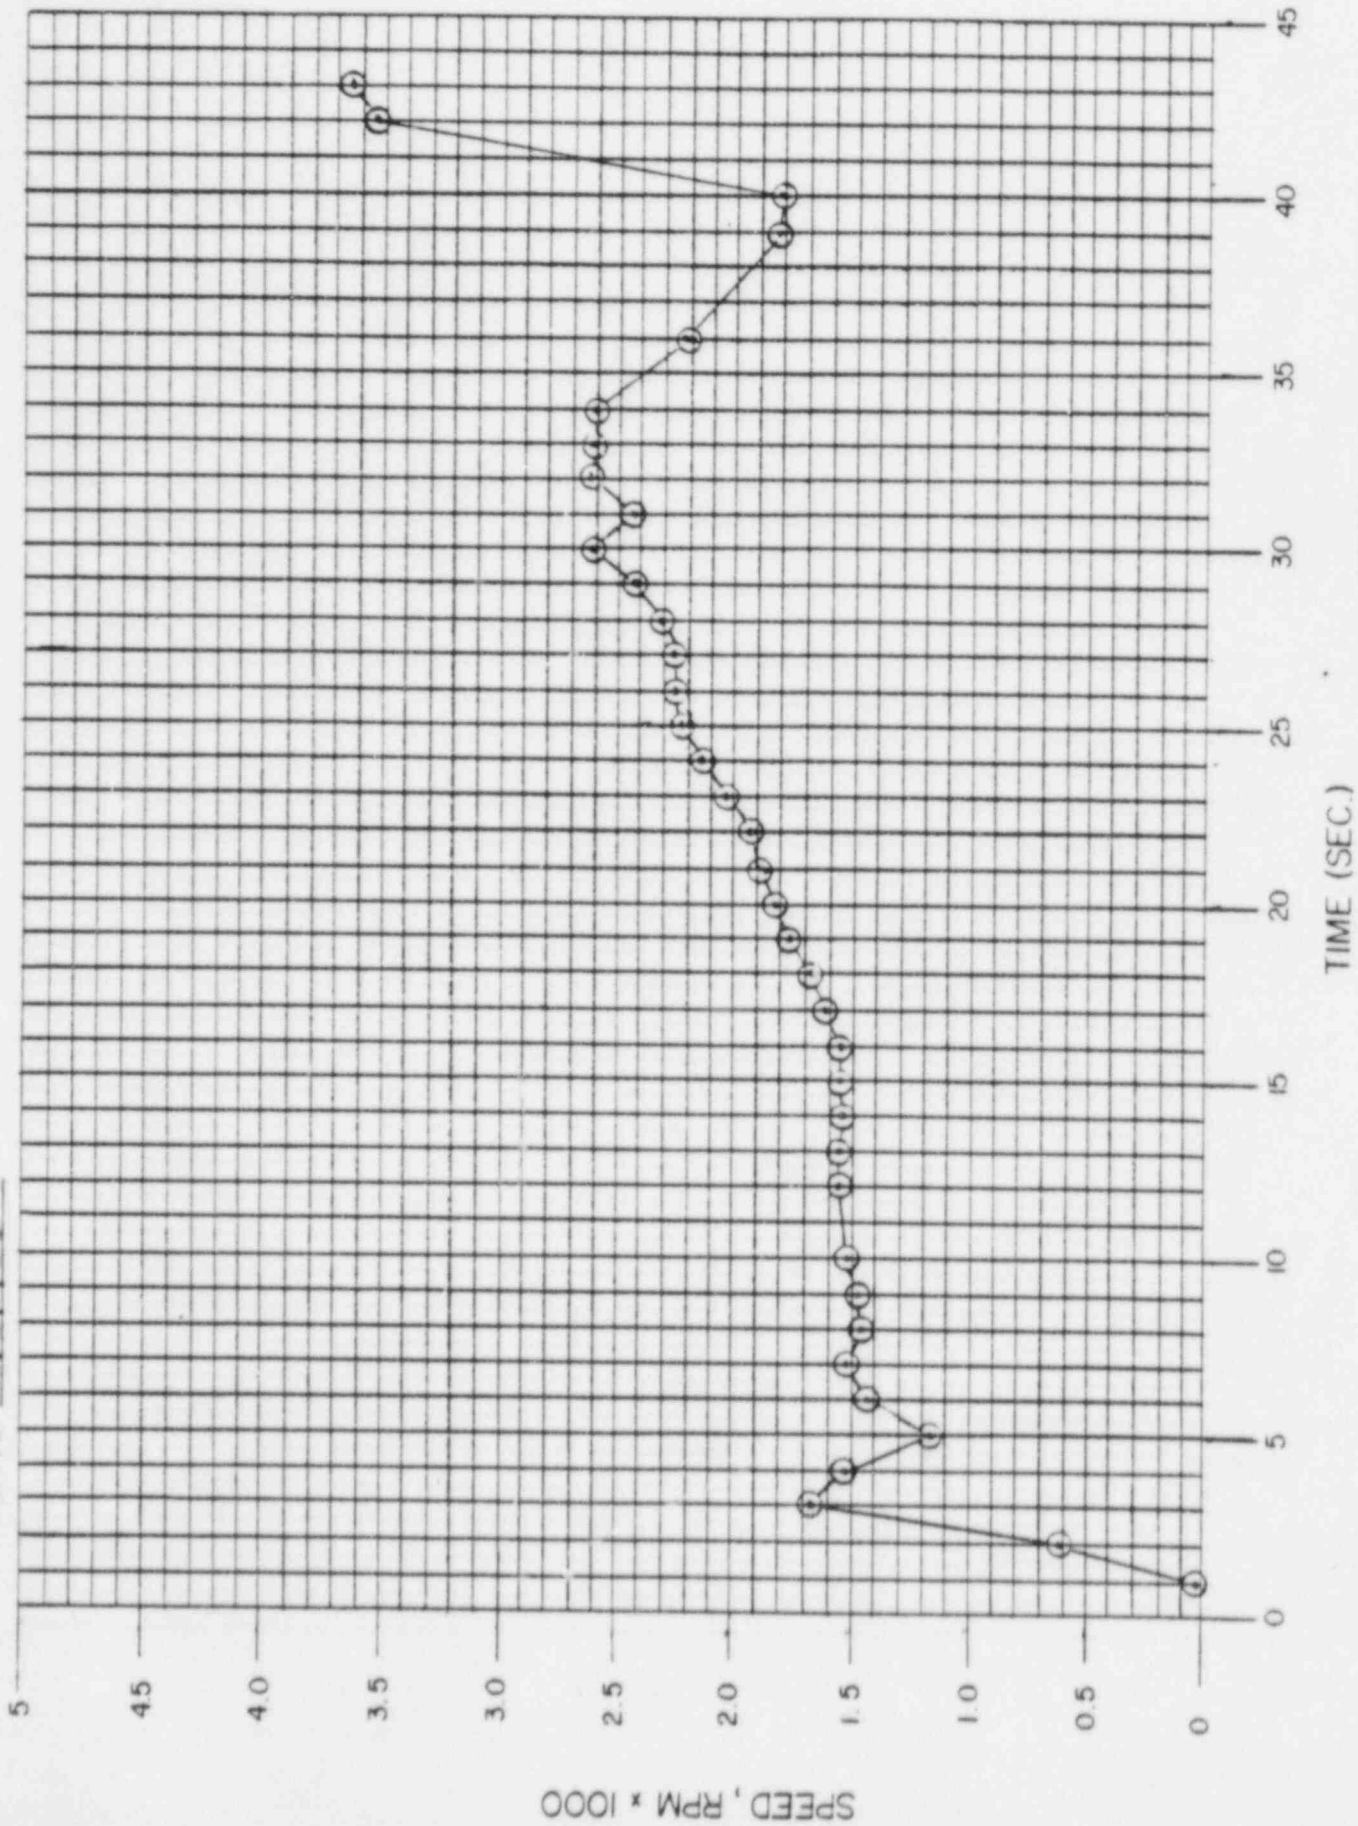
The speed characteristics are shown on Figures 8 and 9 of Attachment 2. A review of the speed characteristics for AFPT #1 show the typical characteristics consistently seen on AFPT #1 (i.e., several oscillations prior to reaching rated speed).

A review of the speed vs. time characteristics show that AFPT #2 indicates a constant rate of acceleration until approximately 35 seconds after initial roll at which time there was an 800 RPM decrease in 2 seconds followed by an 1800 RPM increase in 3 seconds. This oscillation may be due to slugs of water.
