PDR

TITLE: AUXILIARY FEED PUMPS OVERSPEED TRIPS

REPORT BY: Dan Wilczynski, Chuck Rupp

DATE PREPARED: 6/24/85

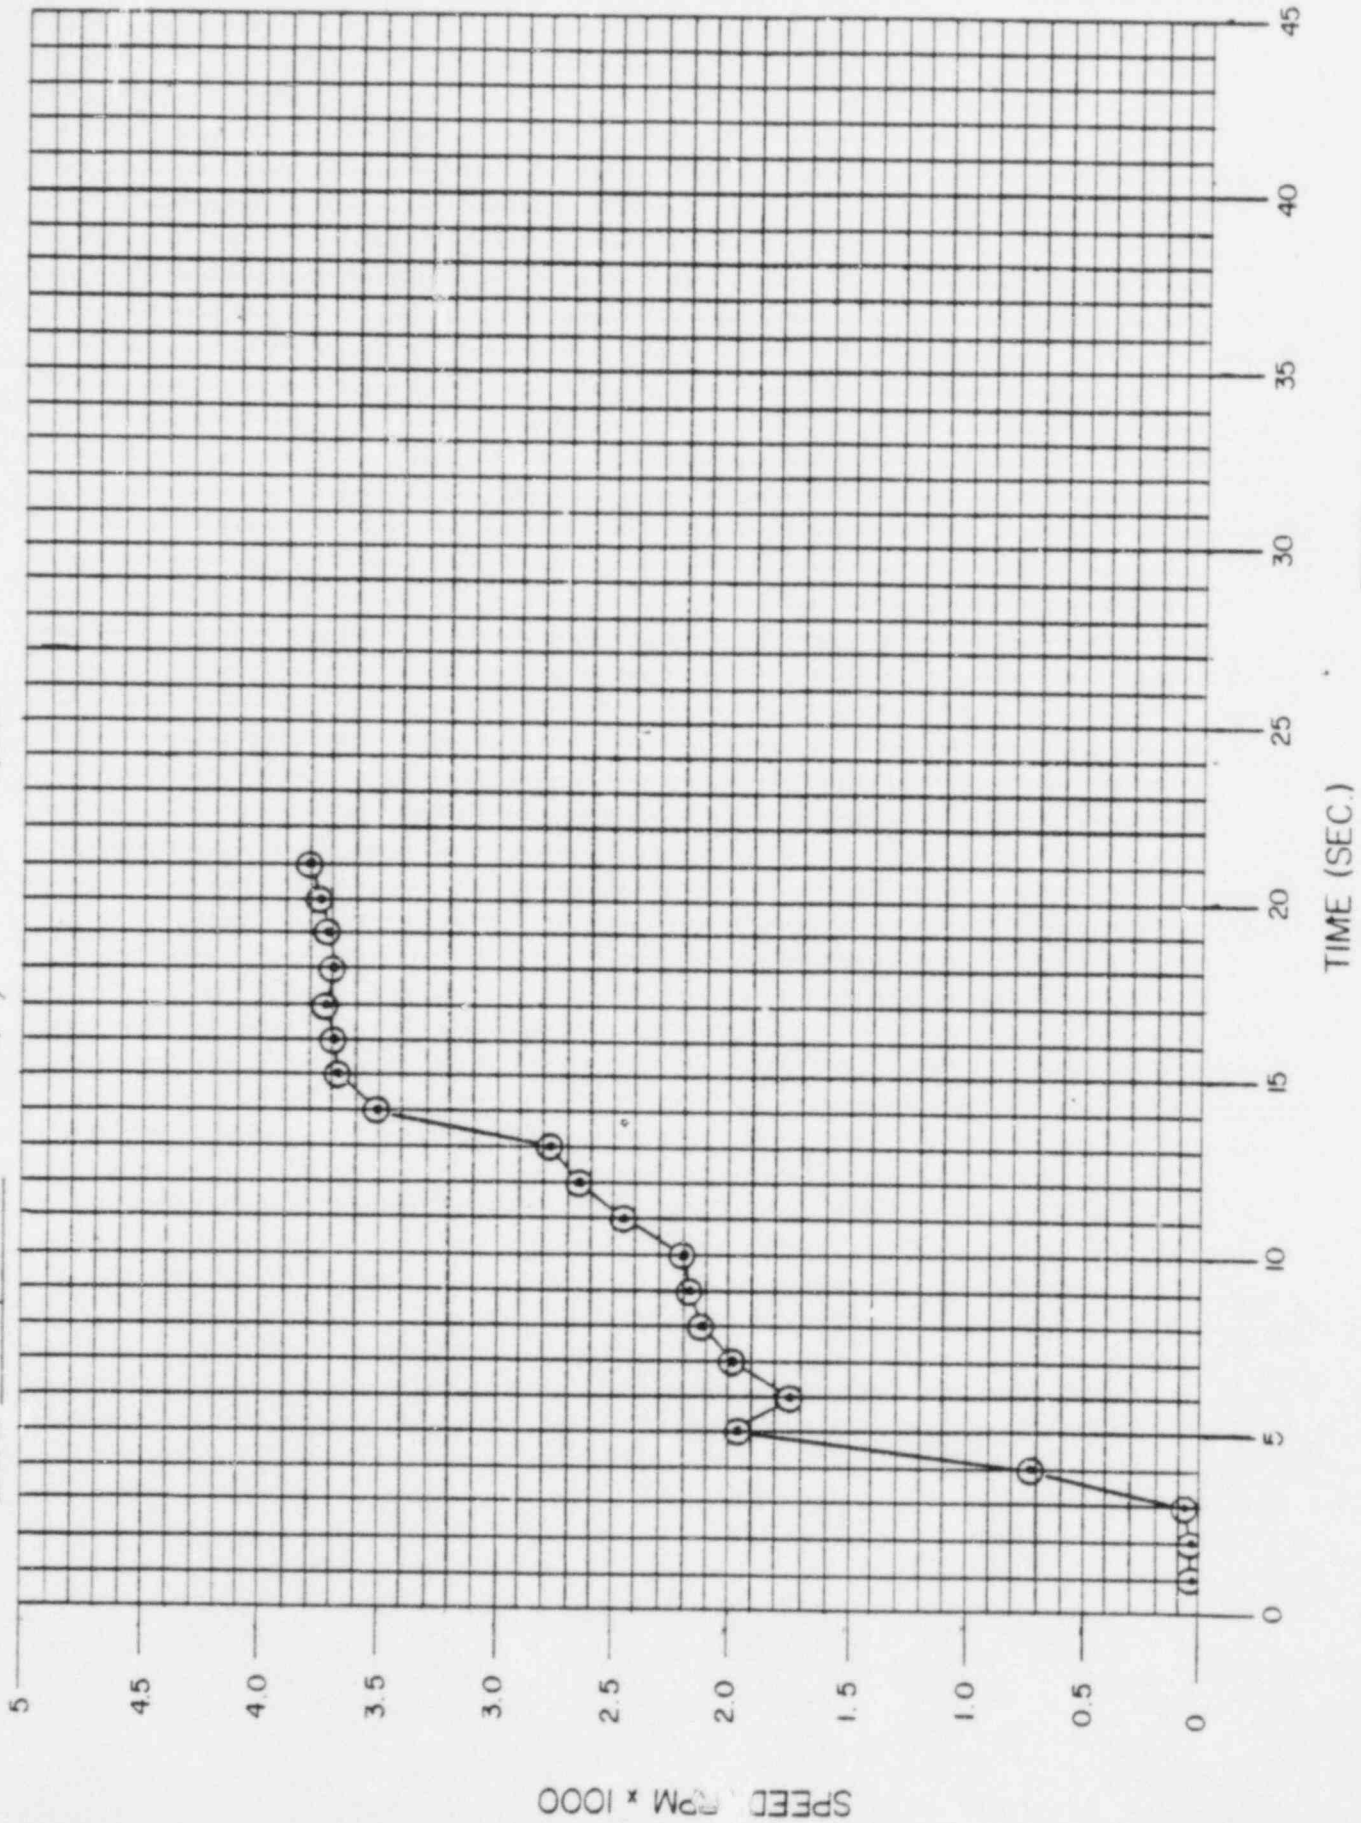
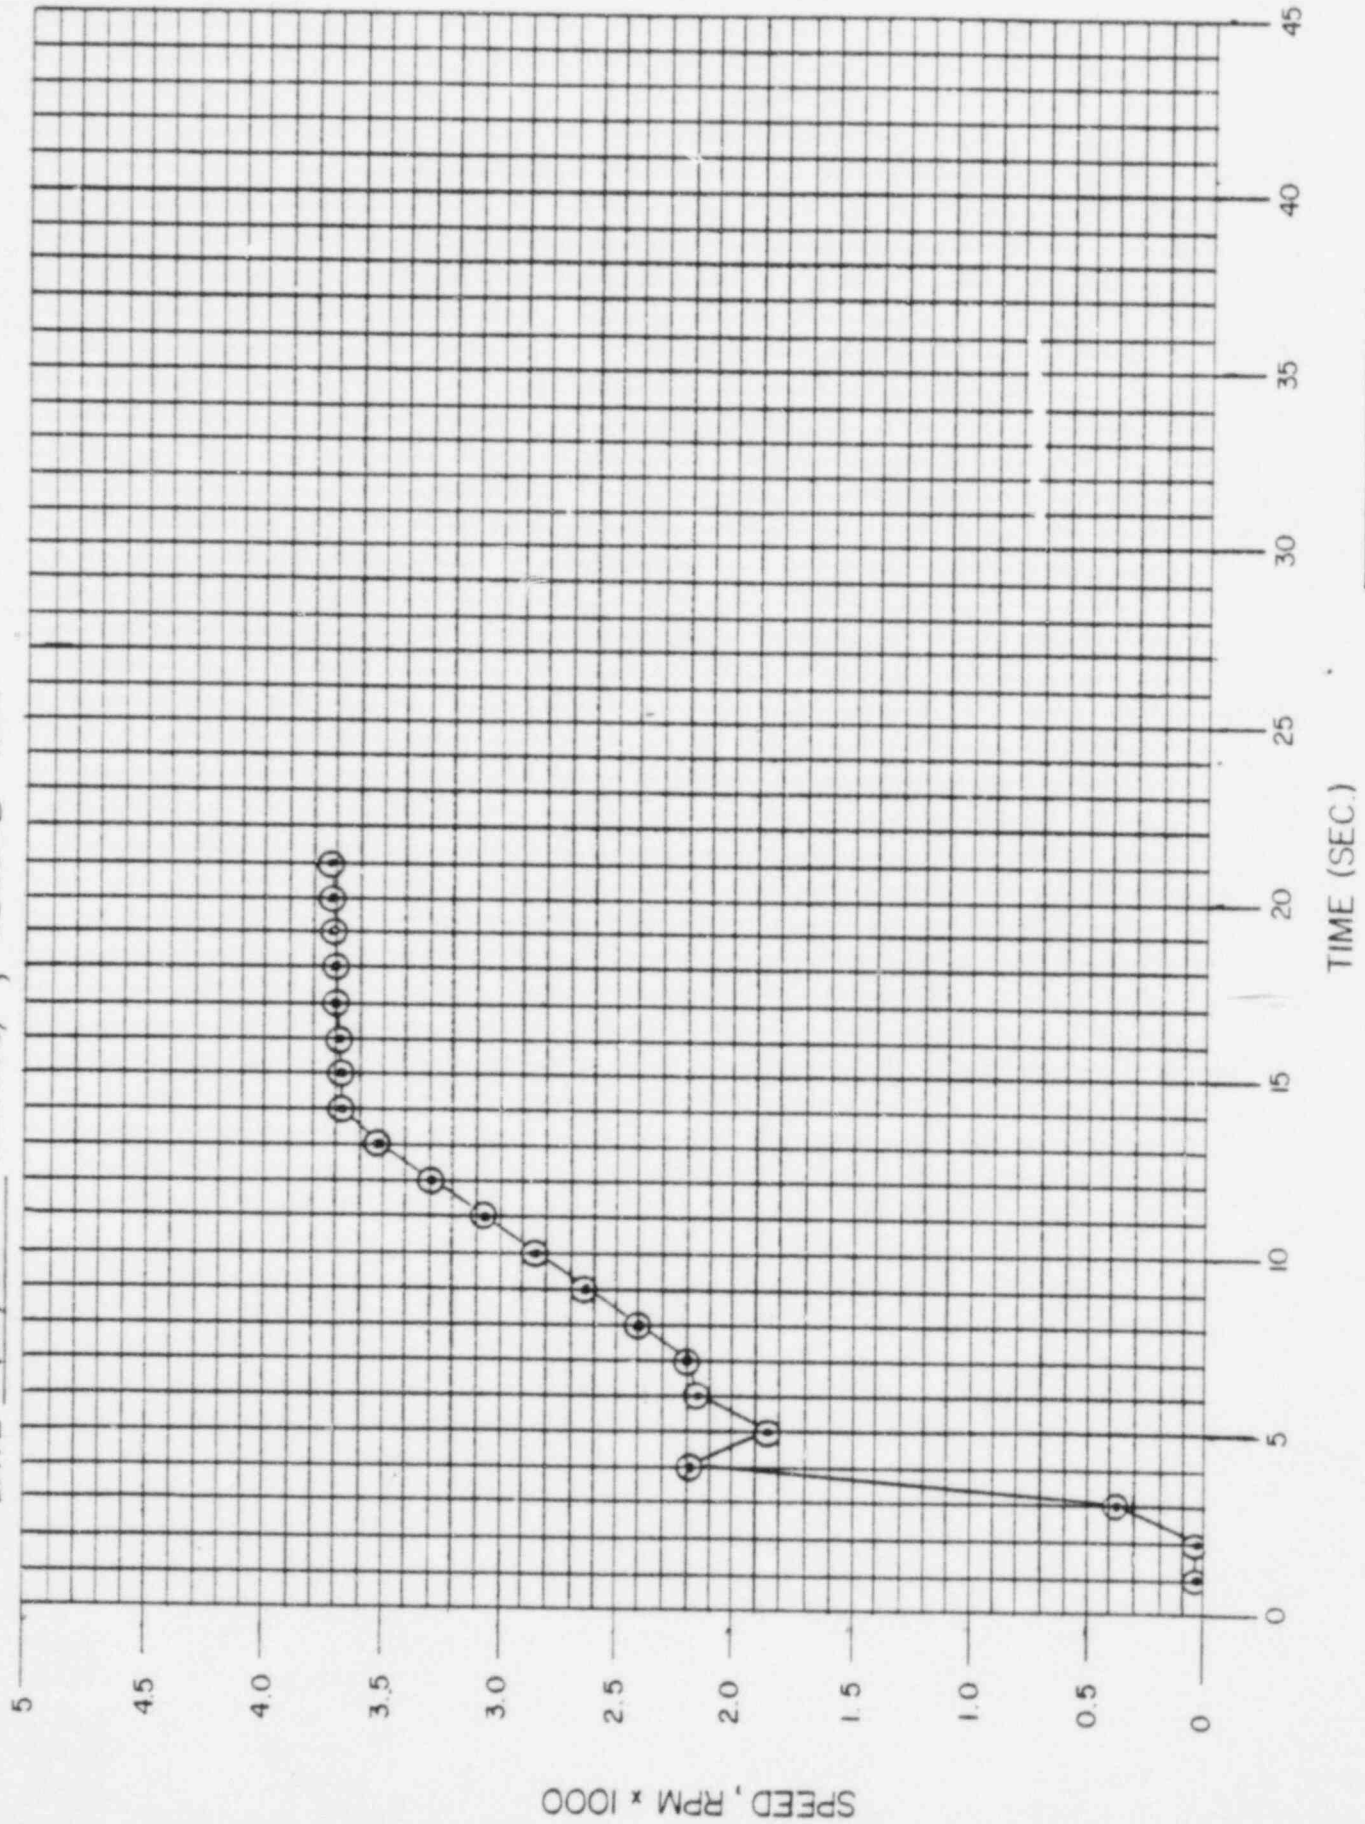
Technical Specifications. These tests were run on the normal steam supply path via MS 107 and with the pump discharge valves closed (i.e., min-recirc path open). Less than 24 hours prior to these two (2) tests some additional testing was done on this same turbine using the same valve line-ups. This prior testing was performed for trouble-shooting. Due to the prior testing, the steam lines may not have been cooled to ambient conditions prior to the two (2) operability tests being run. The speed characteristics are shown in Figures 10 and 11 of Attachment 2.

A review of the speed vs. time characteristics shows that the first run exhibited speed increases which appear to be a series of step changes rather than a constant acceleration to rated speed. The second run (performed immediately after the first) shows a constant rate of acceleration to rated speed. This is attributed to the fact that the steam lines were already heated, therefore, there would have been less condensation.

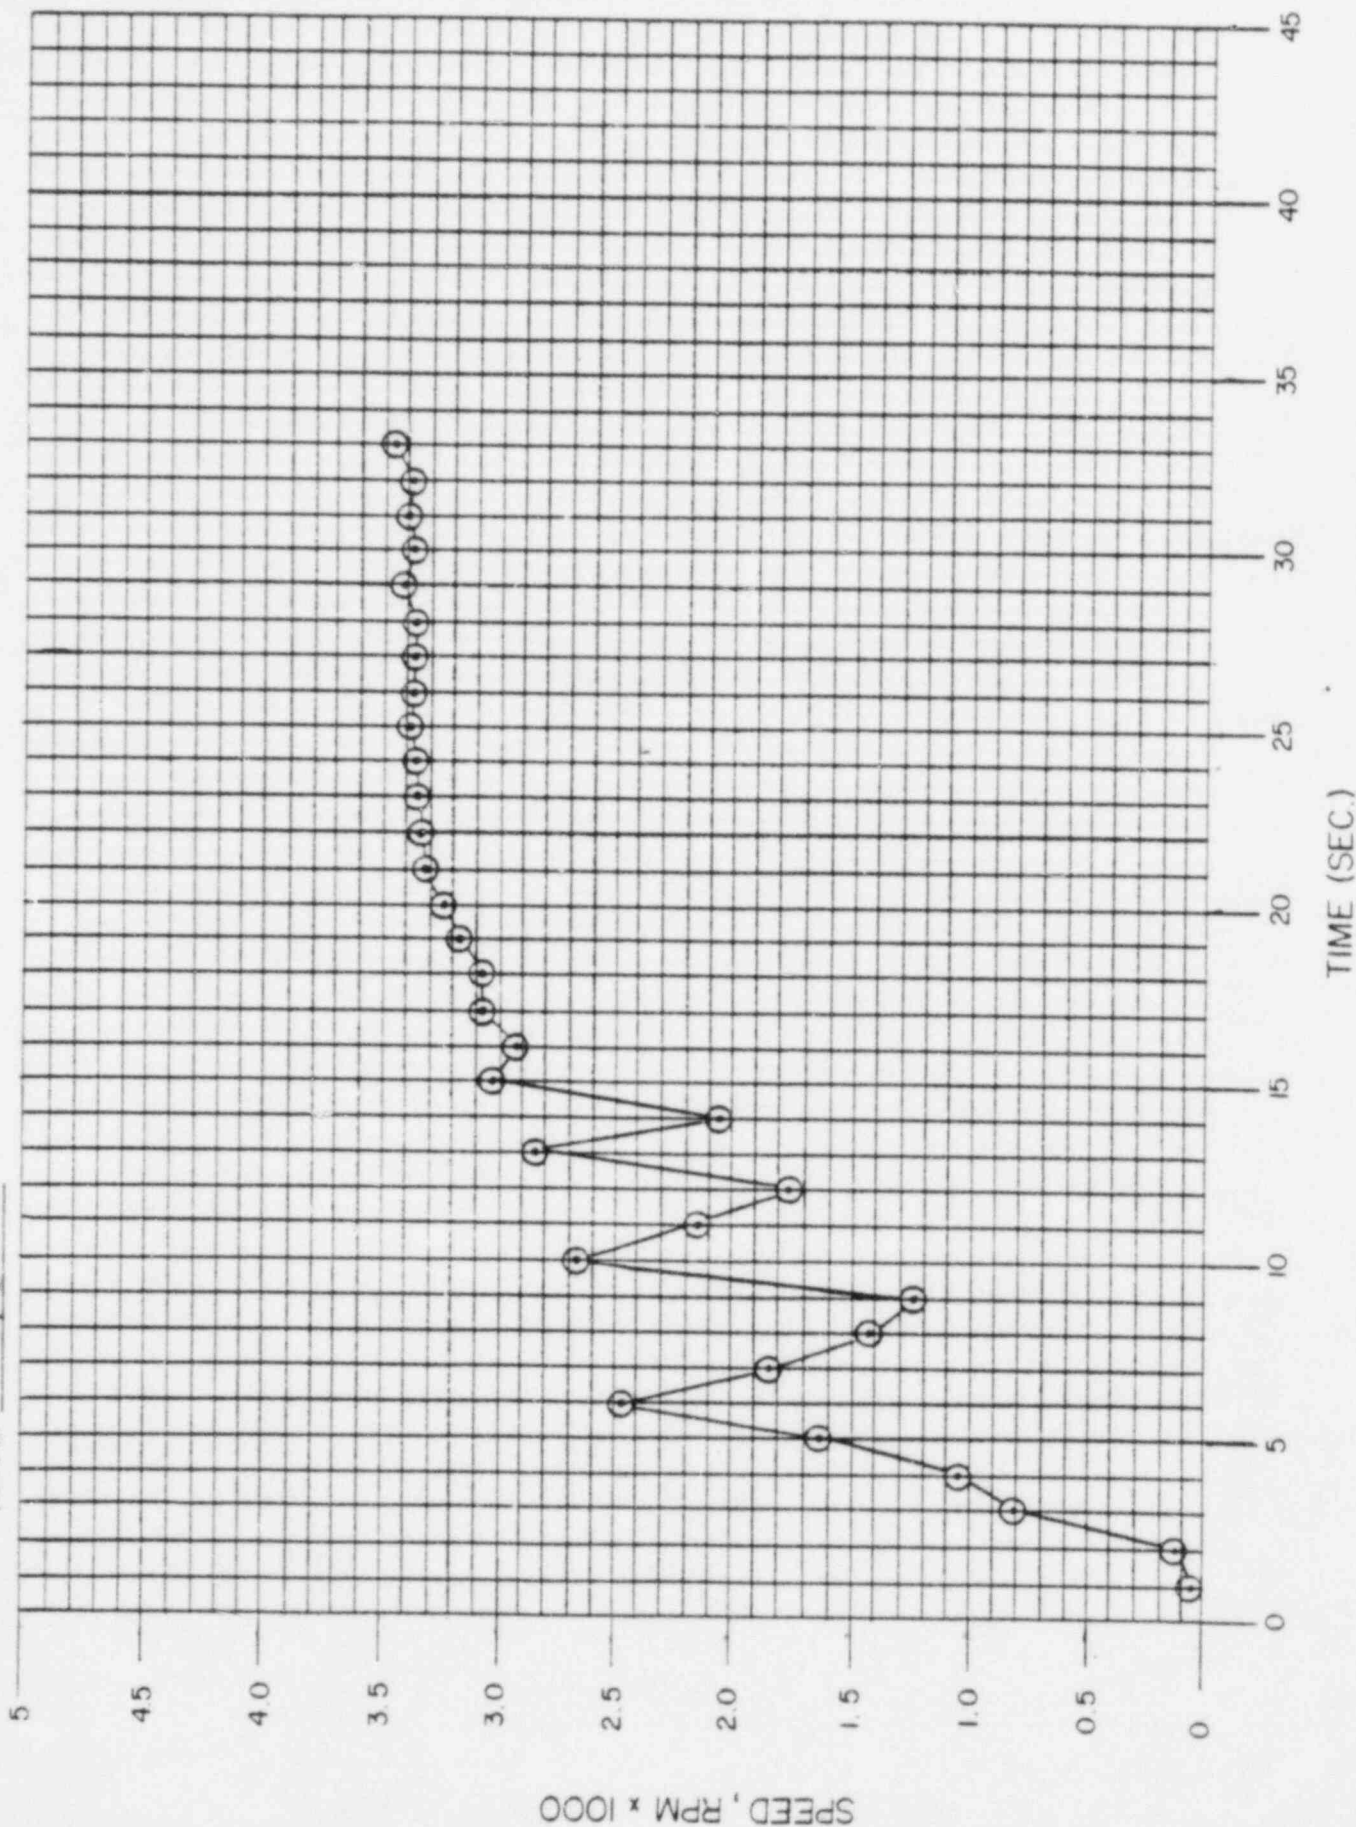
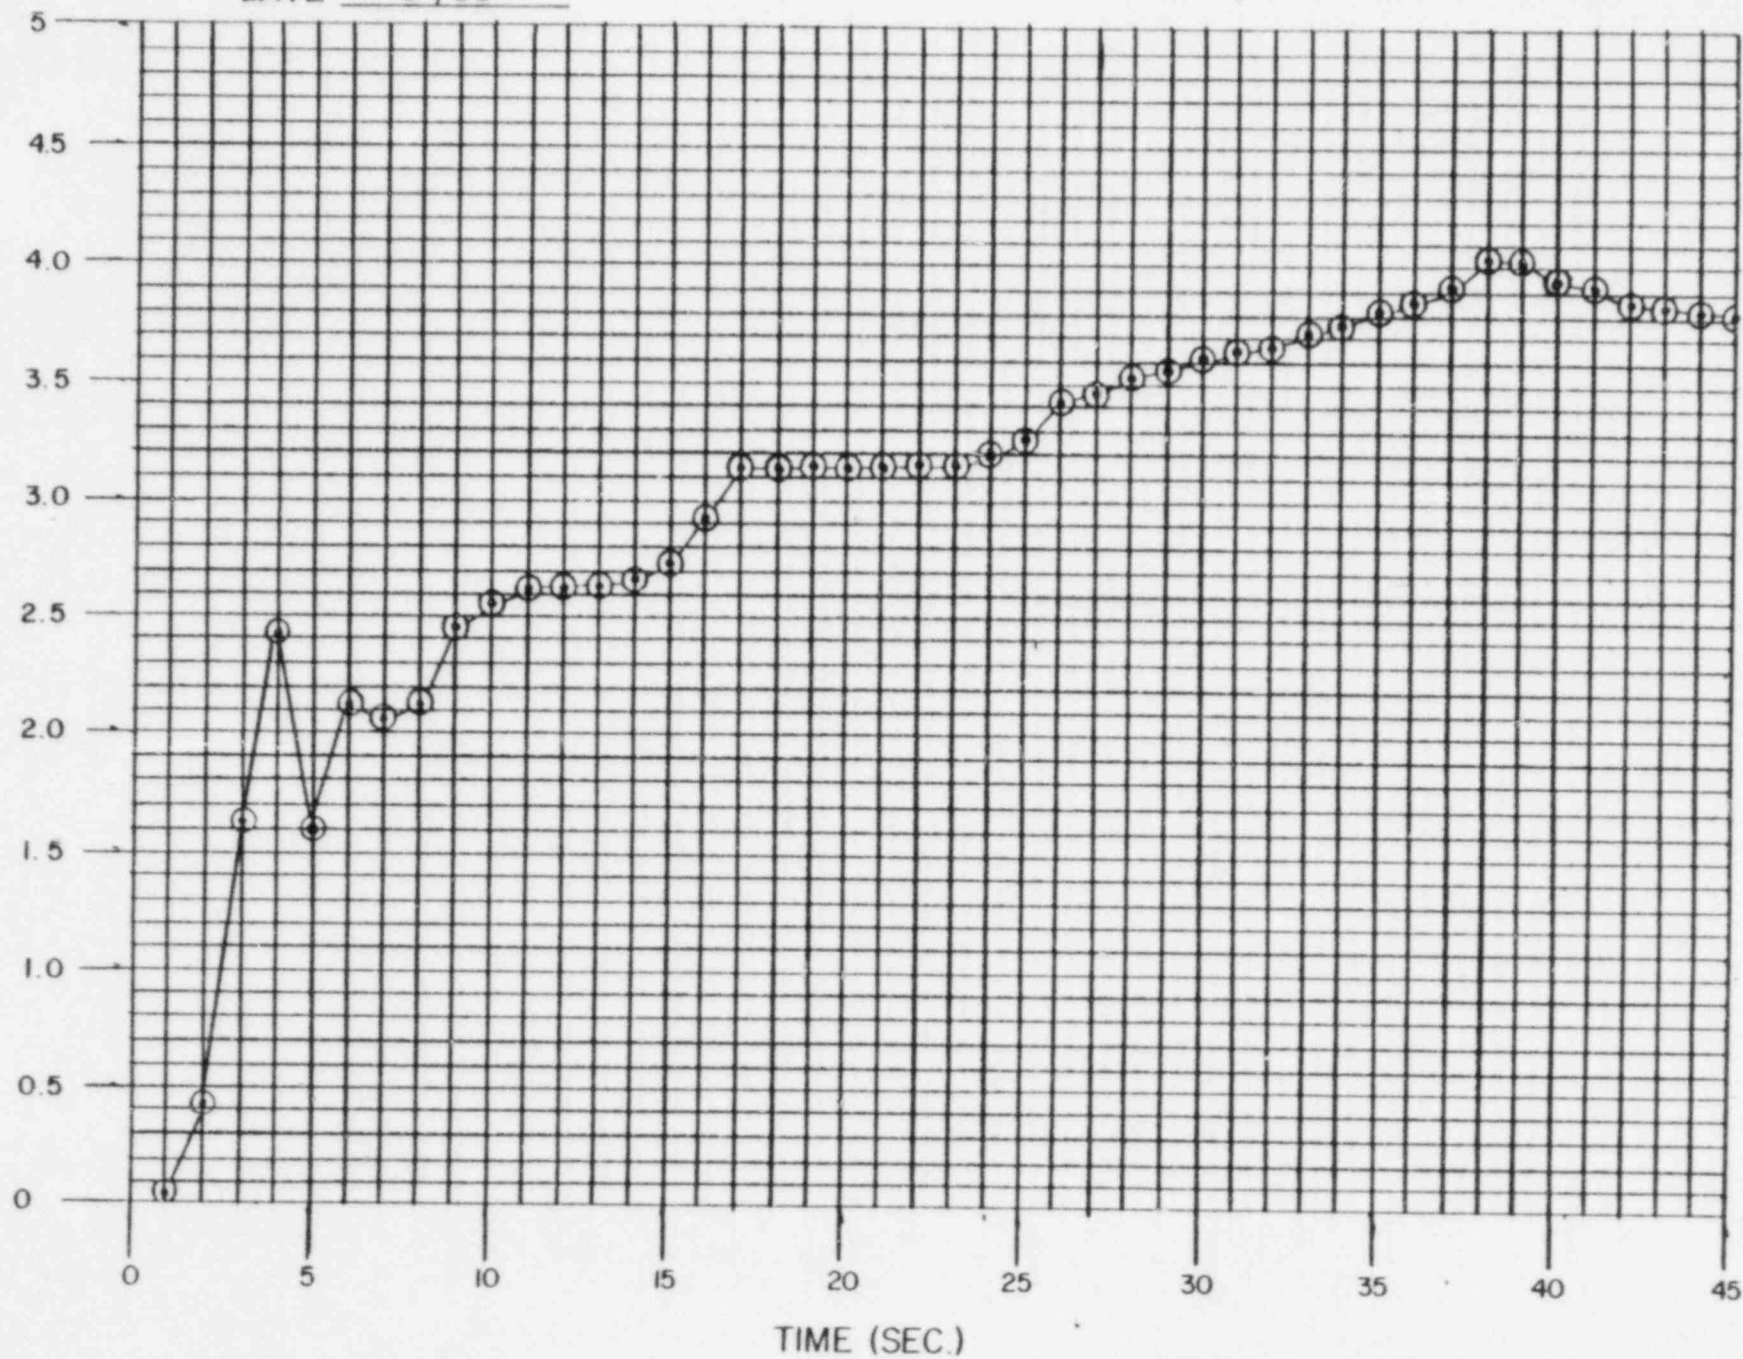
The speed characteristics are shown on Figures 12 and 13 of Attachment 2. A review of the speed characteristics for AFPT #1 shows the typical characteristics consistently seen on AFPT #1 (i.e., several oscillations prior to reaching rated speed).

A review of the speed vs. time characteristics for AFPT #2 shows a fairly steady increase to rated speed but the speed continues past the high speed setpoint (3710 RPM) to approximately 4000 RPM for about three (3) seconds. The turbine then decreased speed and controlled at the high speed setpoint. During the initial increase to rated speed, the speed increases are seen as step changes rather than a straight line. These step changes, and the increase to approximately 4000 RPM, may be attributable to water slugs.

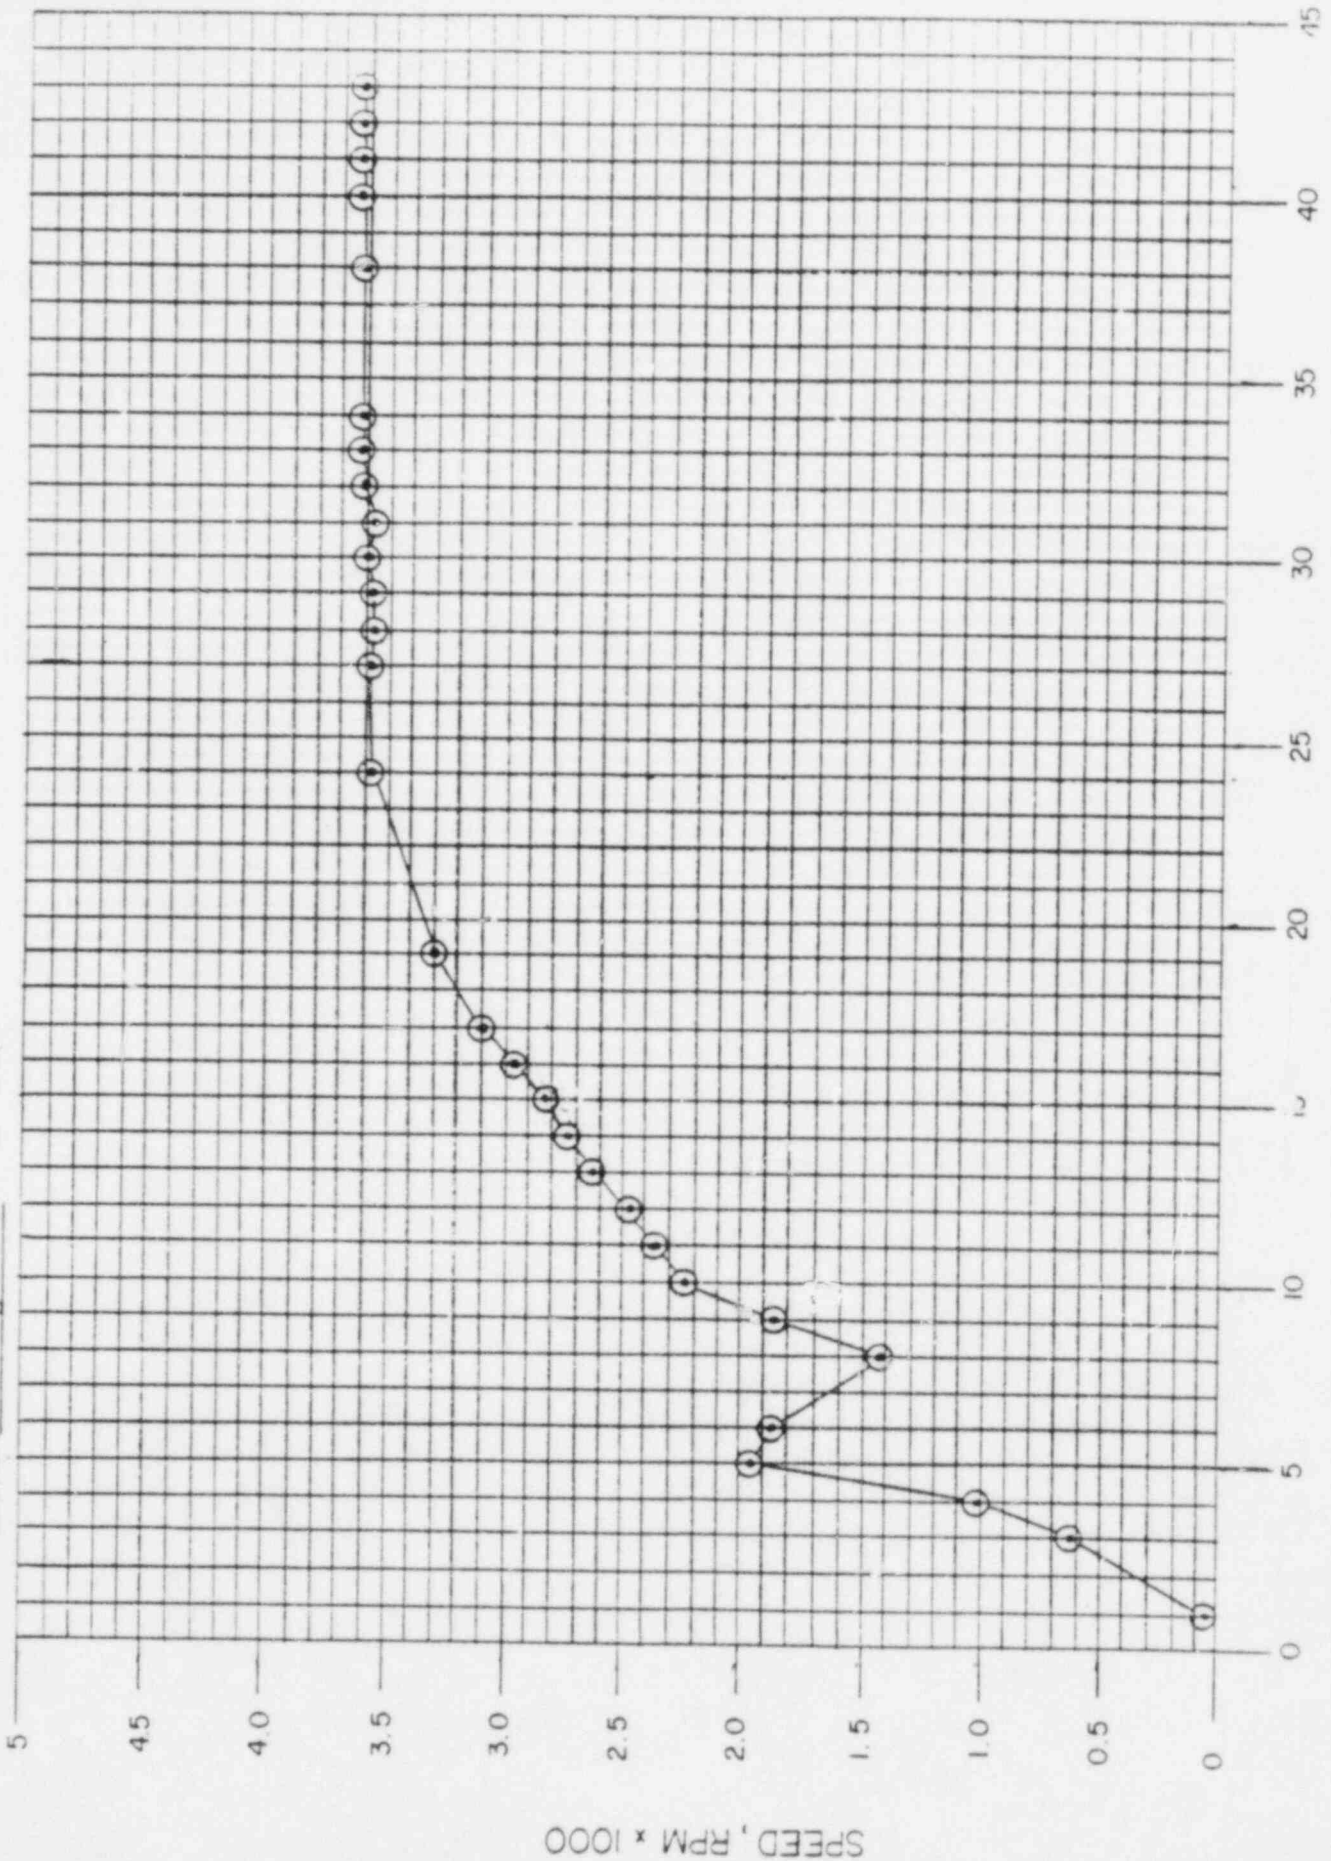
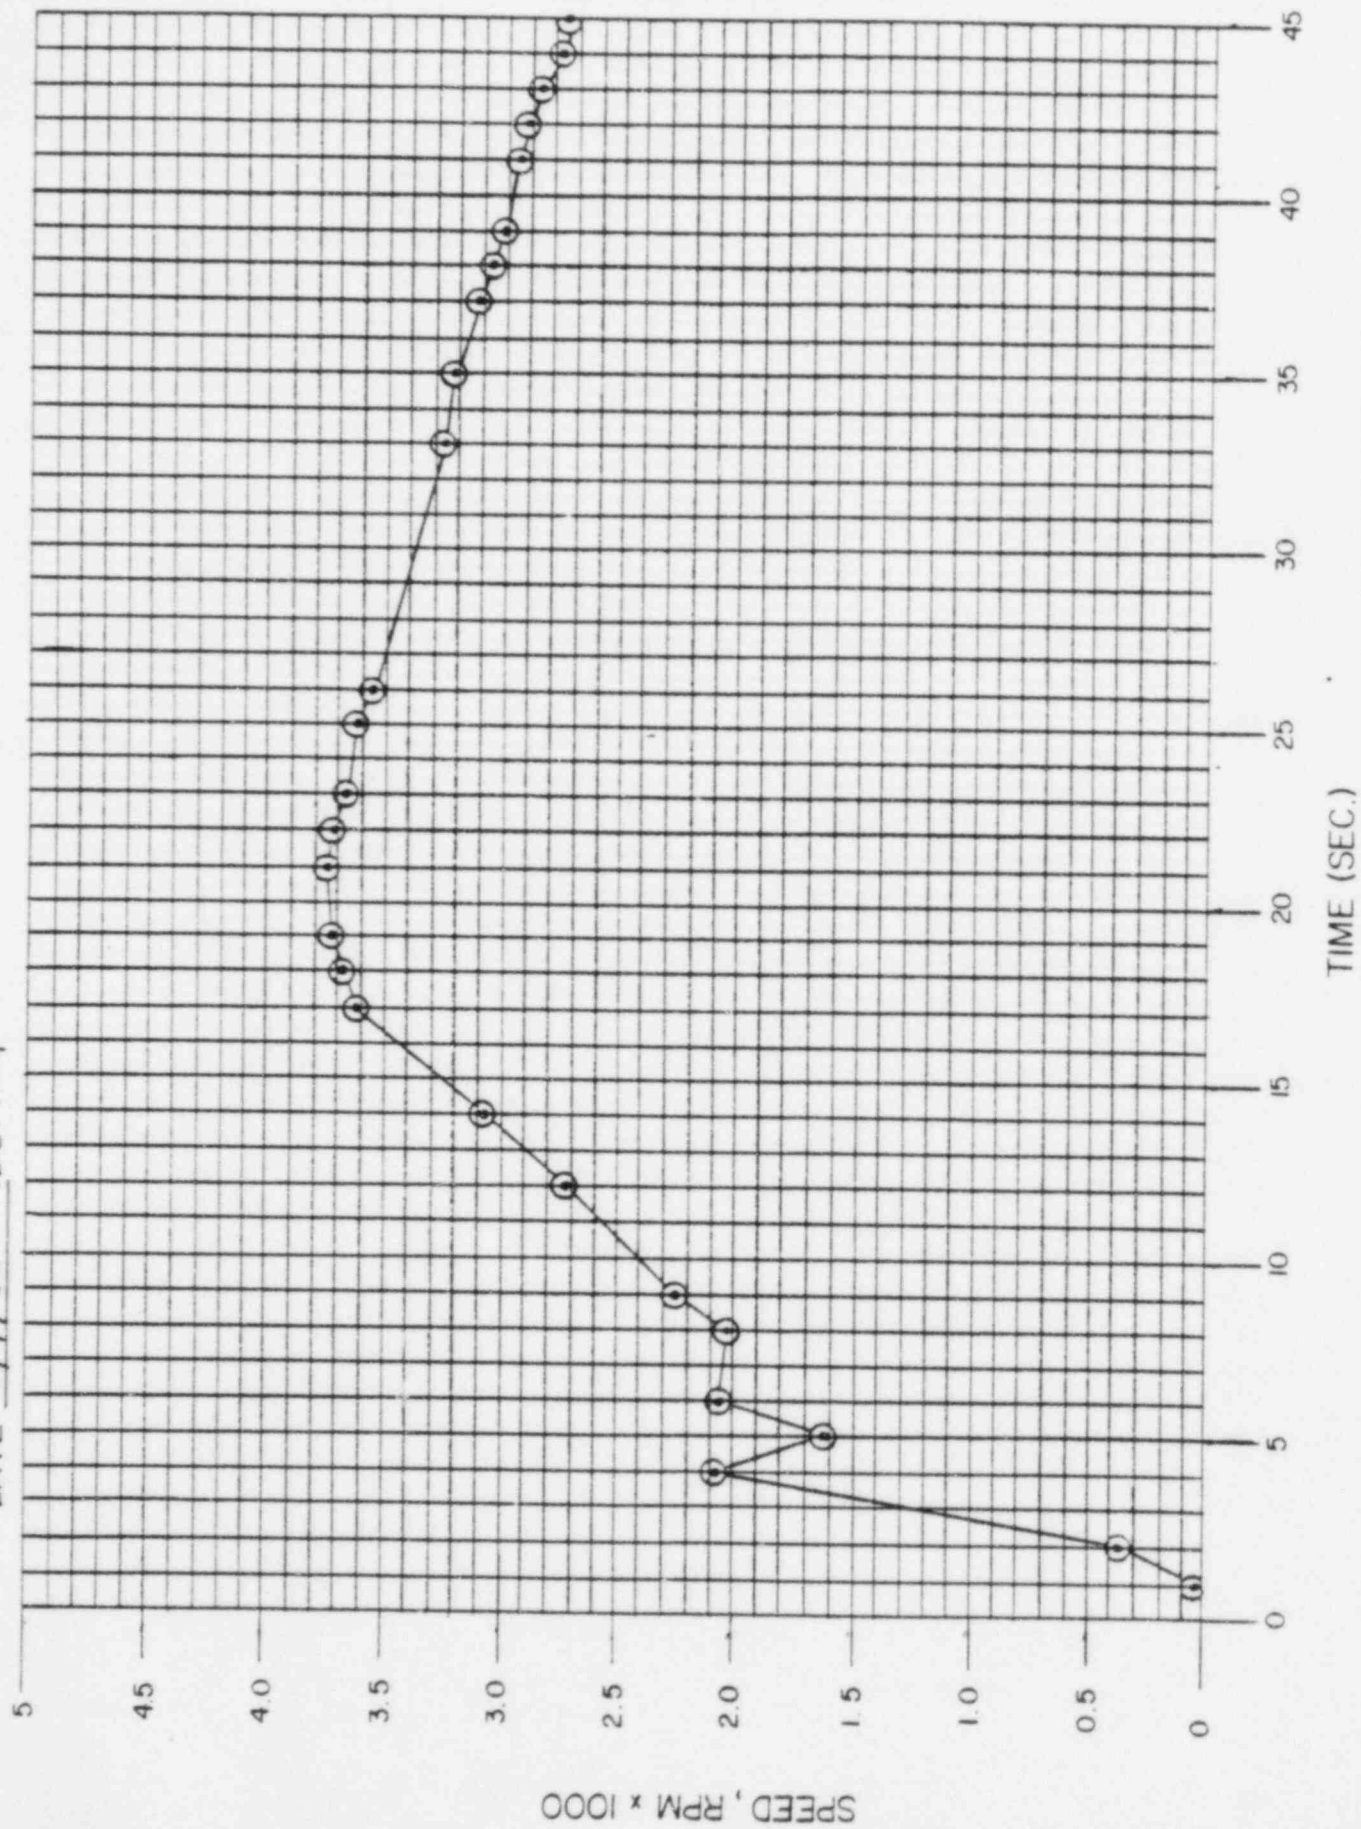
After the plant trip, a quick start test was performed on each of the AFPTs. These tests were run on the normal supply paths via MS 106 and MS 107. Both pumps discharge valves were closed such that only minimum recirculation flow was provided. These tests were run approximately ten (10) hours after the AFPTs had been shut down, therefore, the lines were still warm and condensation would not be expected. The speed characteristics are shown on Figures 14 and 15 of Attachment 2.

A review of each speed vs. time characteristic shows a constant acceleration to rated speed. AFPT #1 does not exhibit oscillations seen at other times. The "smoothness" of these graphs may be attributable to the fact that minimal condensation would be expected since the lines were already heated.
