NED-85-422
1746N

NRC DOCKETS 50-321, 50-366
OPERATING LICENSES DPR-57, NPF-5
EDWIN I. HATCH NUCLEAR PLANT UNITS 1, 2
PROJECT COMPLETION ADDENDUM TO RECIRCULATION
PIPING REPLACEMENT REPORT

PROJECT COMPLETION ADDENDUM TO
RECIRCULATION PIPING REPLACEMENT
REPORT TO NRC

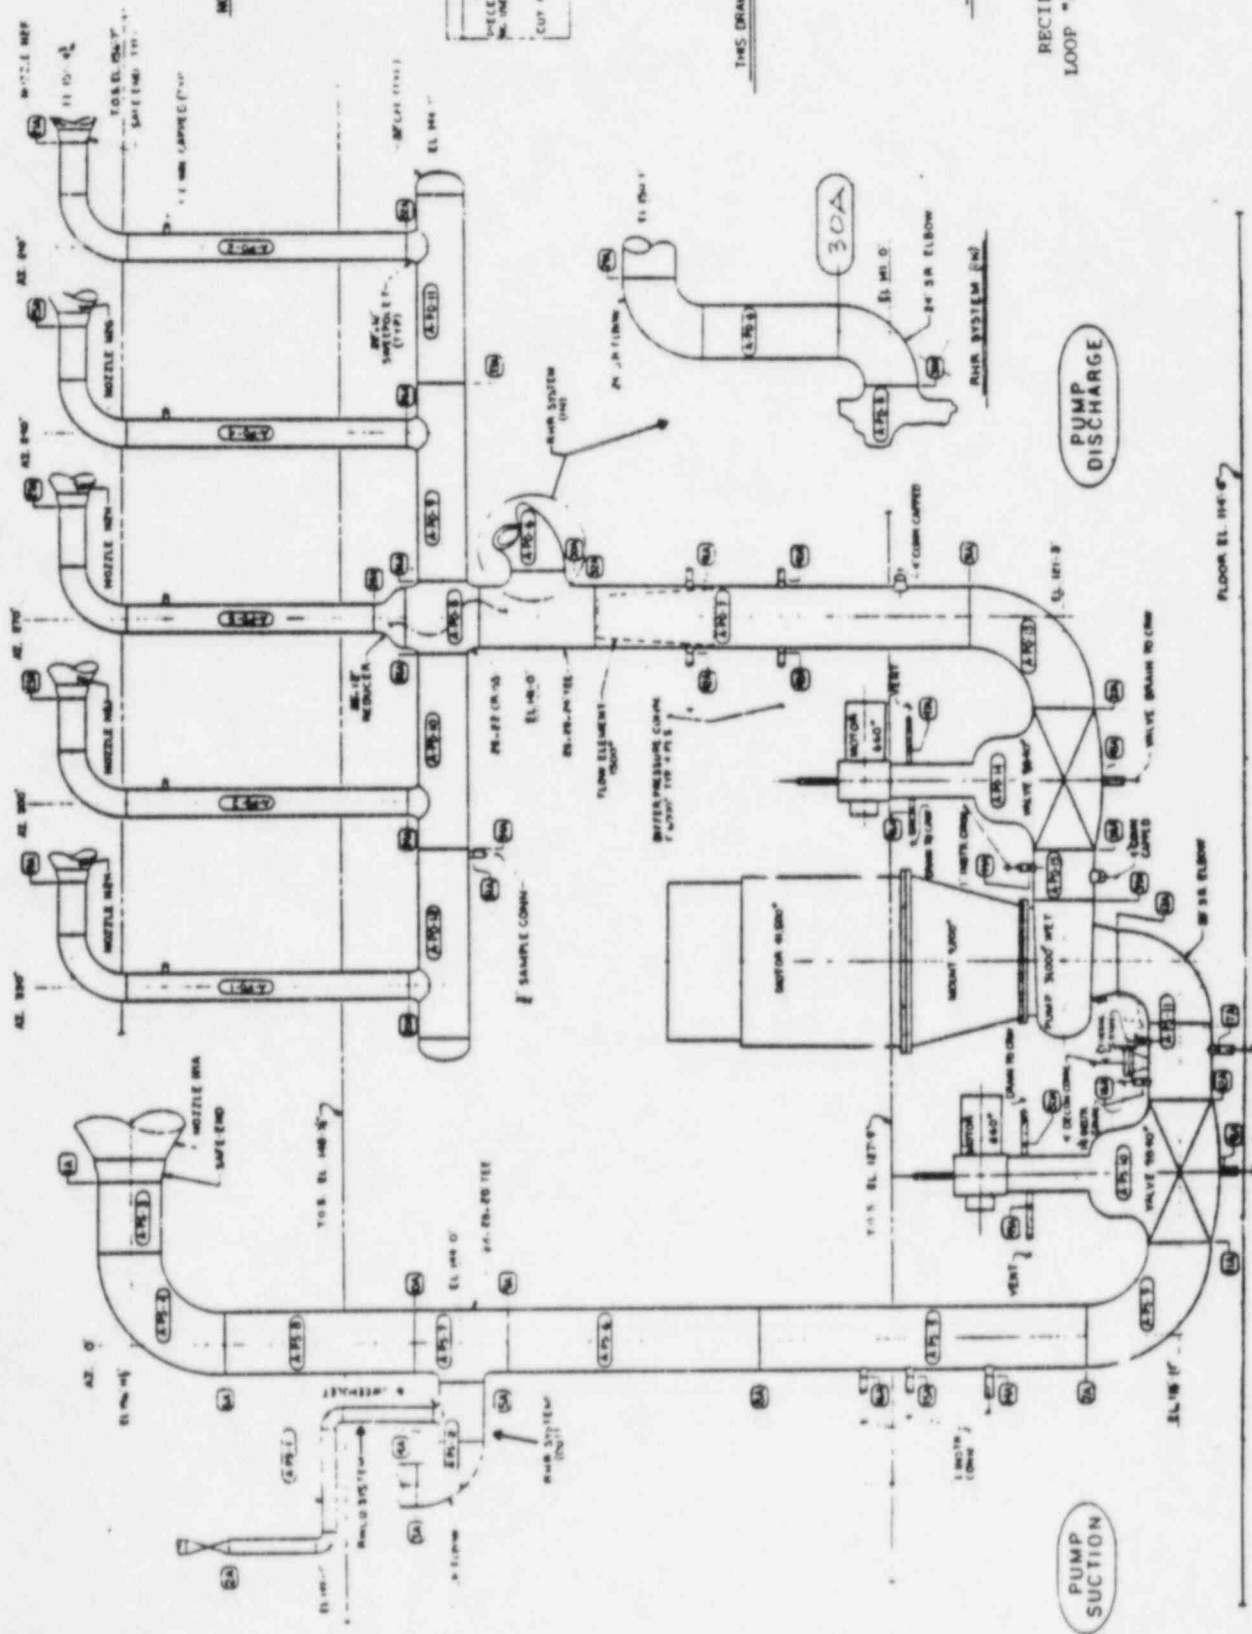
FIGURE 2

Page 3-11, Figure 2 provides the cutting diagram for Loop "A" of the main recirculation and attached systems' piping. Cut 30A, which severs the 20" RHR piping from the 28" Recirculation System piping, is incorrectly located. Cut 30A should have been located at the adjacent RHR weld (i.e., at the pipe-to-elbow weld) as shown in the enclosed figure.

RECIRCULATION PIPING
LOOP "A" CUTTING DIAGRAM
