ATLAS CORPORATION

Re: Transmittal of Atlas Corporation's *As-Built Construction Report for the Completion of the Interim Cover*

As-Built Construction Report for the Completion of the Interim Tailings Cover

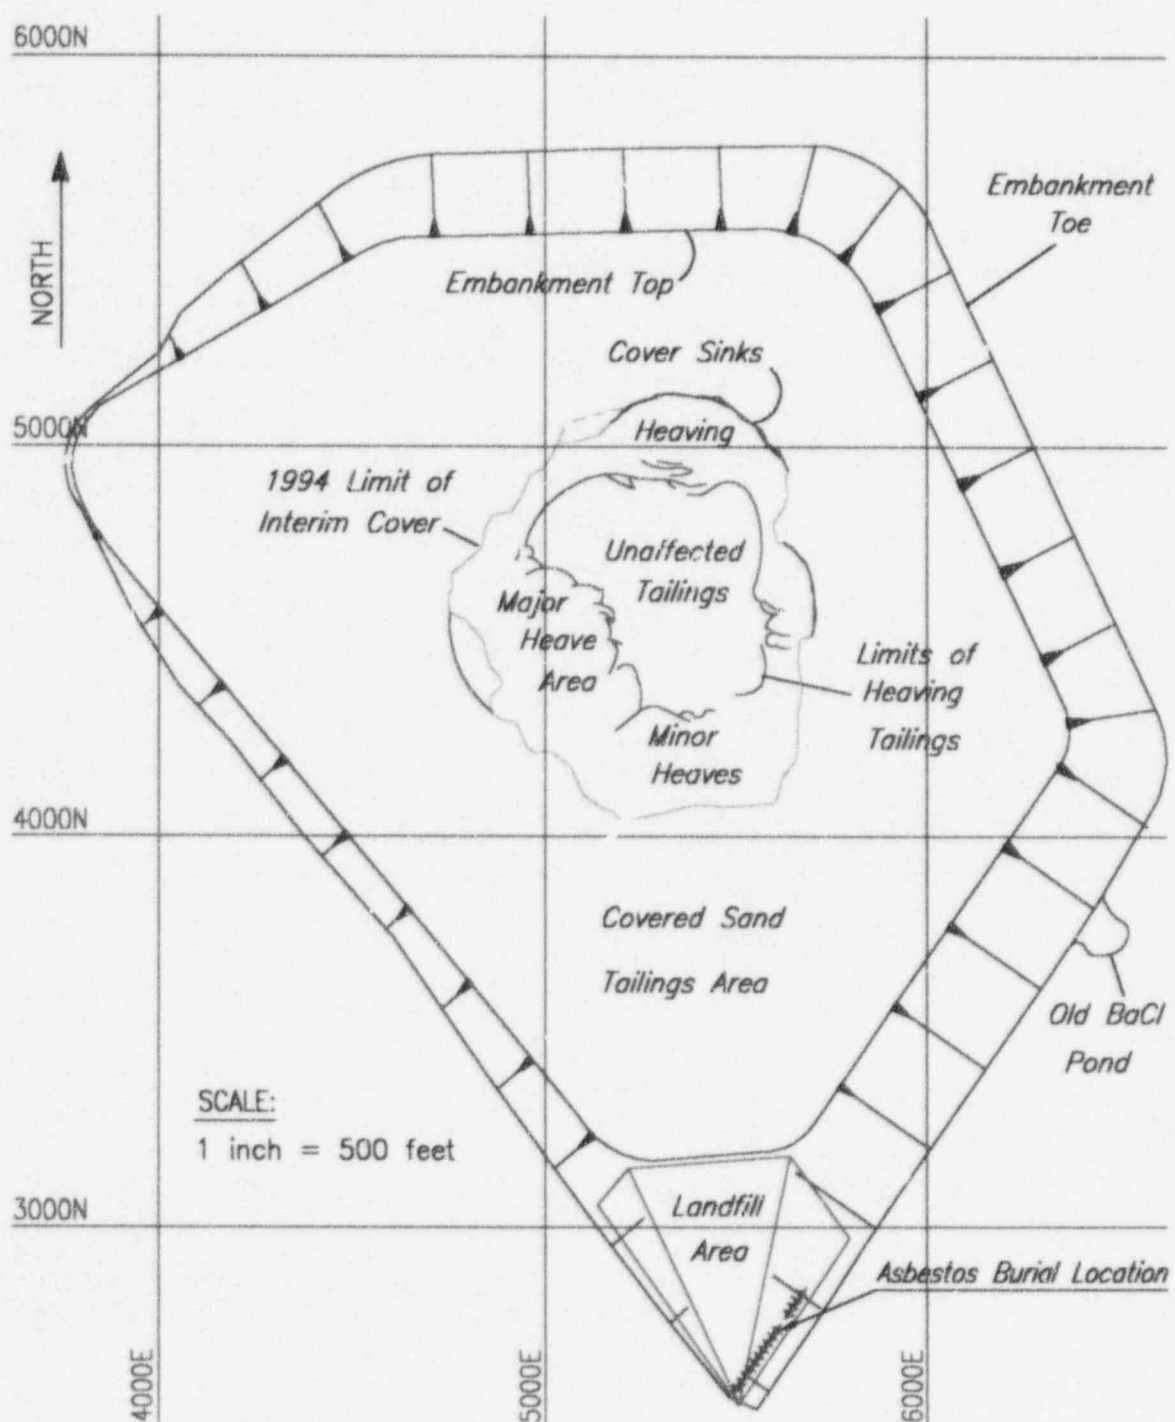
Figure 1: The Atlas Tailings Pile Showing the 1994 Limit of Cover and the 1996 Landfill Area

Nevertheless, in all cases the volume and weight of cover material sinking into the slimes simultaneously caused the tailings in front of the leading edge of the fill to rise, or heave, above the tailings pool level, in some cases as much as four feet (see Figure 1). Only about 7-8 acres were unaffected. Adding more fill only made matters worse. In addition, using lighter weight, low ground pressure (LGP) equipment did not help much because it was the weight of the cover that was the main problem. These global failures occurred because the underlying slimes tailings were less able to support the cover weight than the sand tailings. Furthermore, although the salt crust could support a person's weight, it could not support the weight of thick earth cover or heavy equipment due to the unconsoli-

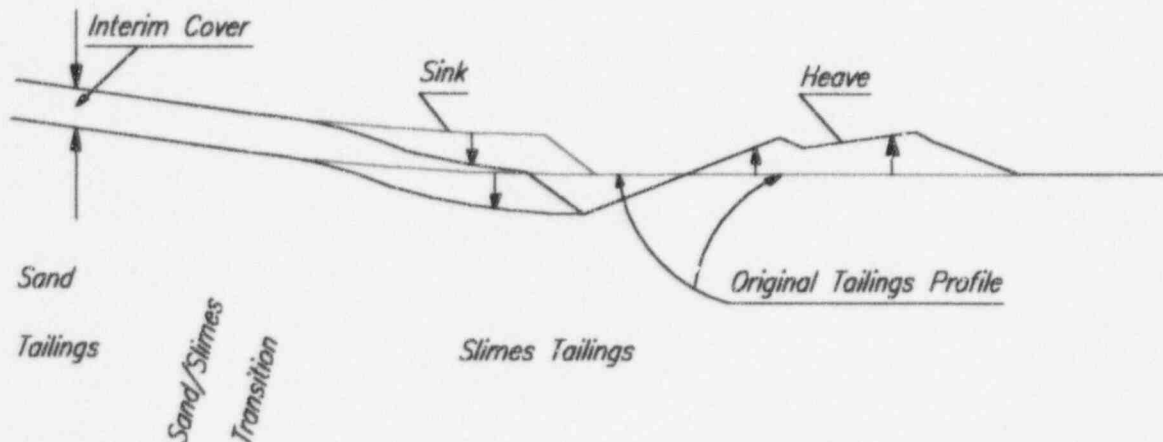
Figure 2: Typical Mode of Cover Failure

As previously mentioned, Atlas experienced no settlement problems in covering the sand-sized tailings. However, as work continued towards the central area of unconsolidated slimes it became increasingly difficult, due to global failures of the cover material. In the typical mode of failure the fill simply sank into the slimes as shown in Figure 2. Another type of failure occurred in which the leading edge of the fill sank into the slimes causing tension cracks several yards back in the fill. The trailing edge of the fill in front of these cracks then had no strength and thus also sank into the slimes. In this case the fill appeared to fail by shearing.

Atlas and Smith Environmental concluded that accelerated de-watering would not be feasible to implement before it was necessary to complete the interim cover. Instead, they chose to use a biaxial geogrid material (Biaxial Geo-grid BX1100), supplied by Tensar Environmental Systems, to provide reinforcing support for the cover and the best chance to prevent further global failures. This geogrid consists of high density polypropylene that has high flexural rigidity and tensile strength relative to the cover dirt. To complement the biaxial geogrid it was also necessary to use low weight LPG equipment. The work of completing the interim tailings cover using this reinforcing geogrid is described in this report, which includes problems met and what was done to overcome them.

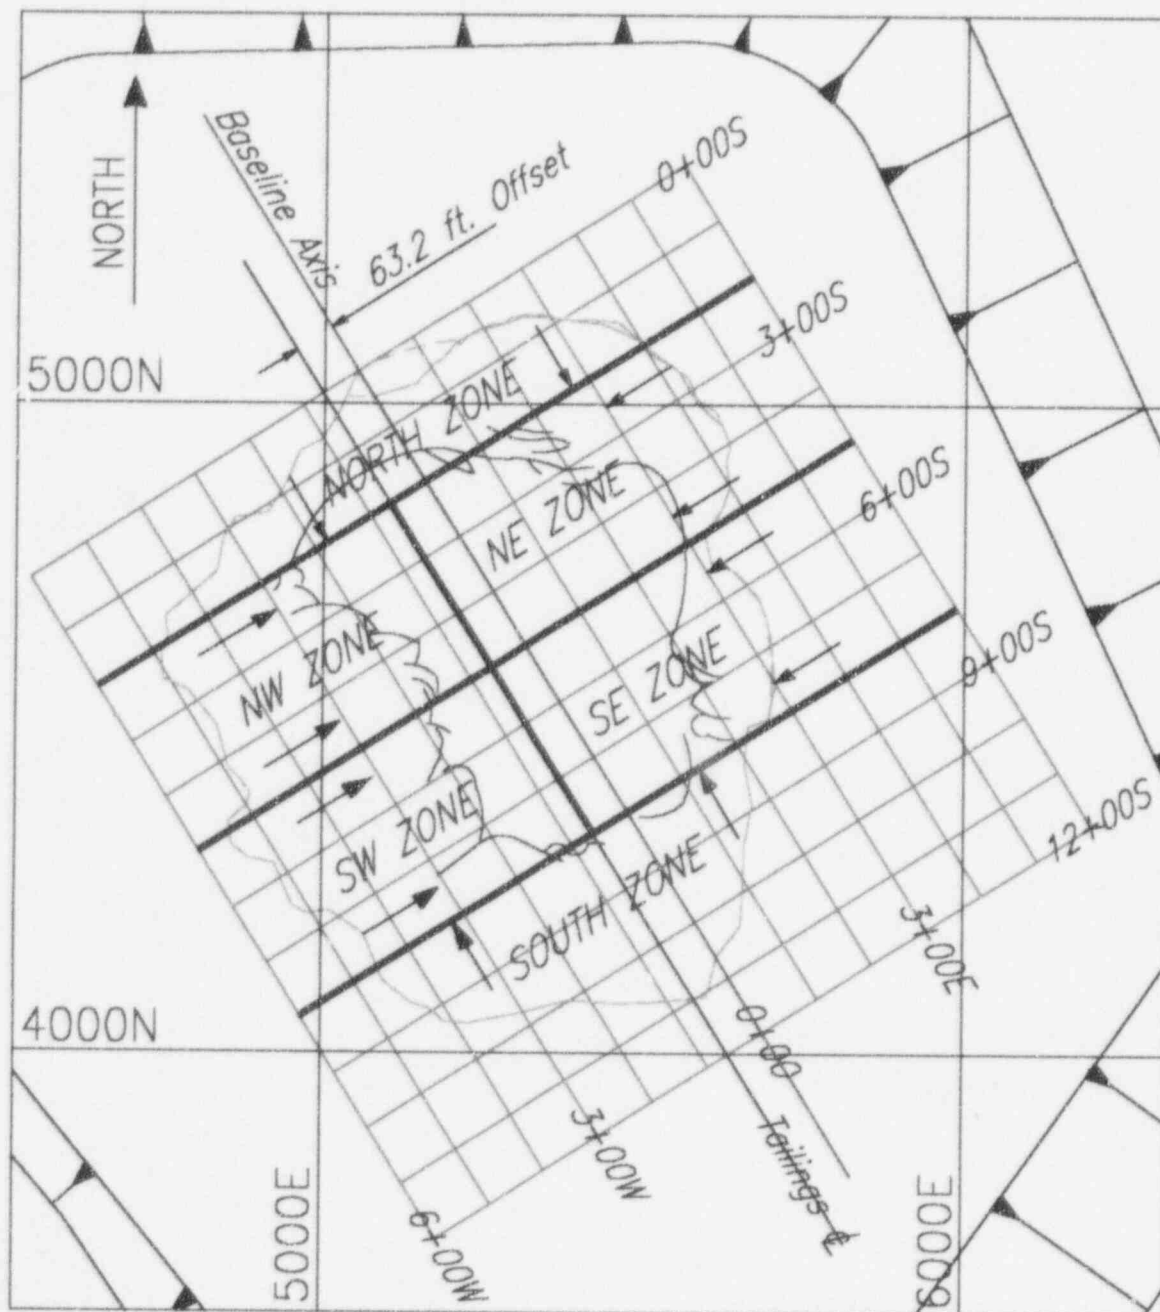
Figure 3: Details of the Slimes Cover Area

It was determined that the longitudinal center line of the area of exposed tailings was 63.2-feet offset from the baseline axis. After allowing for this, the work area was split into six manageable zones as shown in Figure 3; the arrows indicating the required direction for fill advancement and unrolling the 13-foot wide (164-foot long) geogrid rolls in each zone. The roll widths were intended to be overlapped by 3-feet and the plan was to work two zones simultaneously. Two D4C-LPG's were to be used at the leading edge of the fill, fed by one D5H-LPG from the specially constructed roadways and over previously laid fill in each zone. The roadways would be constructed at the center of each zone to allow for this and to allow the loaded trucks access onto the pile. A 50,000lb gross vehicle weight limitation was placed on the size of trucks allowed onto the slimes area. Where possible, cover material from existing upper tailings areas was proposed to be used. The first equipment arrived on September 28, 1995.

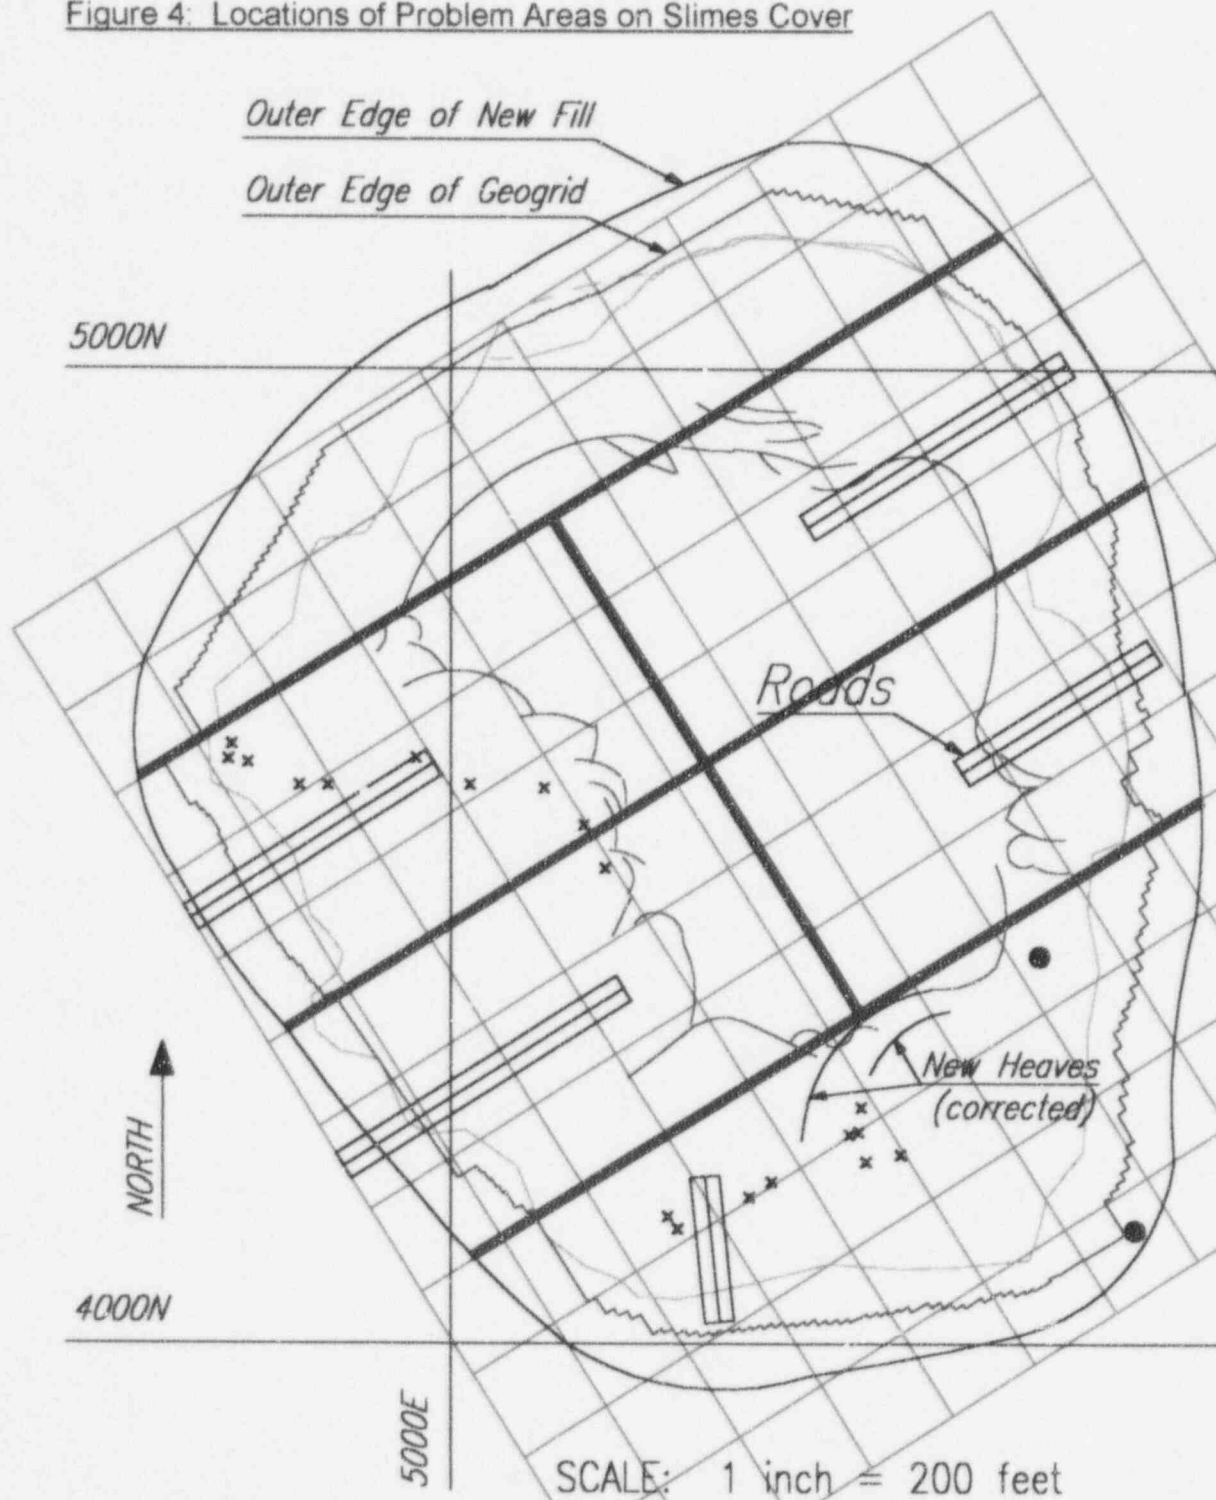
Figure 4: Locations of Problem Areas on Slimes Cover

We continued laying geogrids and dirt on the north and south zones for the rest of the week. A major global failure started in the south zone from the weight of excessive cover thickness, shown in Figure 4. This was a "shear"-type failure and resulted in a minor amount of heaving ahead of the fill. We took immediate steps to lighten the weight ahead of the fracture and implemented a method of measuring the cover depth to prevent a recurrence of placing too much fill. We observed no further movement at this particular fracture. Mr. Blubaugh visited

- = Cat621 Water Wagon Sunk
- X = Geogrid Clipped and Eruption of Slimes

The natural dirt proved to be much worse than low grade ore for covering the slimes, primarily because it was poorly graded material. This was proven by the fact that we did not even need roads when we used the low grade ore. Actual roads used are shown in Figure 4. This figure also shows locations where we had difficulties, such as new heaves, etc. In addition, we had to use a greater thickness of natural dirt than low grade ore because it tended to sieve through the geogrid rather than setting up on top of the grid. Comparing the loads of natural dirt hauled against the depth of fill on top of the geogrid we estimated that almost 40% fell through the geogrid.

Since the Caterpillar 621 water wagon is in essence a scraper, it proved that it would have been folly to use scrapers for this job since it sank into the tailings on two occasions. For this reason, the operator had to be always alert as to his position on the tailings.
