PECO Nuclear

10CFR50.59 Review for NCR PB 96-03414,  
Core Spray T-Box Cracks

Peach Bottom Atomic Power Station Unit 2  
Revision 0

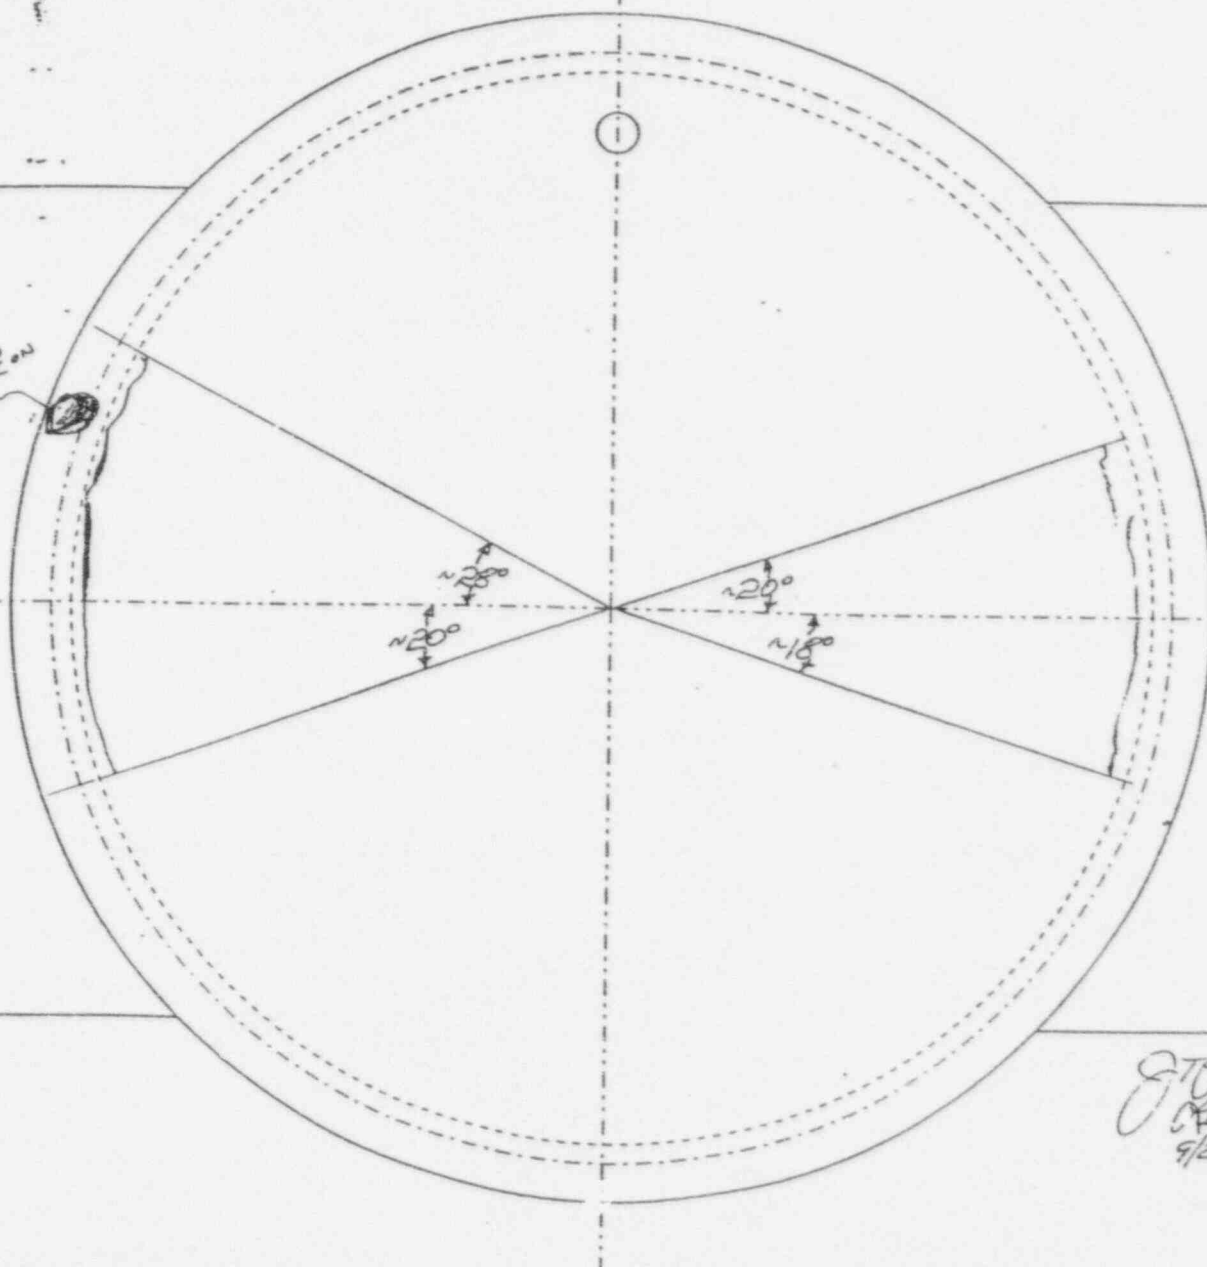
PBAPS Unit 2  
Core Spray Tee-Box Az 120 Deg  
Left Side Angle Approx. 48 Deg.  
Right Side Angle Approx. 38 Deg.

This 50.59 Review has been prepared in support of the 'Use-As-Is' disposition of NCR PB 96-03414. The subject NCR documents the continued operability of the Unit 2 Core Spray System through the next operating cycle (Unit 2 Cycle 12) with cracks in the T-box cover plate at the 120° Reactor Pressure Vessel (RPV) penetration. The crack indications are at symmetric locations in the heat affected zone (HAZ) of the T-box cover plate as illustrated in Figure 1 (Attachment 1). Visual inspection (enhanced VT-1) and follow up UT examination of the crack indications has determined the cracks to be 9.4 inches in length from 45.2° to 168.4°, and 3.4 inches from 231° to 275.6° when looking at the cover plate face.

Based on the above discussion, the root cause of the cover plate cracking is believed to be IGSCC initiating and propagating from the areas of highest stress.

As discussed above, the enhanced VT-1 and follow up UT examination have determined the flaw lengths on the cover plate face to be 9.4 and 3.4 inches respectively. The flaw lengths and orientation are considered conservative since they represent the limiting case of multiple UT scans of the cover plate. Based on the thickness of the cover plate and the type of UT examination, all flaws are assumed to be through wall. Therefore, the combined total flaw length in the cover plate was evaluated using a value of 12.8 inches ( $170^\circ$ ), through wall. The correlation of the ID to OD cracking detected in the cover plate is consistent with the cracking history observed with IGSCC at uncreviced and moderately creviced locations in BWRs.

GRIND  
FILL ON  
WELD
