Subject: Peach Bottom Atomic Power Station, Unit 2  
Core Spray In-Vessel Piping

# PEACH BOTTOM ATOMIC POWER STATION - UNIT 2

## CORE SPRAY SPARGER TEE-BOX

**Subject: Peach Bottom Unit 2 Core Spray Loop B Sparger Tee-Box Allowable Flaw Evaluation**

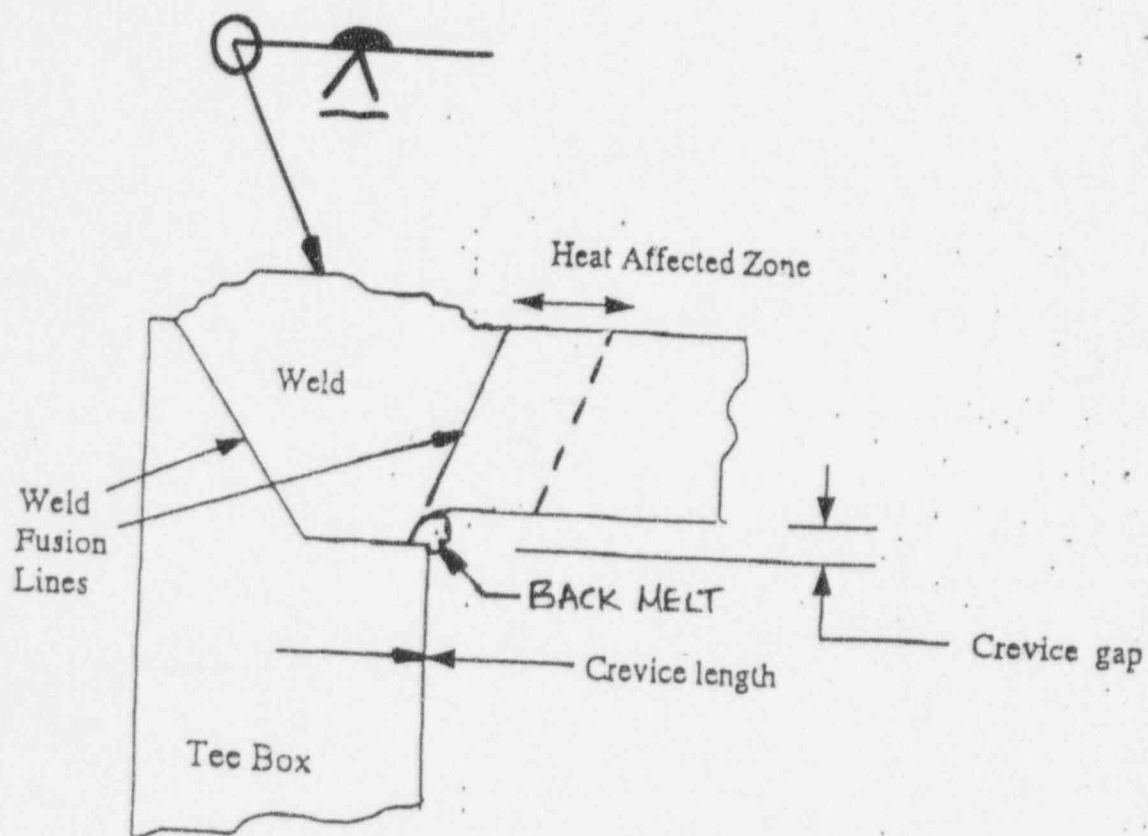
FIGURE 1

The Core Spray Sparger cover to Tee-box weld (Figure 1) is a full penetration weld and therefore non-creviced, eliminating a significant contributor to IGSCC initiation. Additionally, the Tee-box and sparger were installed and welded in the shop, which provides better control of design and fabrication tolerances, and reduces or eliminates induced loads due to fit up. Finally, sparger Tee-box operational loads due to flow and pressure are approximately one third of those at the header Tee-box resulting in lower stresses in the cover plate than that of the header Tee-box cover plate.

The sparger Tee-box configuration is different than the header Tee-box. The header Tee-box is a .437" thick forging with a .25" cover plate attached utilizing a partial penetration groove weld (Figure 2). The sparger Tee-box is a .28" thick forging with a .25" cover plate attached utilizing a **full** penetration groove weld (Figure 1) which is a non-creviced weld, therefore eliminating a significant contributor to IGSCC initiation. Additionally, sparger Tee-box fabrication was done in the shop rather than in the field and the potential for fabrication induced stresses is expected to be lower.

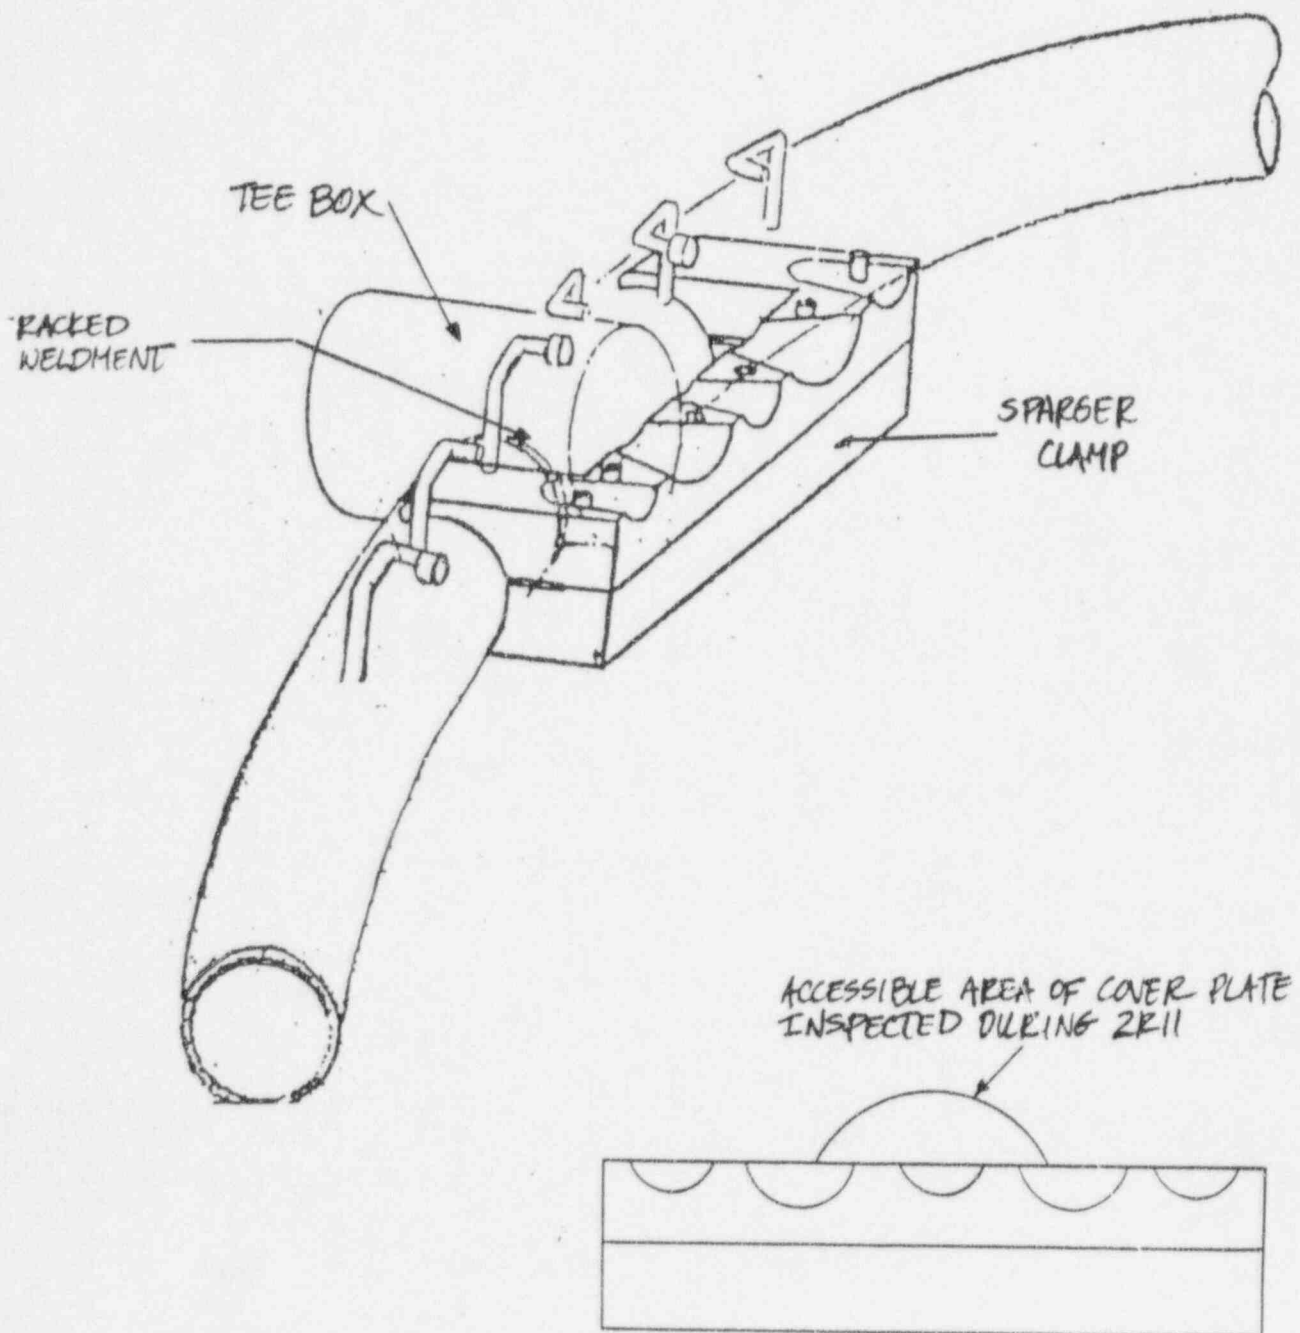
FIGURE 3

In addition to design and operational evaluations, sparger Tee-box inspections have been performed since 1980 in accordance with USNRC IEB 80-13. One sparger pipe to Tee-box weld ("B" sparger) cracked as a result of excessive cold working during pre-construction repairs. A repair clamp was installed in 1982 (Figure 3) and inspections are performed on this repair clamp each refueling outage. No other indications have been identified to date. The clamp and accessible areas of the cover plate weld were inspected during 2R11 with no indications identified.

# 'B' SPARGER TEE-BOX CLAMP REPAIR

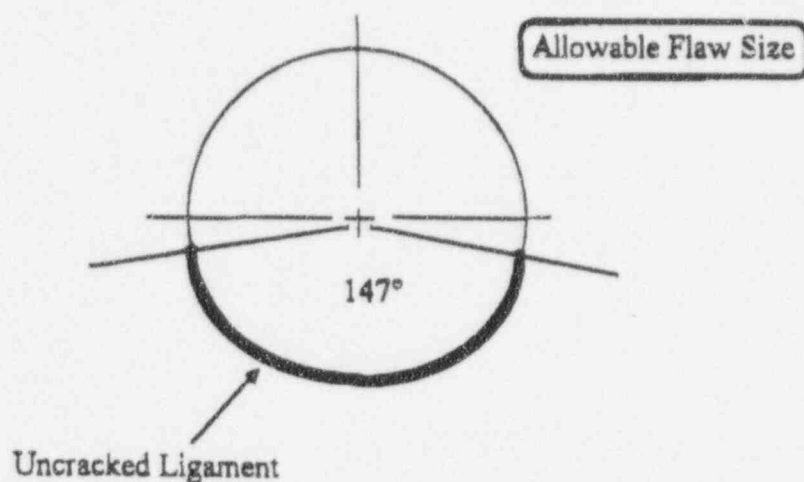
Based on these assumptions and methodology, calculations were performed to determine the allowable through-wall crack in the cover plate. Results of this calculation demonstrate that the allowable through-wall flaw can be 213° of the circumference of the cover plate. This is shown in the following schematic.

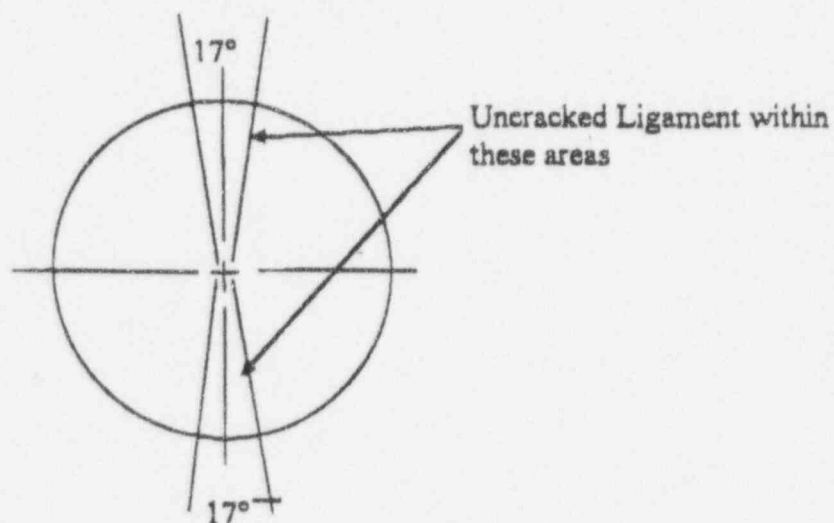
The results of the calculation also determined that two equally spaced uncracked ligaments of length equivalent to  $17^\circ$  of the cover plate circumference are required at end-of-cycle to assure structural integrity. This is demonstrated in the following figure.
