U.S. NUCLEAR REGULATORY COMMISSION
REGION I

Report No. 96-08

Facility: Vermont Yankee Nuclear Power Station

Vermont Yankee Nuclear Power Station NRC Inspection Report 50-271/96-08

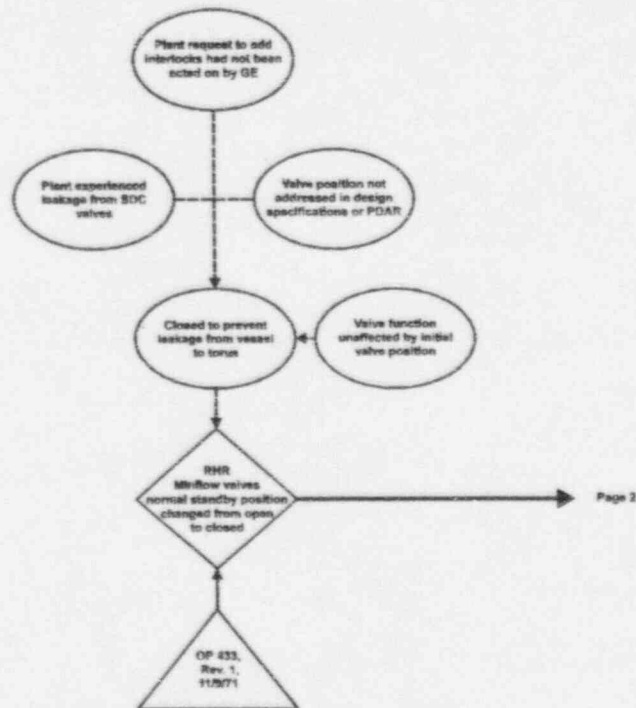
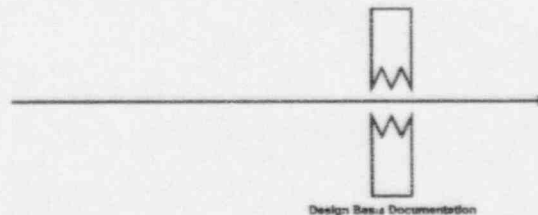
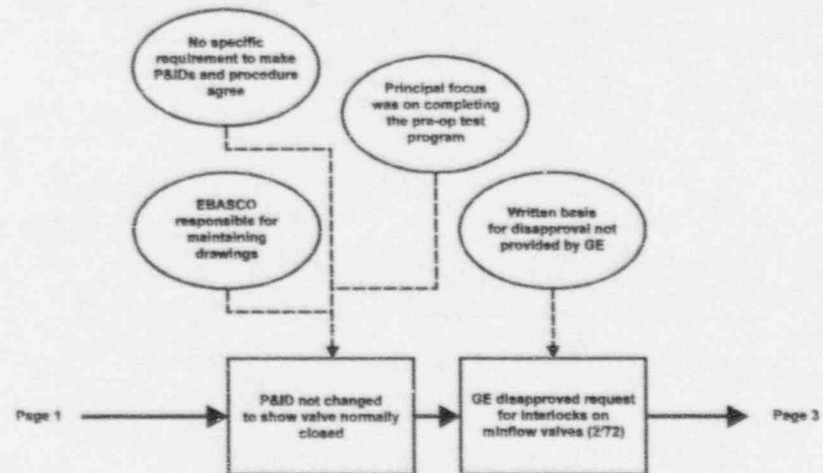
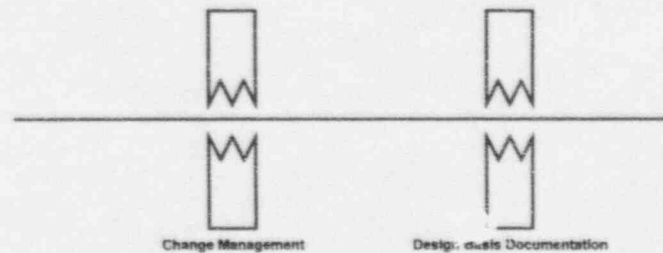
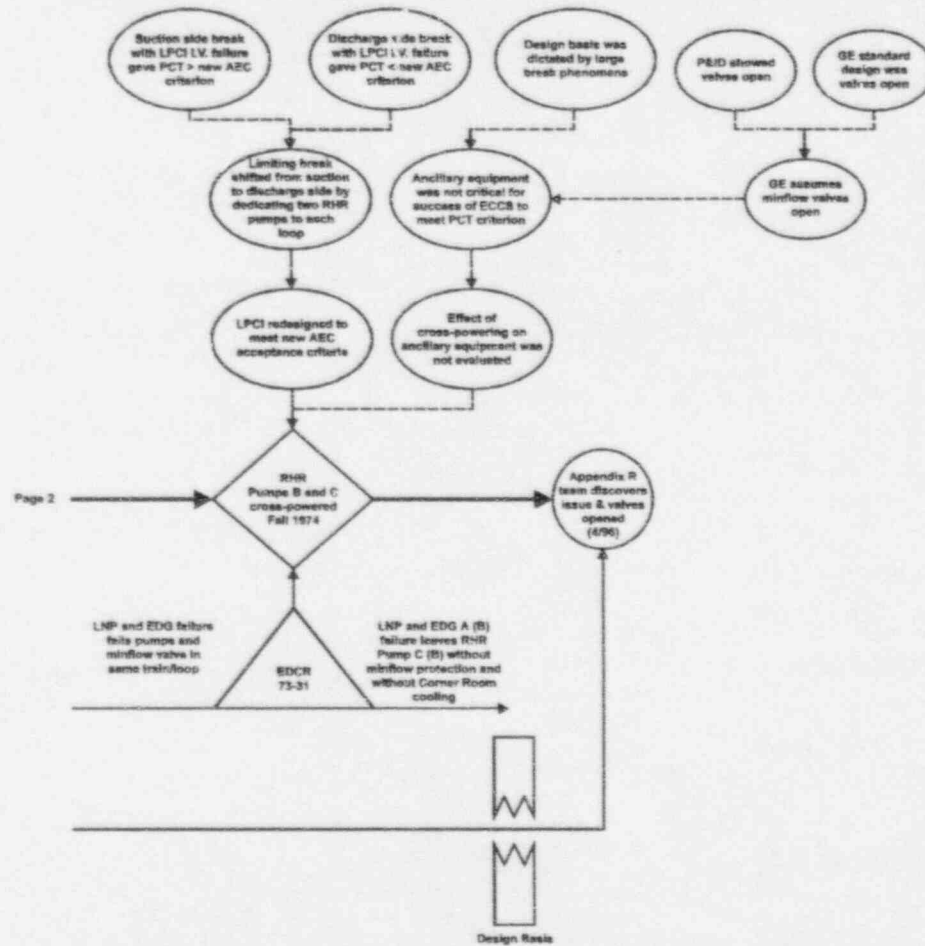
Loss of RHR Minflow Protection

- **Event Definition**
 - Failure to provide minimum flow protection for cross-powered RHR pumps
- **Primary Effects**
 - Minimum flow valves closed by procedure, but P&ID unchanged
 - RHR Pumps B and C cross-powered but not minimum flow valves
