South Texas Project
Units 1 & 2
Docket Nos. STN 50-498, STN 50-4⁹9
First Interim Report Concerning
Pipe Support Eye-Rod Interferences

South Texas Project
Units 1 & 2
First Interim Report Concerning
Pipe Support Eye-Rod Interferences

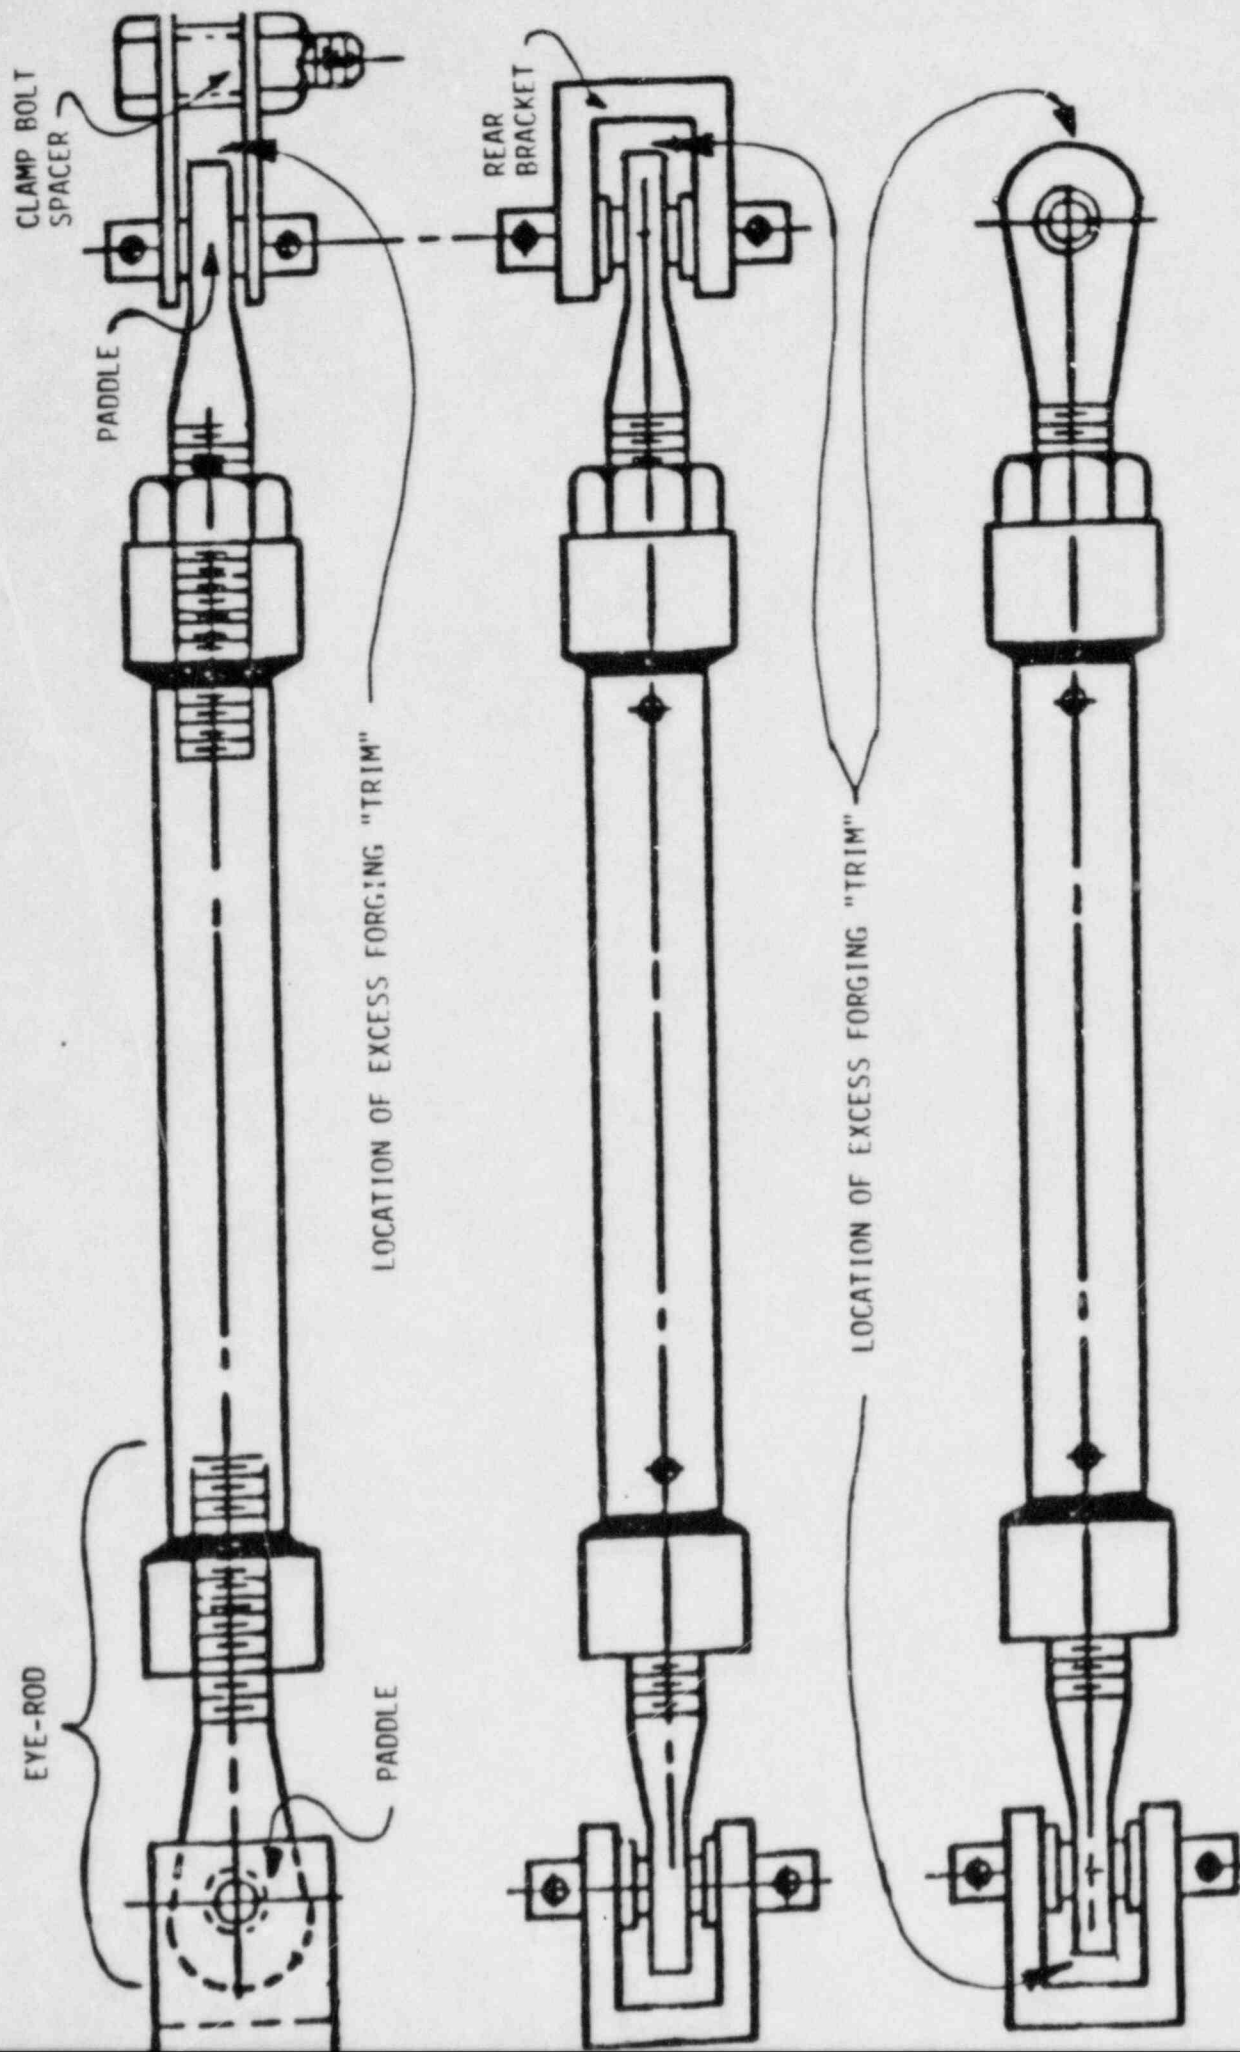
FIGURE 1

Eye-rods are used in rigid sway struts, adjustable sway struts, and snubber transition kits. The eye-rod is a threaded rod with one end having a spherical bearing installed for a load pin to attach the eye-rod to a bracket or pipe clamp (refer to Figure 1). The bearing allows $\pm 6^\circ$ of misalignment on each eye-rod.

Excess forging "trim" on the bearing end of the eye-rod can result in an interference between the eye-rod and the rear bracket and/or between the eye-rod and the clamp-bolt spacer depending on tolerance "stack-up" of the various parts. This could reduce the freedom of motion of the strut during high temperature operation and could increase the stress on the load pin.

The root cause of this problem appears to be a "stacking up of tolerances". As shown in Attachment 2, the calculated clearance for size 6, 10, and 14 struts with the additive "worst case" tolerances results in a zero clearance situation between the eye-rod and rear bracket even without the presence of forging trim on the eye-rod. Fabrication tolerances are apparently being met, but those specified tolerances can result in zero clearance. Additional measurements have been taken to determine if the interference exists because of the eye-rod, bracket, or both. The base thickness (K) of seven machined

The third step is to repair the eye-rods affected. NPSI has authorized STP personnel to grind the forging "trim" back to within the acceptable "E" dimensions.
