CATAWBA NUCLEAR STATION

Significant Deficiency 414/85-06

Overpressurizing and Rupture of Volume Control Tank During Cold Hydrostatic Testing

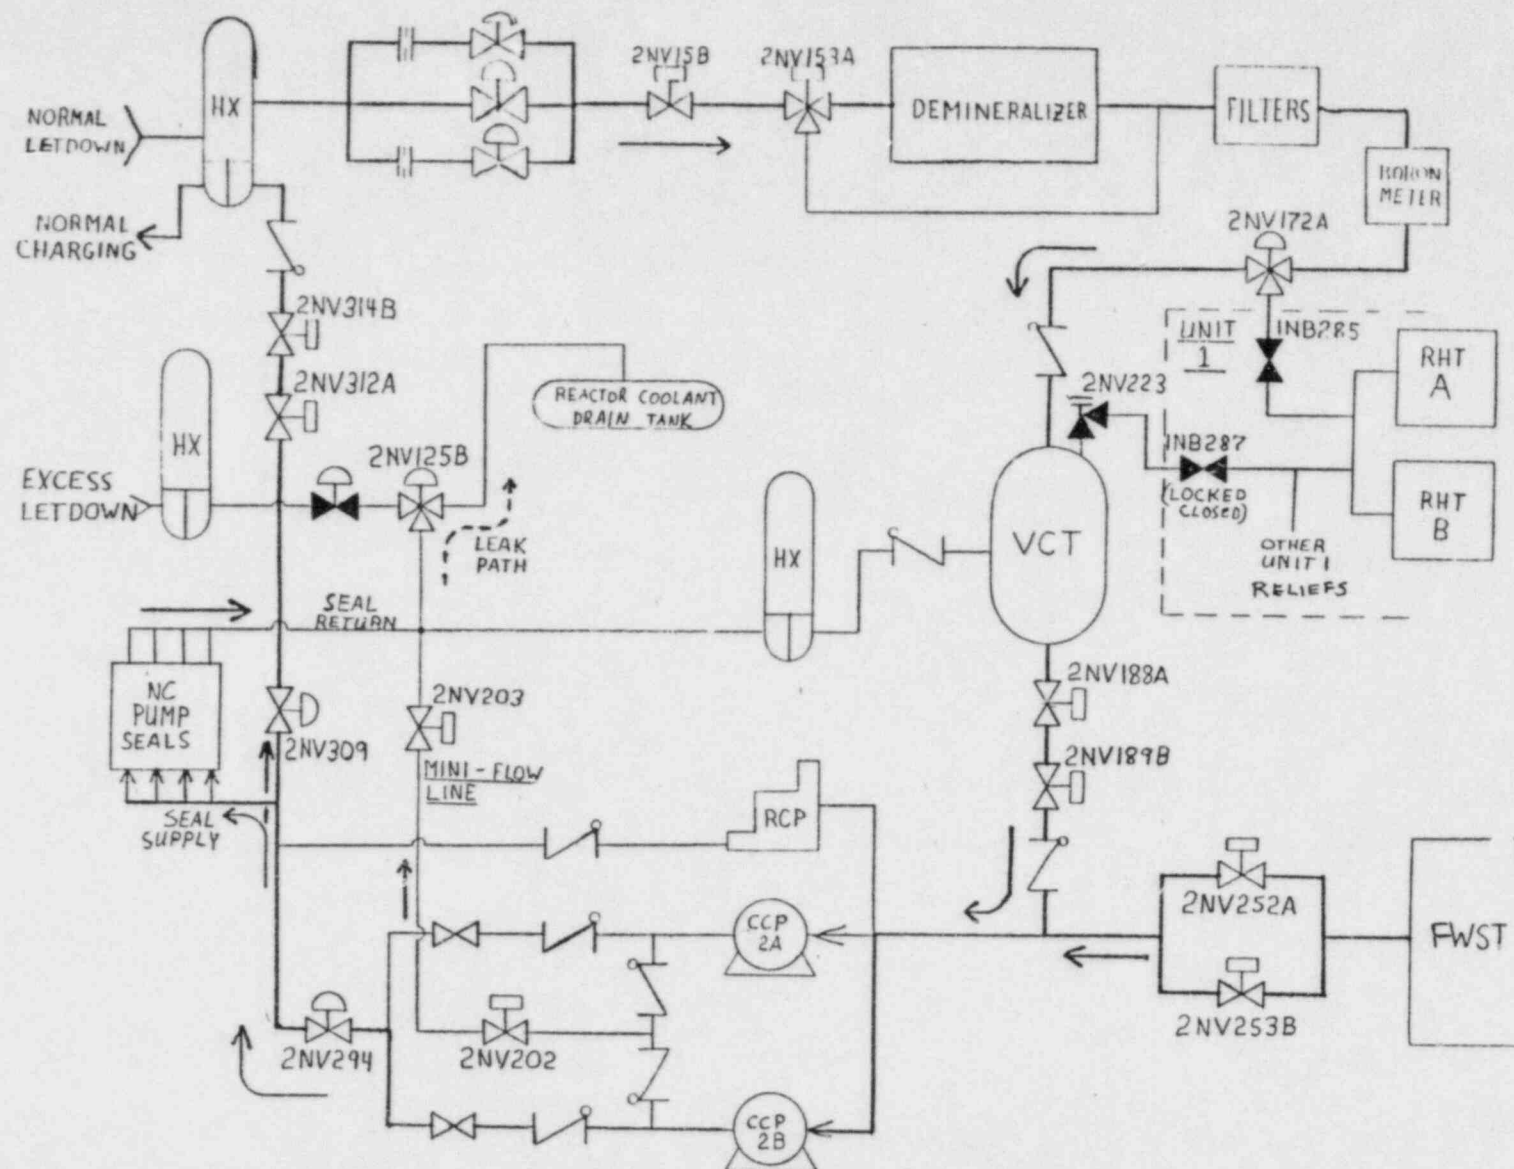
ENCLOSURE 1
 NV SYSTEM - UNIT 2
 CATAWBA NUCLEAR STATION

Summary: The VCT is a 2,992 gallon capacity stainless steel tank, designed for an internal pressure of 75 psig. As part of the Chemical and Volume Control System (NV), it was being used to accept letdown and as a suction source for the centrifugal charging pumps in the filling and venting of the Reactor Coolant System (NC) for Cold Hydro testing. Enclosure 1 describes the NV system and flow paths used during the test.

The VCT had two inlet sources: the normal NC letdown, and the mini-flow line from the centrifugal charging pump. Prior to the incident, leakage of the NC pump seal return flow at valve 2NV125B had been causing the VCT level to drop, so the Refueling Water Storage Tank (FWST) was swapped alternately with the VCT in order to bring the VCT level back up. This manual re-filling of the VCT was in progress at the time of the incident. Added to this, the VCT relief path isolation valve had been locked closed prior to Unit 1 operation because the relief path is through a Unit 1/Unit 2 boundary into a common relief header to the recycle holdup tanks.

The VCT was allowed to overfill during this swap-over to the FWST, causing the flow to cease from the letdown orifice, therefore putting it under the NC pressure of 700 psig. Additional pressure was applied from the centrifugal charging pump 2B through the mini-flow line. Having no relief protection, the tank ruptured.
