INVESTIGATION OF FAILED FIELD ANCHOR HEADS
HVO16 AND HVO38 FROM THE J. M. FARLEY
NUCLEAR POWER PLANT UNIT 2 CONTAINMENT

INRYCO, INCORPORATED

April 9, 1985

BATTELLE
Columbus Laboratories
505 King Avenue
Columbus, Ohio 43201

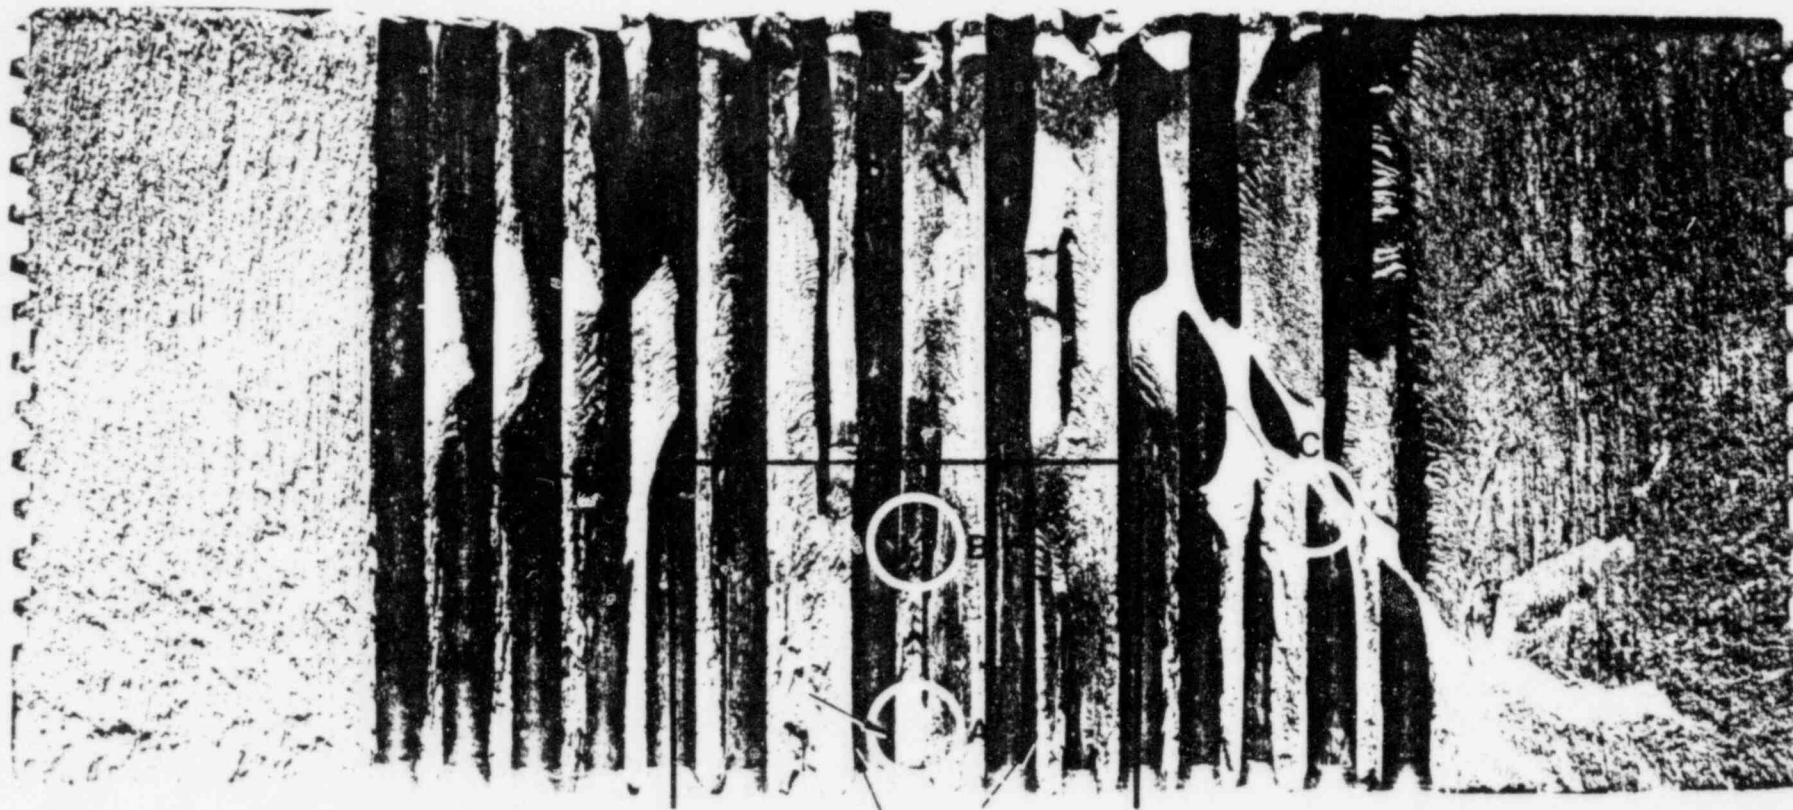
FIGURE 3. FRACTURE SURFACE OF PIECE FROM ANCHOR HEAD HV038

The fracture surface on the portion of Anchor Head HV038 provided for study is shown in Figure 3. A distinct fracture origin was not obvious on that surface. However, the general appearance of that surface indicated that the fracture most likely initiated in one or more of the ligaments or webs between the tendon holes in the central region of the anchor head near the shim face. Several of those regions contained no shear lips adjacent to their surfaces and, thus, they were considered to be potential origin sites. The markings on the 2-inch-wide rim portions of the anchor head indicated that those surfaces most likely were formed during the latter stages of the failure of the anchor head. Those fracture surfaces were quite flat and exhibited a woody texture that most likely was related to the nonmetallic inclusions and banding (alloying element segregation) in the steel. Small shear lips were present on the rim fracture surfaces adjacent to the shim-side surface. The presence of those shear lips and the absence of other distinct features of the surfaces of the fracture through the rim regions indicated that the failure did not initiate in those regions.

The button-head surface is at the top of the figure, and the shim-side surface is at the bottom. The portion of the surface contained within the outlined area was examined in the SEM. The arrows point to suspected fracture-origin regions. Circled Regions A and B indicate where SEM fractographs discussed in subsequent sections of this report were taken. Note the white-appearing deposit on the surface of the tendon hole in circled Region C.

No evidence of significant corrosion (rust) was present on the fracture surfaces or on the surfaces of either anchor head. In addition, no evidence was present that would indicate that quench cracks had formed prior to tempering of the anchor heads during their heat treatment. However, some small pits and whitish desposits were present on the surfaces of the tendon holes. One particularly noticeable deposit was located on the surface of a tendon hole in Region C circled on Figure 3.

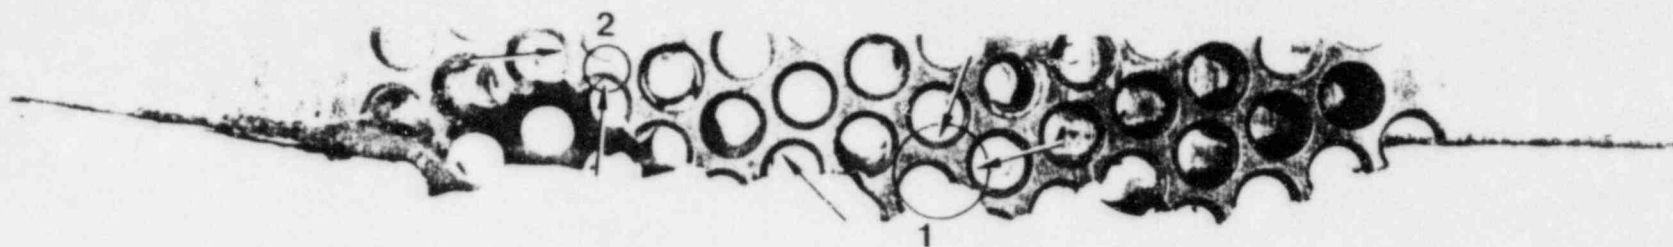
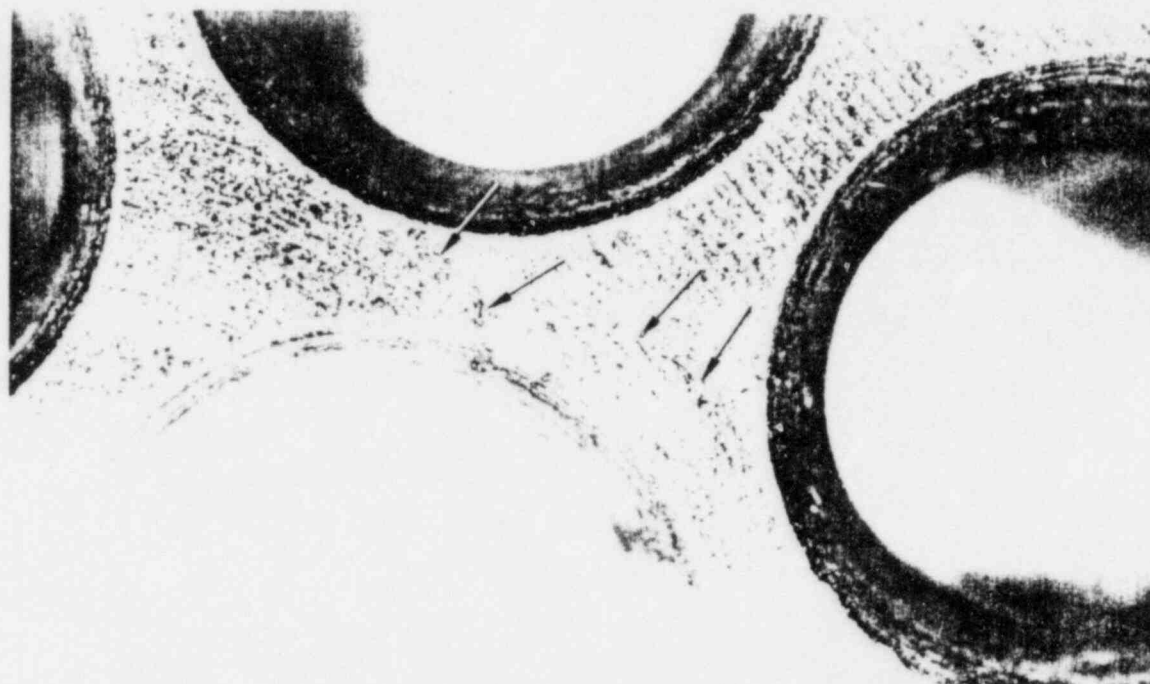
FIGURE 4. PHOTOGRAPHS SHOWING THE LOCATIONS OF CRACKS IN THE LIGAMENTS BETWEEN TENDON HOLES IN ANCHOR HEAD HV038

Examination of the shim-side surfaces of the ligaments between tendon holes revealed the presence of cracks in several of those ligaments in Anchor Head HV038. The locations of those cracks are shown in Figure 4a; Figure 4b shows two of those cracks at higher magnification.

a. Locations of Cracks Between Tendon Holes. Arrows Indicate Ligaments That Were Cracked; the Crack in Circled Region 2 was Opened to Allow Examination of its Surfaces.

b. Cracks in Circled Region 1 From (a)

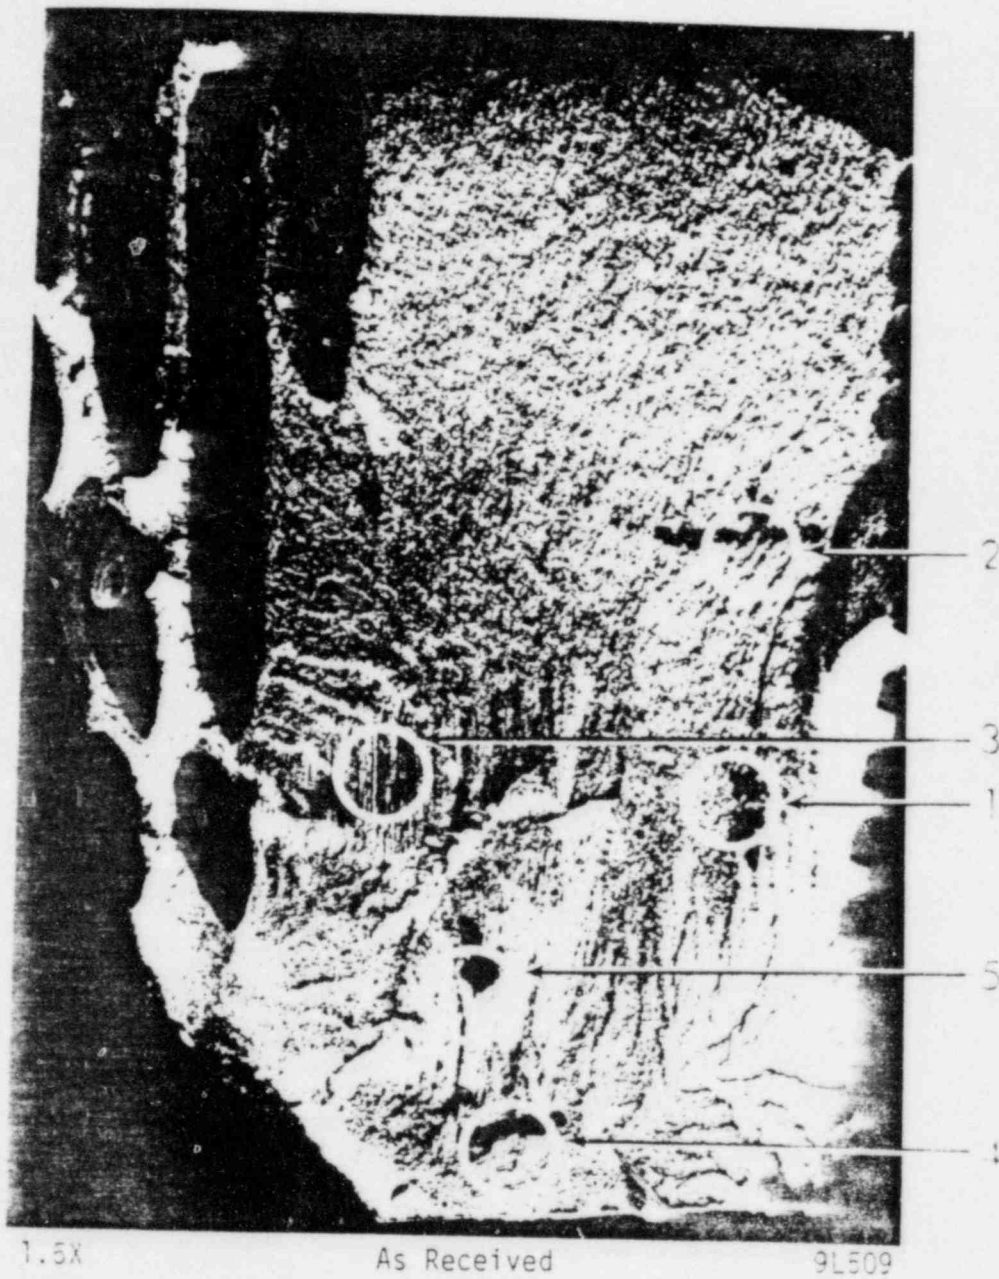
FIGURE 5. ONE FRACTURE SURFACE ON PIECE 5 FROM ANCHOR HEAD HV016

The majority of the fractographic examination of the pieces from Anchor Head HV016 in the scanning electron microscope (SEM) was conducted on a fracture surface from Piece 5. That fracture surface is illustrated in Figure 5. The bulk of the other fracture surfaces were destroyed during sectioning to obtain the mechanical-property specimens. The predominant fracture mode observed on the lower portion of the fracture surface shown in Figure 5 was intergranular fracture. Figures 6a and 6b illustrate the predominantly intergranular fracture mode in the regions identified as 5 and 4, respectively, in Figure 5. In Region 3, the fracture mode consisted of a mixture of intergranular fracture and ductile fracture, as is shown in Figure 7. In that region, the intergranular fracture occurred in bands on slightly different planes, and the ductile fracture appeared to result from shear between those bands, forming steps on the fracture surface. In Regions 1 and 2 and the upper portion of the fracture surface shown in Figure 5, the fracture mode consisted of a mixture of ductile and cleavage fracture with varying amounts of cleavage fracture. The typical appearance of the fracture surface in Region 2 is shown in Figure 8, and Figure 9 shows an area of predominantly cleavage fracture in Region 1.

The numbered regions indicate the locations where SEM fractographs described in subsequent figures were taken.

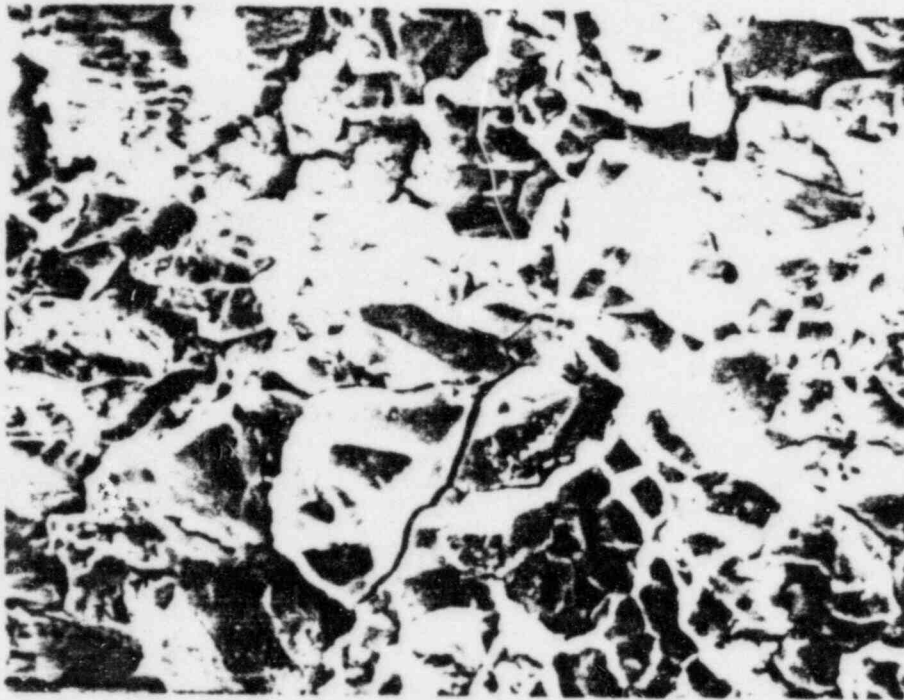
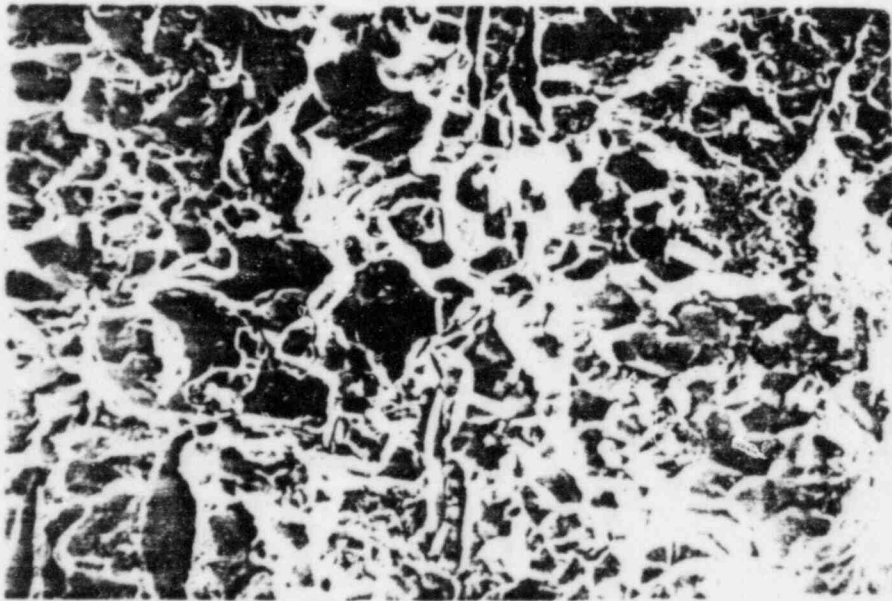
FIGURE 6. PREDOMINANTLY INTERGRANULAR FRACTURE ON THE LOWER PORTION OF THE FRACTURE SURFACE FROM ANCHOR HEAD HV016 SHOWN IN FIGURE 5

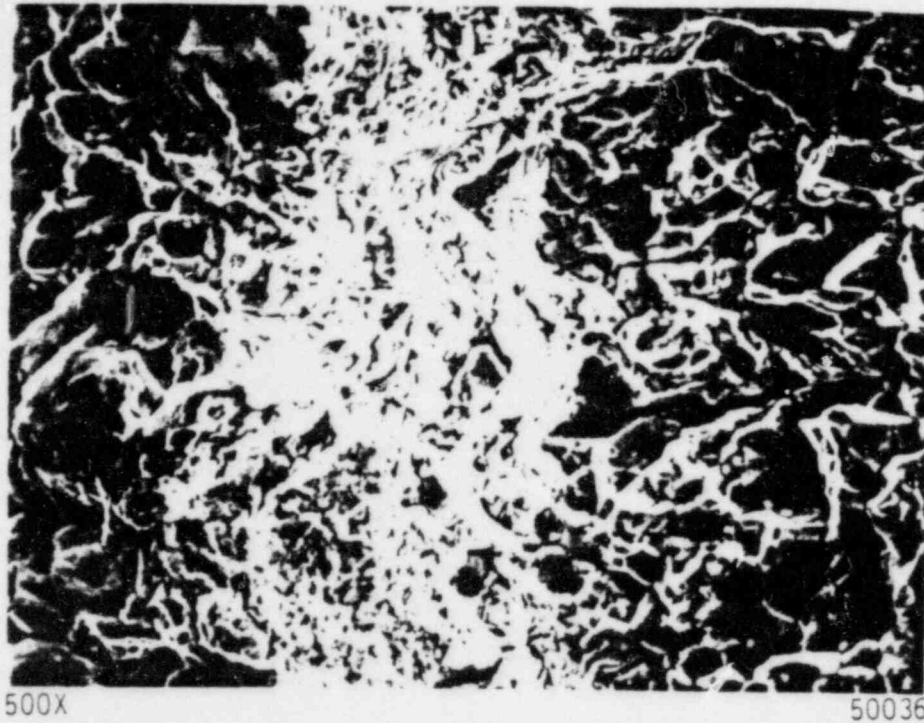
FIGURE 7. BANDS OF INTERGRANULAR FRACTURE AND DUCTILE FRACTURE (SHEAR STEP) OBSERVED IN REGION 3 ON THE FRACTURE SURFACE SHOWN IN FIGURE 5

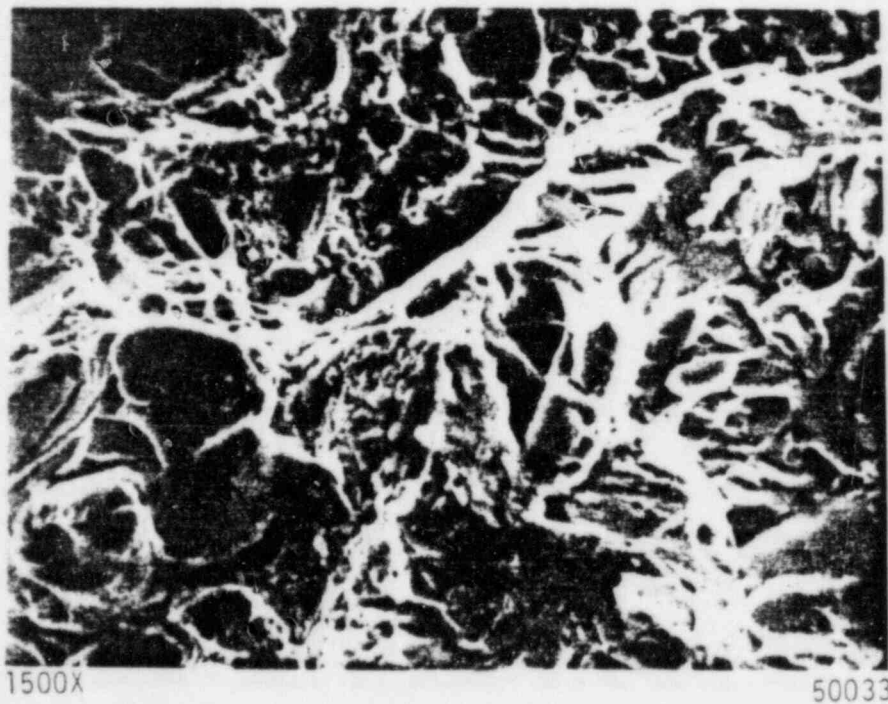
FIGURE 8. MIXTURE OF CLEAVAGE AND DUCTILE FRACTURE OBSERVED IN REGION 2 ON FIGURE 5

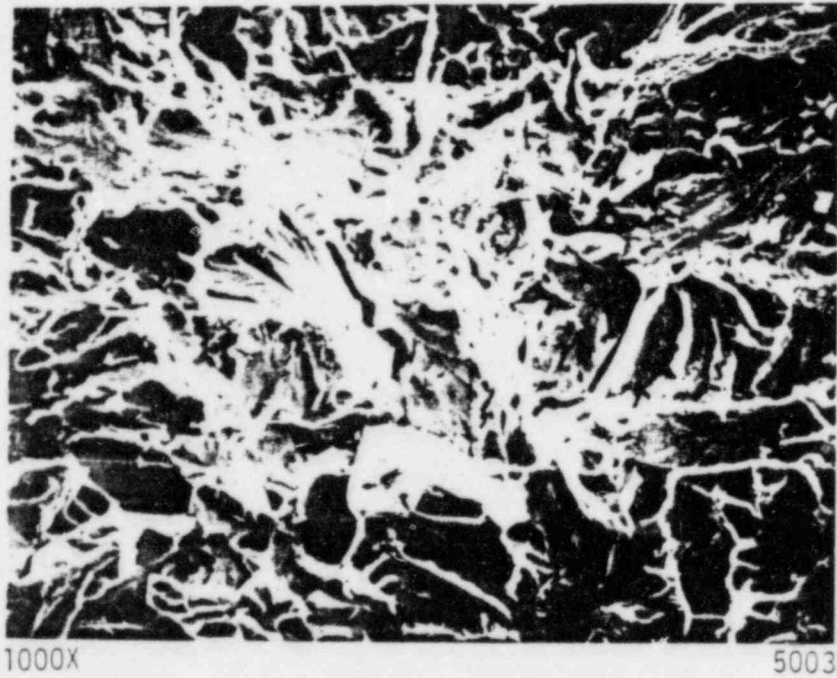
FIGURE 9. PREDOMINANTLY CLEAVAGE FRACTURE OBSERVED
IN REGION 1 ON THE FRACTURE SURFACE
SHOWN IN FIGURE 5

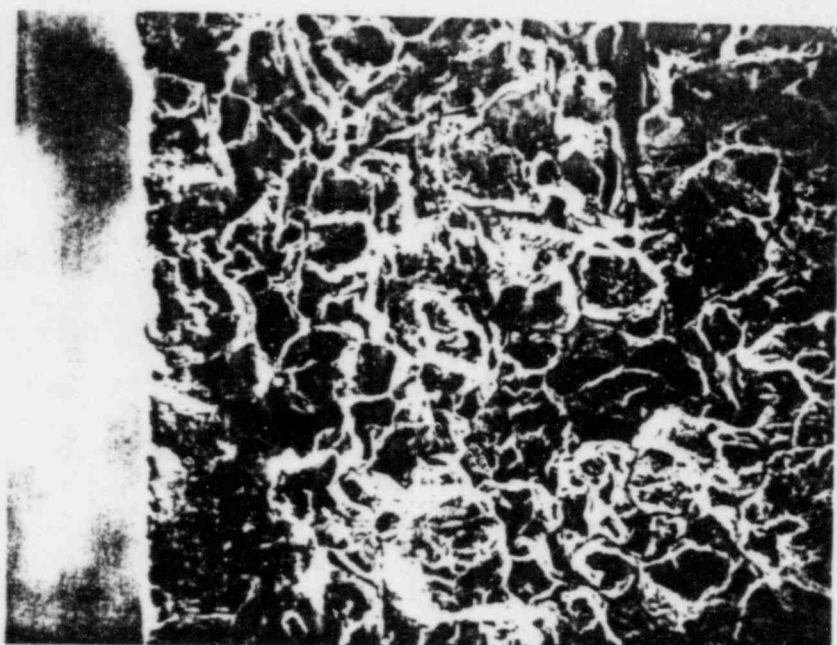
Figure 10 illustrates the typical fracture appearance of the suspected fracture-origin regions; that SEM fractograph was taken in Region A shown on Figure 3. As is shown in Figure 10, the fracture surfaces in those regions exhibited predominantly intergranular fracture. Similarly, the predominant fracture mode within the region outlined in Figure 3 was intergranular; however, some regions with mixtures of intergranular and ductile fracture modes also were present in that region as is shown in Figure 11. Figure 11 also shows manganese sulfide inclusion stringers that often were present on the fracture surfaces of many regions examined.

FIGURE 10. TYPICAL INTERGRANULAR FRACTURE OBSERVED AT THE SUSPECTED ORIGIN REGIONS OF THE FRACTURE IN ANCHOR HEAD HVO38

The fractograph was taken in Region A shown in Figure 3.

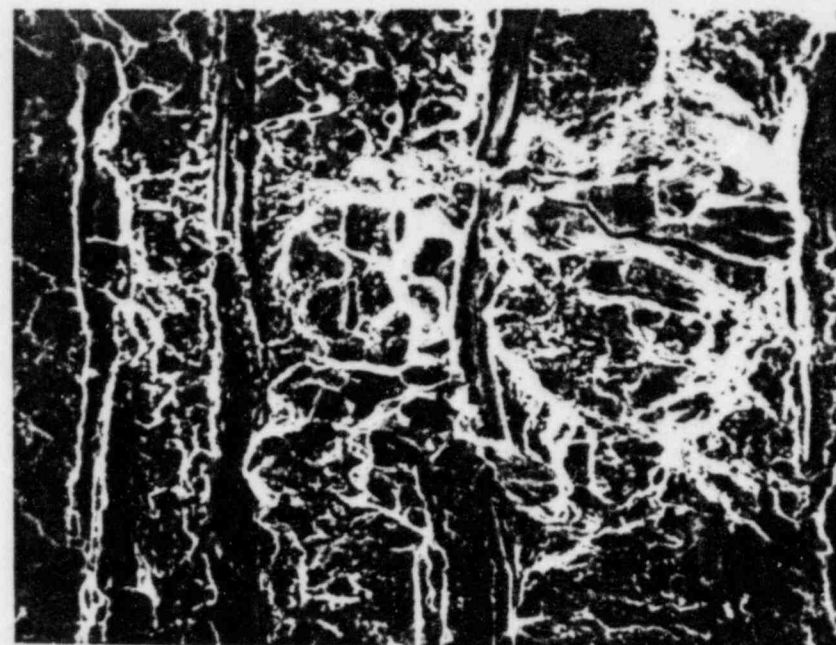
FIGURE 11. MANGANESE SULFIDE INCLUSION STRINGERS AND MIXED FRACTURE MODES ALSO PRESENT IN REGION A IN FIGURE 3

The fracture modes present were intergranular and ductile. This fractograph was taken from a region at the right side of the circle labeled A.

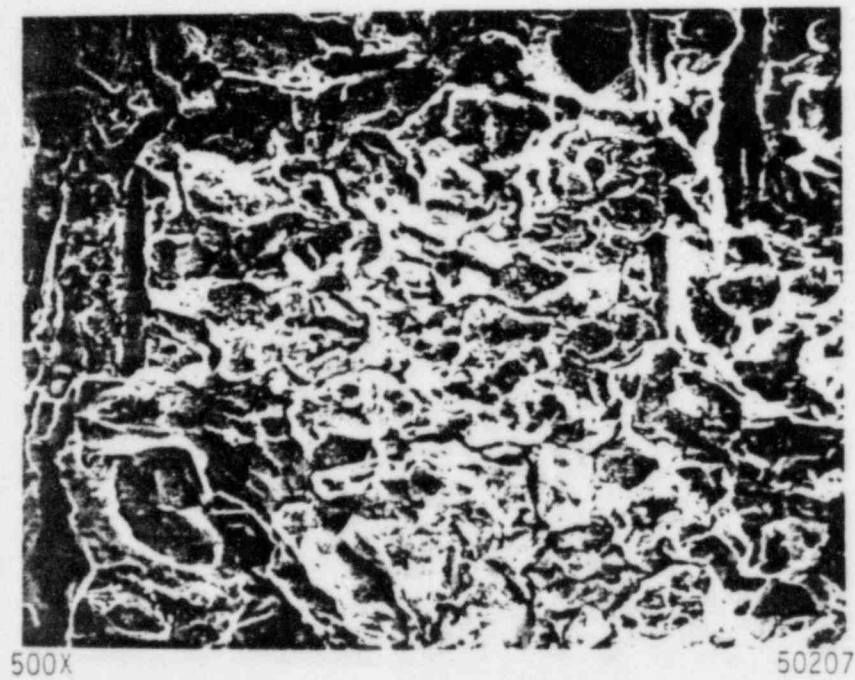
Portions of the fracture surface within the region examined in the SEM exhibited a dark appearance, perhaps indicating the presence of corrosion products. Region B in Figure 3 illustrates that feature. Examination of the surfaces in that region revealed again that the predominant fracture mode was intergranular, as is shown in Figure 12. Energy-dispersive analysis of X-rays (EDAX) in that region revealed the presence of calcium and zinc on the surfaces of that region, in addition to iron, chromium, sulfur, and silicon; the latter four elements were present in the steel. The corrosion-preventative grease contains calcium, and, thus, it

FIGURE 12. TYPICAL INTERGRANULAR FRACTURE
IN THE DISCOLORED REGION B IN
FIGURE 3

it was presumed to be the source of the calcium detected on the fracture surface. The zinc detected in that region most likely came from corrosion of particles of zinc that may have been transferred to that region when the tendon wires were strung through the galvanized tendon conduit.

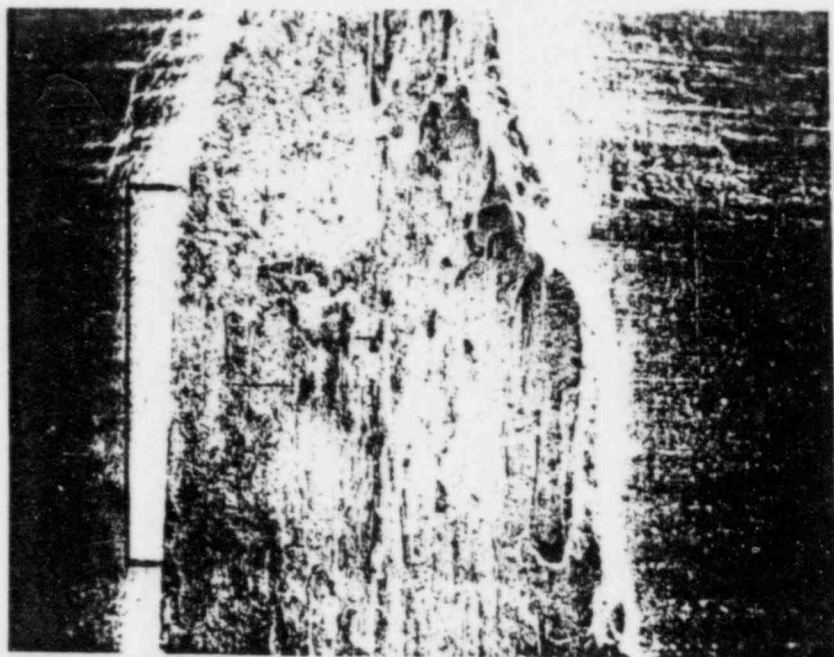
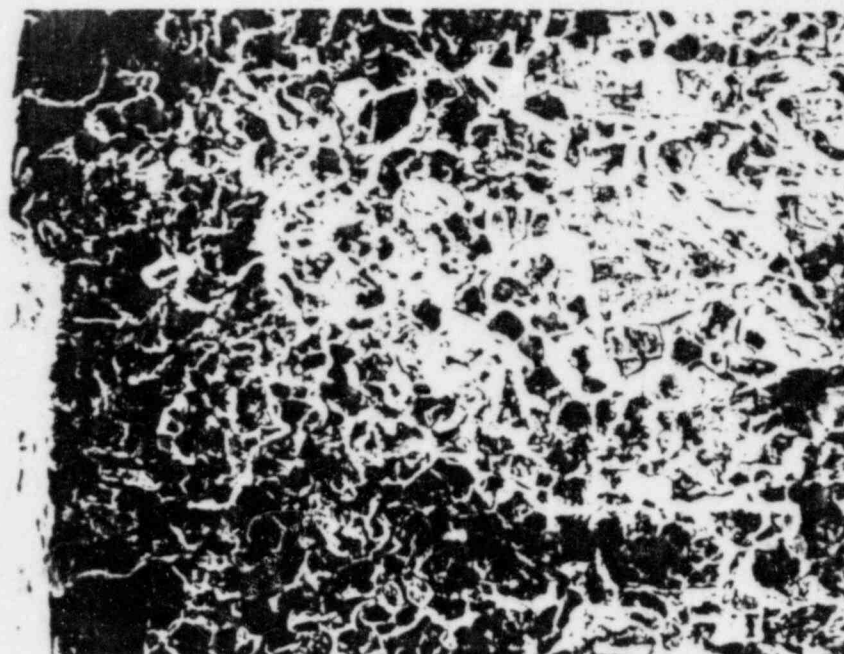
FIGURE 13. SURFACE OF THE CRACK IN THE LIGAMENT BETWEEN TENDON HOLES SHOWN IN REGION 2 OF FIGURE 4a THAT WAS OPENED IN THE LABORATORY

Figures 13a and 13b illustrate the appearance of the surfaces of the pre-existing crack in a ligament that was opened in the laboratory. As is shown in Figure 13a, there was a faint thumbnail-shaped region that extended inward from the tendon-hole surface on the left side of the figure, thereby indicating a fracture-origin in that region. As is shown in Figure 13b, the predominant fracture mode adjacent to the tendon-hole surface in that region was intergranular. Toward the tendon surface opposite the origin region, shown in Figure 13a, the fracture surface exhibited a mixture of intergranular and ductile fracture similar to that shown previously in Figure 11.

11X 50217
a. General Appearance of Crack Surface Indicating an Origin Adjacent to the Tendon-Hole Surface (Origin Region is Indicated by the Bracket)

500X 50221
b. Intergranular Fracture Mode at the Origin Region in (a)

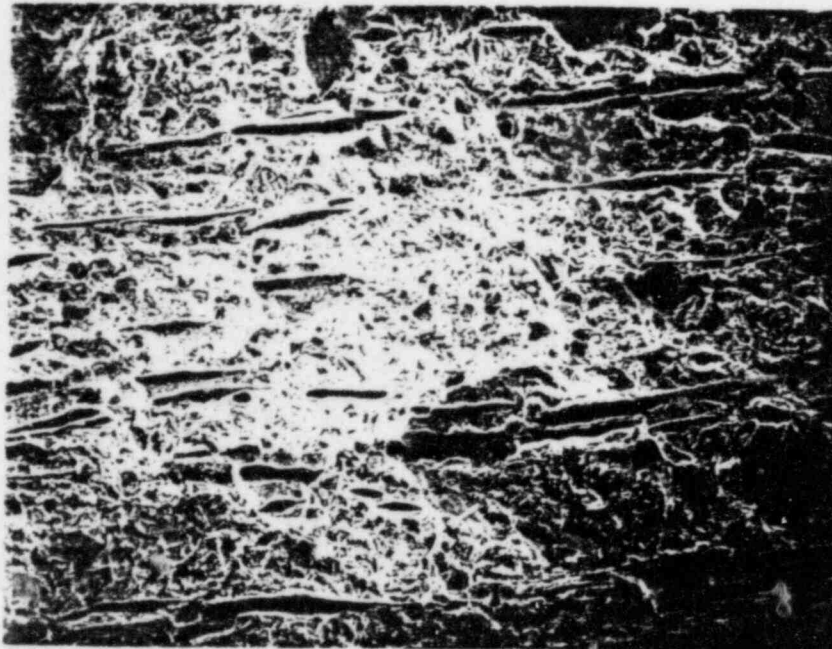
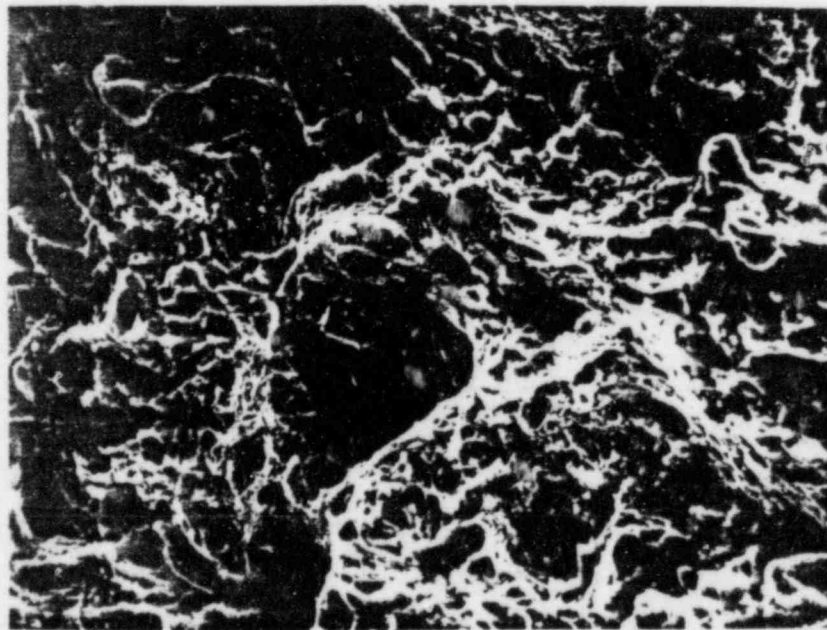
FIGURE 14. TYPICAL APPEARANCE OF THE FRACTURE SURFACE OF LIGAMENT BETWEEN TENDON HOLES THAT DID NOT CONTAIN A CRACK AND WAS BROKEN IN THREE-POINT BENDING IN THE LABORATORY

Figures 14a and 14 illustrate the appearance of the surface of the fracture of a ligament in which no pre-existing crack was present, which was fractured by three-point bending in the laboratory. Figure 14a shows that numerous manganese sulfide inclusion stringers were present, and Figure 14b shows that the fracture mode was a mixture of ductile and cleavage fracture; no intergranular fracture was observed.

a. Typical Fracture Appearance Showing Presence of Numerous Manganese Sulfide Inclusions

b. Mixture of Ductile and Cleavage Fracture

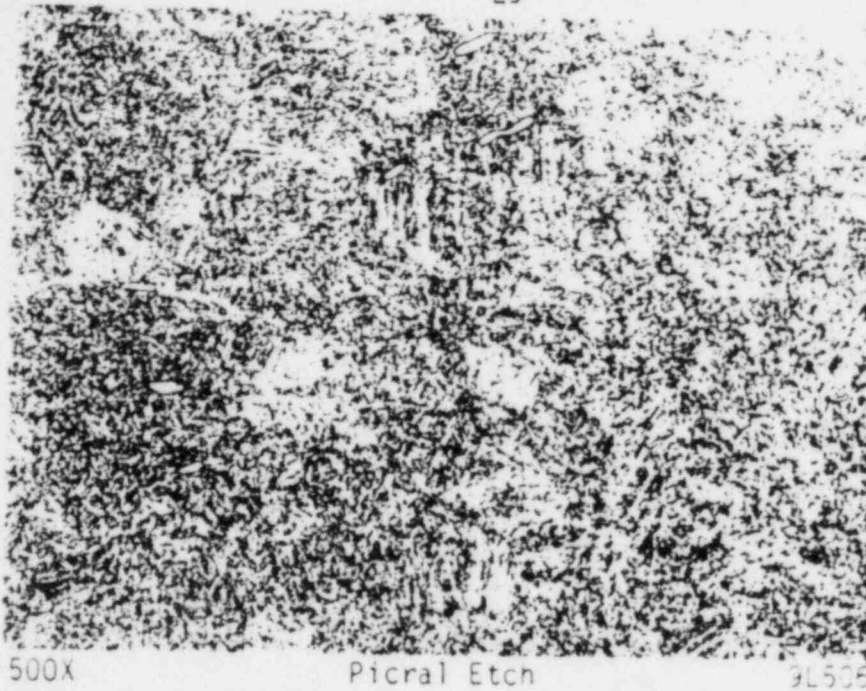
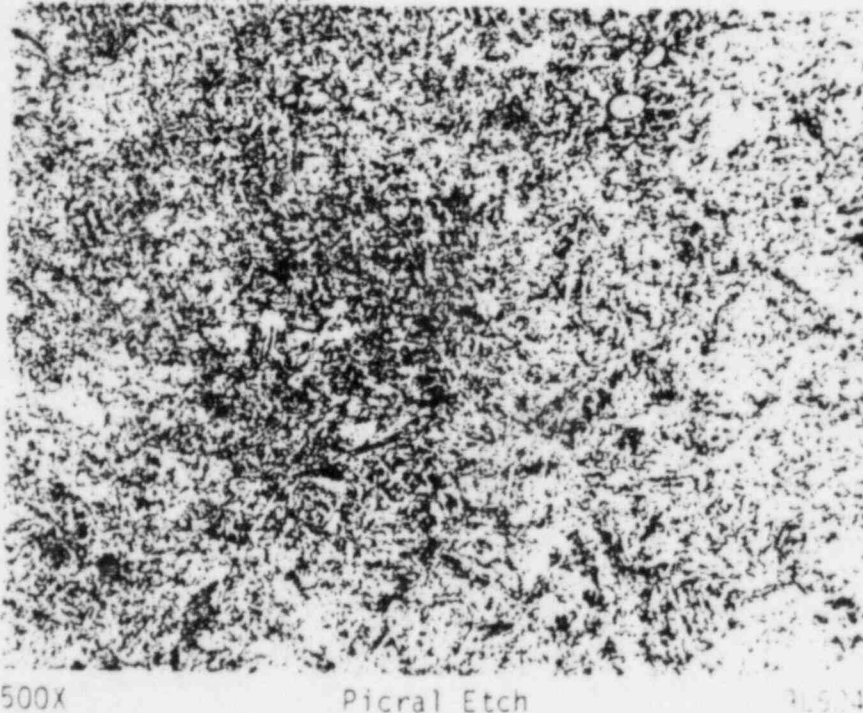
FIGURE 15. TYPICAL MICROSTRUCTURES OF THE STEEL FROM ANCHOR HEADS HV016 AND HV038

- a. Typical Microstructure Near the Circumferential Surface and Adjacent to the Tendon Holes. The microstructure consists of tempered martensite and/or bainite.

- b. Typical Mixed Microstructure Approximately 1 Inch From the Circumferential Surface of the Anchor Head. It consists of a mixture of tempered martensite and bainite with some small patches of ferrite.

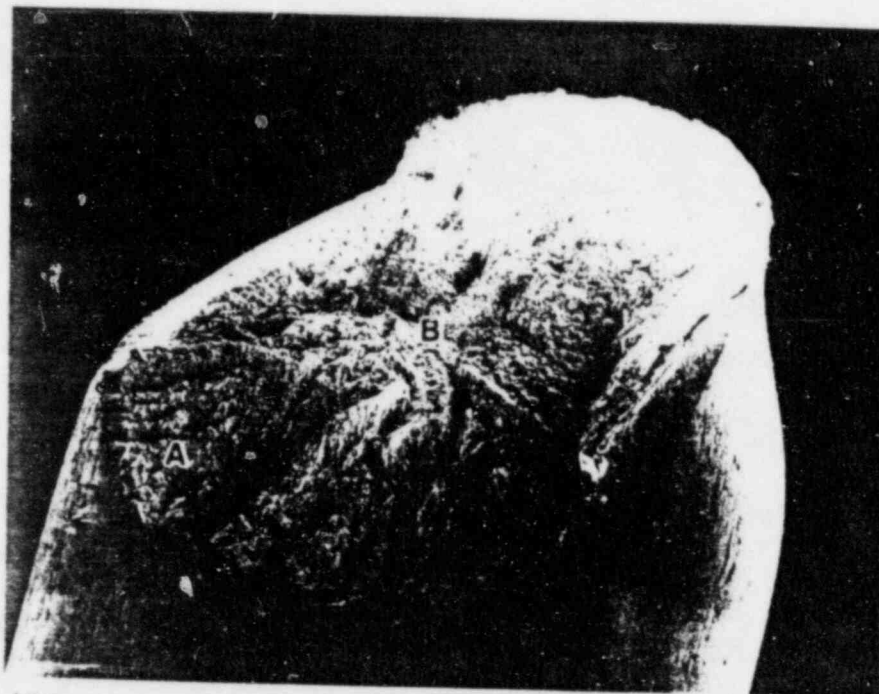
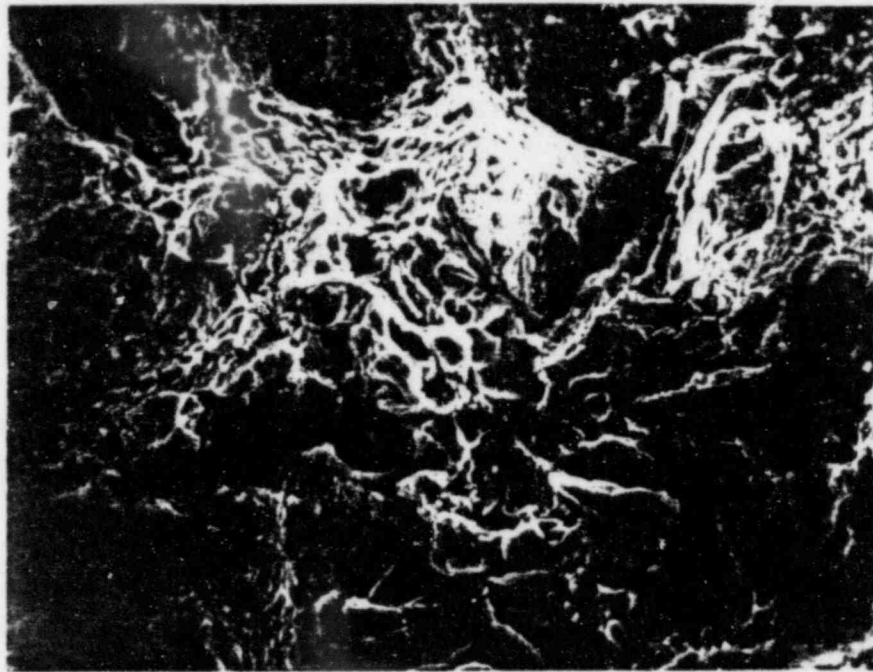
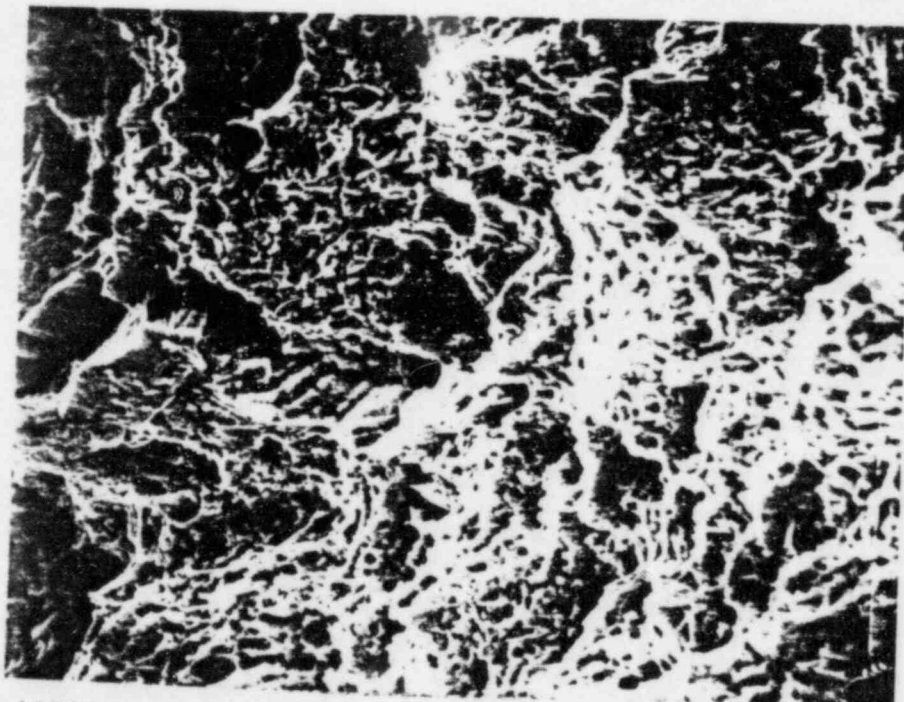
FIGURE 16. TYPICAL APPEARANCE OF THE FRACTURES OF THE
TENDON WIRES EXAMINED

Figure 16 illustrates the typical appearance of the fractures in the tendon wires at low magnification and shows the very apparent necking of the wire prior to rupture. Examination of the fracture surfaces of the three tendon wires at higher magnifications revealed that the fracture modes present were ductile and cleavage fracture. Figure 16b illustrates a mixture of ductile and cleavage fracture in Region A of Figure 16a, and Figure 16c illustrates predominantly ductile fracture in Region B of Figure 16a. These observations suggest that the tendon wires examined failed by overstress, most likely as a result of the changes in stress distribution when the anchor head failed, rather than prior to the failure of the anchor head. However, only a limited number of tendon wire fractures were available for examination. On the other hand, none of the tendon wires that passed through cracked Anchor Head HV038 reportedly had failed. That observation suggests that the anchor heads fail prior to failure of the tendon wires.

a. General Appearance of Failed Tendon Wire

b. Ductile and Cleavage Fracture in Region A in Figure 15a

c. Predominantly Ductile Fracture in Region B in Figure 15a
