SUBJECT: INVESTIGATION NOTIFICATION

Vogtle Elec. Gen. Plant Case No. 2-90-020 Opened: 11/06/90

LOSS OF OFFSITE POWER LEADS TO SITE AREA EMERGENCY

SUBJECT: ENFORCEMENT CONFERENCE SUMMARY
(NUREG-1410 AND NRC INSPECTION REPORT NOS. 50-424/90-16
AND 50-425/90-16)

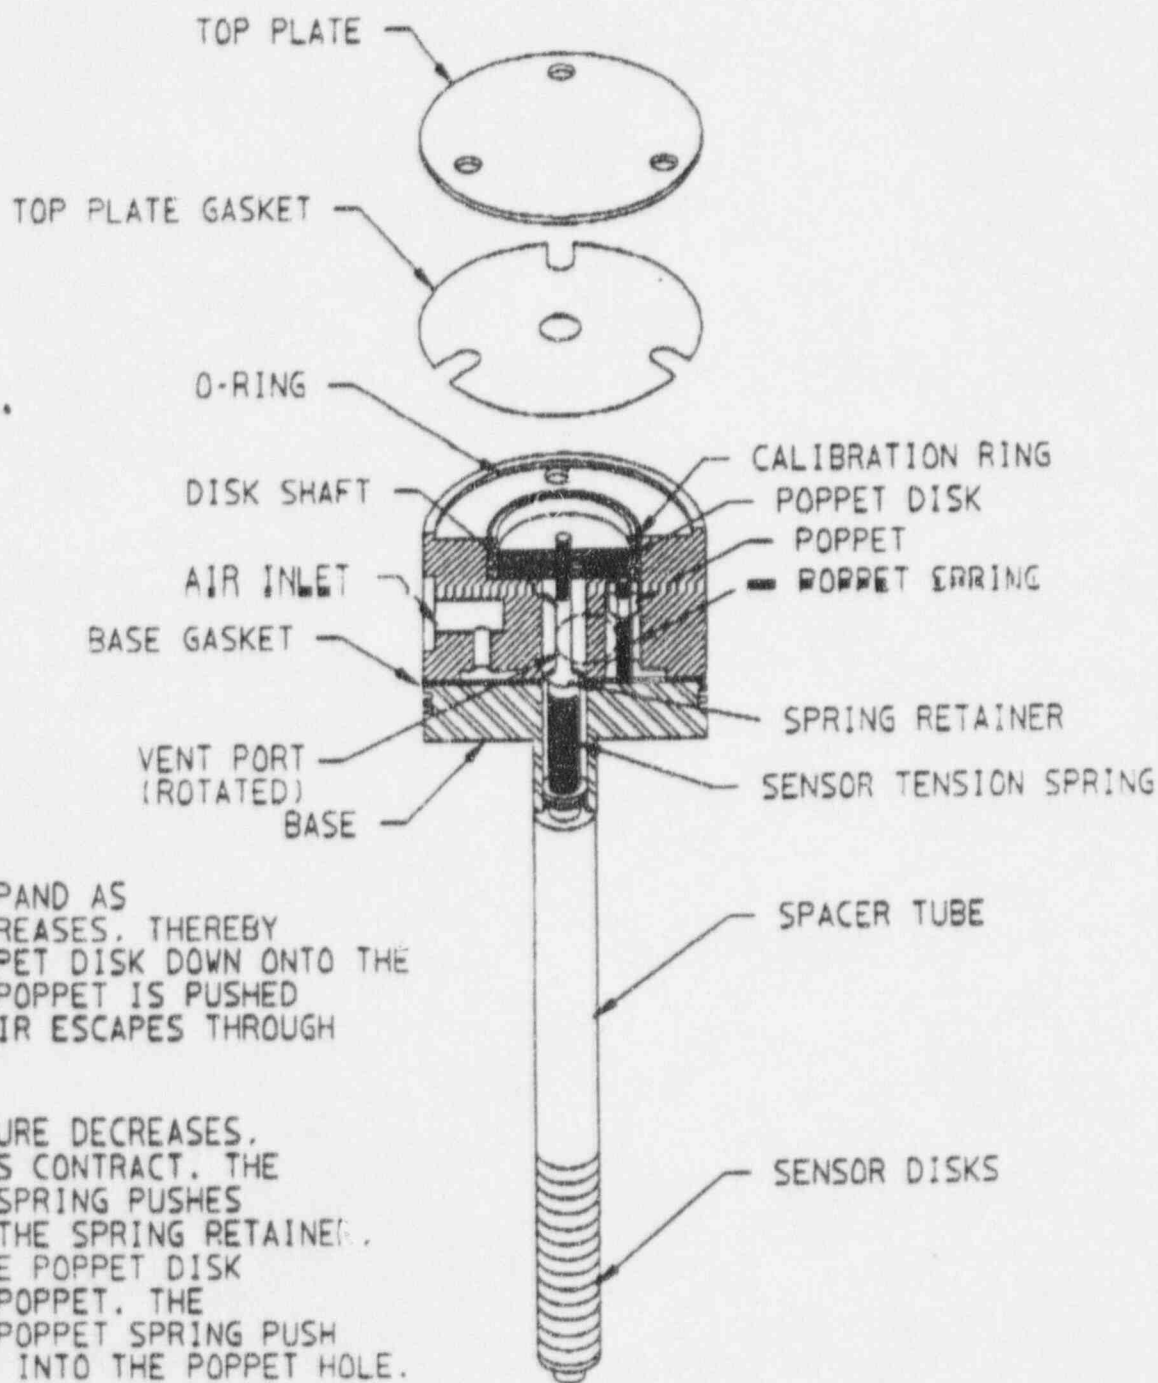
CALCON TEMPERATURE SENSOR MODEL A3500-W3

2. The root cause for the failure of DG1A has not been conclusively determined. There is no record of the trips that were annunciated after the first trip because the annunciators were reset before the condition was fully evaluated. Therefore, the cause of the first trip can only be postulated, but it was most likely the same as that which caused the second trip. The second trip occurred at the end of the timed sequence of the group 2 block logic. This logic allows the DG to achieve operating conditions before the trips become active. The block logic timed out and the trip occurred at about 70 seconds. The annunciators observed at the second trip included jacket water high temperature along with other trips. In conducting an investigation, the trip conditions that were observed on the second DG trip on 3-20-90 could be duplicated by venting 2 out of 3 jacket water temperature sensors, simulating a tripped condition. The simulation duplicated both the annunciators and the 70 sec. trip time. The most likely cause of the DG trips was intermittent actuation of the jacket water temperature switches.

Following the 3-20-90 event, all three jacket water temperature switches, which all have a design setpoint of 200°F, were bench tested. Switch TS-19110 was found to have a setpoint of 197 degrees F, which was approximately 6 degrees below its previous setting. Switch TS-19111 was found to have a setpoint of 199 degrees F, which was approximately the same as the original setting. Switch TS-19112 was found to have a setpoint of 186 degrees F, which was approximately 17 degrees F below the previous setting and was re-adjusted. Switch TS-19112 also had a small leak which was judged to be acceptable to support diagnostic engine tests and was reinstalled. The switches were recalibrated with the manufacturer's assistance to ensure a consistent calibration technique.

SENSOR DISKS EXPAND AS TEMPERATURE INCREASES, THEREBY PULLING THE POPPET DISK DOWN ONTO THE POPPET. AS THE POPPET IS PUSHED DOWNWARD, THE AIR ESCAPES THROUGH THE VENT.

AS THE TEMPERATURE DECREASES, THE SENSOR DISKS CONTRACT. THE SENSOR TENSION SPRING PUSHES UPWARD AGAINST THE SPRING RETAINER, WHICH PUSHES THE POPPET DISK UPWARD OFF THE POPPET. THE AIR SUPPLY AND POPPET SPRING PUSH THE POPPET BACK INTO THE POPPET HOLE.

5. The jacket water temperature switches for each DG were replaced or re-calibrated using a more appropriate technique prior to their installation.
6. A back-up ENN system powered from the AT&T system, which previously existed and was operational for South Carolina agencies, has been extended to include Georgia local and state agencies. Instructions have been given to Emergency Directors and Communicators concerning use of the emergency communication systems.

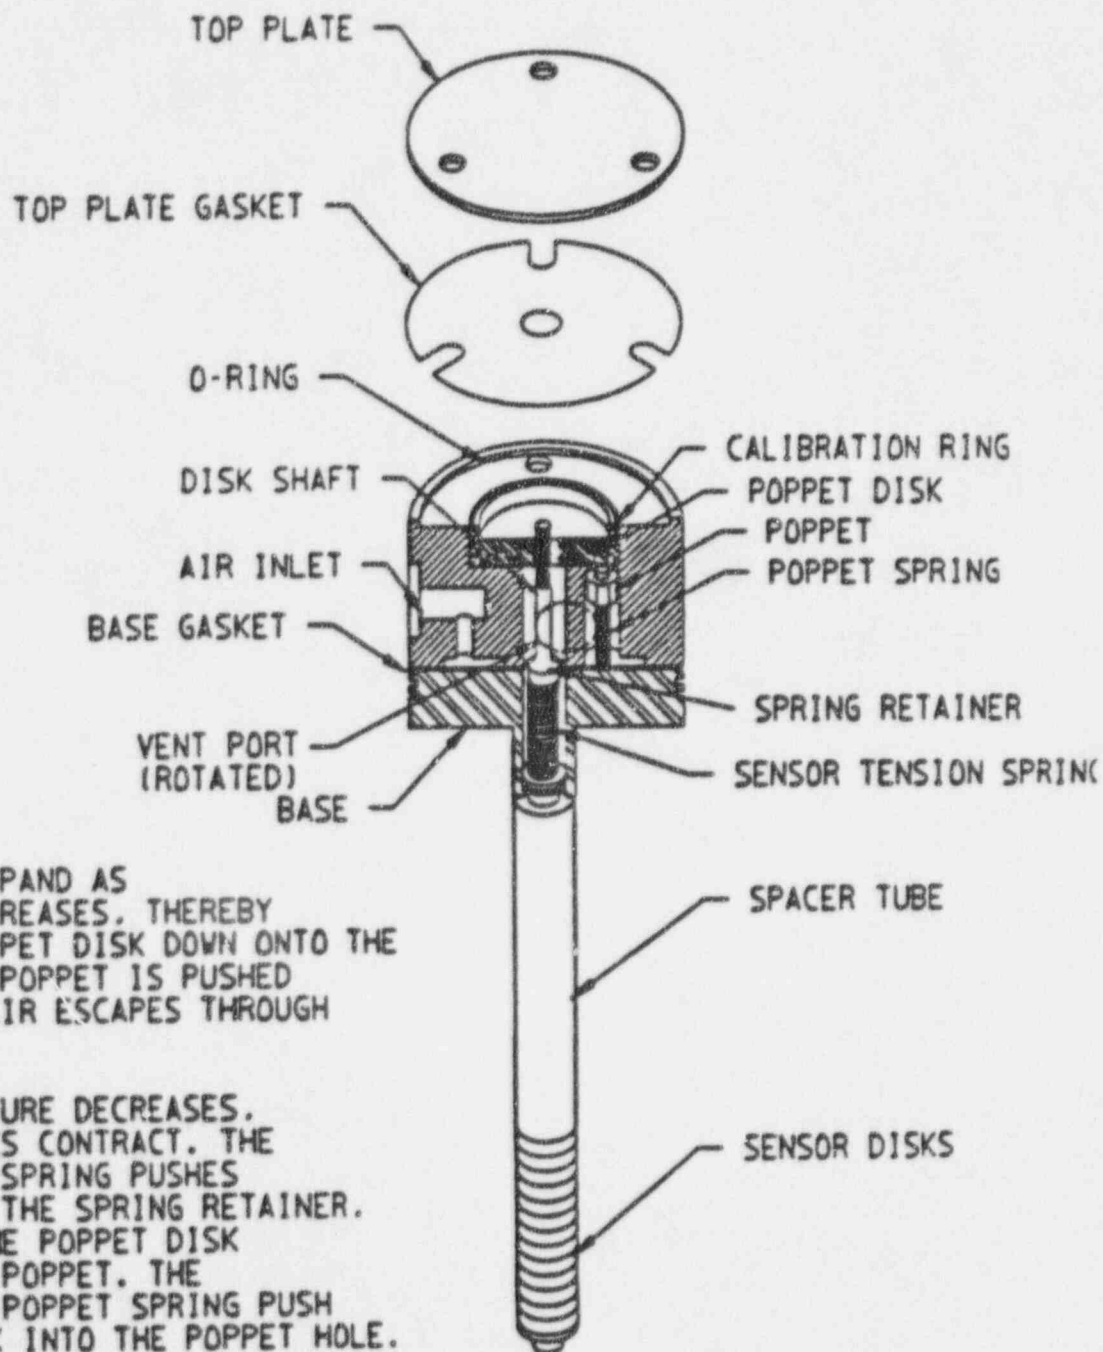
CALCON TEMPERATURE SENSOR MODEL A3500-W3

SENSOR DISKS EXPAND AS TEMPERATURE INCREASES, THEREBY PULLING THE POPPET DISK DOWN ONTO THE POPPET. AS THE POPPET IS PUSHED DOWNWARD, THE AIR ESCAPES THROUGH THE VENT.

AS THE TEMPERATURE DECREASES, THE SENSOR DISKS CONTRACT. THE SENSOR TENSION SPRING PUSHES UPWARD AGAINST THE SPRING RETAINER, WHICH PUSHES THE POPPET DISK UPWARD OFF THE POPPET. THE AIR SUPPLY AND POPPET SPRING PUSH THE POPPET BACK INTO THE POPPET HOLE.

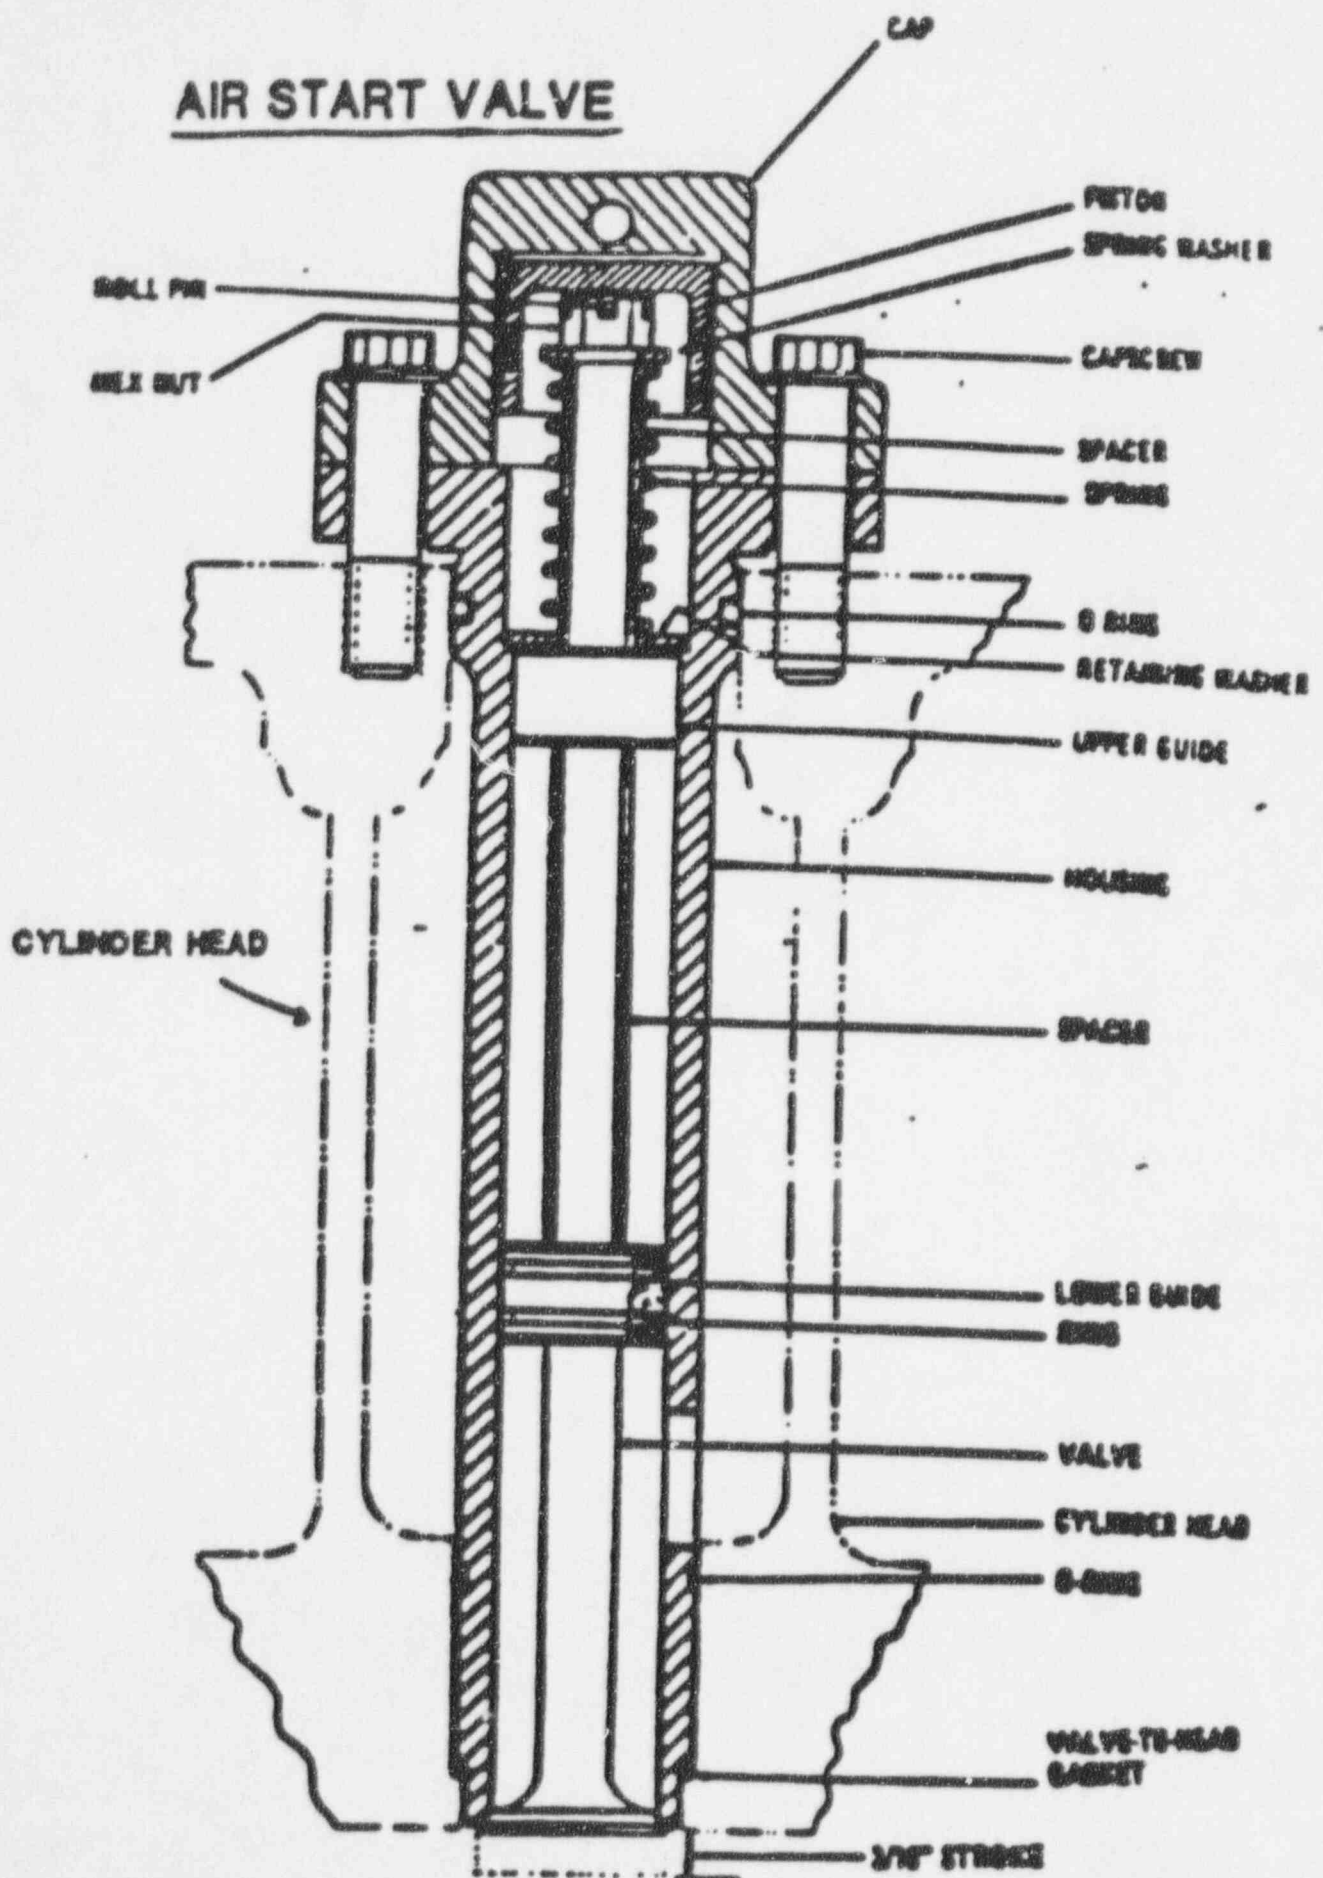
DIESEL GENERATOR STARTING AIR ADMISSION VALVE PROBLEM

- . DG would not start if a particular crankshaft alignment and stuck air valve combination existed. This condition was ex__ during surveillance testing when half of the cylinders were isolated from starting air.

INDICATION OF AIR START PROBLEMS
