INTER-COMMUNICATION
INLAND STEEL COMPANY
INDIANA HARBOR WORKS

DATE MARCH 27, 1985

INRYCO POST TENSIONING DIVISION
JOSEPH M. FARLEY NUCLEAR PLANT, UNIT NO. 2
ANCHOR HEAD INVESTIGATION
OMD INVESTIGATION NO. 19875 - FINAL REPORT

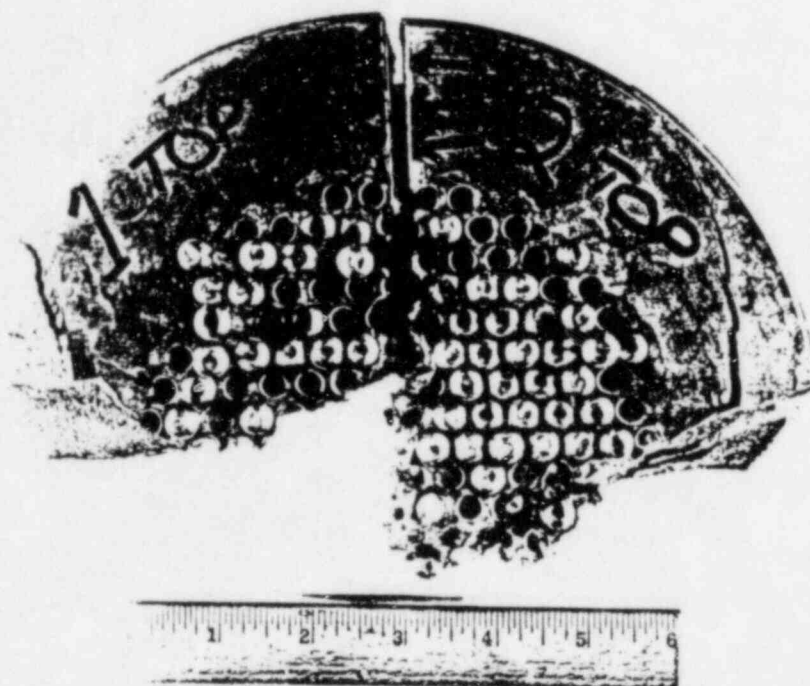
Figure 3. Buttonhead face of the two sections of Anchor Head HV 016 submitted for metallurgical analysis. Arrows indicate mating fracture faces. Note the angled nature of the non-mating faces and the spalling on the button head faces.

THE TWO SUBMITTED SECTIONS OF ANCHOR HEAD HV 016 ARE SHOWN IN FIGURE 3. THE MATING FRACTURED FACES OF THE HEAD EXHIBITED A WOODY, FIBROUS-TYPE FRACTURE APPEARANCE. THE FRACTURE FACES WERE NORMAL TO THE INBOARD (SHIM FACE) AND WERE STRAIGHT AND ALIGNED PARALLEL TO THE ROLLING DIRECTION. IT IS NOT KNOWN IF THE FRACTURE COINCIDED WITH THE SPLIT SHIM SPACE. IT APPEARS THAT THE FRACTURE OF THE RING PORTIONS OF THE HEAD ORIGINATED AT OR NEAR THE SHIM FACE OF THE HEAD NEAR OR AT THE HONEYCOMB; SEE FIGURE 4. NOTE THE INDICATIONS OF A LIGHT CHEVRON PATTERN POINTING TOWARD THESE LOCATIONS. A DEFINITE ORIGIN OF THE HONEYCOMB FRACTURE WAS NOT APPARENT, ALTHOUGH THE FAILURE OF THE HEAD PROBABLY ORIGINATED WITHIN THE HONEYCOMB AND PROPAGATED TO THE OUTER RING. NOTE THAT THE HONEYCOMB HAD REPORTEDLY SHATTERED INTO APPROXIMATELY 80 PIECES; HOWEVER, THE HONEYCOMB FRACTURES IN THE AREA OF THE MATING FACES REMAINED PARALLEL TO THE ROLLING DIRECTION AND NORMAL TO THE SHIM FACE INDICATING A BIAXIAL TENSILE LOADING.

THE ADDITIONAL TWO FRACTURE FACES APPEAR TO BE SECONDARY FAILURES. THEY ALSO HAVE THE WOODY FRACTURE APPEARANCE, BUT THE FRACTURE FACES ARE ANGLED AT APPROXIMATELY 10 DEGREES FROM THE ROLLING DIRECTION. THE FRACTURE FACE FROM SECTION #1 ALSO HAS A STRIATED APPEARANCE ON THE UPPER TWO-THIRDS OF THE FRACTURE INDICATING A PROGRESSIVE FRACTURE WHICH PROBABLY OCCURRED LAST AND ORIGINATED NEAR THE BOTTOM (SHIM FACE) OF THE HEAD. THE FRACTURE FACE OF SECTION #2 APPEARS TO HAVE ORIGINATED AT MULTIPLE ORIGINS (AS INDICATED BY THE RATCHET MARKS) AT, NEAR OR WITHIN THE HONEYCOMB; SEE FIGURES 5 AND 6. THE FRACTURES IN THE HONEYCOMB AREAS ADJACENT TO THE SECONDARY FRACTURES WERE ANGLED TO THE ROLLED DIRECTION INDICATING A MORE COMPLEX, POSSIBLY TENSILE-SHEAR LOADING. IT WAS ALSO NOTED THAT SPALLING OF THE BUTTONHEAD SURFACES OF THE HEAD HAD OCCURRED ADJACENT TO THE SECONDARY FRACTURES INDICATING SIGNIFICANT COMPRESSIVE LOADING ALONG THAT SURFACE; SEE FIGURE 3.

THE HONEYCOMB AREA REVEALED IGS ON BOTH THE VERTICAL AND ANGLED WEB FRACTURES. ALSO, THE SPALLED AREAS OF THE TOP (BUTTONHEAD) END OF THE RING, SHOWN IN FIGURE 3, EXHIBITED HEAVY IGS.

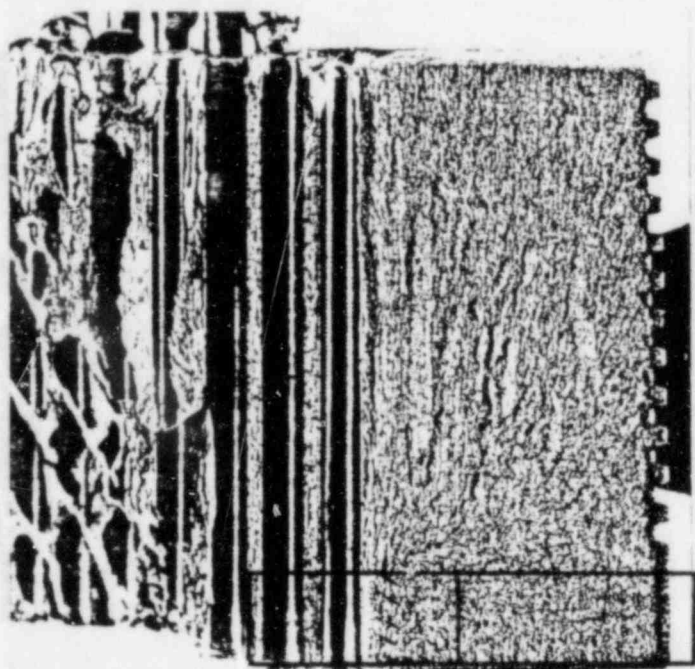
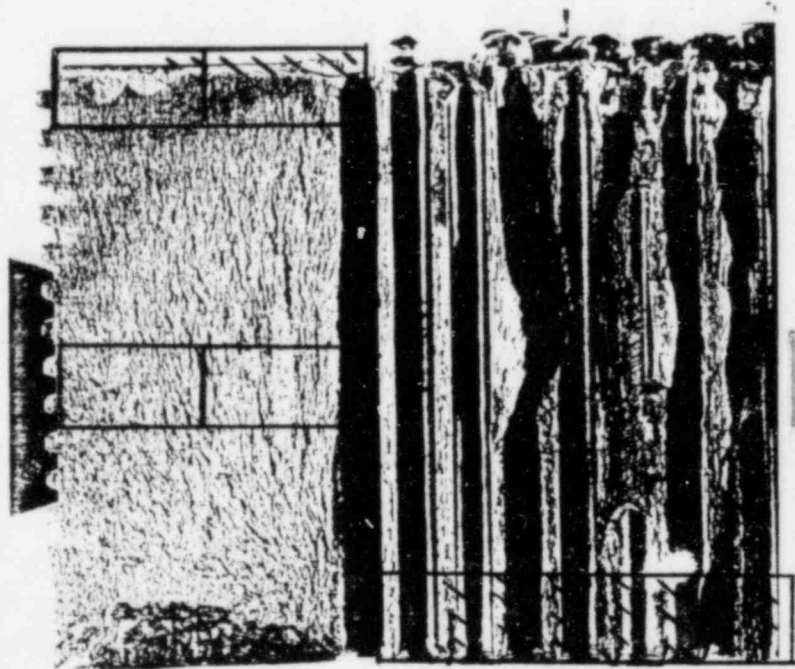
ures 4A and 4B. Light fractographs of the mating fractured faces from Anchor Head HV 016. Note the woody appearance of the fractures. Arrows point to region shown in Figures 14A and 14B. The light chevron pattern on the outer ring indicates the ring fractures originated at or adjacent to the honeycomb and near the shim face (bottom surface as shown).

SCANNING ELECTRON MICROSCOPIC (SEM) ANALYSES WERE PERFORMED ON ALL THE RING FRACTURE FACES AND SELECTED AREAS OF THE HONEYCOMB; REFER TO FIGURES 4-6. THE RING OF THE HEAD AND HONEYCOMB REVEALED INTERGRANULAR SEPARATION (IGS) TO VARYING DEGREES; SEE FIGURES 14A AND 14B. IGS INDICATES THAT THE FRACTURE OCCURRED WHILE THE HEAD WAS IN A PARTIALLY EMBRITTLED CONDITION. THE MATING FRACTURE FACE, SHOWN IN FIGURES 4A AND 4B, REVEALED IGS AT THE TOP AND BOTTOM, INNER SIDE (ADJACENT TO THE HONEYCOMB) OF THE RING. THE BALANCE OF THE SECTIONS EXAMINED FROM THESE FRACTURES PREDOMINANTLY SHOWED COMBINATIONS OF CLEAVAGE AND DUCTILE FRACTURE MODES.

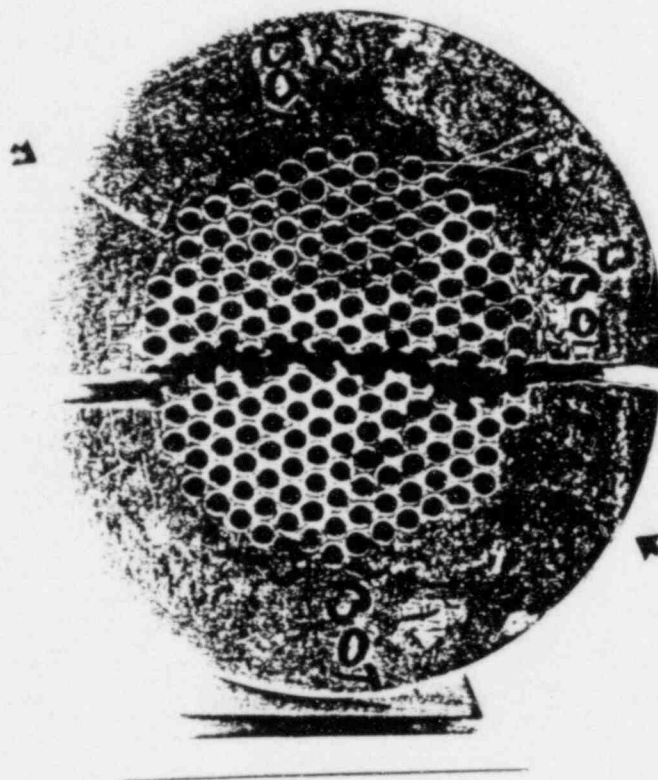
Figure 7. Photograph of the inboard end (shim face) of HV 038. Note the crack between Sections #2 and #3. The split shim spacing is denoted by the arrows. Section #1 (lower half) was retained by Battelle along with a small fragment from the honeycomb area. Sections #2 and #3 (upper half) were retained by Inland.

THE SHIM FACE OF ANCHOR HEAD HV 038 IS SHOWN IN FIGURE 7. WHEN THE ANCHOR HEAD WAS RECEIVED, SECTION #3 WAS NOT COMPLETELY SEPARATED FROM SECTION #2. THERE WAS ALSO A SMALL FRAGMENT OF THE HONEYCOMB FROM THE AREA CIRCLED IN FIGURE 8. THE FRAGMENT WAS JOINTLY EXAMINED AND RETAINED BY BATTELLE. A LIGHT FRACTOGRAPH OF THE RADIAL FRACTURE OF SECTIONS #2 AND #3 IS SHOWN IN FIGURE 8. THE FRACTURE FACES AS SHOWN IN FIGURE 8 ALSO HAD A WOODY, FIBROUS APPEARANCE, WERE NORMAL TO THE SHIM FACE AND WERE STRAIGHT AND ALIGNED PARALLEL TO THE ROLLING DIRECTIONS EXCEPT IN THE AREA WHERE THE FRACTURE FACES OF SECTIONS #1, #2 AND #3 INTERSECTED. THE FRACTURES WERE NOT ALIGNED WITH THE SPLIT SHIM SPACE, WHICH IS DENOTED BY THE ARROWS IN FIGURE 7. A DEFINITE FAILURE POINT ORIGIN IS NOT READILY APPARENT IN FIGURE 8 OR THE DETAIL FIGURES 9 AND 10. HOWEVER, THE FRACTURES OF THE OUTER RING AREAS APPEAR TO HAVE ORIGINATED AT OR ADJACENT TO THE HONEYCOMB AND IN THE LOWER QUARTER OF THE RING. INDEED, THE FAILURE OF THE HEAD MAY HAVE ORIGINATED WITHIN THE HONEYCOMB AREA AND PROPAGATED TO THE OUTER RING.

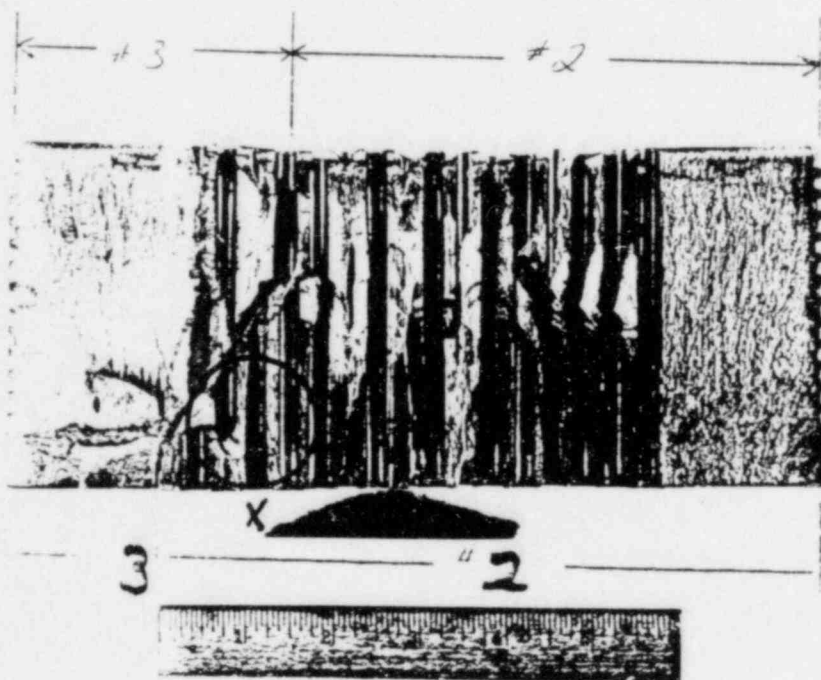
Figure 8. Light fractograph of Sections #2 and #3 of HV 038 retained by Inland. The inboard (shim face) end of the head is the bottom surface, as shown. The small honeycomb fragment retained by Battelle came from the circled area denoted by the "X". Refer to Figures 3 and 4 for detailed fractographs of Sections #3 and #2, respectively.

SEM ANALYSES WERE PERFORMED ON THE FRACTURED FACES OF ANCHOR HEAD HV 038; SEE FIGURES 9-11. AGAIN, THE RING AND HONEYCOMB SHOWED IGS; SEE FIGURES 15A AND 15B. THE RING PORTION OF SECTION #2 (RIGHT SIDE OF FIGURE 8 AND FIGURE 10) SHOWED A NARROW BAND OF IGS ADJACENT TO THE HONEYCOMB AT THE BOTTOM THIRD OF THE RING.

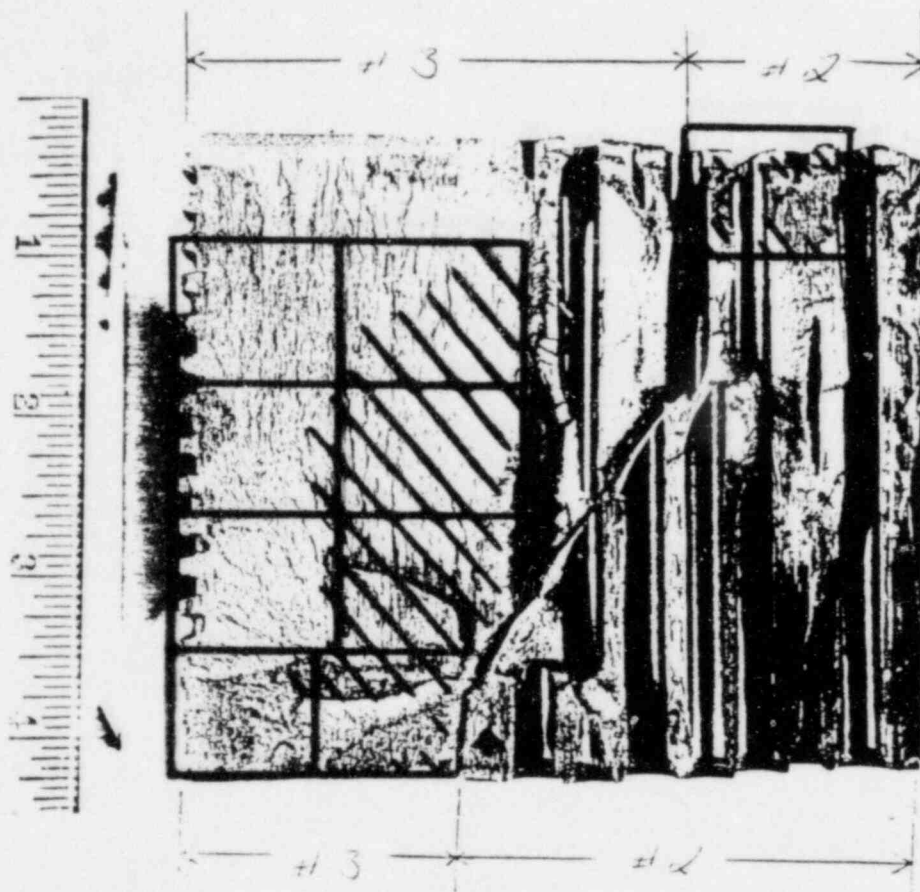
Figure 9. Light fractograph of Section #3 and a portion of Section #2, Anchor Head HV 038. Note the woody appearance of the fracture. The fracture of the outer ring appears to have propagated from the location denoted by the arrow. However, it is suspect that the head fracture origin was located within the honeycomb area, which exhibited multi-directional and possibly multi-origin fracture faces. The small fragment retained by Battelle was above and to the right of the arrow.

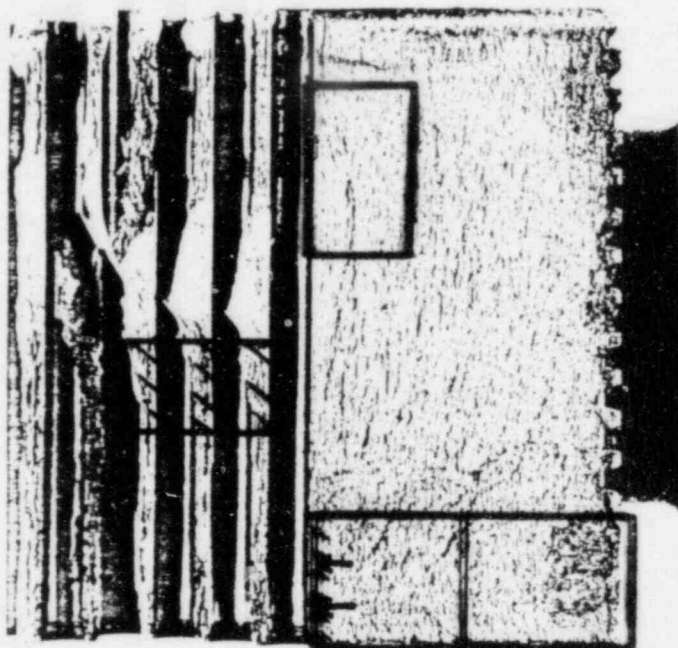
Figure 10. Light fractograph of the remainder of Section #2, Anchor Head HV 038. Note the woody appearance of the fracture. The fracture of the outer ring appears to have propagated from the location denoted by the arrows. However, it is suspect that the head fracture originated within the honey-comb.

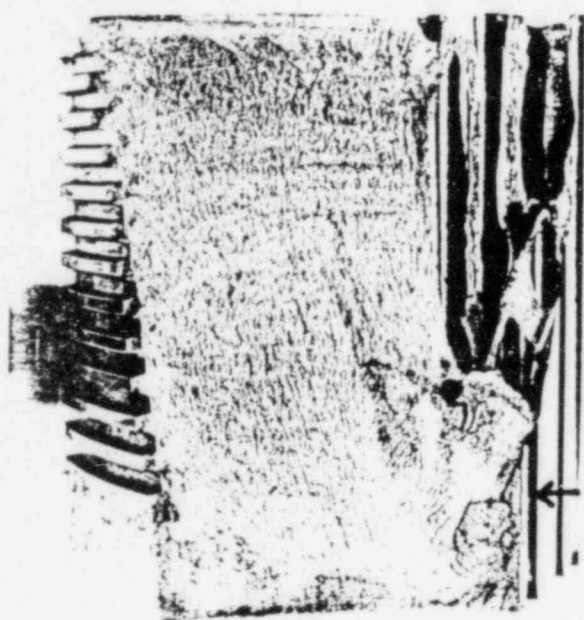
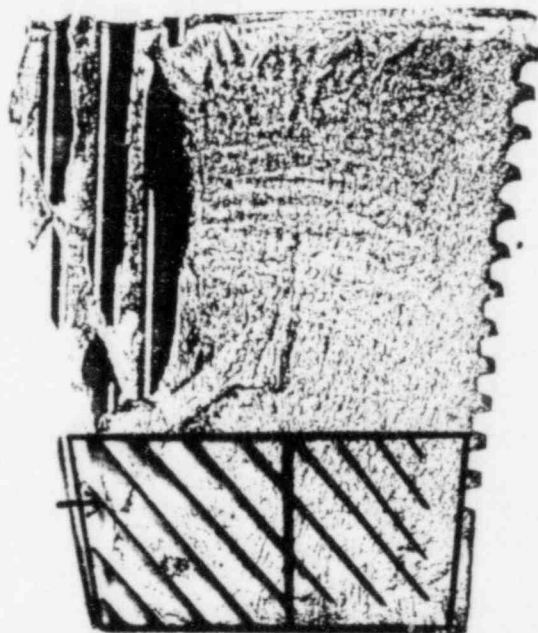
Figure 11. Light fractograph of the mating fracture faces of Anchor Head HV 038 between Sections #2 and #3. Note the woody appearance of the fracture and the striations on the upper half of the ring face. The fracture appears to have propagated from the location denoted by the arrows.

SECTION #3 WAS SEPARATED FROM SECTION #2 AND APPEARS TO BE A SECONDARY FAILURE. AGAIN, THE FRACTURED FACES EXHIBITED THE WOODY FRACTURE APPEARANCE, BUT THE FACES ARE ANGLED AT APPROXIMATELY 10 DEGREES FROM THE ROLLING DIRECTION. THE FRACTURED FACES ALSO HAVE A STRIATED APPEARANCE ON THE UPPER HALF OF THE FRACTURE, SIMILAR TO THE SECONDARY FRACTURES OF ANCHOR HEAD HV 016. IT APPEARS THAT THIS FRACTURE ALSO ORIGINATED AT OR ADJACENT TO THE HONEYCOMB AND SHIM FACE; SEE FIGURE 11.

THE NON-RADIAL FRACTURE FACE BETWEEN SECTIONS #2 AND #3; SEE FIGURE 11, SHOWED IGS ACROSS THE LOWER THIRD OF THE RING.

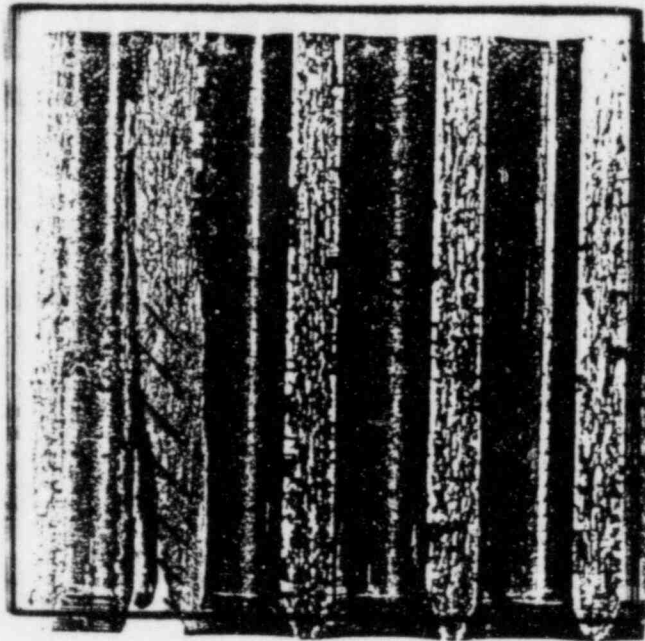
Figure 12. Light fractograph of the fracture face of Anchor Head HV 039, which was separated mechanically. The arrow indicates the precracked web where it appears a fracture originated. Note the smoother, more crystalline appearance of the precracked area versus the balance of the fracture surfaces.

FRACTURE FACES. CARE WAS TAKEN IN SECTIONING HV 039 TO INCLUDE BOTH PRECRACKS AND POST-CRACKS. THE FRACTURED FACES OF THE THREE ANCHORAGES ALSO SHOWED THE WOODY, FIBEROUS APPEARANCE. FIGURE 12 SHOWS THE FRACTURE FACE OF HV 039; THE ARROW INDICATES THE PRE-CRACKED WEB AREA WHICH HAD A SMOOTHER, MORE CRYSTALLINE APPEARANCE AS COMPARED TO THE ADJACENT POST-CRACKED WEB AREAS.

THE ANALYSIS WAS PERFORMED ON THE HONEYCOMB FRACTURED FACES OF ANCHOR HEAD HV 039. THE PRECRACKED WEB, SHOWN IN FIGURE 12, EXHIBITED HEAVY IGS ALONG THE BOTTOM INCH OF THE WEB; SEE FIGURE 16A. ABOVE THE BOTTOM INCH THE FRACTURE MODE WAS A COMBINATION OF CLEAVAGE AND DUCTILE; SEE FIGURE 16B. THE OTHER WEBS WHICH WERE CRACKED DURING LOAD TESTING SHOWED A COMBINATION OF CLEAVAGE AND DUCTILE FRACTURE MODES. NO IGS WAS NOTED ON THESE POST-CRACKS.

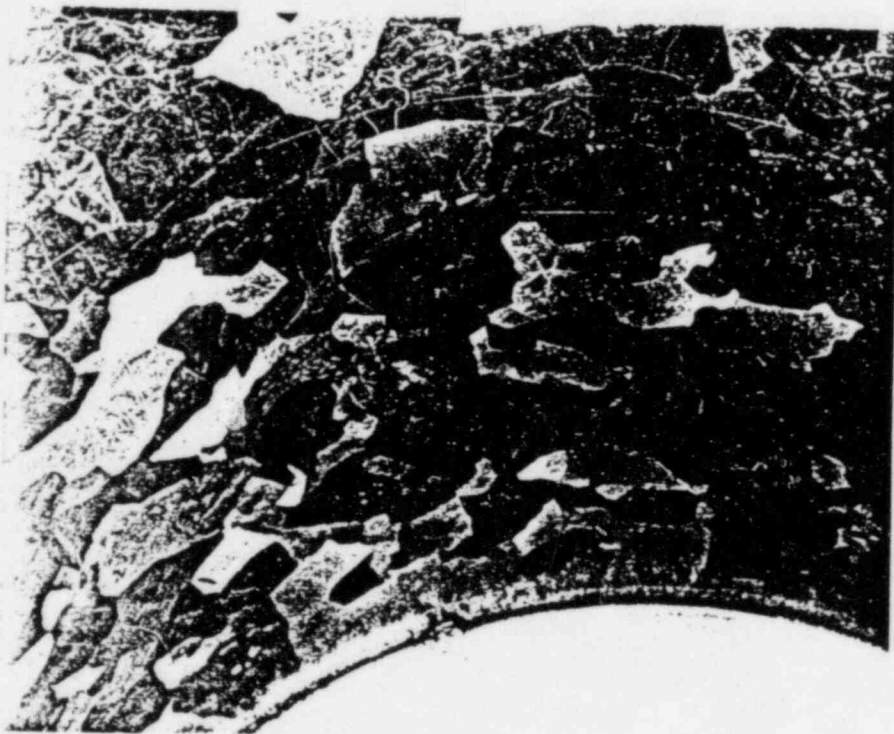
Figure 13A. Photograph of the interior surface of the galvanized grease cover from V-21 (HV 038) after removal of the grease. Note the "etched" condition of the galvanized coating.

THE GALVANIZED GREASE COVER FROM THE LOWER END OF VERTICAL TENDON V-21 (HV 038) EXHIBITED AN "ETCHED" CONDITION ON THE INNER SURFACES AS SHOWN IN FIGURE 13A. THE "ETCHED" CONDITION IS AN INDICATION THAT ACTIVE CORROSION HAD OCCURRED OR WAS OCCURRING WITHIN THE GREASE COVER. THE GREASE COVER FROM THE LOWER END OF TENDON V-17 (HV 016) HAD A SIMILAR "ETCHED" APPEARANCE BASED ON ON-SITE PHOTOGRAPHS. SURFACE IRREGULARITIES, WHICH APPEARED TO BE DROSS, WERE ALSO EVIDENT ON THE INNER SURFACES OF THE GALVANIZED COVER; SEE FIGURE 13B. WHEN OBTAINING GREASE SAMPLES FROM THE TENDON V-21 GREASE COVER, POCKETS OF LIQUID WATER WERE ENCOUNTERED WITH APPROXIMATELY 200 ML OF WATER BEING FOUND NEAR THE LOWER END OF THE COVER. THIS AMOUNT OF WATER IS EXCESSIVE.

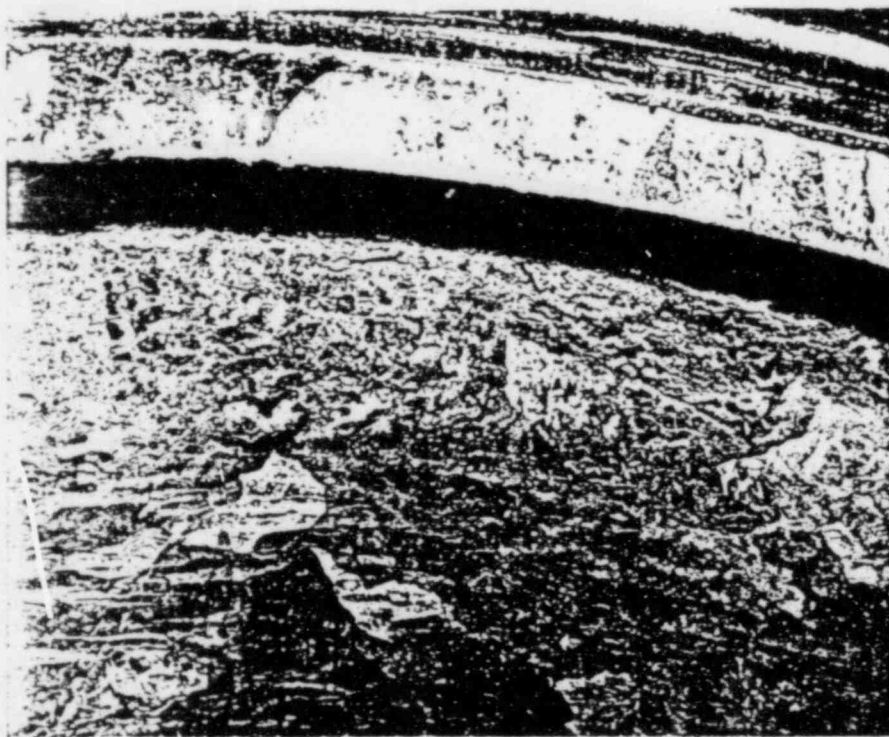
Figure 13B. Photograph of the interior surface of the galvanized grease cover from V-21 (HV 038) after removal of the grease. Note the surface irregularities (dross) of the galvanized coating.

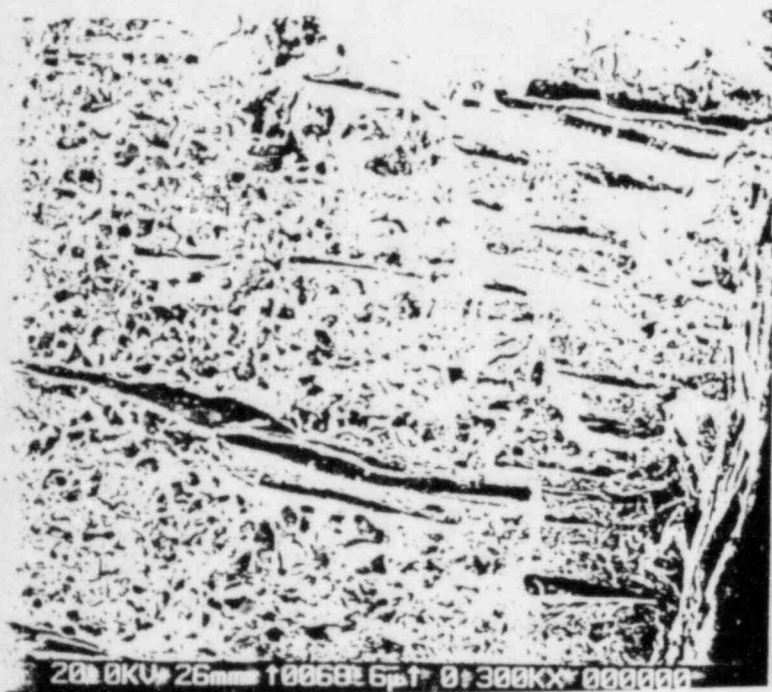
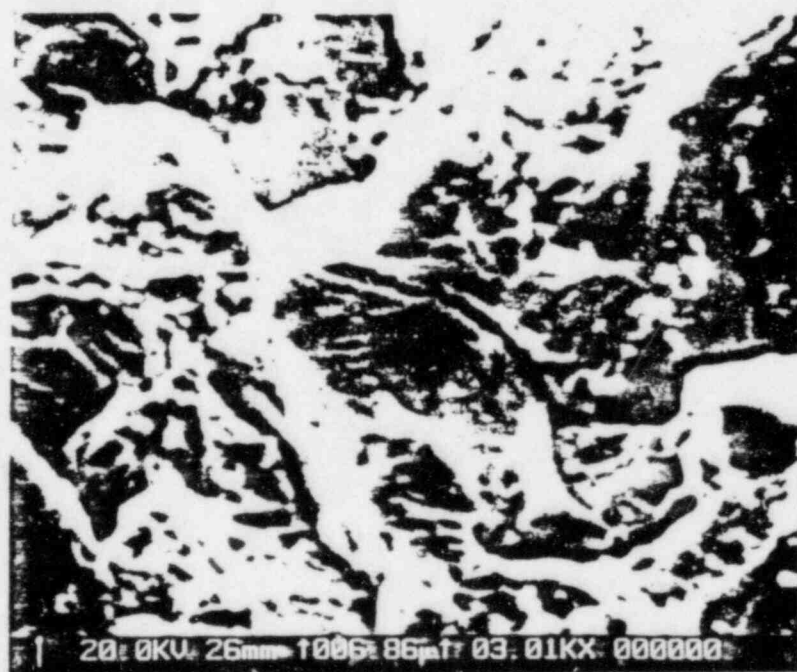
Figure 14A. SEM fractograph of HV 016 of region denoted by arrow in Figure 4A. The low magnification shows the inclusion troughs. The high magnification shows the intergranular separation.

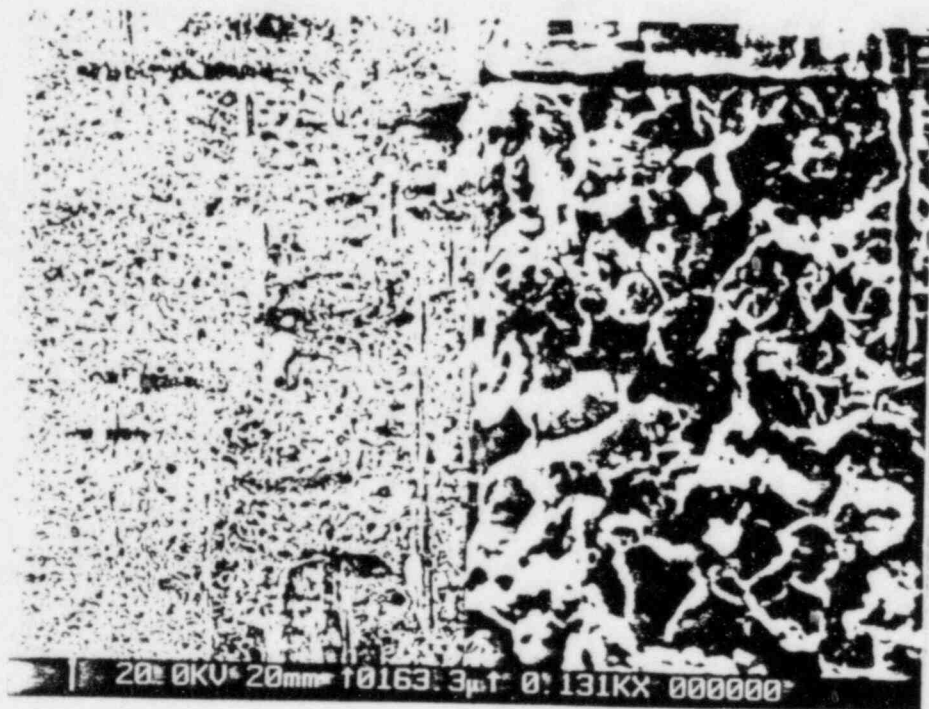
Figure 14B. SEM fractograph of HV 016 of region denoted by arrow in Figure 4B. The low magnification shows the inclusion troughs. The high magnification shows the intergranular separation.

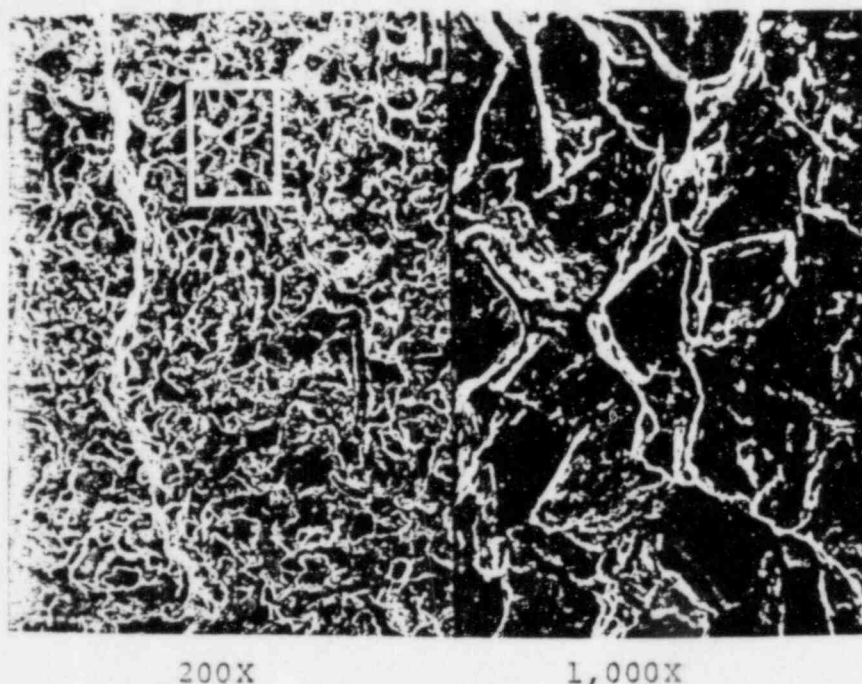
Figure 15A. SEM fractograph of HV 038 of the selected region denoted by the arrow in Figures 8 and 9 (outer ring near the junction of Sections #2 and #3 and approximately 1" above the shim face). The lower magnification (left side) shows scattered inclusion troughs. The higher magnification (right side showing the area in the box on the left side) clearly shows heavy IGS. Note the relative cleanliness (lack of corrosion products) of the fracture face.

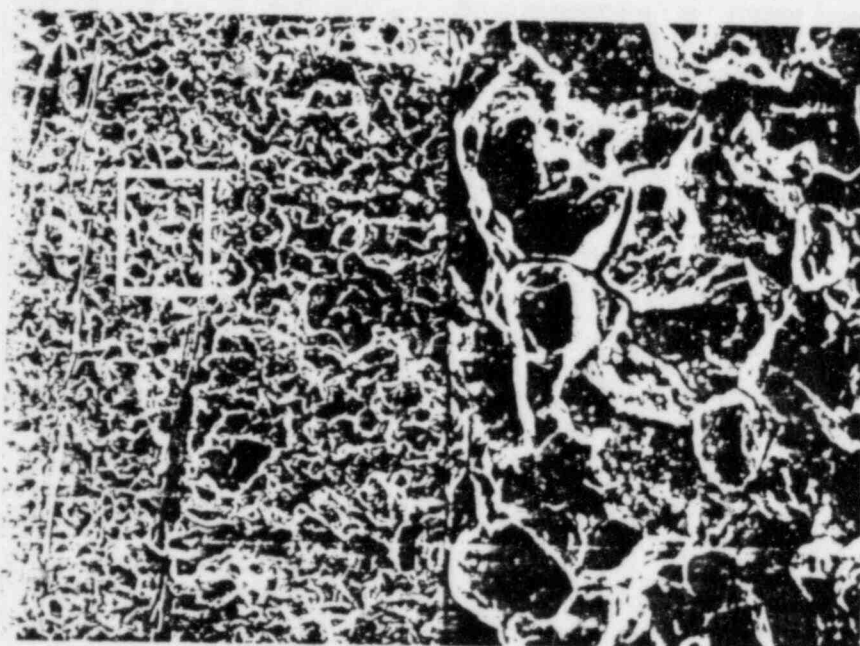
Figure 15B. SEM fractograph of HV 038 of the selected region denoted by the arrows in Figure 10. The lower magnification (left side) shows scattered inclusion troughs. The higher magnification (right side showing the area in the box on the left side) clearly shows heavy IGS. Note the relative cleanliness of the fracture face.

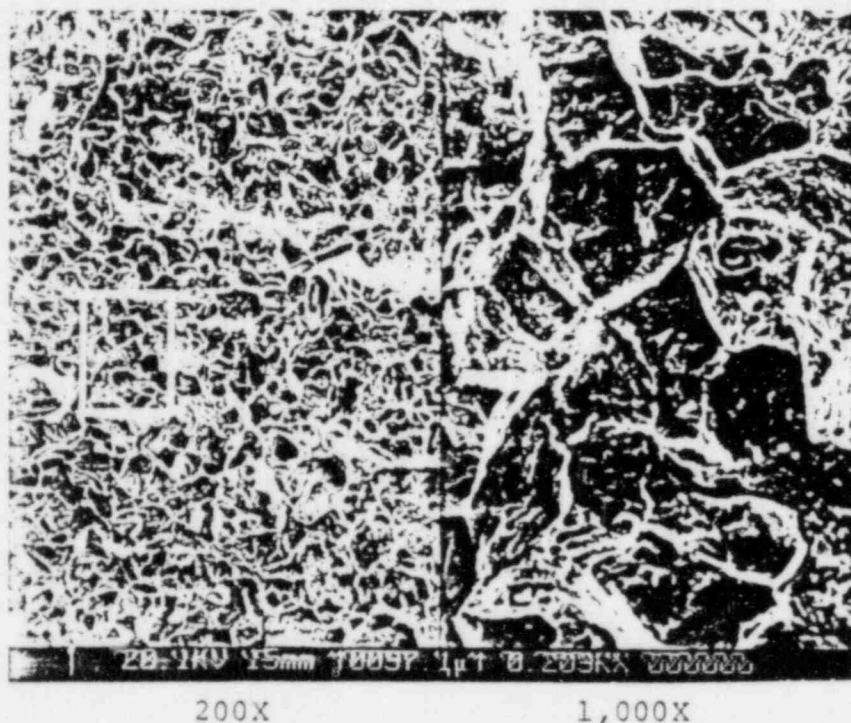
Figure 16A. SEM fractograph of the precracked web of Anchor Head HV 039, Figure 12, approximately 3/4" from the bottom surface. The lower magnification (left side) shows the general IGS condition. The higher magnification (right side showing the area in the box on the left side) clearly shows heavy IGS. Note the relative cleanliness of the fracture face.

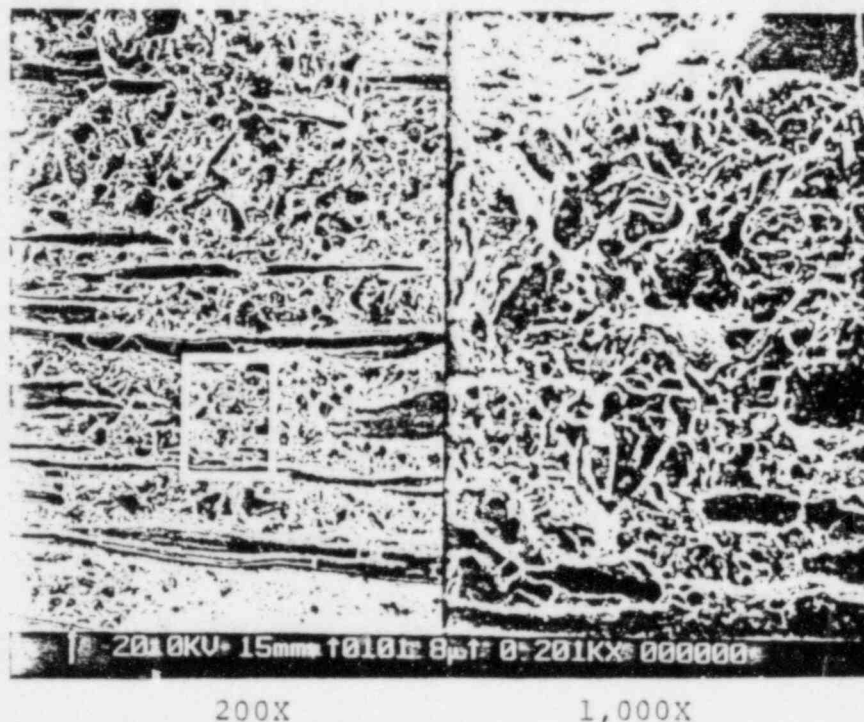
Figure 16B. SEM fractograph of the cracked web of Anchor Head HV 039, Figure 12, approximately 1-1/4" from the bottom surface. The lower magnification (left side) shows scattered inclusion troughs. The higher magnification (right side showing the area in the box on the left side) clearly shows the cleavage and ductile fracture modes.
