U.S. NUCLEAR REGULATORY COMMISSION
REGION IV

Docket No.: 40-8084
License No.: SUA-1119
Report No.: 40-8084/96-01
Licensee: Rio Algom Mining Company
Facility: Former Lisbon Mill Facility
Location: La Sal, San Juan County, Utah
Dates: September 4-5, 1996
Inspector: Robert J. Evans, P.E., Health Physicist
Nuclear Materials Inspection and
Fuel Cycle/Decommissioning Branch
Division of Nuclear Materials Safety
Approved By: Charles L. Cain, Technical Assistant
Division of Nuclear Materials Safety

Former Lisbon Mill Facility NRC Inspection Report 40-8084/96-01

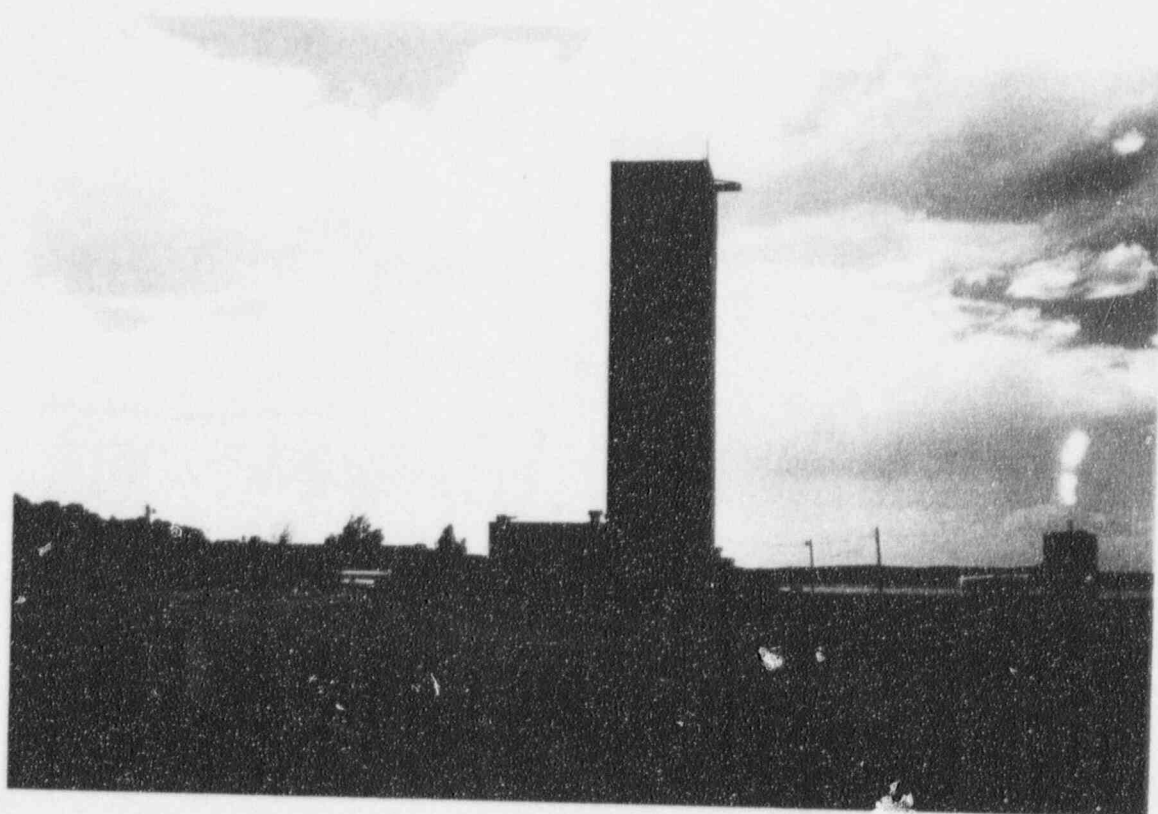
Photograph 1 - Rio Algom-Lisbon site structures (as seen from the area of the former mill).

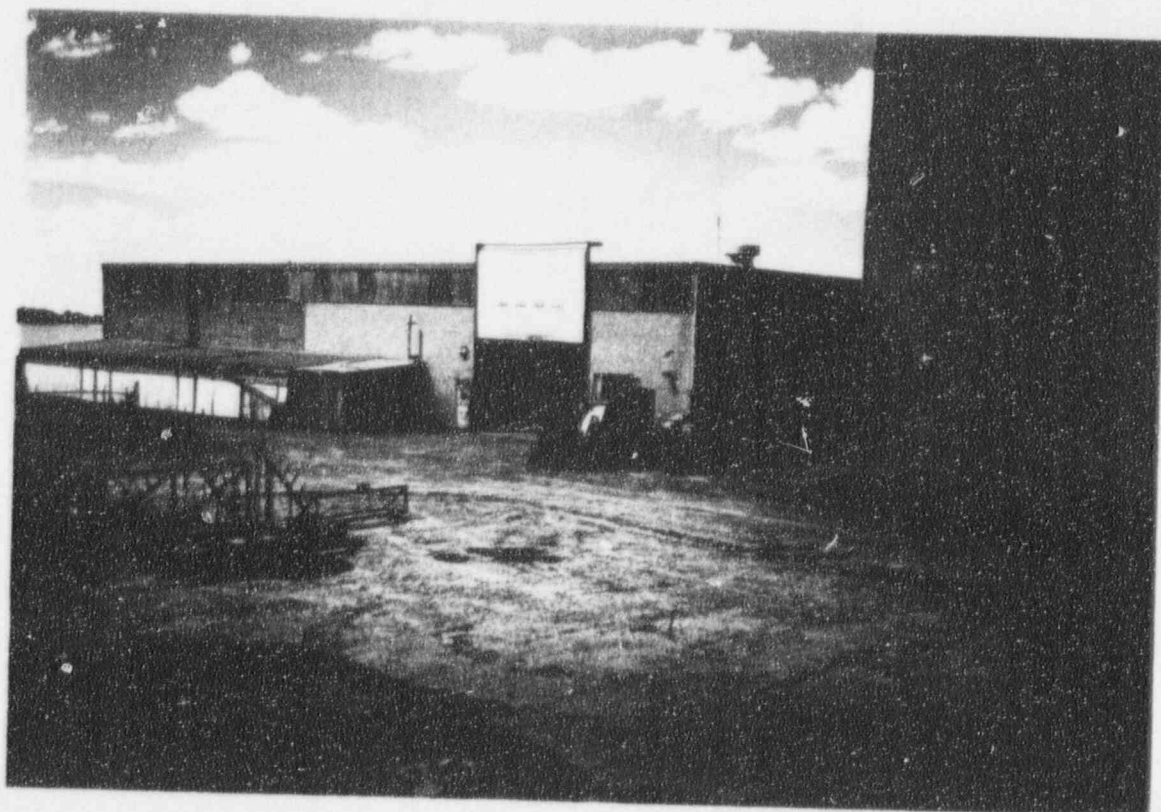
Photograph 2 - Headframe on right and warehouse/shop on left; area where former crusher building was located is in the foreground.

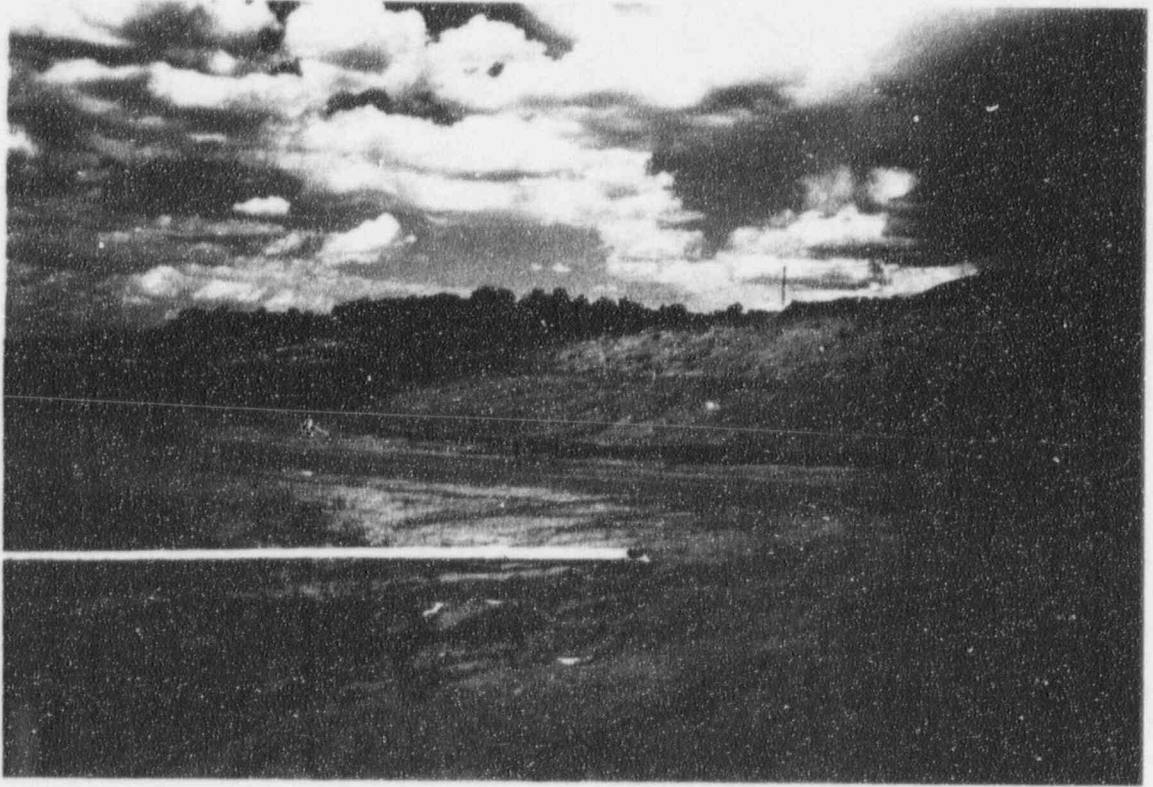
Photograph 5 - Outslope of upper tailings impoundment; the location where the former mill was buried.
