LICENSEE EVENT REPORT (LER)

FACILITY NAME (1)
Davis-Besse Unit 1

Reactor Trip and Loss of Feedwater Event at Davis-Besse on June 9, 1985

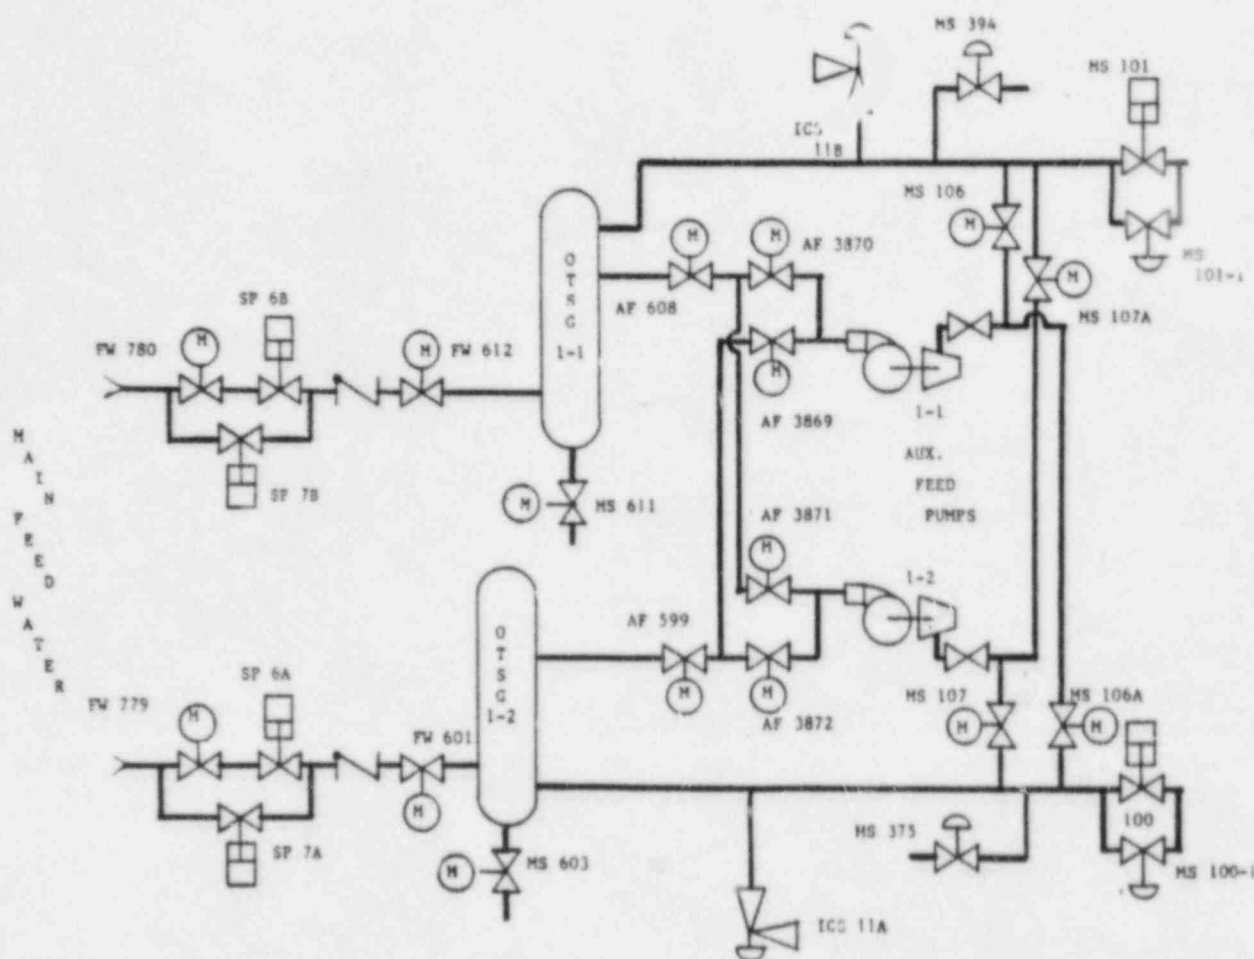
LER 85-013
SFRCS ACTUATED COMPONENTS

Immediately following the trip, a spurious Steam and Feedwater Rupture Control System, SFRCS, low steam generator level full trip occurred on Channel 2, an SFRCS full trip alarm was received, and both main steam isolation valves, MSIVs, closed. An actual low steam generator level did not exist at this time. This spurious trip resulted in a partial actuation of the SFRCS components since only the MSIVs actuated. When the MSIVs closed, the main steam supply was isolated to the MFPs. The No. 2 MFP continued to supply feedwater until approximately 0140 hours at which time its discharge pressure was not high enough to supply feedwater to the steam generators. The level in the steam generators which was being maintained at the low level limit setpoint (35 inches) began to decrease. SFRCS Actuation Channel No. 1 then automatically initiated on low steam generator level, starting the No. 1 Auxiliary Feedwater Pump, AFP, to feed the No. 1 Steam Generator (see Attachment 1 for a diagram of SFRCS actuated components).

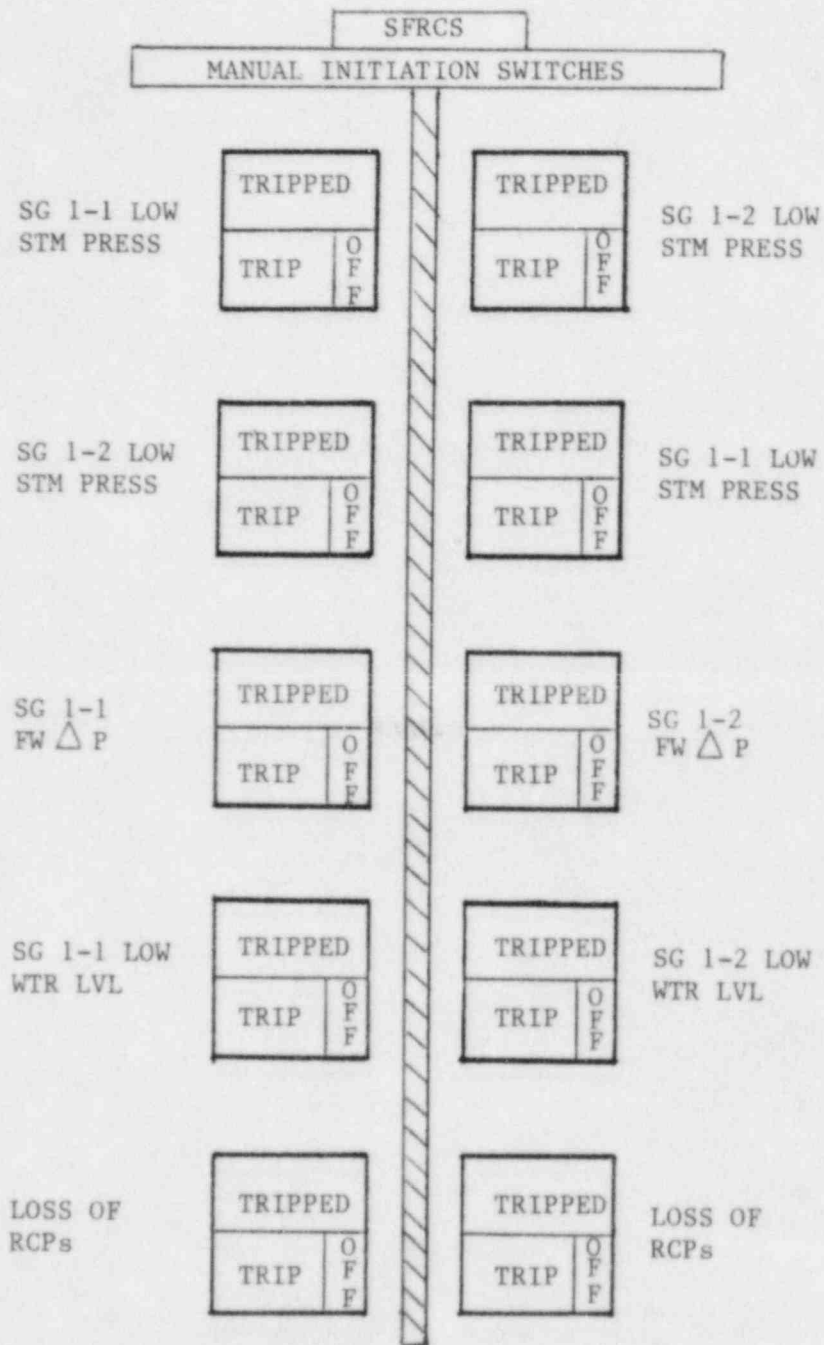
ORIGINAL LAYOUT

The cause of the incorrect manual SFRCS initiation was personnel error attributed to a poor switch layout. These SFRCS manual initiation pushbuttons had been identified in the Detailed Control Room Design Review as one of the principal items needing human engineering improvements. There are two adjacent vertical columns of buttons with five buttons in each column (see Attachment 3 for arrangement details). Each column represents one SFRCS actuation channel. To manually initiate both channels of the SFRCS for steam generator low level, the operator should have depressed the fourth button from the top in each column; instead, the two top buttons were depressed. A design change had been developed prior to this event to improve the switch layout and will be implemented during this outage.

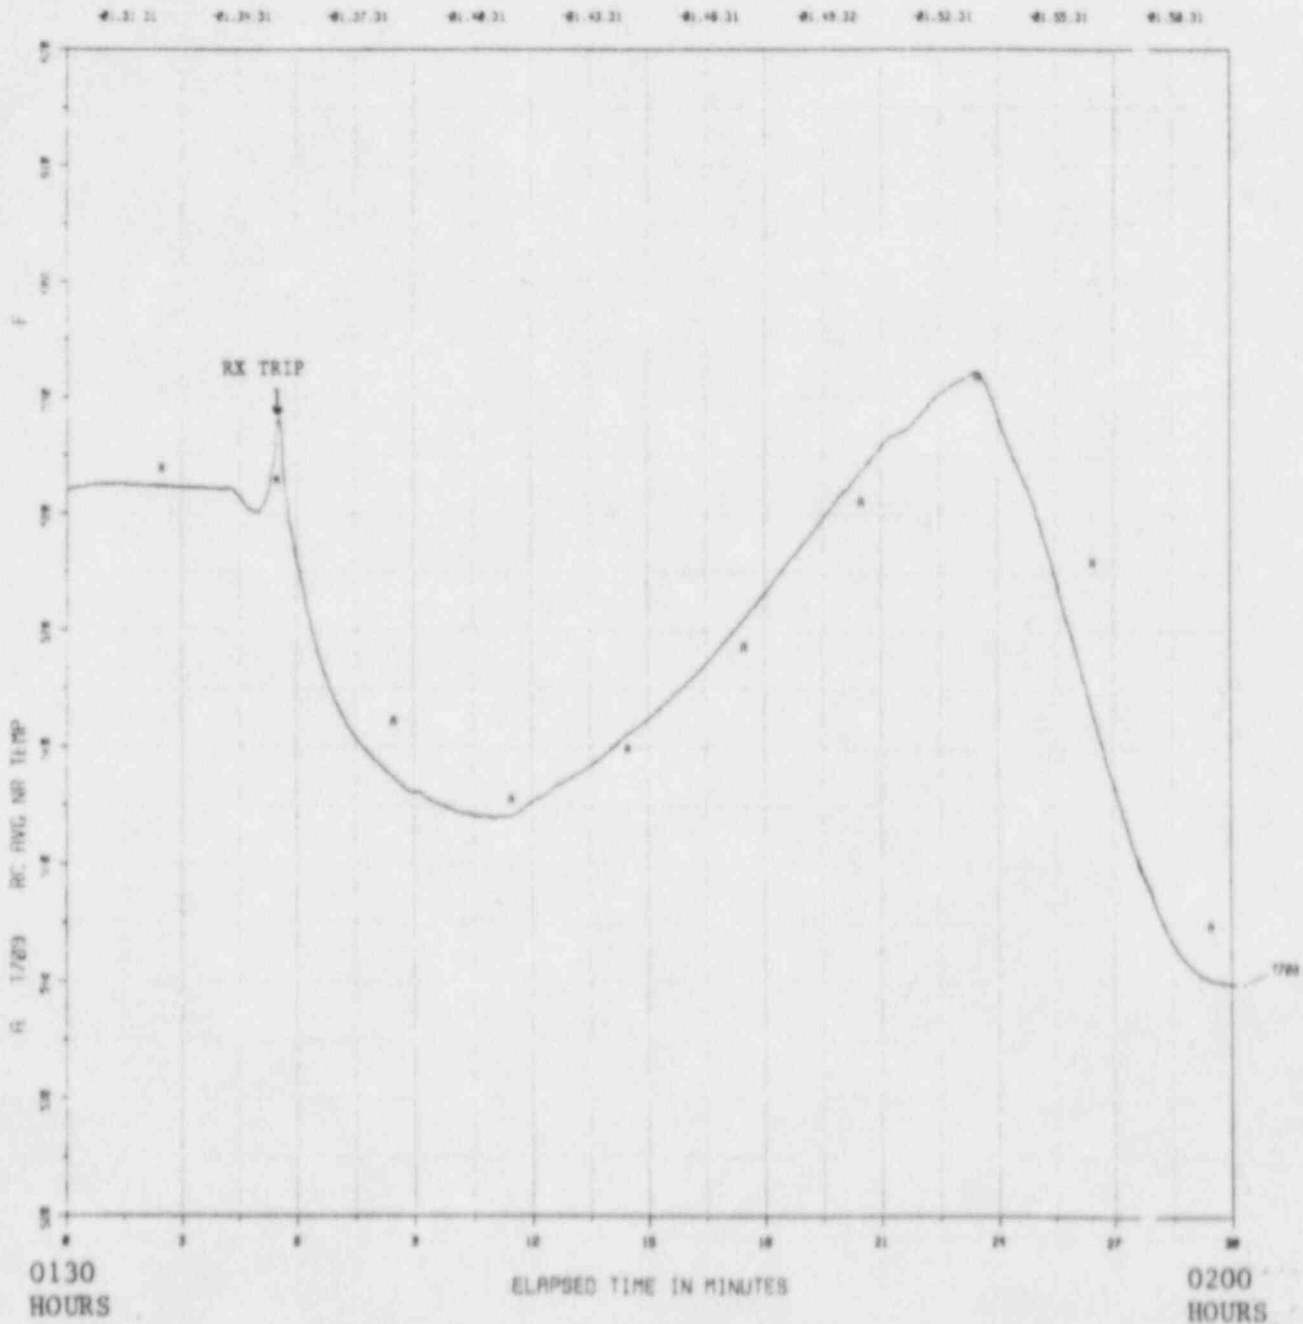
PLOT OF JUNE 9, 1985
TRANSIENT AT DAVIS-BESSE UNIT 1REACTOR COOLANT AVERAGE TEMPERATURE
VS
TIME

01:47:33	OTSG #1 below 960 psig and decreasing.
01:48:49	Pressurizer PORV opens (first time) at 2433 psig (2425 setpoint). Attachment 5 contains traces of RCS pressure and RCS temperature for the event.
*01:48:51	OTSG #2 below 960 psig and decreasing. (Both OTSGs now "dried out", according to criteria in plant emergency procedures.)
