Southern California Edison Company

Subject: Docket Nos. 50-361 and 50-362
Reactor Coolant Pump Lube Oil Collection System
San Onofre Nuclear Generating Station
Units 2 and 3

SONGS UNIT 2&3 RCP OIL COLLECTION FIRE HAZARDS EVALUATION

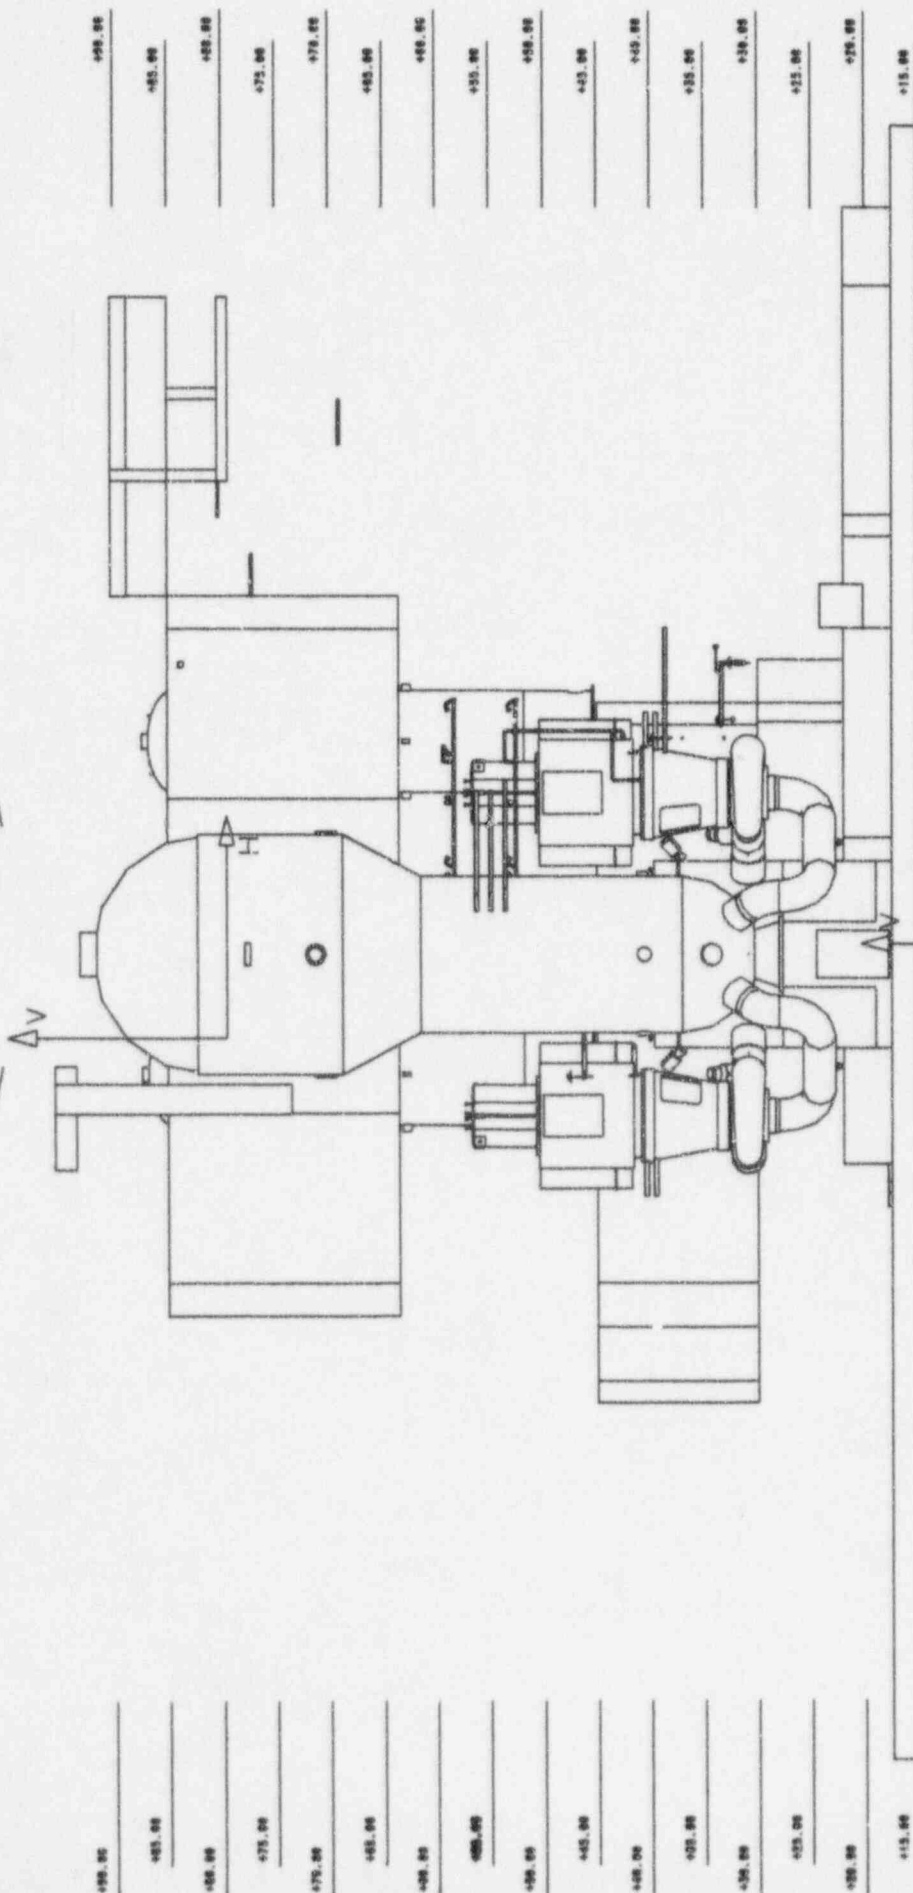
PLAN VIEW

A three dimensional drawing showing the location of the postulated leak and the surrounding equipment is provided in Attachment 1.

CATIA 3-D drawings indicating locations of proposed leakage points (2LE0157), fire protection systems, safe shutdown components, HVAC flow rates, and general configurations of the RCP's, Steam Generators, and associated piping.
