St. Anthony's Medical Center

Re: Control No. 05241
License No. 24-01041-04

ST. ANTHONY'S MEDICAL CENTER
DEPARTMENT OF NUCLEAR MEDICINE

RADIATION SURVEY

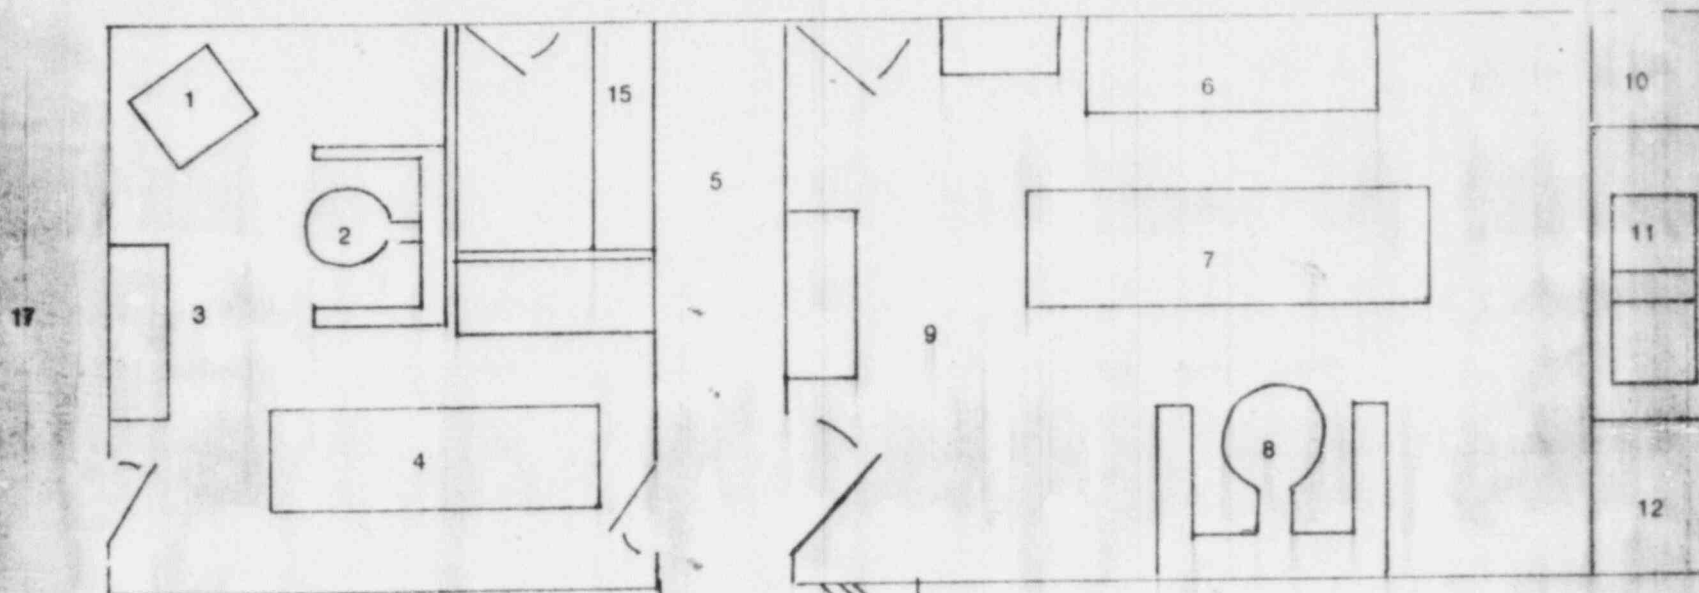
- b, Closeout survey of old Nuclear Medicine area revealed no detectable or removable contamination at any of the locations listed on the Area Radiation Survey diagram enclosed. None was expected in that only relatively short-lived radioactivity, principally Technetium 99m and occasionally, Thallium 201, and rarely, I-123 and I-131 was used in this area and none of the spent Molybdenum 99 generators are stored in this area but rather in a remote area of the hospital, previously approved and unchanged. Furthermore, the old area has been closed off and idle for six months, allowing ample time for decay to background of any possible contamination.

1. Console	No detectable or removable contamination				
2. Detector	"	"	"	"	"
3. Floor	"	"	"	"	"
4. Patient Cart	"	"	"	"	"
5. Floor	"	"	"	"	"
6. Console	"	"	"	"	"
7. Patient Cart	"	"	"	"	"
8. Detector	"	"	"	"	"
9. Floor	"	"	"	"	"
10. Dosecalibrator Area	"	"	"	"	"
11. Hot sink	"	"	"	"	"
Refrigerator (not shown)	"	"	"	"	"

12. Radiopharm Prep Area	No contamination observed	
13. Well Counter	"	"
14. Uptake Scaler	"	"
15. Radiopharm Area	"	"
16. Floor	"	"
17. Floor	"	"

Date: 12/12/81 (None expected after 6 months of disuse and only short lived radionuclides in prior use)
Performed by: *John H. Bradley, M.D. R.S.O.*

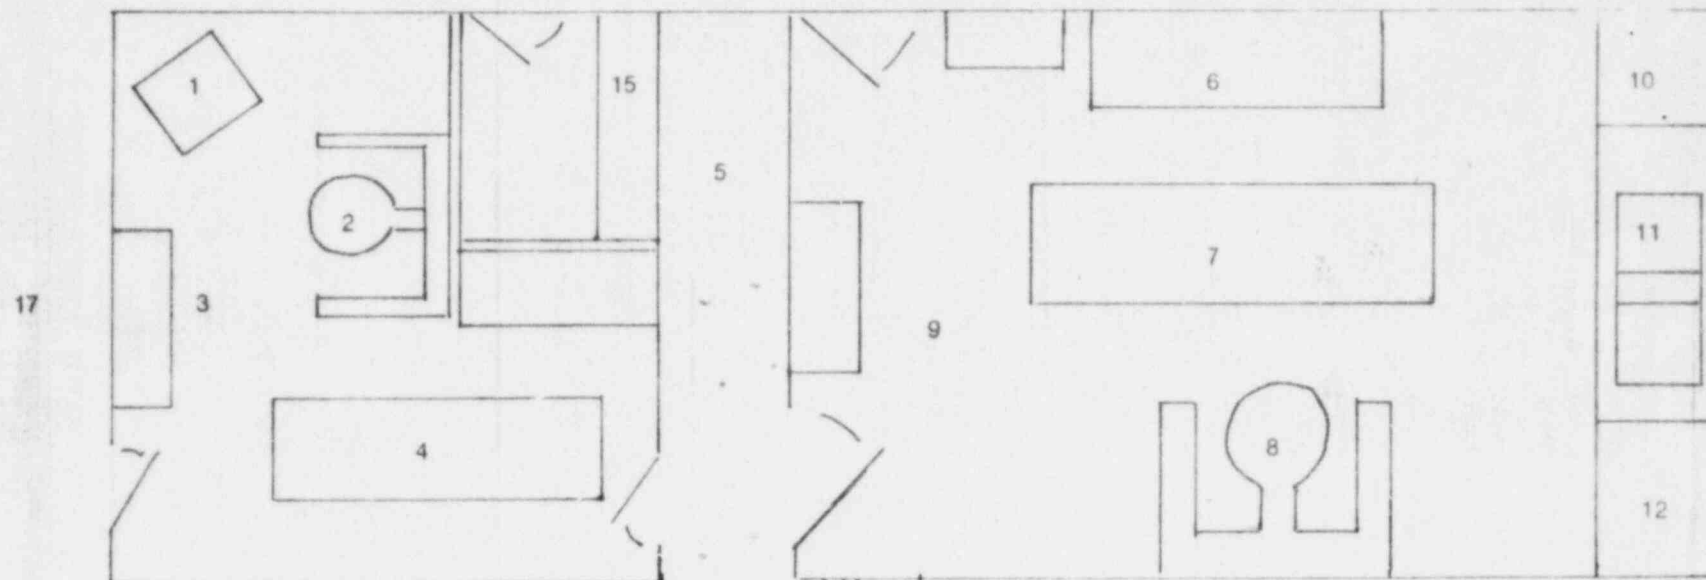
LAST SURVEY BEFORE MOVING TO NEW AREA

Console	MR/HR	CPM
Detector	.1	637
Floor	.1	646
Patient Cart	.1	659
Floor	.1	646
Console	.1	659
Patient Cart	.1	633
Detector	.1	647
Floor	.1	649
Dosecalibrator Area	.1	637
Hot sink	.1	651
Refrigerator (not shown)	.1	662
	.1	635

- 12. Radiopharm Prep Area
- 13. Well Counter
- 14. Uptake Scaler
- 15. Radiopharm Area
- 16. Floor
- 17. Floor

MR/HR	CPM
.1	641
.1	644
.1	648
.1	659
.1	644
.1	656
