U.S. NUCLEAR REGULATORY COMMISSION

Report No: 50-440/96015(DRS)

Facility: Perry Nuclear Power Plant

Pre-Decisional  
Enforcement Conference Presentation  
to the  
U.S. Nuclear Regulatory Commission

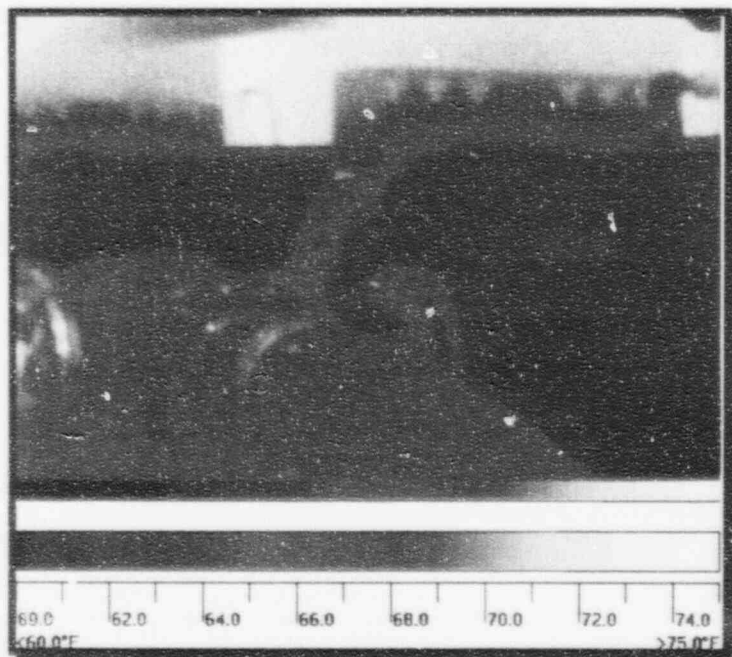
Time = - 12 min.

Heat Exchanger  
1P42-B0001B  
5/20/96  
Inlet

The infrared images shown below document the flow test performed on the 1P42-B0001B heat exchanger. This view is of the heat exchanger inlet. The entire test was run with the inlet 3-way temperature control valve in the **full bypass** position.

The image labeled T= -12 min was taken with P42 isolated, and P45 had been running for approximately 1 hour to cool the static water contained in the shell. The P42 Pump was started at T= 0 min. The other thermal image was taken 7 minutes after the start of the P42 pump.

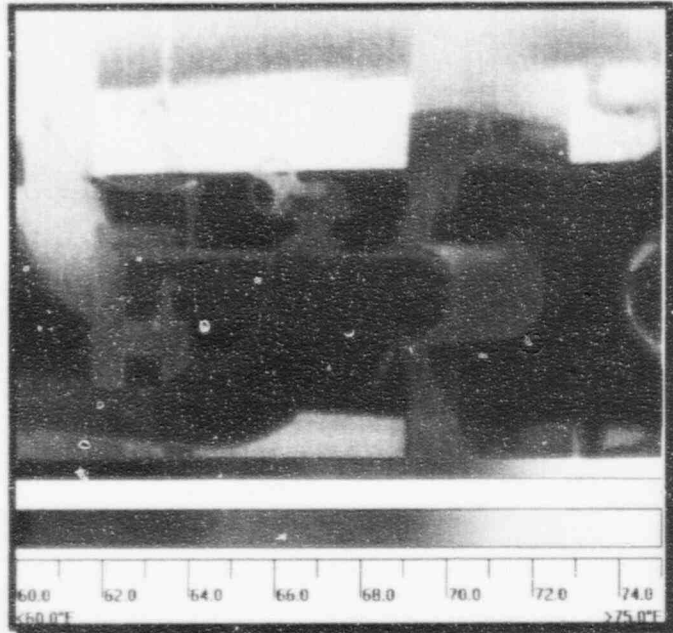
Time = - 9 min.

Heat Exchanger  
1P42-B0001B  
5/20/96  
Outlet

The infrared images shown below document the flow test performed on the 1P42-B0001B heat exchanger. This view is of the heat exchanger outlet. The entire test was run with the inlet 3-way temperature control valve in the **full bypass** position.

The image labeled T= -9 min was taken with P42 isolated, and P45 had been running for approximately 1 hour to cool the static water contained in the shell. The P42 Pump was started at T= 0 min. The other two thermal images were taken 1 minute and 5 minutes after the start of the P42 pump.

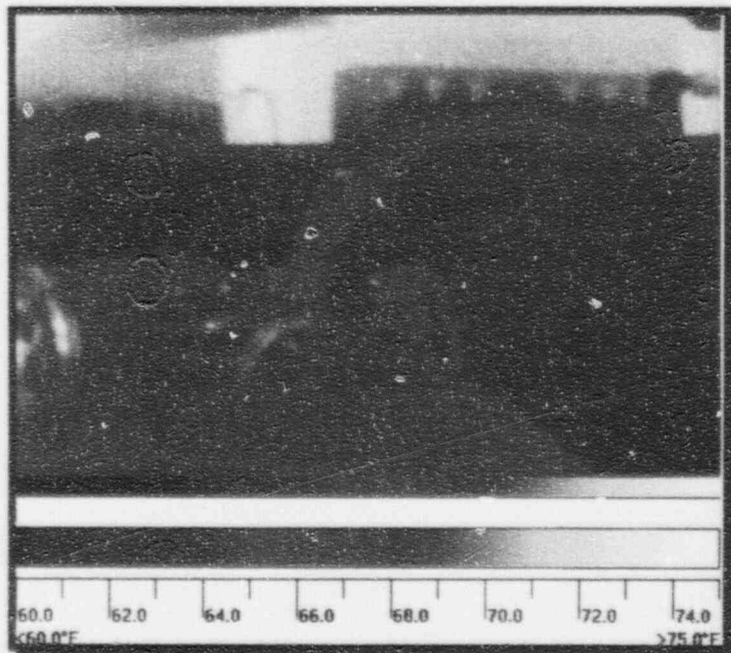
**Time = - 12 min.**

**Heat Exchanger**  
**1P42-B0001B**  
**5/20/96**  
**Inlet**

The infrared images shown below document the flow test performed on the 1P42-B0001B heat exchanger. This view is of the heat exchanger inlet. The entire test was run with the inlet 3-way temperature control valve in the **full bypass** position.

The image labeled T= -12 min was taken with P42 isolated, and P45 had been running for approximately 1 hour to cool the static water contained in the shell. The P42 Pump was started at T= 0 min. The other thermal image was taken 7 minutes after the start of the P42 pump.

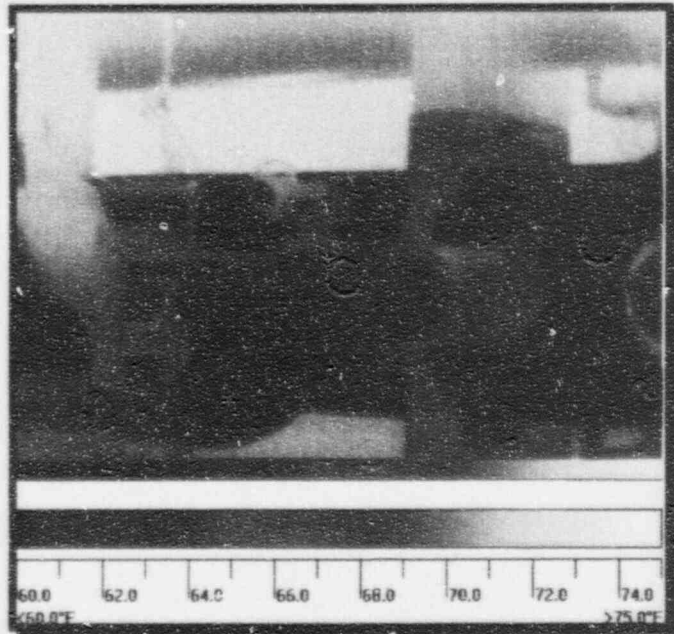
Time = - 9 min.

Heat Exchanger  
1P42-B0001B  
5/20/96  
Outlet

The infrared images shown below document the flow test performed on the 1P42-B0001B heat exchanger. This view is of the heat exchanger outlet. The entire test was run with the inlet 3-way temperature control valve in the full bypass position.

The image labeled T= -9 min was taken with P42 isolated, and P45 had been running for approximately 1 hour to cool the static water contained in the shell. The P42 Pump was started at T= 0 min. The other two thermal images were taken 1 minute and 5 minutes after the start of the P42 pump.
