U.S. NUCLEAR REGULATORY COMMISSION
REGION I

Report No.: 50-213/96-80

Facility: Haddam Neck Station

Haddam Neck Station
NRC Inspection Report No. 50-213/96-08

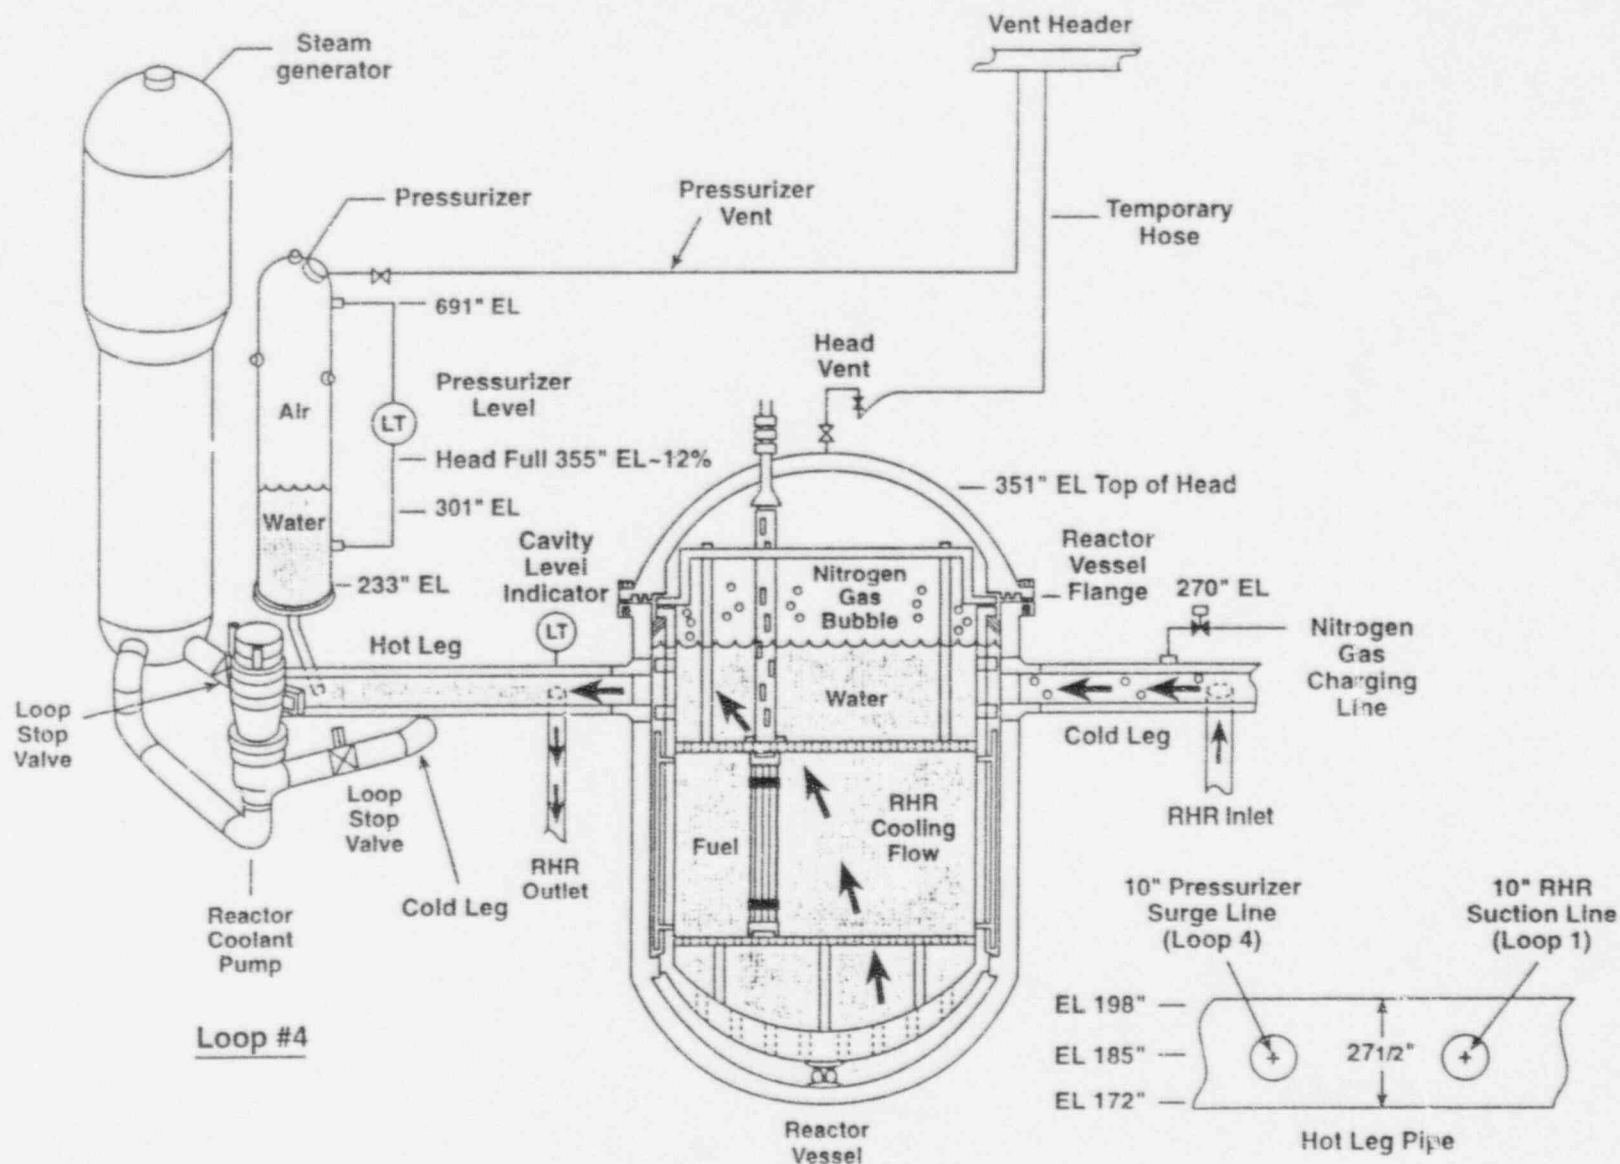
FIGURE 1

**The Undetected Nitrogen Gas
Introduction into the
Reactor Vessel from the Charging Line**

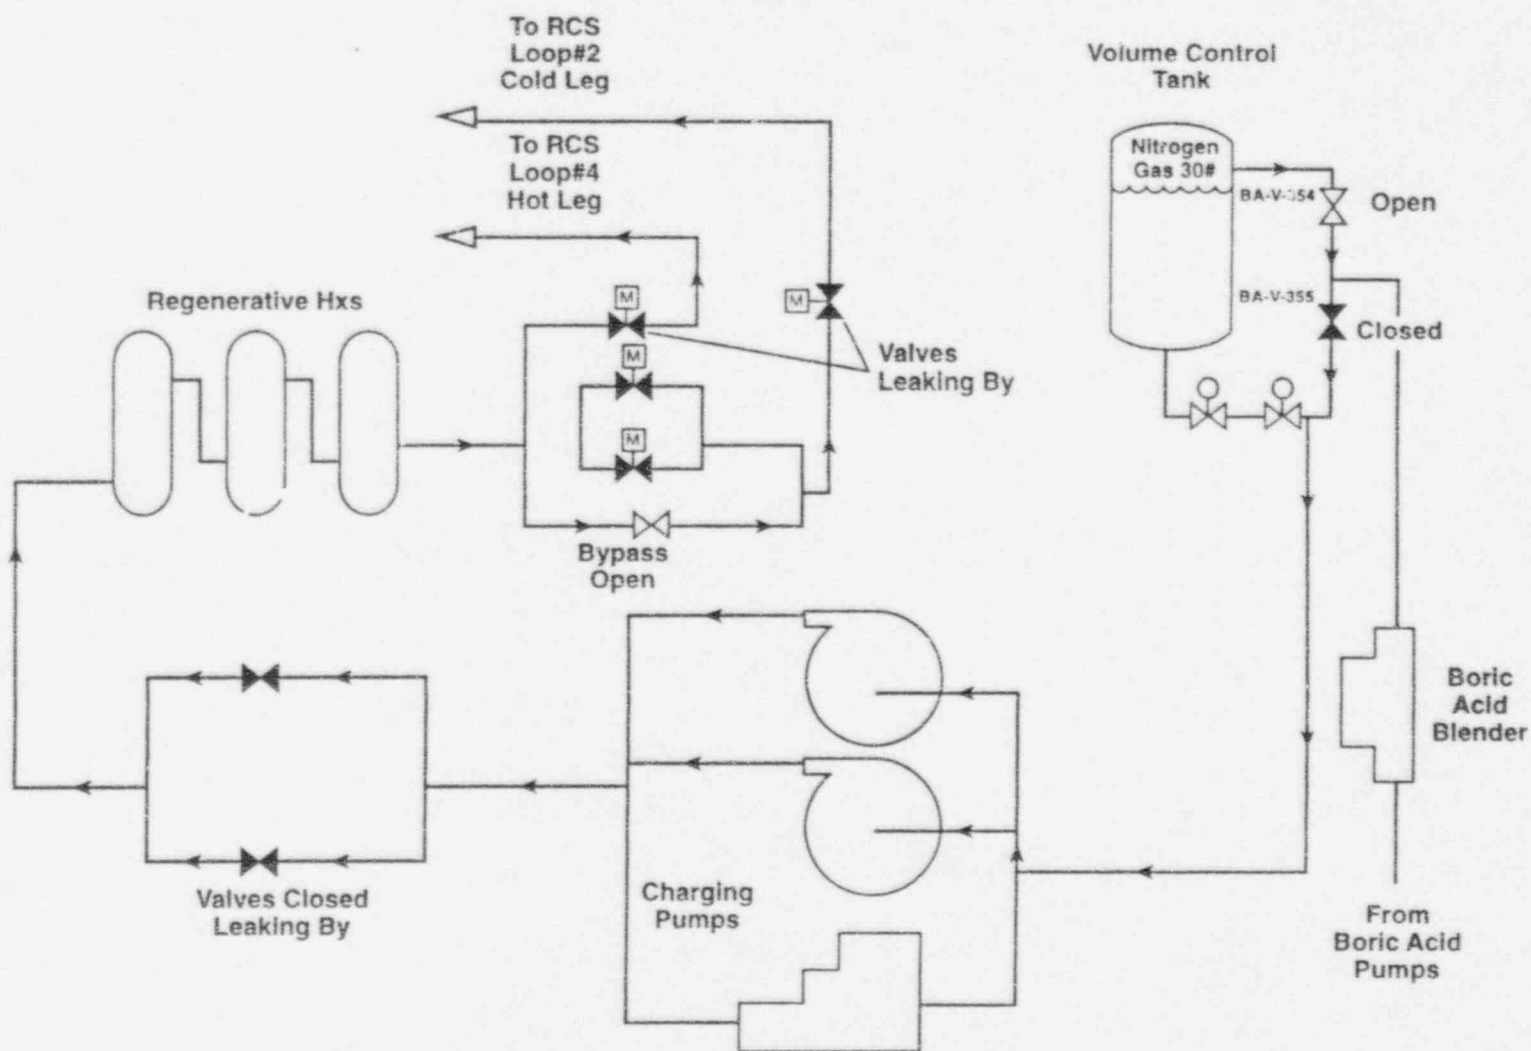
FIGURE 2

On August 28, 1996, nitrogen gas from the VCT began to enter the reactor vessel (See Figure 2 of this report). A Nuclear Systems Operator (NSO) was in the process of realigning certain CVCS valves to establish a new boric acid flow path. During this evolution, the NSO inadvertently opened the wrong manual valve (BA-V-355). This error caused water and nitrogen gas from the CVCS system to enter the RCS. Control room operators noticed an increase in RCS level and promptly instructed the NSO to reclose the valve. Closing the valve should have stopped the nitrogen gas from entering the RCS; however, the valve failed to fully close and nitrogen gas continued to leak into the RCS. Nitrogen gas continued to flow through the idle charging pumps and several leaking valves into the reactor vessel. The nitrogen gas accumulated in the top of the reactor vessel head. The rate of addition of nitrogen gas exceeded the removal capacity of the vent header system. Therefore, a nitrogen gas bubble began to grow in the top of the reactor vessel. The water displaced by the gas bubble was forced out of the reactor vessel and into the pressurizer. The transfer of water inventory from the reactor vessel to the pressurizer resulted in a decrease in reactor vessel level.

NITROGEN GAS LEAK PATH FROM VOLUME CONTROL TANK TO THE RCS

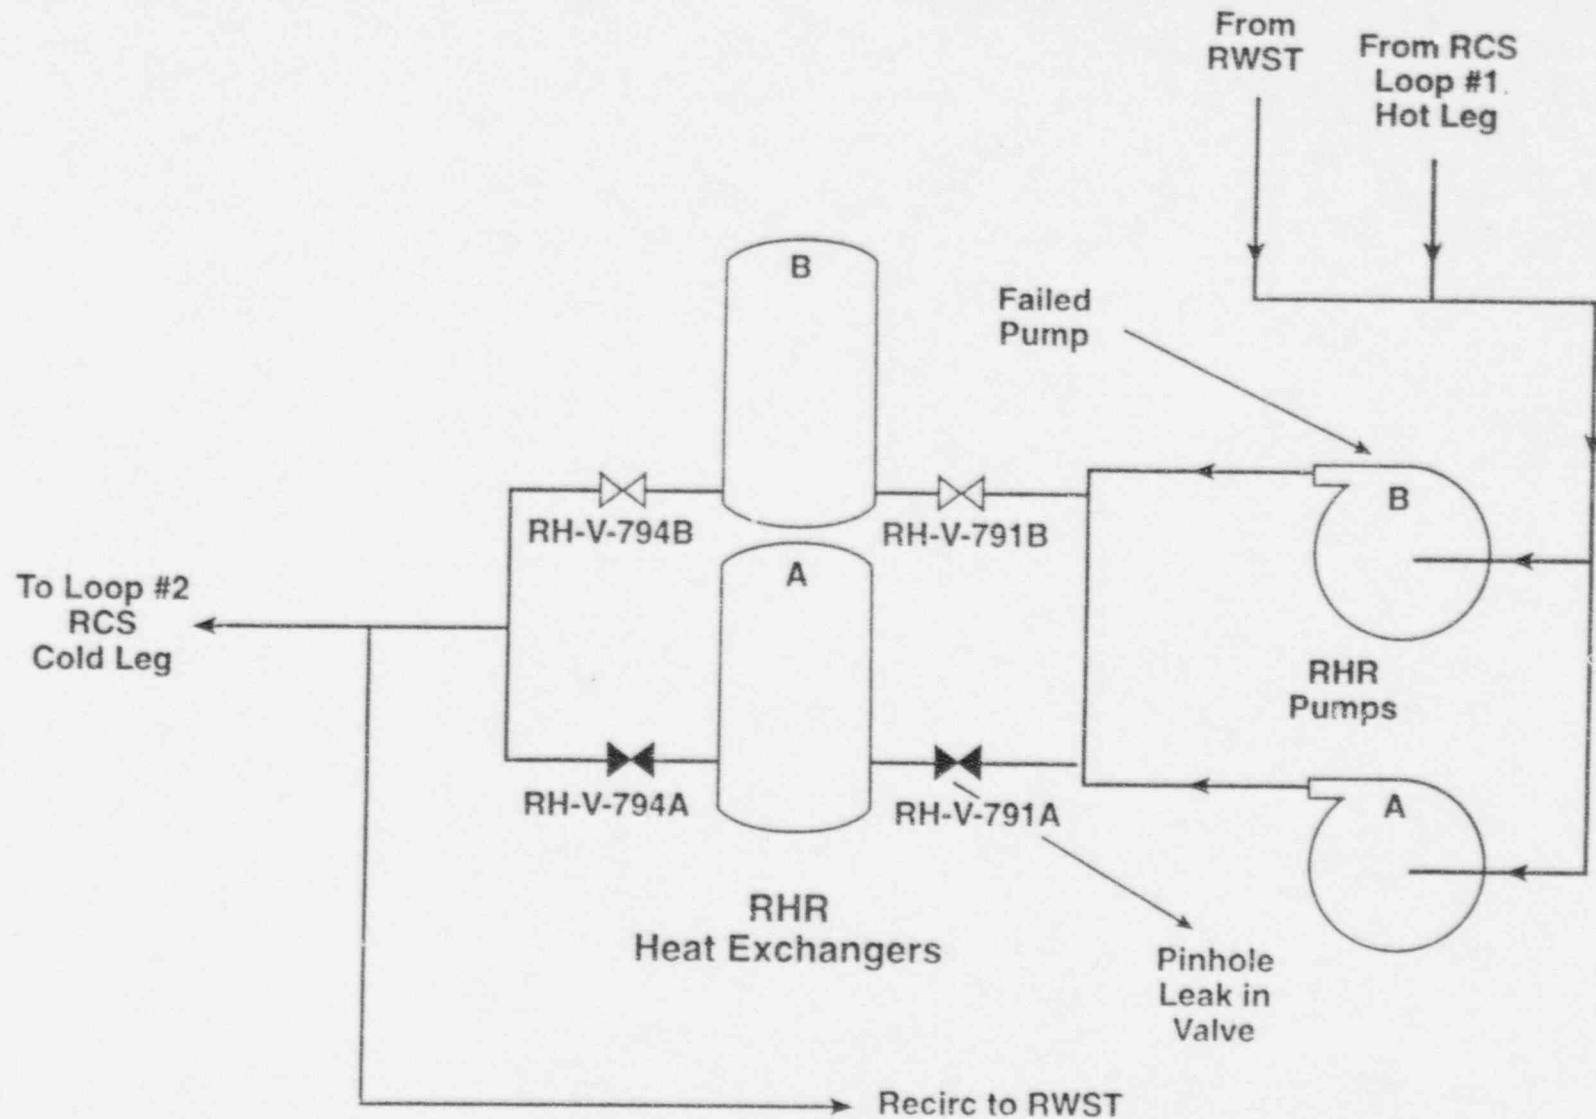
FIGURE 3

The RHR system is used to remove decay heat from the fuel when the reactor is shutdown. The system is designed such that a single failure, of certain components, will not prevent the system from performing its decay heat removal function. At the same time there was a nitrogen gas bubble in the reactor vessel, one redundant RHR pump and heat exchanger were not available for service (See Figure 3 of this report).

Residual Heat Removal System (RHR)
