**RADIOLOGIC AND ENGINEERING ASSESSMENT**

DOE ID NO.: GJ-04257-RS  
ADDRESS: 2312 MESA AVENUE

JULY 1985

URANIUM MILL TAILINGS REMEDIAL ACTION PROJECT OFFICE

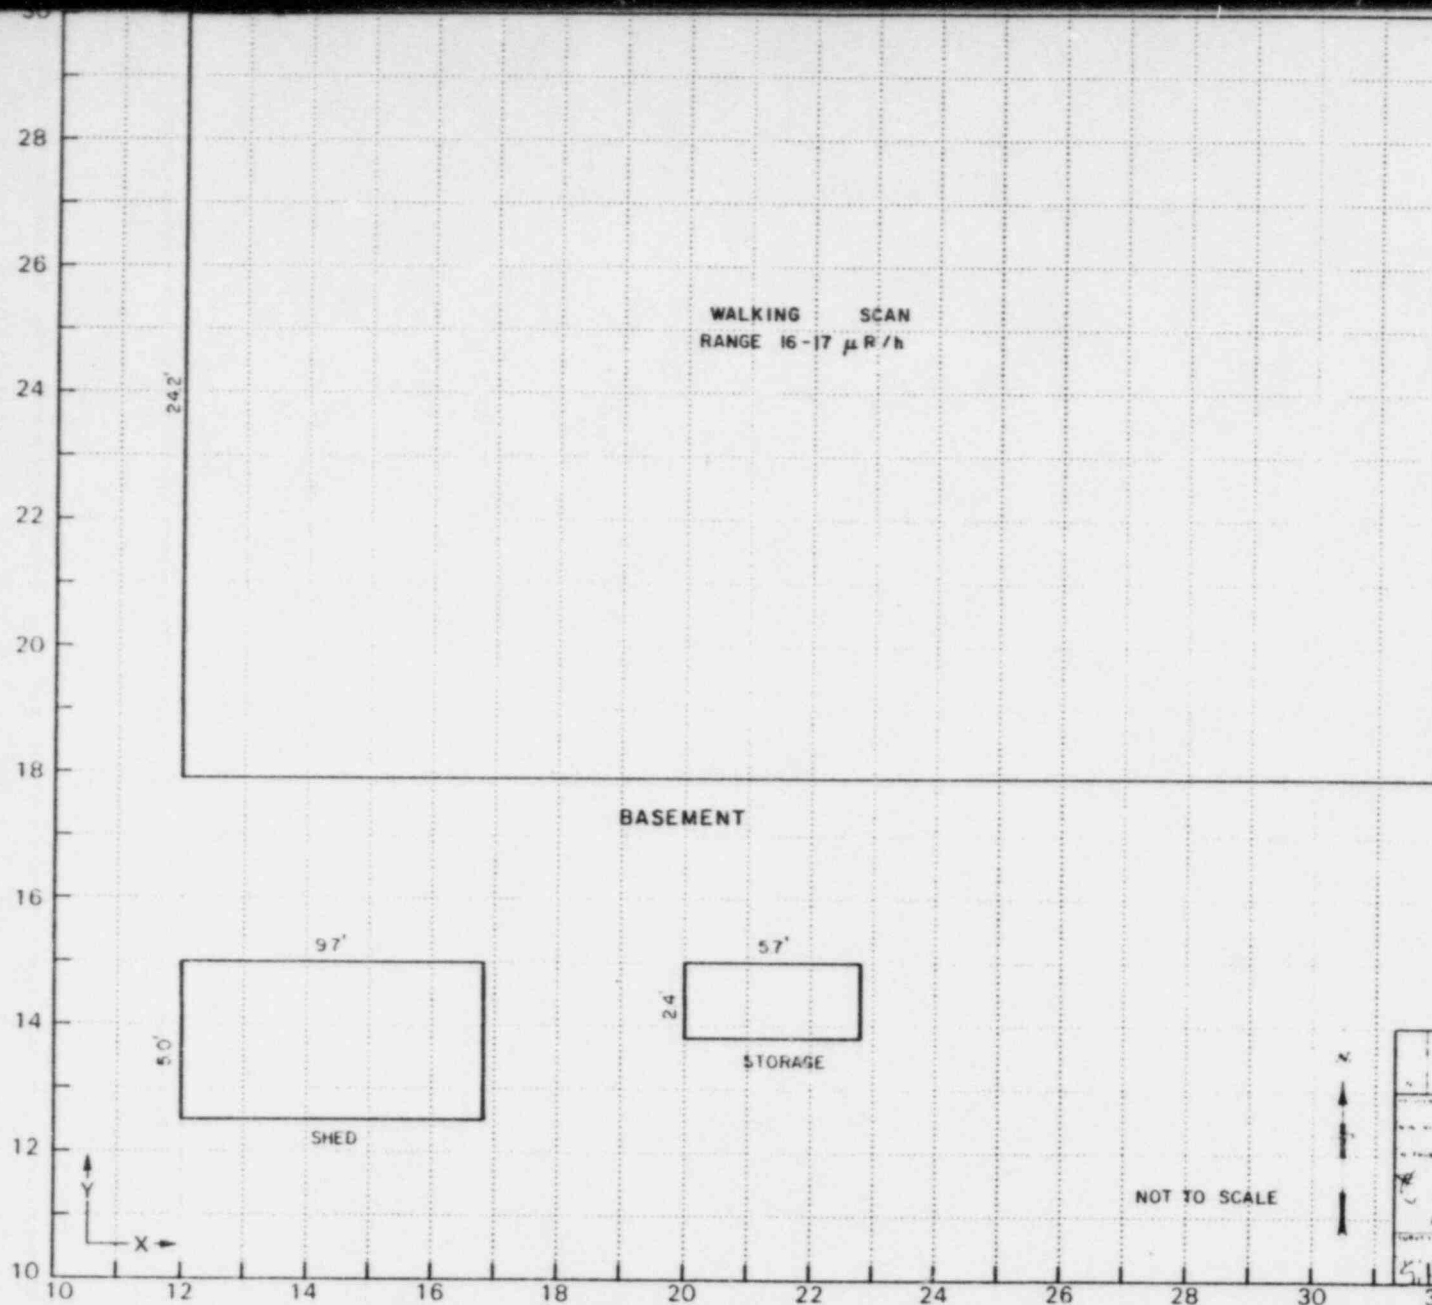
FIGURE 3.3a - BASEMENT

The interior radium-concentration measurement is presented in Appendix Table 3.2. Interior gamma exposure-rate measurements are summarized in Appendix Table 3.3. Appendix Figures 3.3a and 3.3b show interior exposure rates and locations of these measurements.

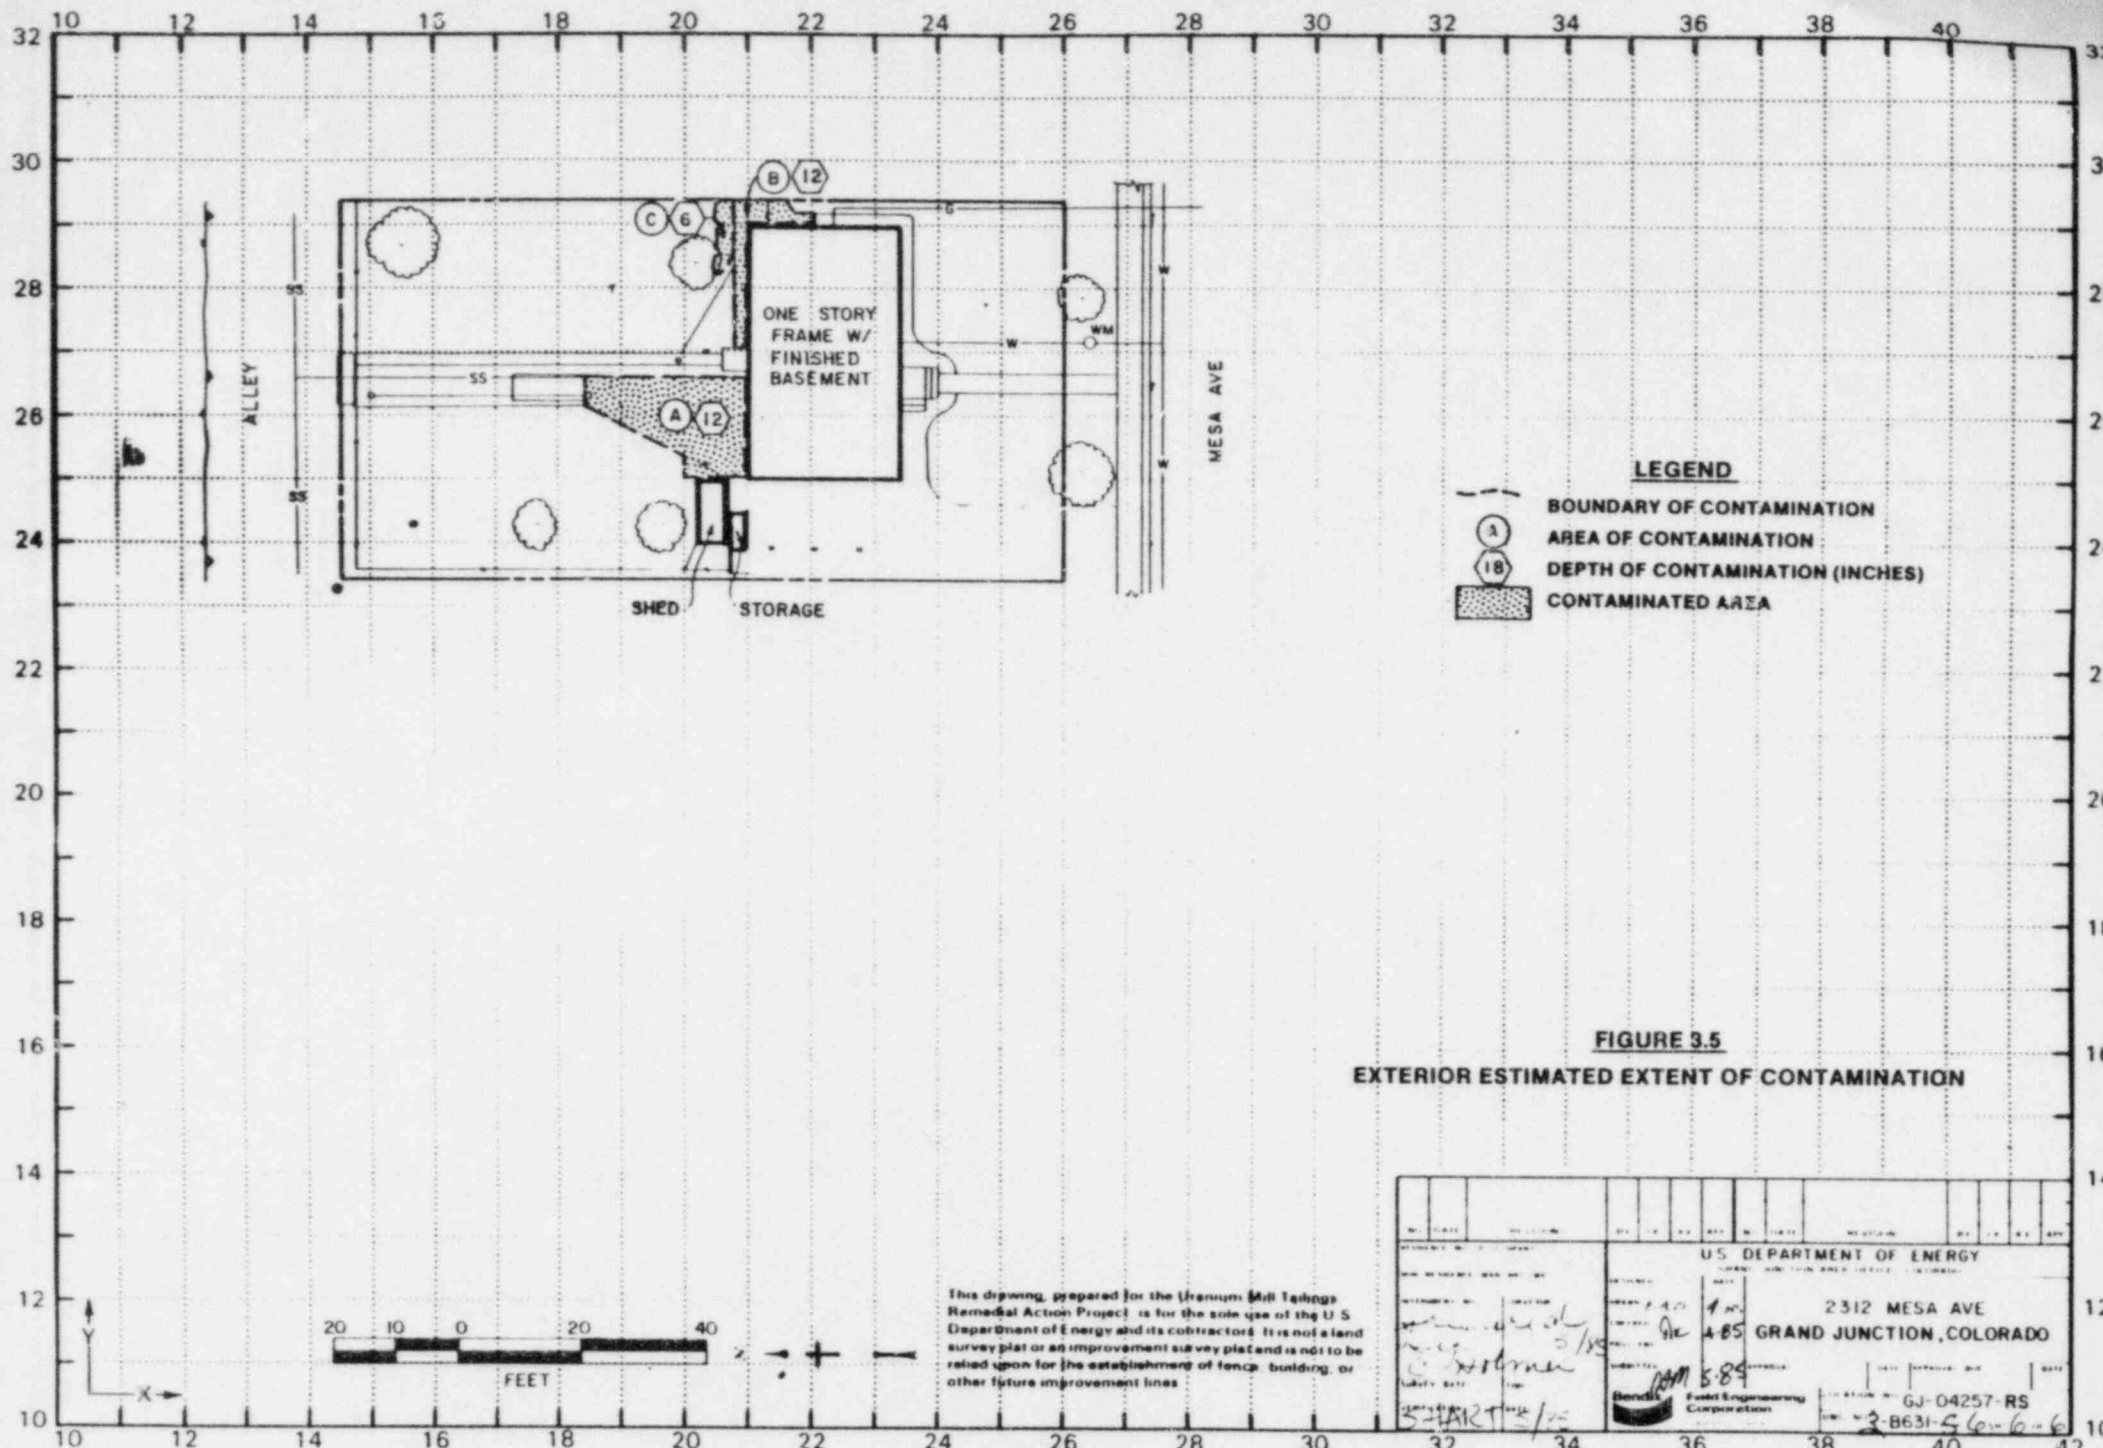
**FIGURE 3.5**  
**EXTERIOR ESTIMATED EXTENT OF CONTAMINATION**

Appendix Figure 3.5 shows identified areas and estimated depths of contamination on this property, based on assessments of all measurements taken. As noted in this figure, areas recommended for remedial action that contain identified residual radioactive materials are:

- (AREA A) Contamination extends 9 inches under the contaminated 3-inch-thick concrete patio slab. The total depth of contamination is 12 inches (approximately 252 sf).
- (AREA B) The contaminated 4-inch-thick sidewalk, at the north and east sides of the primary structure, is underlain with contaminated soil to a depth of 8 inches. The total depth of contamination is 12 inches (approximately 82 sf).
- (AREA C) Lawn directly north of primary structure is contaminated to a depth of 6 inches (approximately 33 sf).

The triangular shaped flagstone and mortar portion of the patio, directly east of Area A, may have contamination beneath it's east corner. During the excavation of Area B additional investigation may be required to accurately assess this area.

The recommended remedial action for this property, DOE ID No. GJ-04257-RS, includes removal of all areas identified as containing radioactive material (as discussed in Section 3.5 and shown in Appendix Figure 3.5) and transport of removed material to the disposal site.
