U.S. NUCLEAR REGULATORY COMMISSION
REGION IV

Report No.: 40-8943/96-02

Licensee: Crow Butte Resources, Inc.

Facility: Crow Butte Project

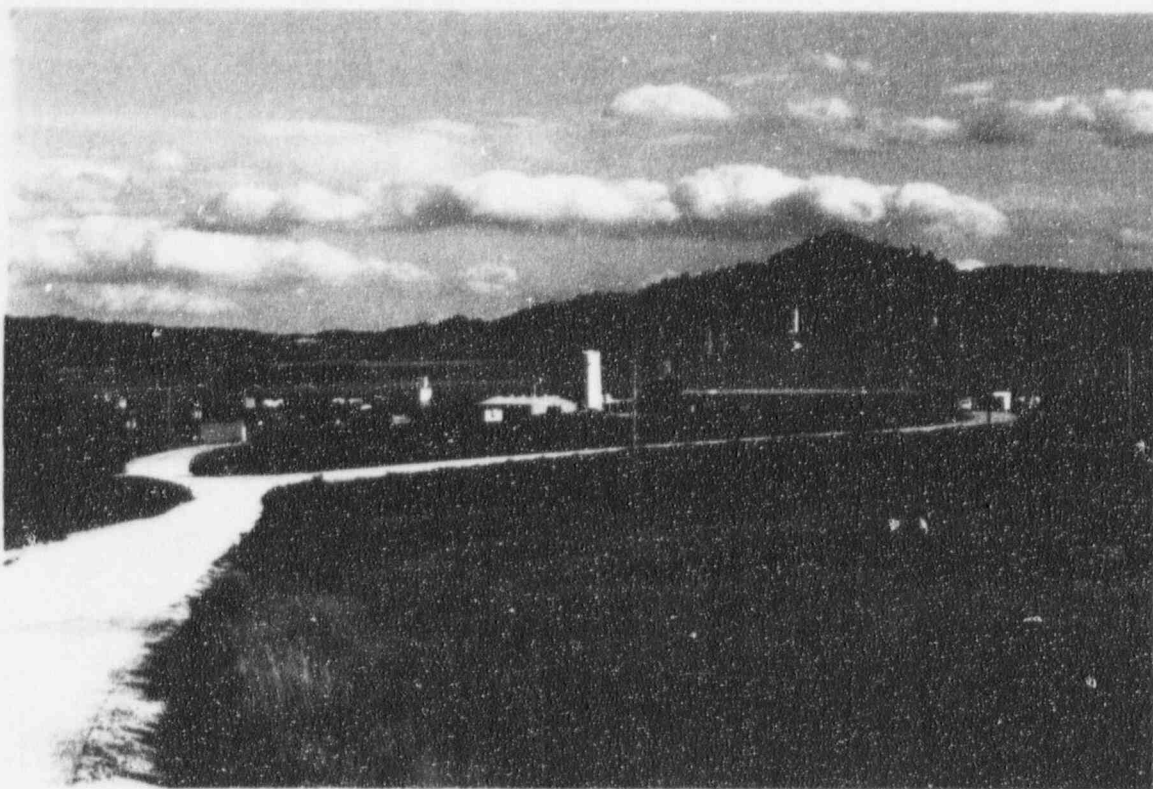
Photograph 1 - The Crow Butte Project with a wellfield in the foreground.

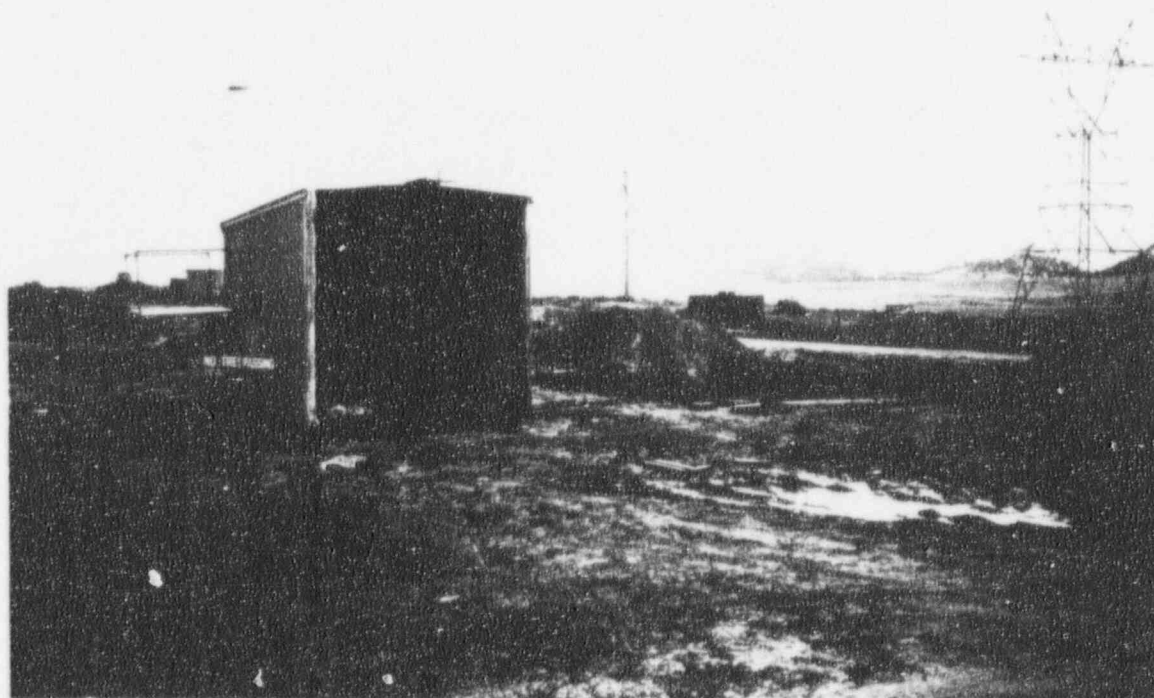
Photograph 2 - A wellfield house under construction in Mine Unit 5.

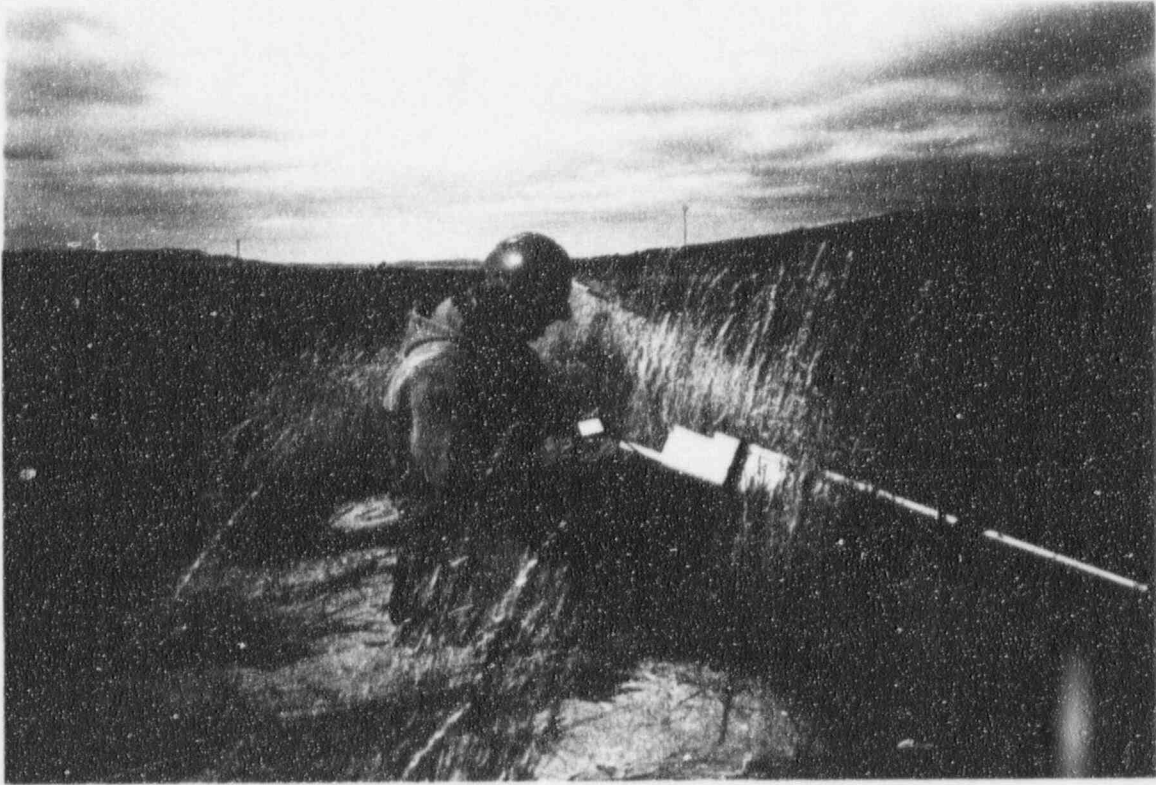
The specific conductivity of the water in the pond was typically ten times the conductivity of the water in the standpipe; high conductivity in the standpipe was indicative of a pond leak. During the inspection, the standpipes' fluid and the pond water were analyzed. The standpipe fluid sample results did not exceed 50 percent of the respective pond waters' specific conductivity indicating that the pond was not leaking a detectable amount of fluid into the ground. The licensee maintained records of the results of these routine samples.

Photograph 3 - Utility person checking pond standpipe fluid conductivity level.

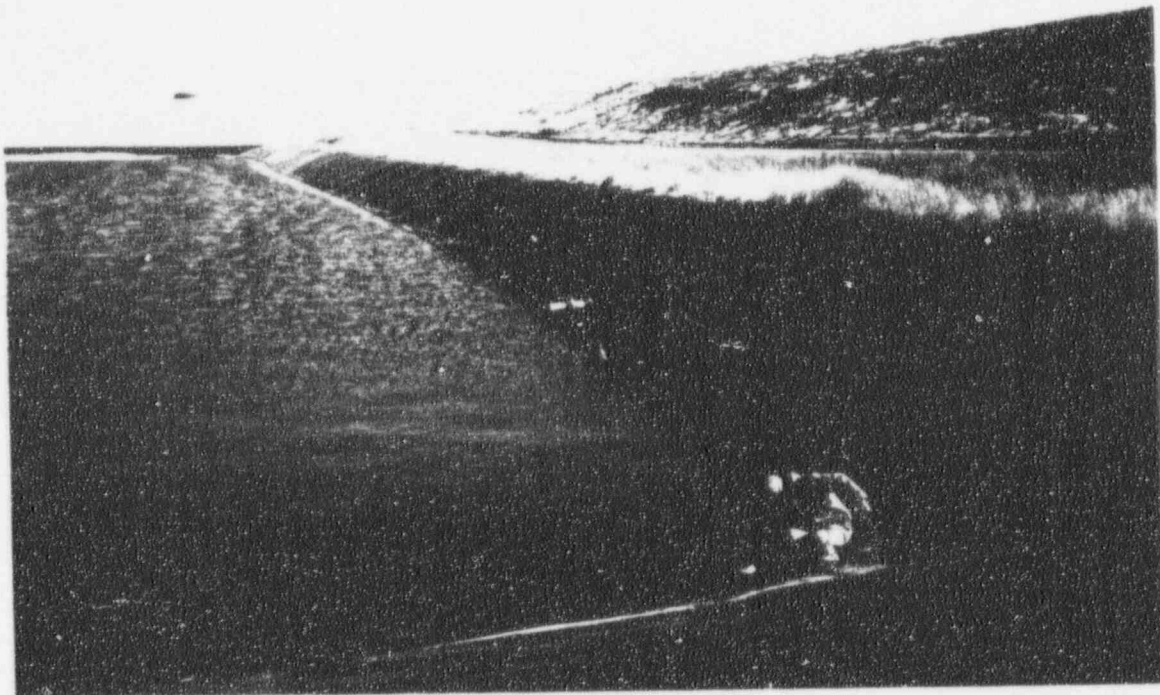
Photograph 4 - Utility person obtaining a pond sample.

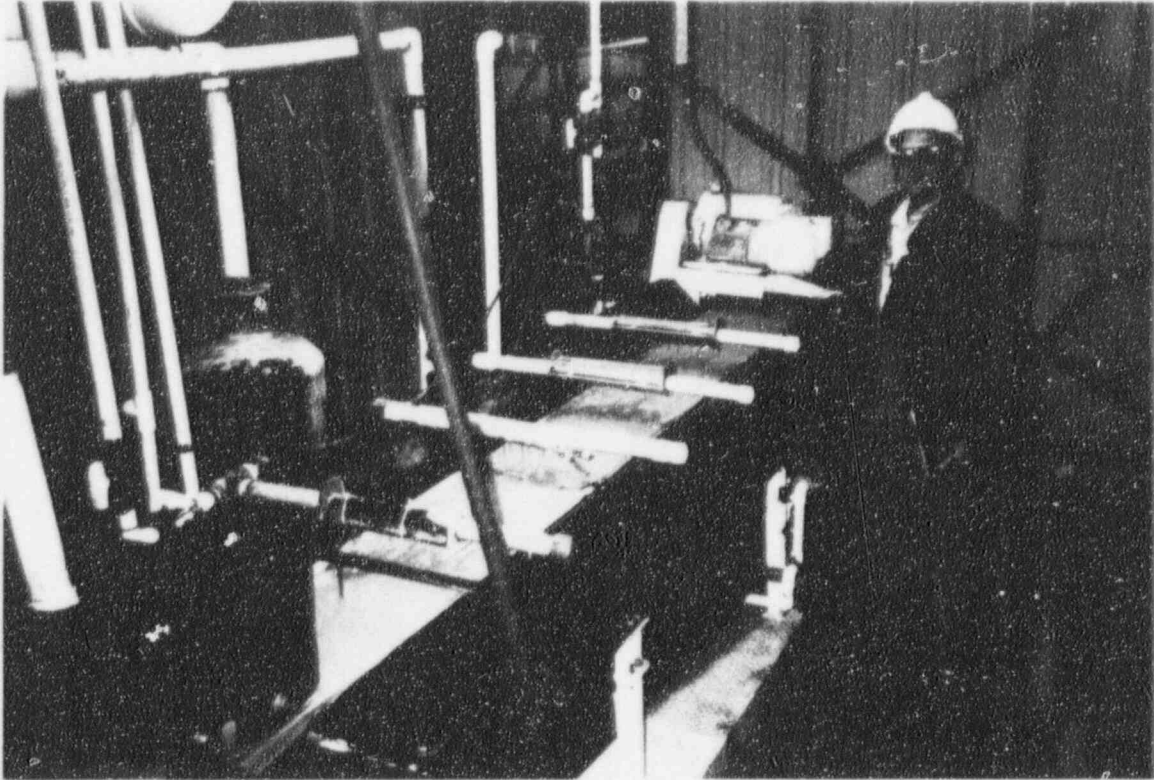
Photograph 5 -NRC inspector adjacent to the belt filter, the location where the uranium product was washed prior to drying.

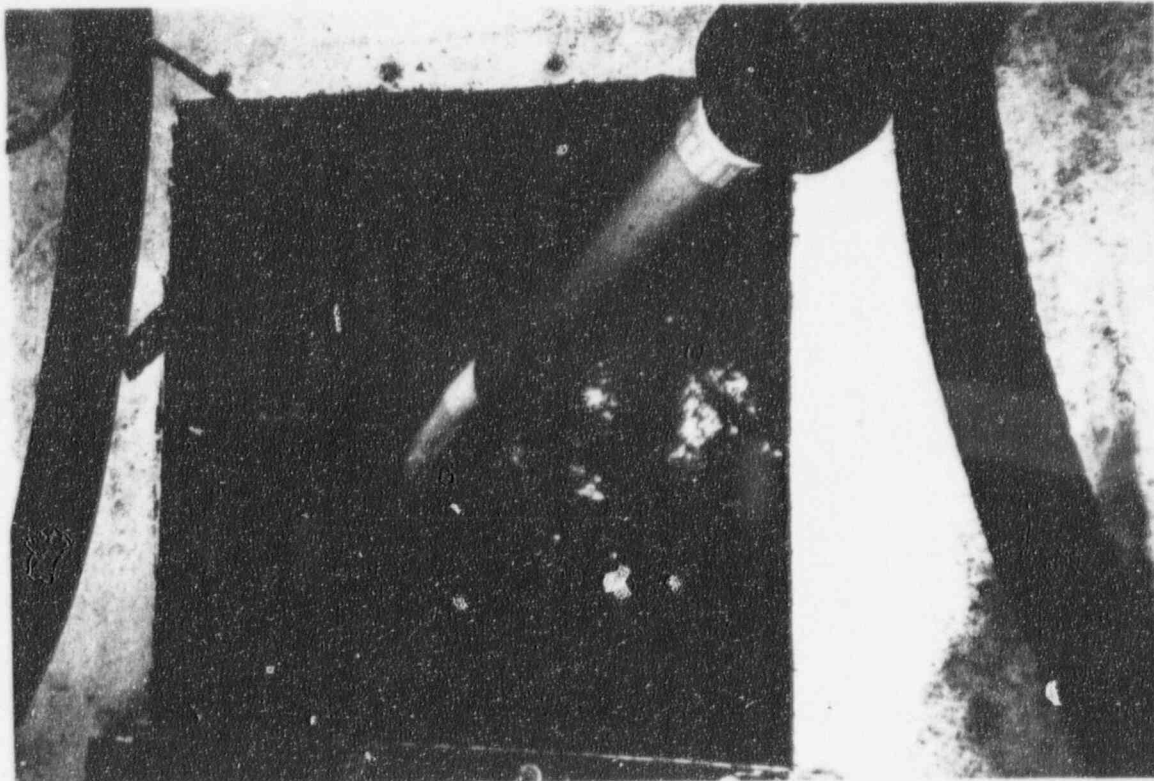
Photograph 6 - Recirculation of contents in the uranium slurry storage tank just prior to transfer to the vacuum dryer.
