RADIOLOGIC AND ENGINEERING ASSESSMENT

DOE ID NO.: GJ-11411-RS
ADDRESS: 524 COMPTON AVENUE

JULY 1985

BENDIX FIELD ENGINEERING CORPORATION
P.O. Box 1569
Grand Junction, Colorado 81502

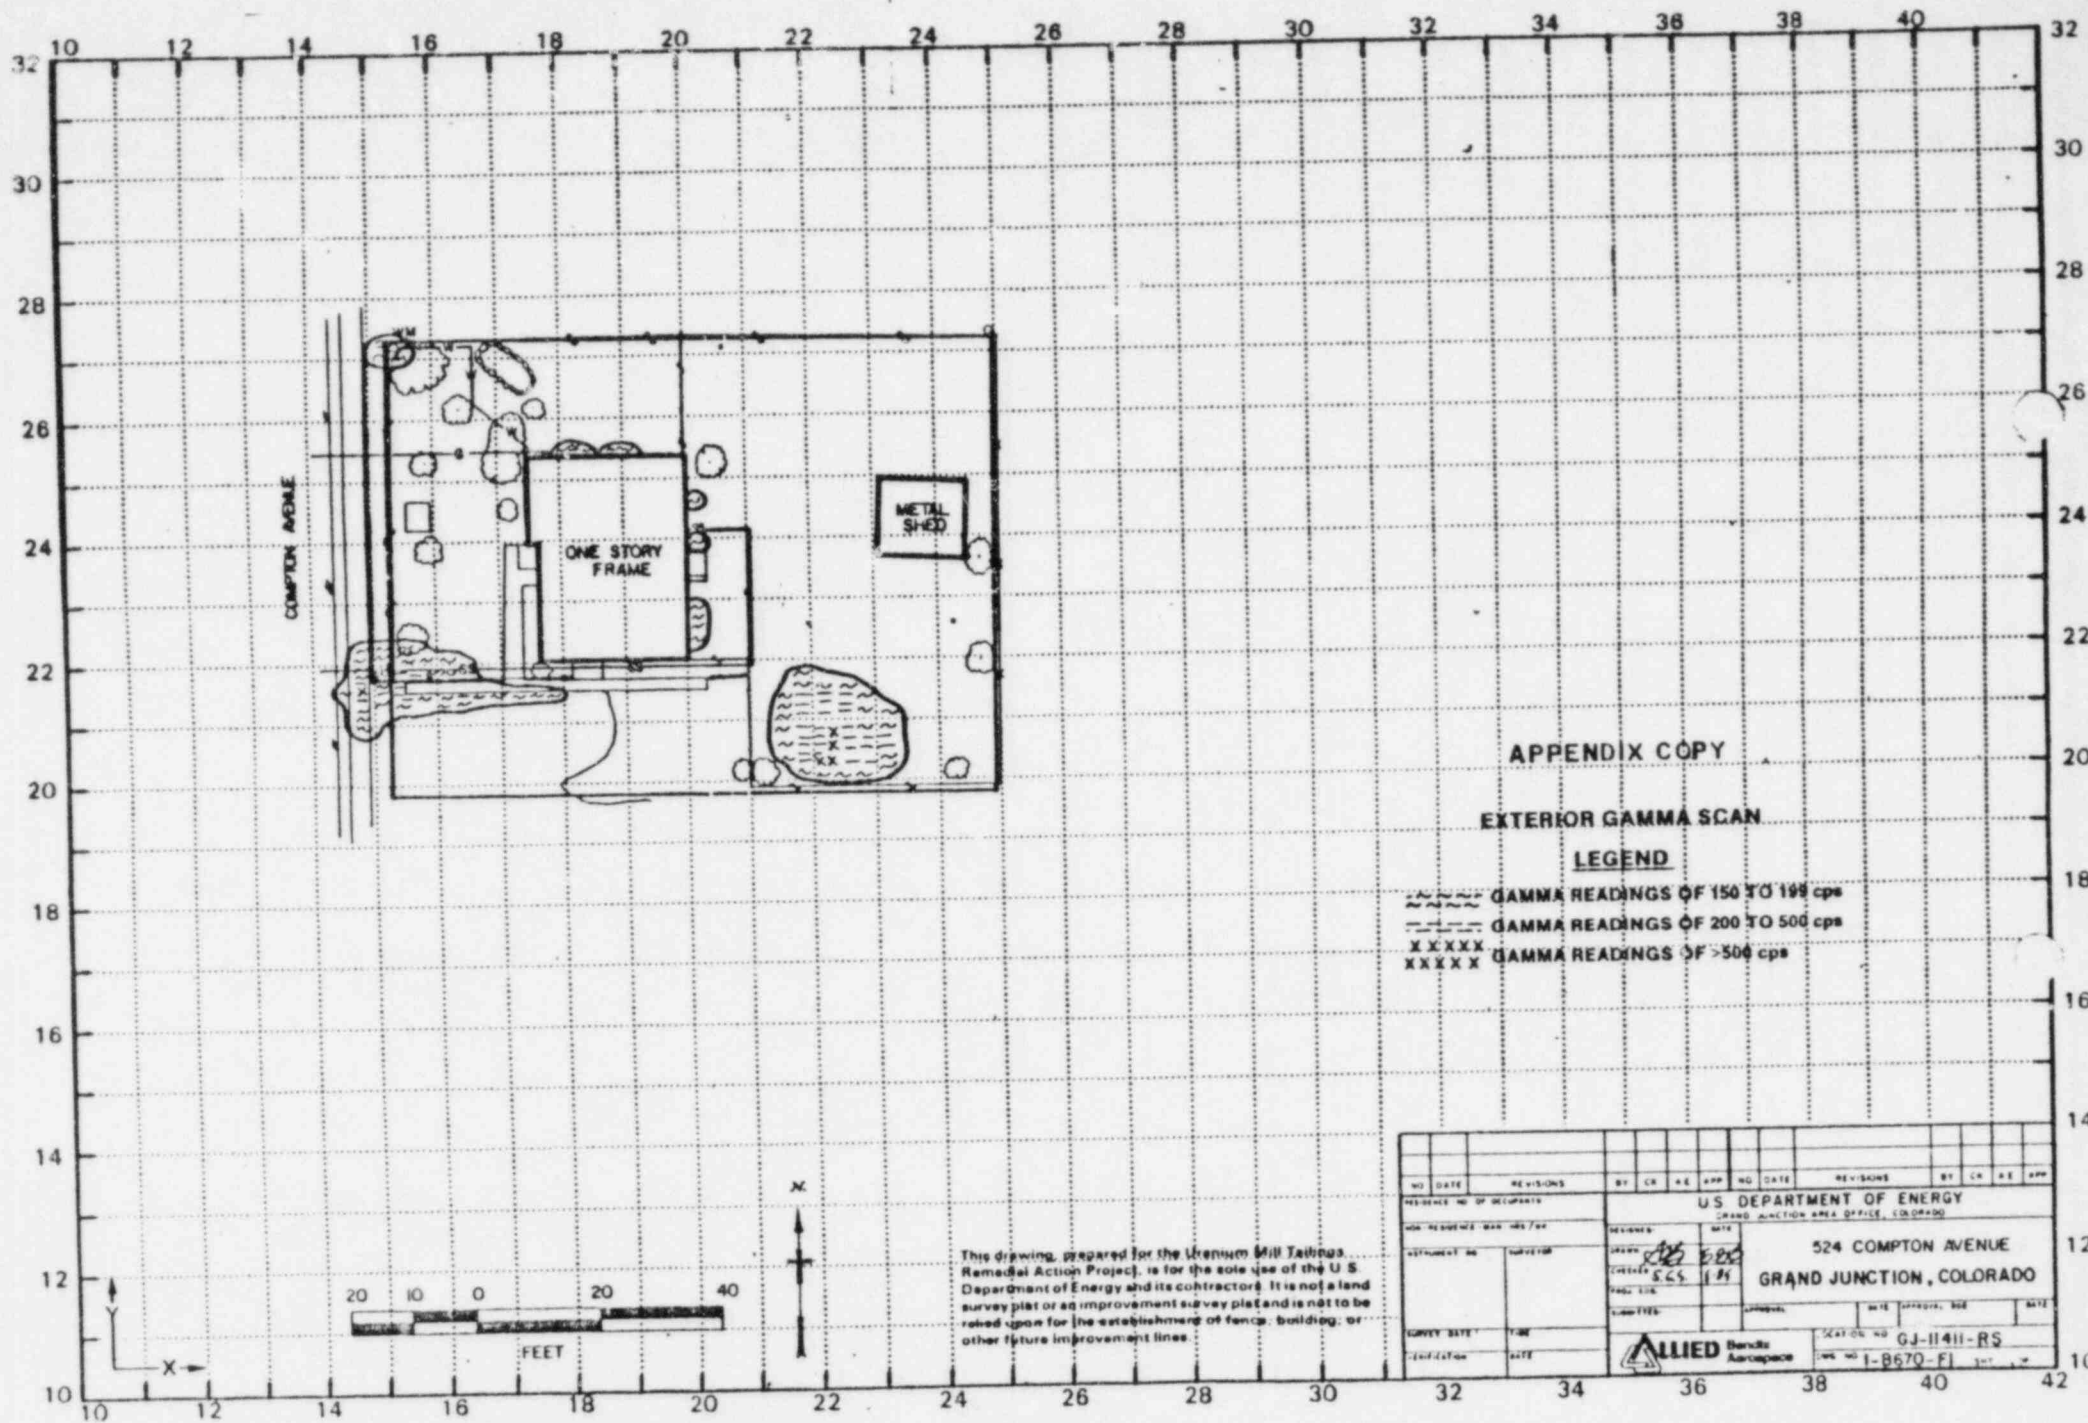
EXTERIOR GAMMA SCAN

1. The elevated total count readings in Borehole 1 are due to sloughing.
2. In the area of Location 2 (by the water meter pit), delta scintillometer readings do not provide evidence of contamination. The slightly elevated readings shown on the gamma scan map derive from rocks and bricks located near the water pit.
3. The depth of contamination at Location 4 is given as 12 inches because the area is contiguous to that of Location 1, and the subsurface base of the deposit is interpreted as grading from 12 inches (Location 1) to 6 inches (Location 2).

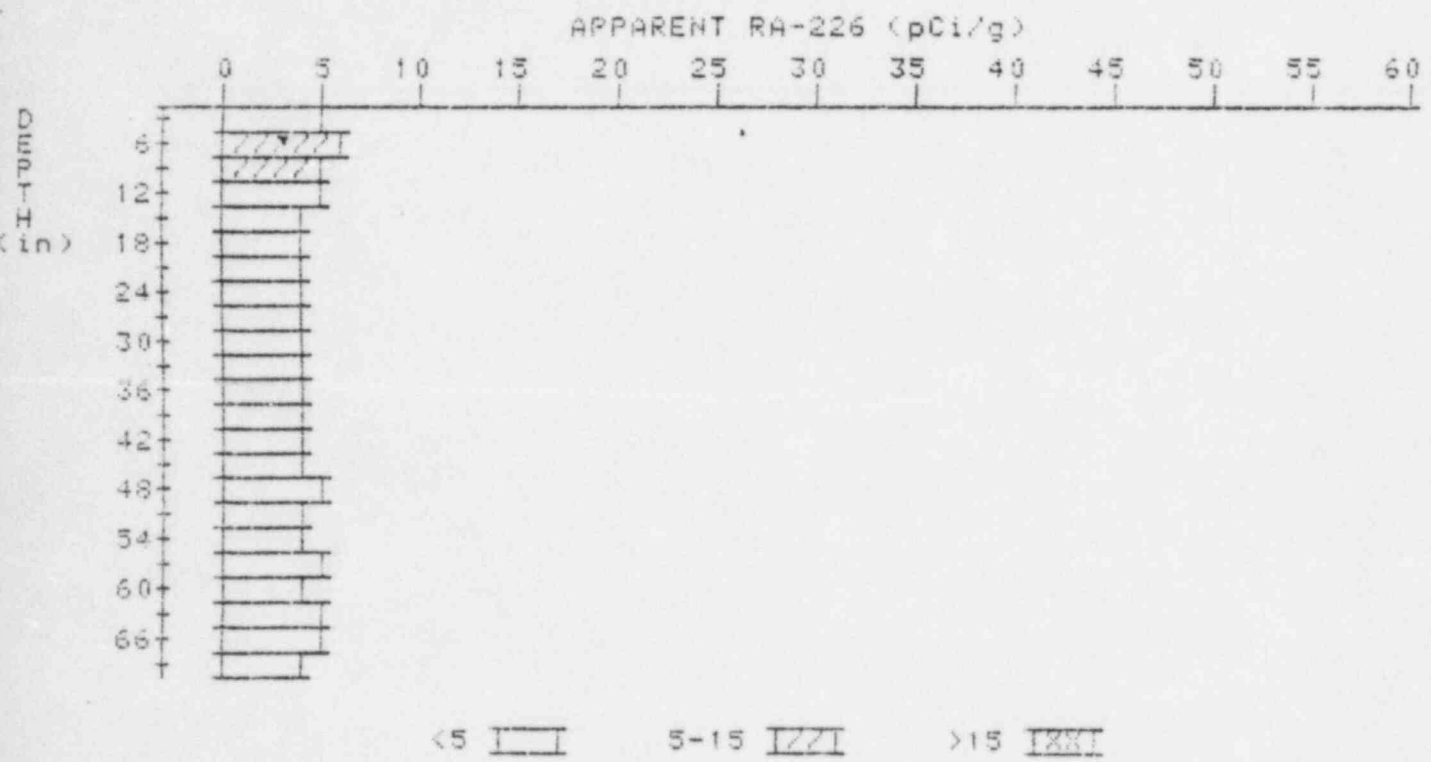
APPARENT RADIUM-226 CONCENTRATION DECONVOLUTION GRAPH 6

15	TC	4.4		*	
		18	TC	4.2		*	DC = 6 inches Based on the deconvolution graph
		21	TC	4.2		*	
		24	TC	4.1		*	
		27	TC	4.1		*

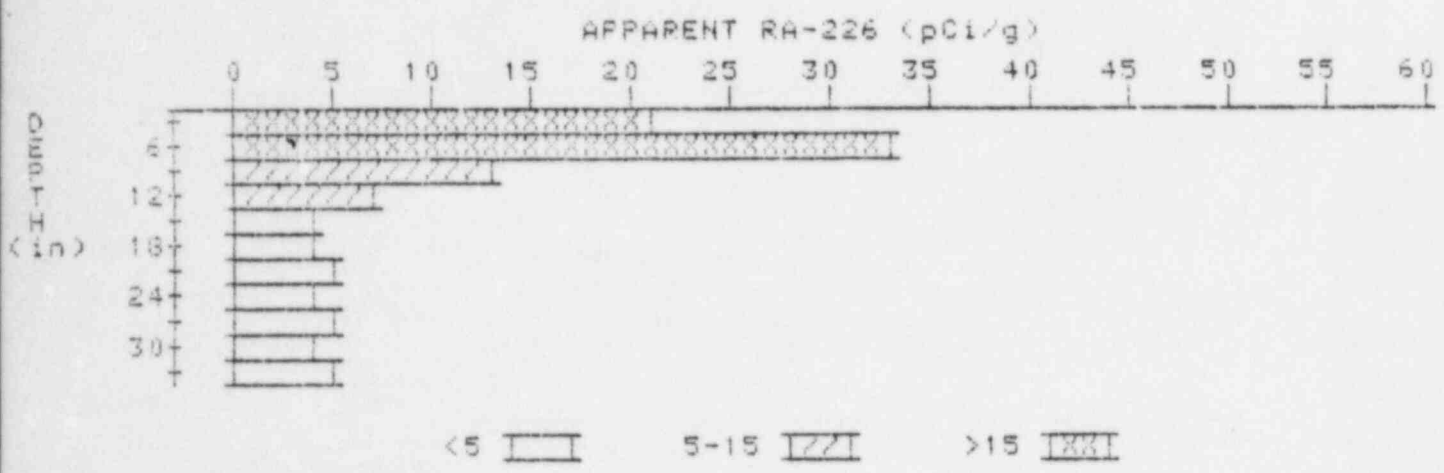
APPARENT RADIUM-226 CONCENTRATION 13

Loc #	Grid Location	Depth (in.)	Meas. Type	In Situ Ra-226 (pCi/g)		Chem Ra-226 (pCi/g)	Comments
				Tot. Ct	Spectr.		
11	201243	45	TC	4.0		*	
		48	TC	4.0		*	
		51	TC	4.1		*	
		54	TC	4.1		*	
		57	TC	4.0		*	
		60	TC	4.0		*	
		63	TC	4.1		*	
		66	TC	3.9		*	
12	220216	00	DS	1.7		*	Southeast backyard
		06	DS	1.5		*	
13	223203	03	TC	21.4		*	South side of backyard
		06	BH	21.6	20.7	*	
		09	TC	15.3		*	
		12	BH	10.2	7.5	*	DC = 15 inches Based on all available data
		15	TC	7.0		*	
		18	BH	5.5	3.7	*	
		21	TC	5.0		*	
		24	BH	4.7	1.8	*	
		27	TC	4.6		*	
		30	TC	4.5		*	
		33	TC	4.5		*	
14	223207	00	DS	28.5		*	Southeast backyard
		06	DS	6.8		*	
		12	DS	3.3		*	
15	240251	00	DS	1.1		*	Background hole, located on north side of shed
		03	TC	3.0		*	
		06	BH	3.6	1.3	*	
		09	TC	3.9		*	
		12	BH	4.0	1.4	*	
		15	TC	4.1		*	DC = 0 inches
		18	BH	4.0	1.4	*	
		21	TC	4.1		*	
		24	BH	3.9	1.1	*	
		27	TC	3.8		*
