UNITED STATES OF AMERICA  
NUCLEAR REGULATORY COMMISSION

LICENSEES' ANSWER  
PROTESTING CIVIL PENALTY

COMANCHE PEAK STEAM ELECTRIC STATION  
UNITS 1 AND 2  
BROOKHAVEN INTERIM REPORT ON PROTECTIVE COATINGS  
FILE NO. 906.1, 10010

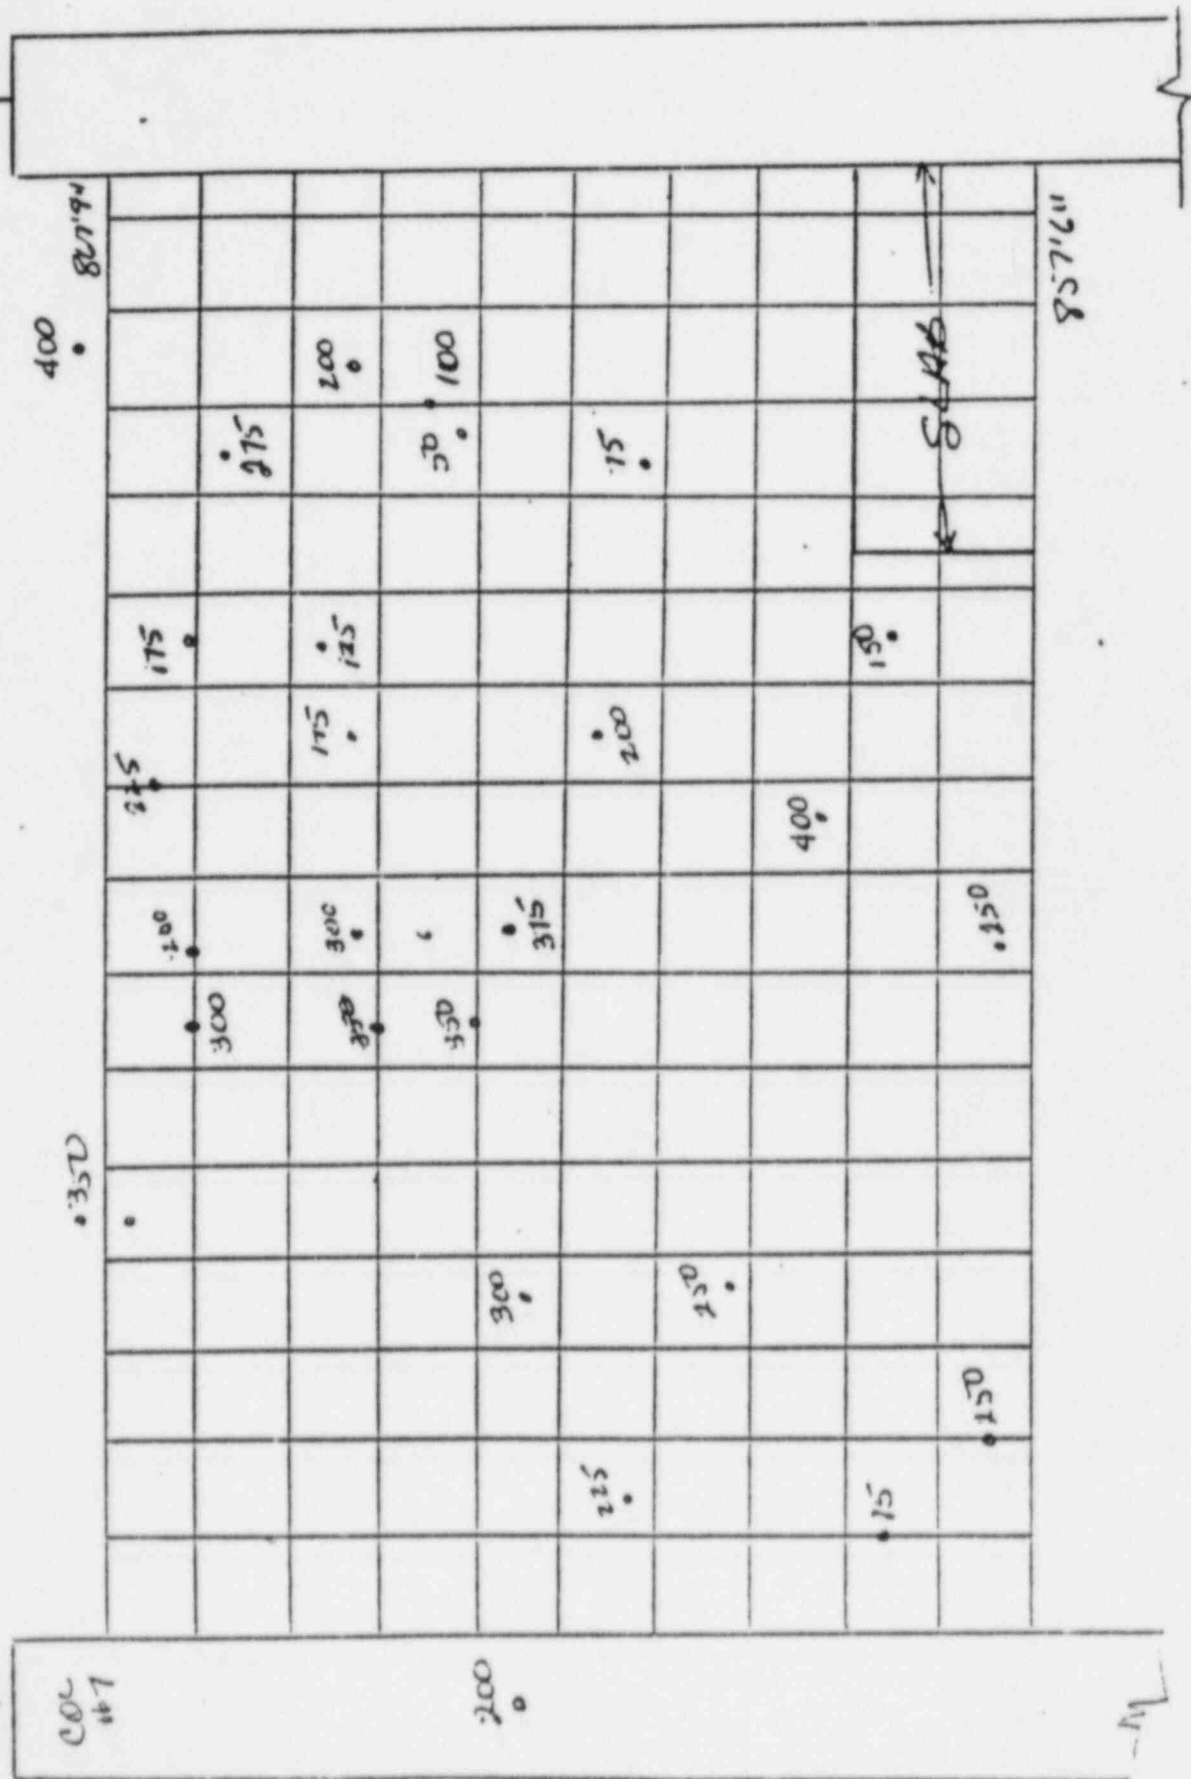
UNIT	STRUCTURE/SYSTEM	ITEM/COMPONENT	TAG/ID NUMBER	LOCATION OR ELEVATION	RIR NO
1	REACTOR CONTAINMENT BUILDING	PROTECTIVE COATINGS	N/A	AZ. 169° EL. 866'-867'	N/A
<p>NONCONFORMING CONDITION</p> <p>APPLIED COATINGS ON CONTAINMENT LINER PLATE EXHIBIT LOSS OF ADHESION PROPERTIES, THEREFORE RENDERING THE QUALITY OF THE APPLIED COATINGS INDETERMINATE. ORIGINAL CAUSE OF FAILURE APPEARS TO BE MECHANICAL DAMAGE, BUT SURROUNDING AREAS EXHIBIT TOTAL LOSS OF ADHESION PROPERTIES. (I.E. TOTAL COATING SYSTEM, PHENOLINE 305 &amp; CE-11, IS PEELING AT EDGES &amp; EXPOSING STEEL SUBSTRATE) AREA IS LOCATED DIRECTLY BEHIND COLUMN #9 @ AZ. 169° EL. 866'-867'</p>					
<p>REFERENCE DOCUMENT: <u>2323-AS-31</u> <u>QT-QP-11.4-5</u> REV <u>1</u> PARA <u>3.9</u></p>					
<p>REPORTED BY: <u>FRED DUNHAM / Fred Dunham</u></p>					<p>DATE: <u>11.9.83</u></p>
<p>QE REVIEW/APPROVAL: <u>K. M. WOLVERTON</u> <u>K. M. Wolvert</u></p>				<p>DATE: <u>11.9.83</u></p>

<p>ACTION ADDRESSEE: <u>Kiewit</u></p>				<p>DEPARTMENT: <u>Engineering</u></p>	
<p>DISPOSITION: REWORK _____ REPAIR <u>XXX</u> USE AS IS _____ SCRAP _____</p> <p>Lack of adhesion is limited to area adjacent to impact (mechanical damage). Repair per CCP-30.</p> <p style="text-align: right;"><b>FOR INFORMATION ONLY</b></p>					
<p>ENG. REVIEW/APPROVAL: <u>J. Matthews</u></p>					<p>DATE: <u>11/16/83</u></p>
<p>QE REVIEW/APPROVAL: <u>W. Kiewit</u></p>					<p>DATE: <u>11/18/83</u></p>
<p>DISPOSITION VERIFICATION &amp; CLOSURE:</p>					<p>DATE: <u>1/1</u></p>
<p>COMMENTS:</p>
