U.S. NUCLEAR REGULATORY COMMISSION
REGION III

Report: 030-05852/96-001(DNMS)

Licensee: Shell Chemical Company

Facility: G-2 Finishing Building

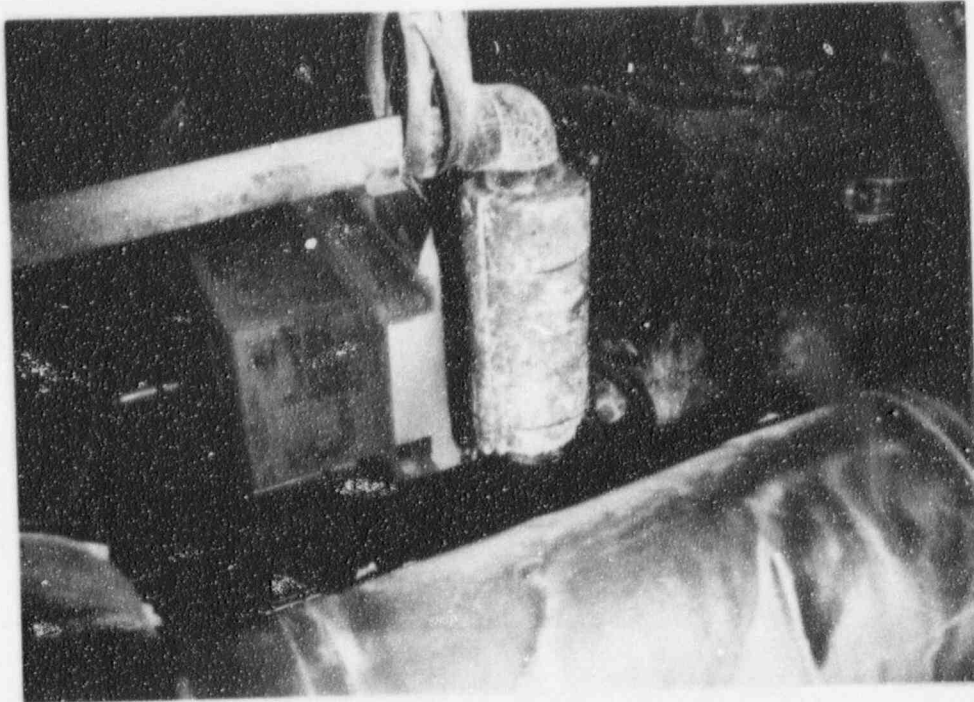
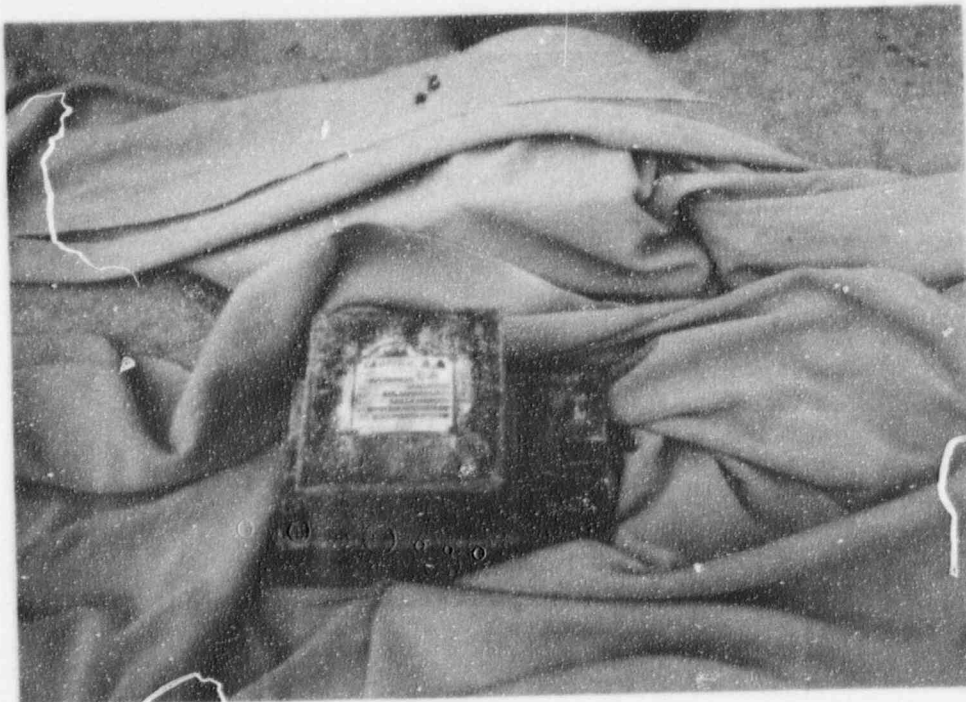
With assistance from a representative of the Ohmart Corporation (the gauge vendor), the licensee developed a gauge recovery plan and successfully implemented the plan. The shutters on the damaged gauges were found to be melted in the "open" position. Leak test results indicated no evidence of source leakage or contamination.

Two 10 millicurie (370 MBq) cesium-137 gauges involved in the fire and explosion showed extensive external heat damage, see Attachment D. According to the Ohmart representative, the radiation level profiles measured by the licensee and confirmed by the NRC indicated that the internal lead shielding may have been compromised. In addition, the shutters to the gauges were melted in the "open" position.

Shell Chemical Co., Belpre, Ohio
License No. 34-13012-01, Docket No. 030-05852
10 millicurie gauges damaged from fire and explosion -August 1996

The recovery plan was implemented and two damaged gauges were removed from the building without incident. The damaged gauges were then packaged by the Ohmart representative and transported back to Ohmart facilities for subsequent disposal.

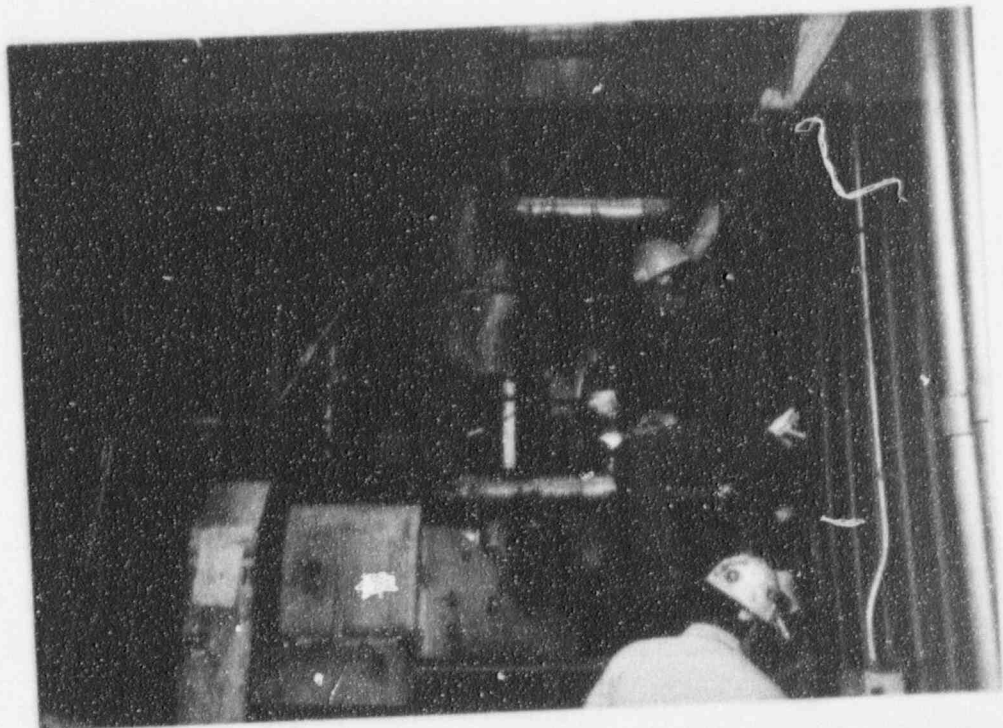
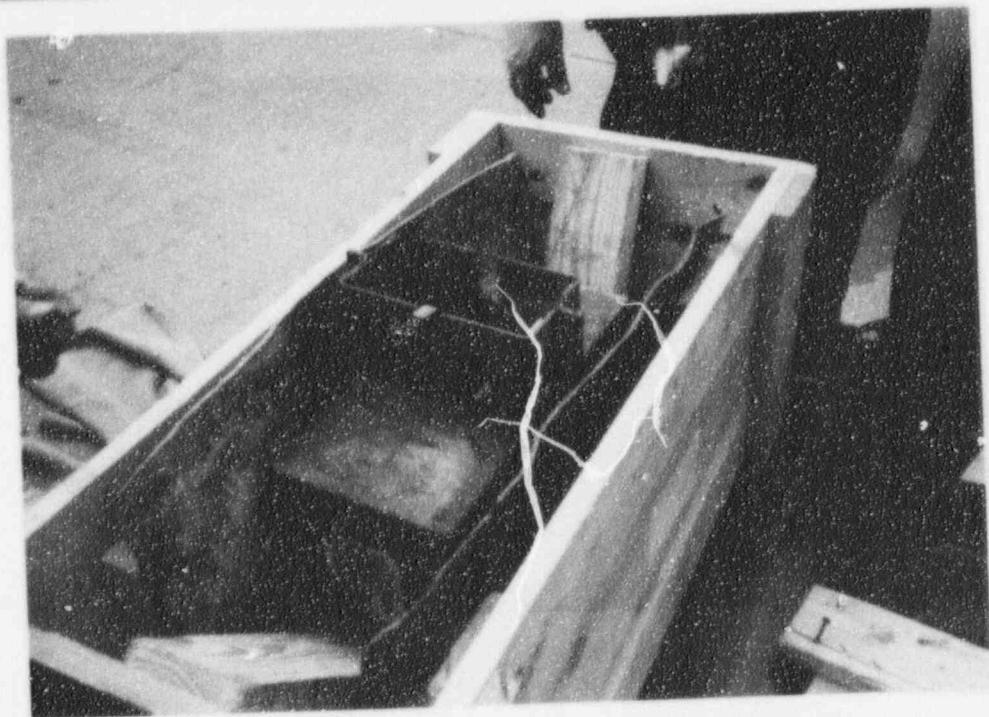
Shell Chemical Co., Belpre, Ohio
License No. 34-13012-01, Docket No. 030-05852
10 millicurie gauges damaged from fire and explosion -August 1996
