SUBJECT: INFORMATION REGARDING SAFETY/RELIEF VALVE PERFORMANCE OBTAINED
DURING SITE VISIT - BROWNS FERRY NUCLEAR PLANT UNIT 2

SAFETY/RELIEF VALVE
PRELIMINARY TEST RESULTS

AEOD TECHNICAL REVIEW REPORT

SUBJECT: TARGET ROCK TWO-STAGE SRV PERFORMANCE UPDATE

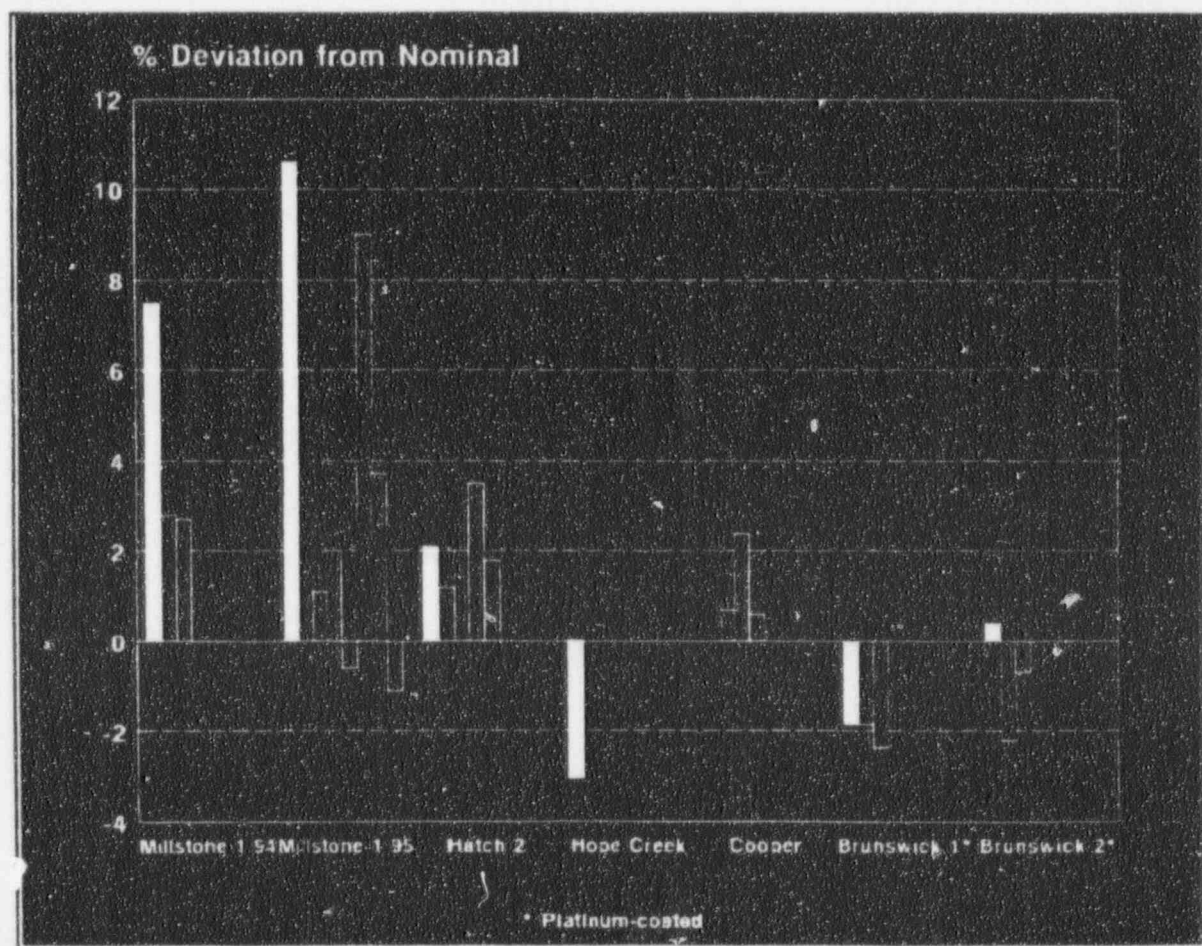
Figure 1: Setpoint Test Results for Platinum Discs

Initial platinate discs were installed at Cooper, Millstone Unit 1, and Hatch Unit 2 in 1994. Brunswick Unit 1 and Unit 2 are using a platinum-coated disc, first installed in 1993 on Unit 2 and 1994 on Unit 1. Pilgrim is using Stellite 21 for their disc material which they first used in 1984. To date, setpoint test results involving SRVs using the platinate discs have been received from Millstone, Hatch, and Cooper. Also, results from Brunswick for as-found testing of their SRVs which have the platinum coated discs have been received. Figure 1 shows the results of the setpoint testing of platinate valve at each of the plants reporting. The shading indicates valve 1, 2, 3, etc.

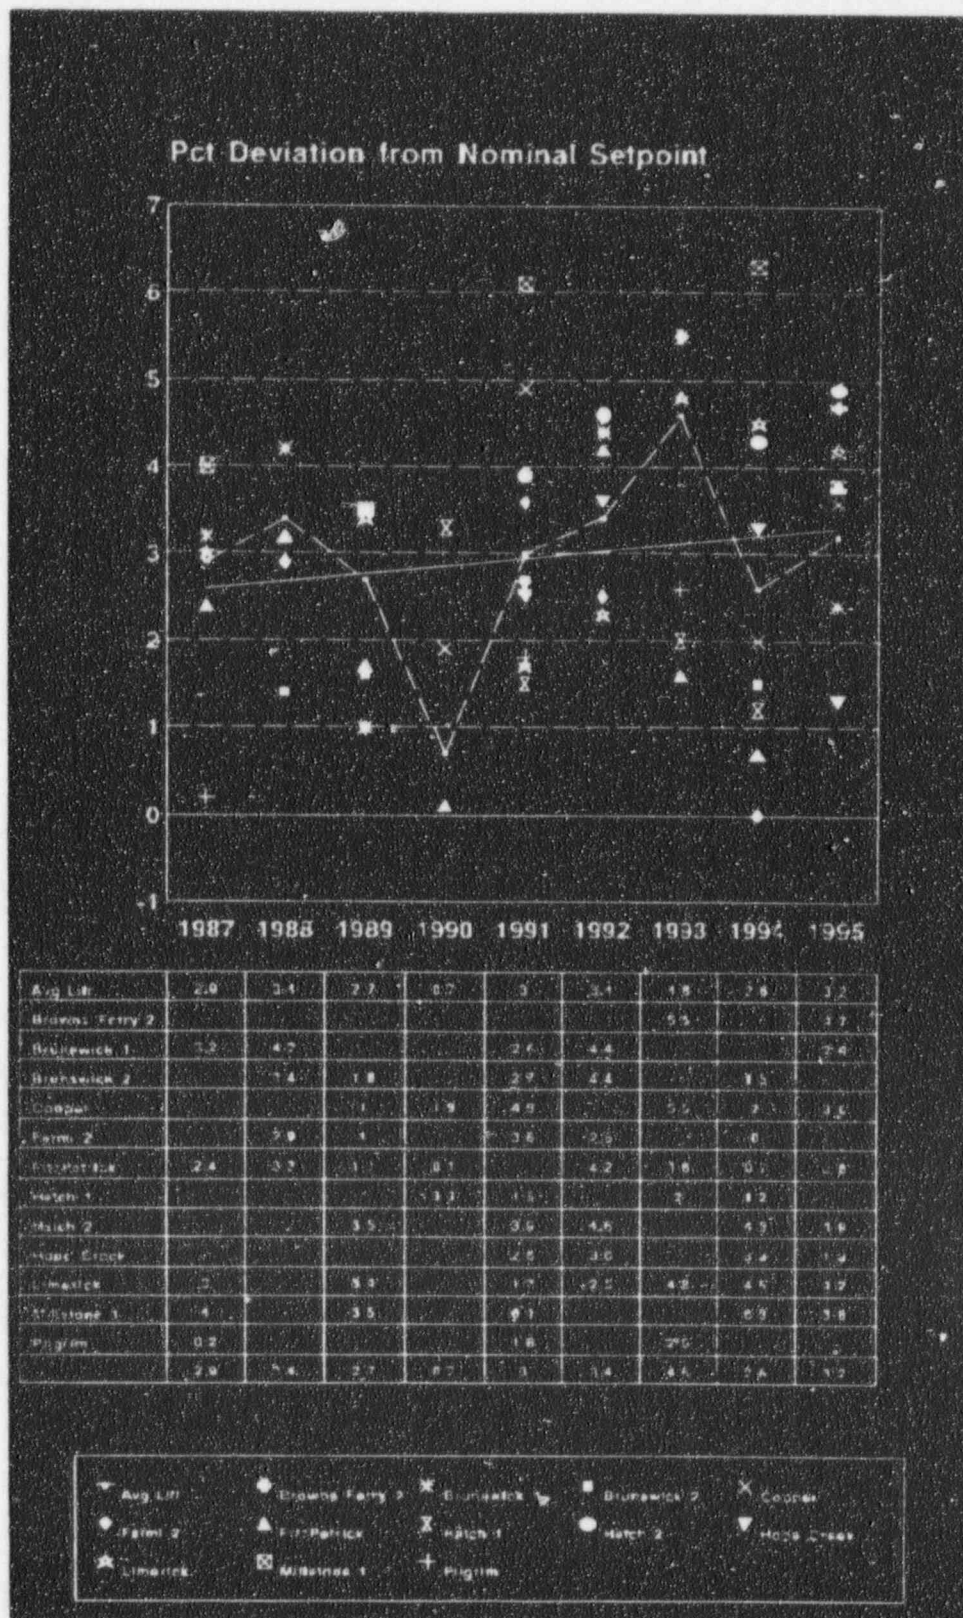
Figure 4: SRV Setpoint Test Averages

In fact, the deviation from the nominal has ranged from the minimal to values in excess of 67 percent, the majority being positive. The solid line in Figure 4 is the linear regression fit of average setpoints of all SRVs tested during the year. The average setpoint has trended upwards from about 2.5 percent above nominal in 1987 to about 3.5 percent above nominal in 1995. The various points represent the average setpoint for SRVs tested by a particular plant for the year. Of these 61 data points, 7 or 11.5 percent were within \pm 1%, 29 or 45.5 percent were within \pm 3%, and 5 or 8.2% were 5 percent or more above the nominal. There are no negative setpoint test averages.

It was common to stop setpoint testing at or near 1250 psig when an SRV would not lift; however, the raw data shows lift points in excess of 1250 psig for some valves. For representation in Figure 4, all valves which did not lift at or before 1250 psig were called stuck and their setpoints were called 1250 psig whether they lifted or not and whether they were pressurized above that pressure or not. The tolerance was then calculated using that number. It should be noted that the SRVs in Figure 4 do not all have the same disc material. Figure 4 includes SRVs having Stellite 6B, PH13-8 Mo and platinate materials.
