**Department of Energy**  
Washington, DC 20585

Subject: U.S. Department of Energy Transition Issues at the Hecla Limited Durita Facility, Montrose County, Colorado; Radioactive Materials License No. 317-02

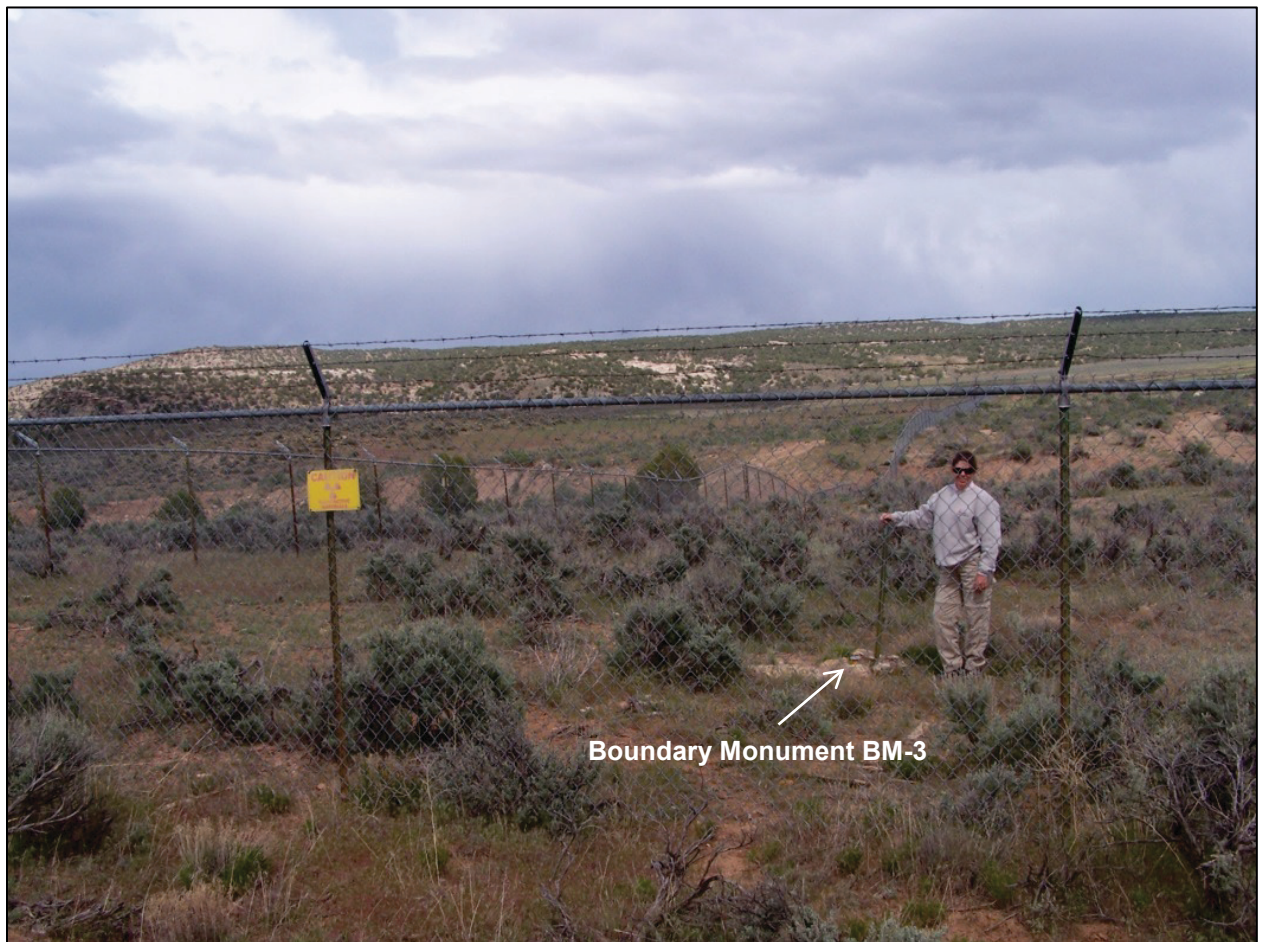
2. Fencing – Fencing has been installed outside the site boundary on the west, north, and south sides of the site. At the northwest corner, the encroachment appears to be 17 feet onto the private property to the west and 36 feet onto BLM property to the north. On the south side of the site, fencing is located on non- right-of-way (ROW) BLM property. All boundary monuments other than BM-3 are outside the fenced area (Figure 1). Boundary monuments are presumed to be in the correct location but will need to be verified (see item 3 below). Replacement fencing should be installed on the proposed site boundary, should the licensee and state agree, and resolve encroachment on adjacent land. The site configuration reflected in the CRR shows fencing around disposal structures only. LM finds fencing around the entire site boundary to be more protective.

*Figure 1. Boundary Monument BM-3 inside Fencing at the Durita, Colorado, Disposal Site (2008)*

3. Survey – As noted in item 2, perimeter fencing is not aligned with boundary monuments and will need to be corrected. To ensure that boundary monuments are placed correctly, LM requests any available survey notes to accompany the plat from the 2000 Del-Mont survey.
