MEETING WITH NRC ON MIDLAND PLANT FILL STATUS AND RESOLUTION

July 18, 1979

NRC, Bethesda, Maryland

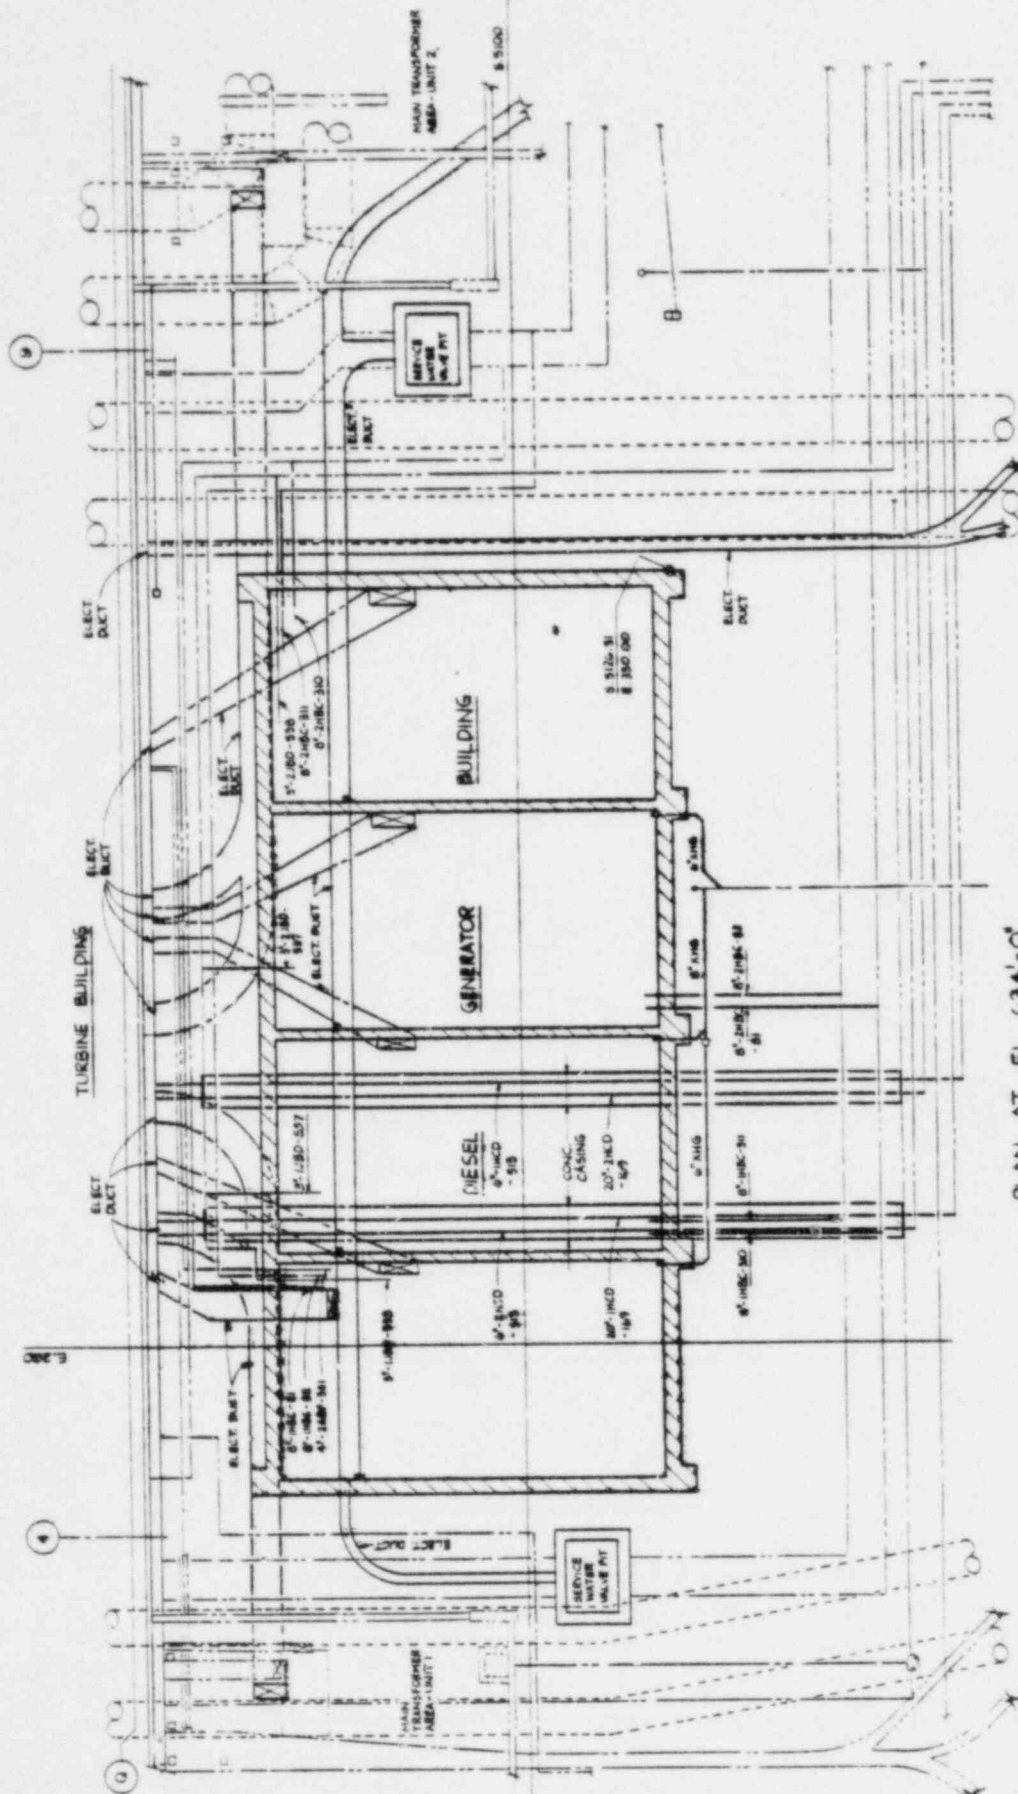
TOTAL SETTLEMENT OF WALLS FROM 7-14-78 TO 6-29-79 IN INCHES

The diesel generator building settlement noted in August of 1978 was larger than expected. An exploration program was initiated to investigate the seat of the settlement and Drs. Peck and Hendron were consulted to discuss the evaluations and corrective actions required. Based on the exploration and the consultants recommendations it was decided to surcharge the building and surrounding area with a load exceeding the operating load. Instrumentation was installed to evaluate rate of soil consolidation and settlements of the structure and supporting soils. The preload was completed to a height of 20 feet in April 1979.

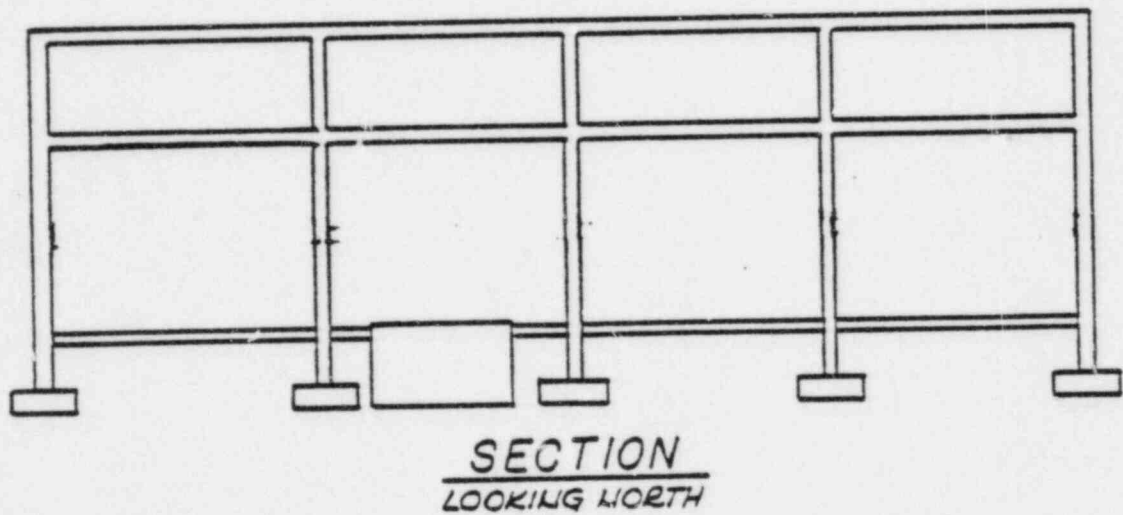
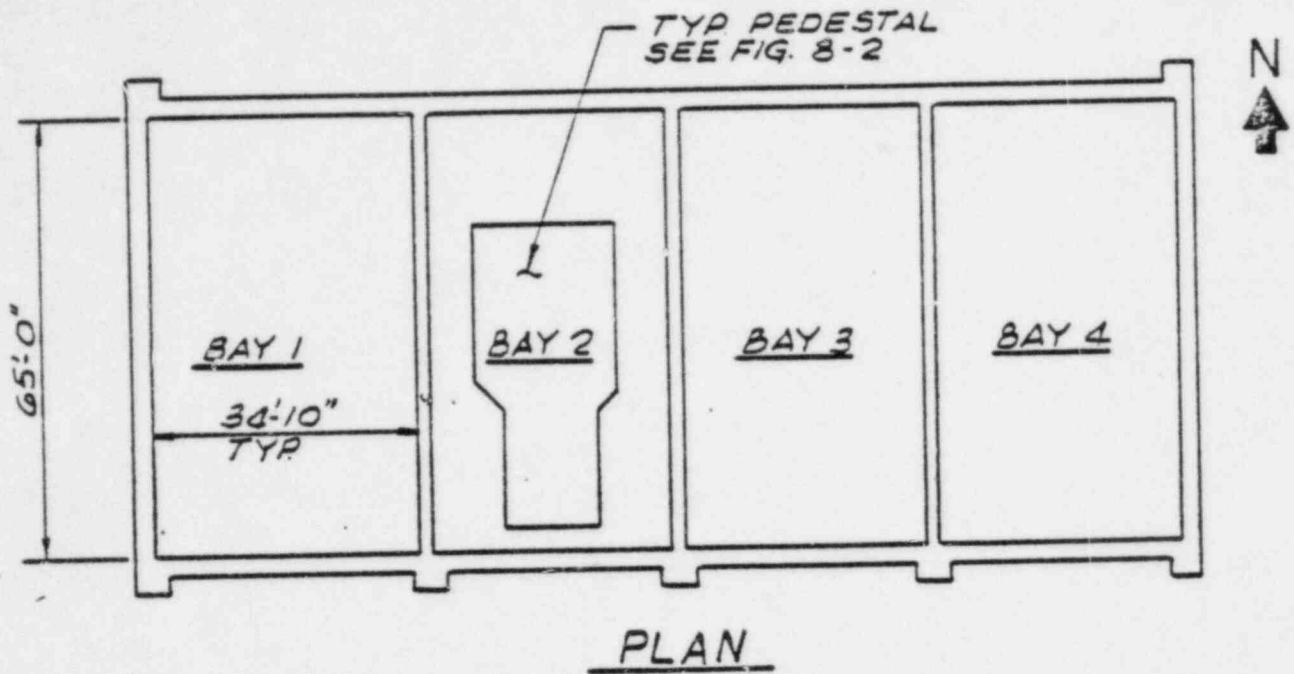
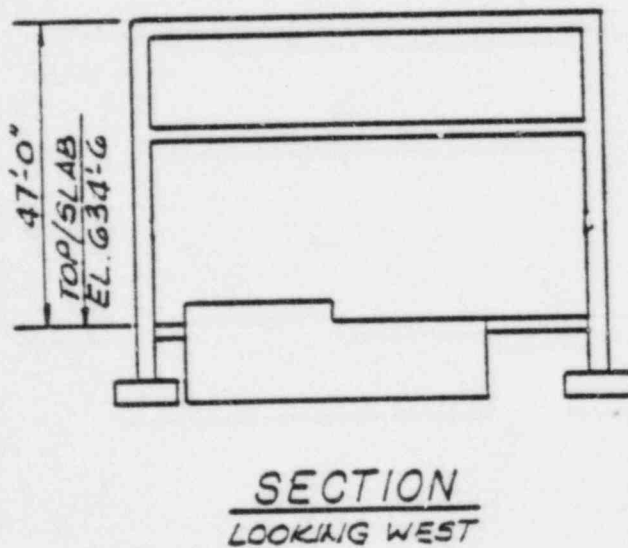
FIG. 14

The diesel generator building is a box-shaped structure. (See Figure 14.) Its main purpose is to provide a housing for the four emergency diesel generators. Structural walls are very rigid and are supported on strip footings. The building and the generator pedestal are founded on approximately 30 feet of fill. During the summer of 1978, settlements more than anticipated values were observed and a detailed soil investigation was conducted. The backfill was found to consist of soft to very stiff clay with pockets and layers of very loose to dense sand backfill. The conclusion of the investigation was that the fill was not adequately compacted. Based upon the recommendation of our soil consultants, Professors Peck and Hendron, the remedial measure chosen was to preload the existing backfill by layers of sand surcharge.

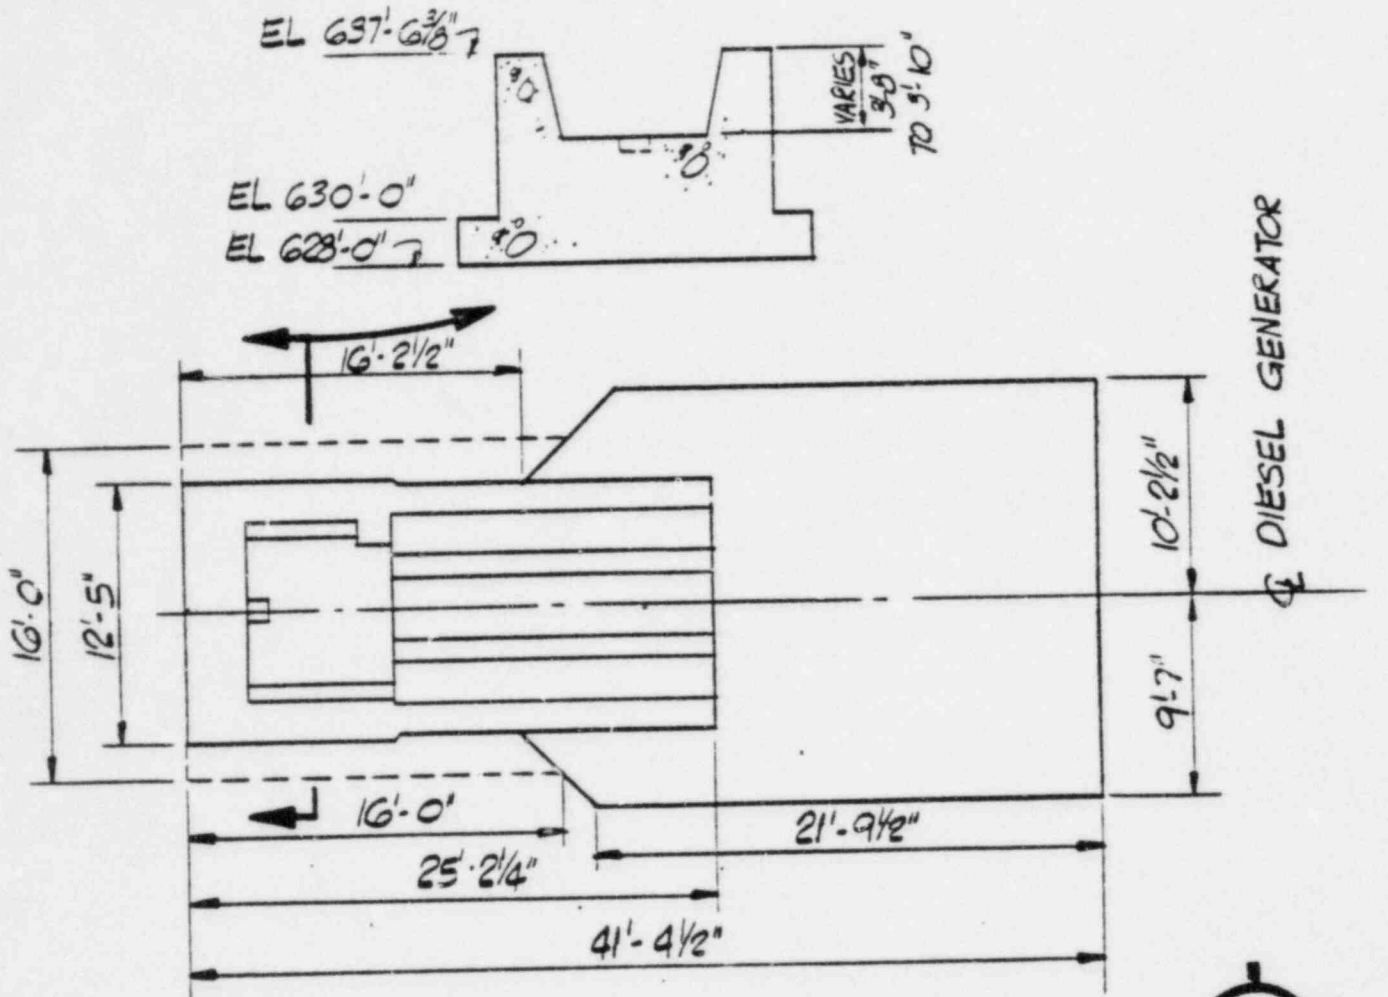
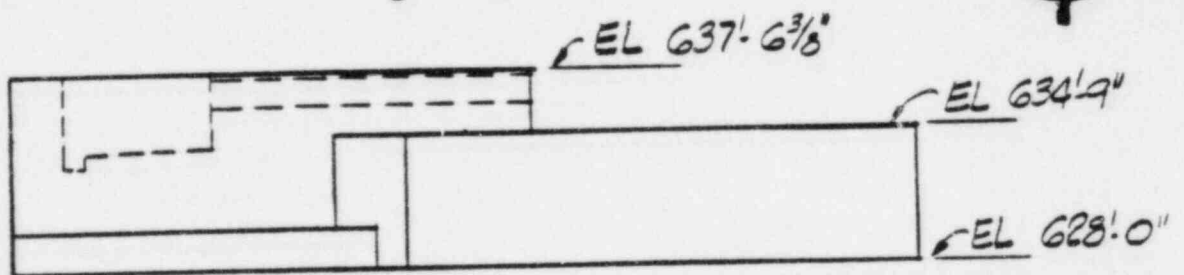
DIESEL GENERATOR  
PEDESTAL

Figure 17 shows plan and cross-sectional elevations of a typical diesel generator pedestal. This is a reinforced concrete structure having a minimum compressive strength of 4000 psi. The fill beneath the pedestals have also consolidated resulting in differential settlement. Differential settlement of the pedestals will have no effect on alignment of the engine and the generator because they are both mounted on the same foundation. Furthermore, because of the enormous stiffness of the pedestal, no significant warping is expected and the top of the pedestal will generally lie within one plane. The diesel generator will be set in a level position irrespective of the amount of differential settlement between the corners of the pedestal. It will be achieved either by a suitable layer of grout on the pedestal or by chipping a few inches of the top concrete and refinishing it to the required level.

The machine itself has considerable tolerance limits for tilt and roll. DeLaval Turbines, the manufacturer of the diesel generator, stated that a  $5^{\circ}$  combined backward tilt and roll of the pedestal or a forward tilt of  $1.4^{\circ}$  and roll of  $5^{\circ}$  combined will not affect the performance of the engine and the generator. Furthermore, during the operation of the plant, if further differential settlement causes this tolerance to be exceeded, the manufacturer states that the generators can be shimmed back to level position. In summarizing, for the diesel generator building the remedial work of preload is in progress and dewatering of site is being planned for implementation soon. No further remedial work on the pedestal than that mentioned above is anticipated.

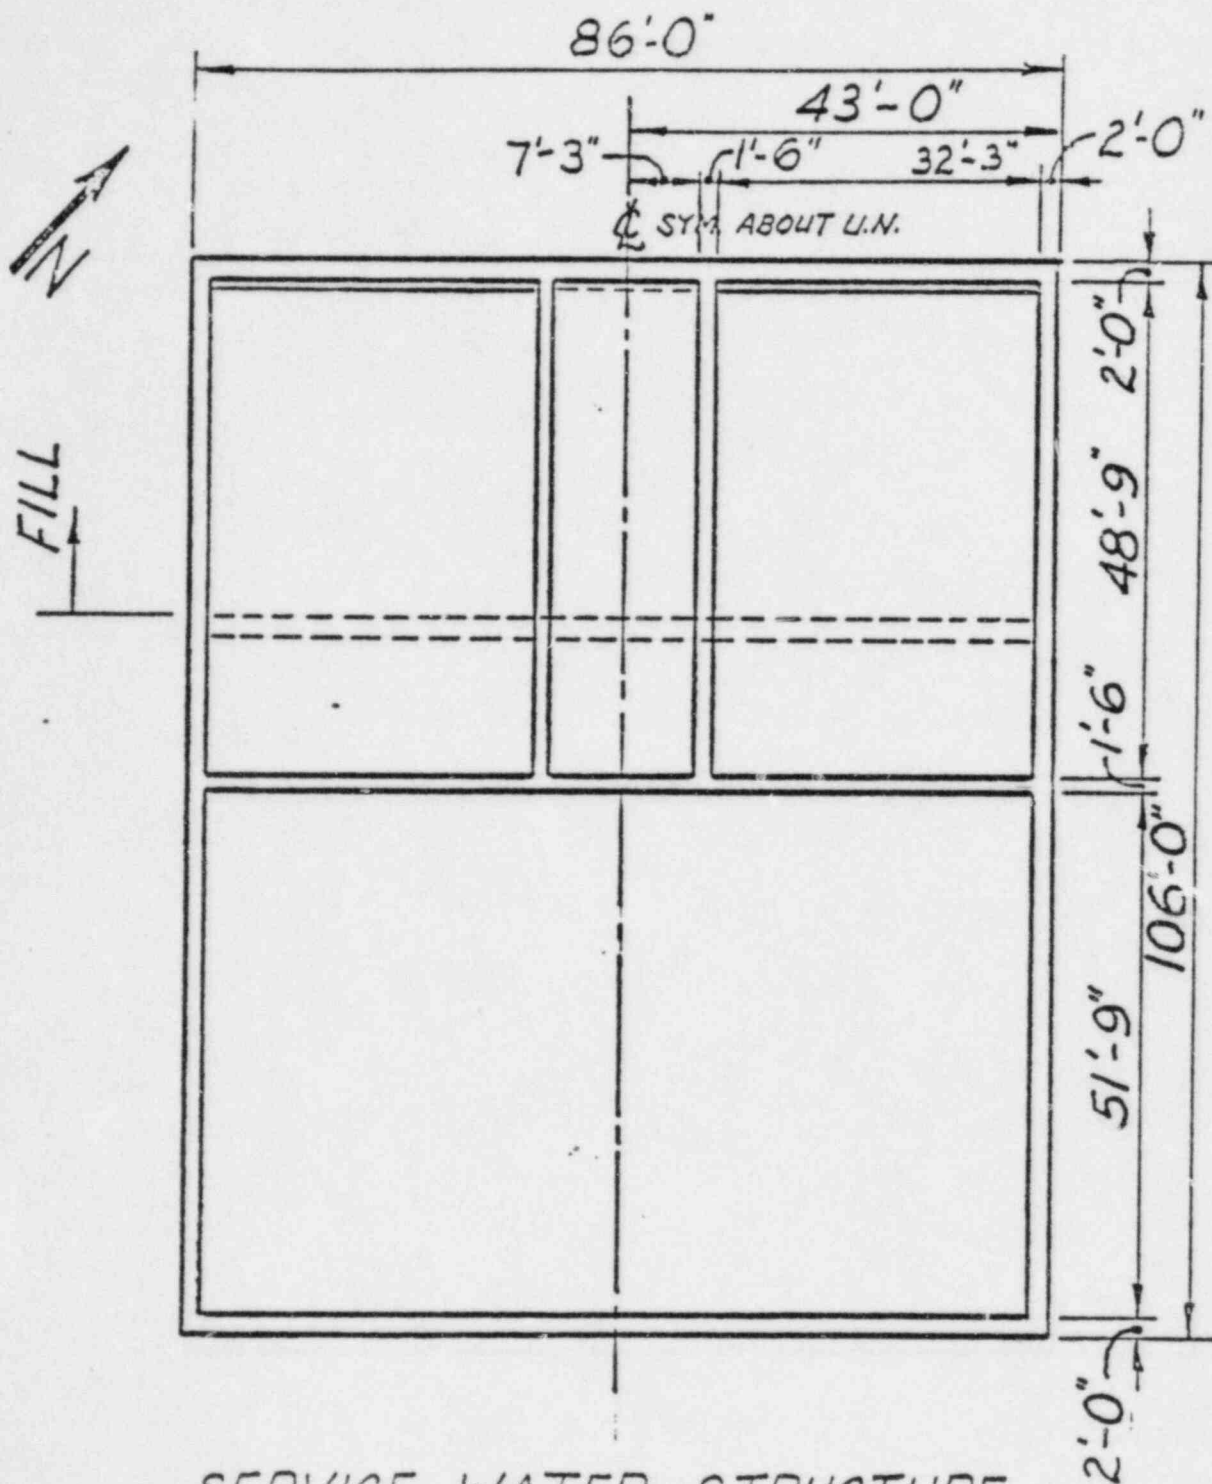
FIG. 18

The service water pump structure is located in the southeast end of the power block area adjacent to the cooling pond. (See Figure 6.) Figure 18 shows a plan view of the structure. The cooling pond is on the southern side. The major portion of the structure is founded on natural soil material except for the northern portion which is founded on fill. Figure 19 shows a cross-sectional view of the structure. As mentioned earlier, the northern section, which is cantilevered off the main building, is founded on backfill material. As a follow-up to the investigation of all Class I structures on fill, several borings were taken in this area. The borings indicated that the backfill consists of soft to very stiff clay and loose to very dense sand. The conclusion was that some areas of the fill material under the northern part of the structure were not sufficiently compacted. However, no significant settlement of the structure has been noted. The reason for this is that the existing dead loads from this portion are being partially supported by the rest of the structures through cantilever action. The remedial measure chosen is to support the north wall on piles driven to hard glacial till. The choice of piles is an economical and expedient solution with minimal impact on the schedule.

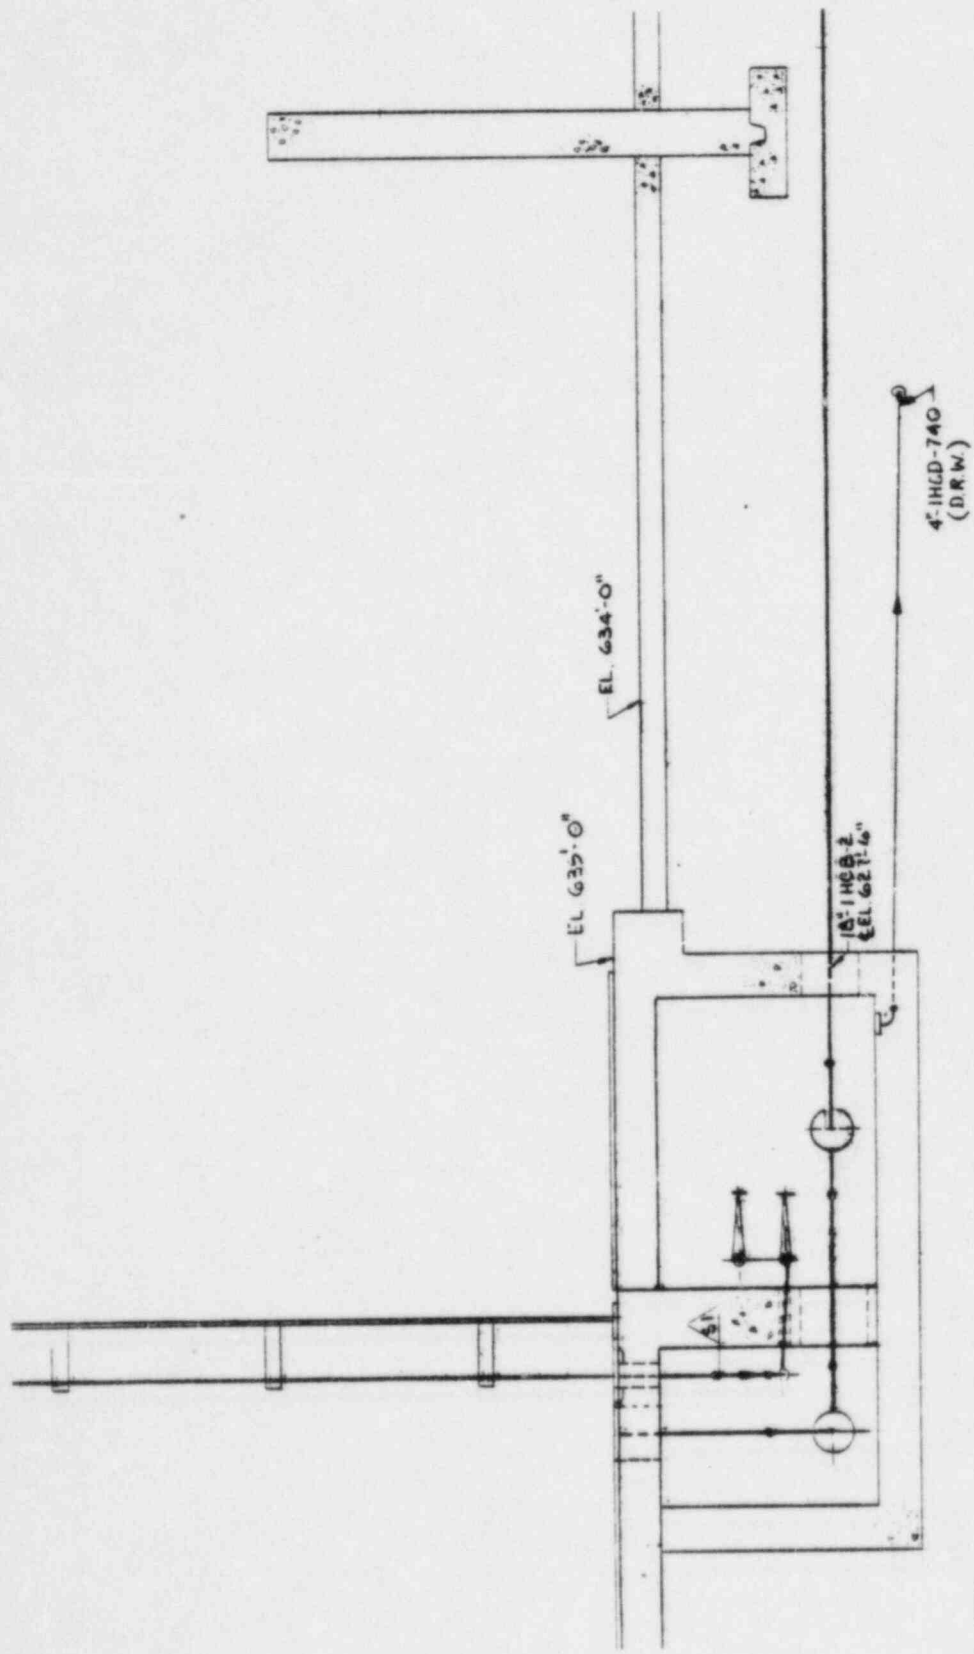
FIG. 24

As shown in Figure 24, a short concrete ring girder foundation with a strip footing is provided for each BWST. The tank is supported on the ring girder and the soil within the foundation. The tank by itself is quite flexible.

Adjoining the ring girder for each tank is a small box-shaped structure called valve pit. This houses valves and other controls. At present, construction of ring girder and valve pits are complete and installation of piping is in progress. As a follow-up to the investigation of all Class I structures founded on fill, several borings and test pit examinations were completed in the tank farm area. The results of the investigation indicated that the tanks are supported on medium to very stiff clay backfill with occasional medium to very dense sand layers. The condition of the fill is suitable for the support of the tanks. To confirm this, the tanks will be constructed and filled with water in order to make a full-scale test of the foundation soil.

In summary, the backfill material on which the BWSTs are founded is satisfactory and will be confirmed by a load test. Borated water lines will be monitored and evaluated for any differential settlements. Therefore, no remedial action is anticipated for these structures.

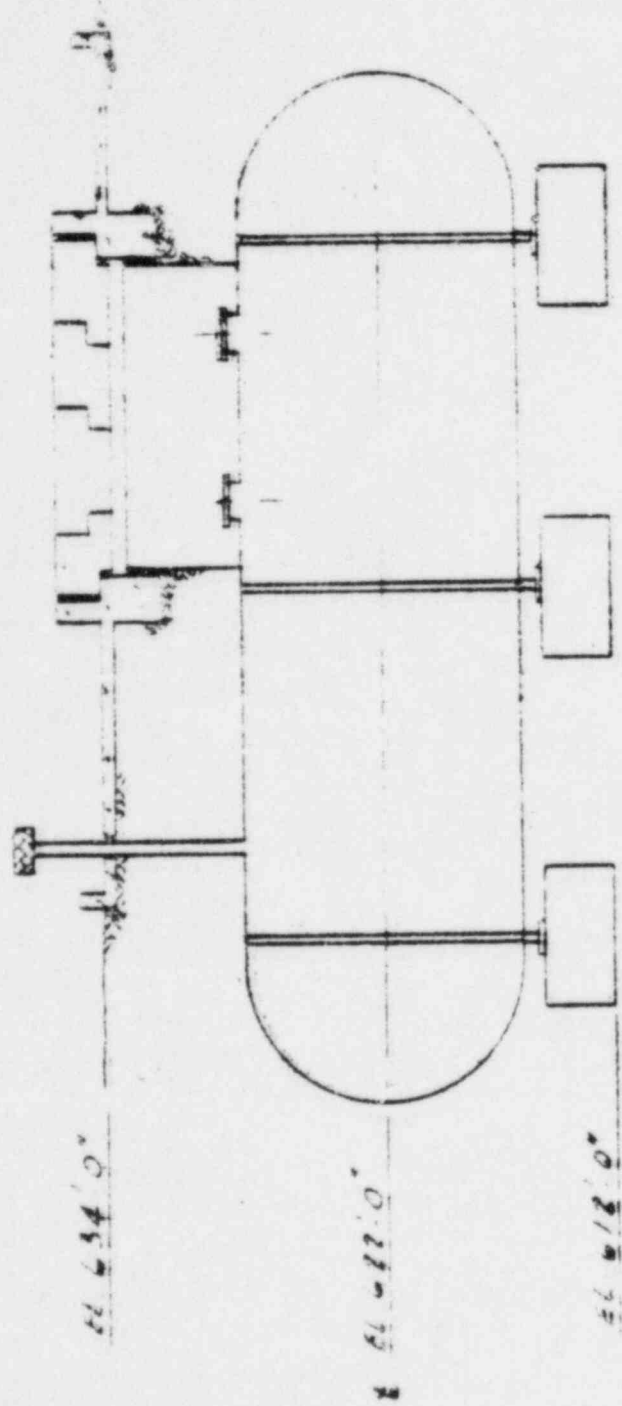
FIG.26

Figure 26 shows a cross-sectional view of a tank. There is six feet of earth covering each tank. The tanks are supported at three points anchored to concrete pedestals. The tanks are founded on backfill and results of the boring program indicated that the tanks are supported on medium to stiff sandy clay backfill. This soil condition is adequate to support the tanks. Moreover, the weight of the tanks is approximately equal to the fill that it replaced. In order to verify that the fill is satisfactory, these tanks have been filled with water and settlements are being monitored. It has been three months since the tanks have been filled with water and no appreciable settlements have been noted yet. Therefore, the backfill is considered adequate and no remedial measures are anticipated.

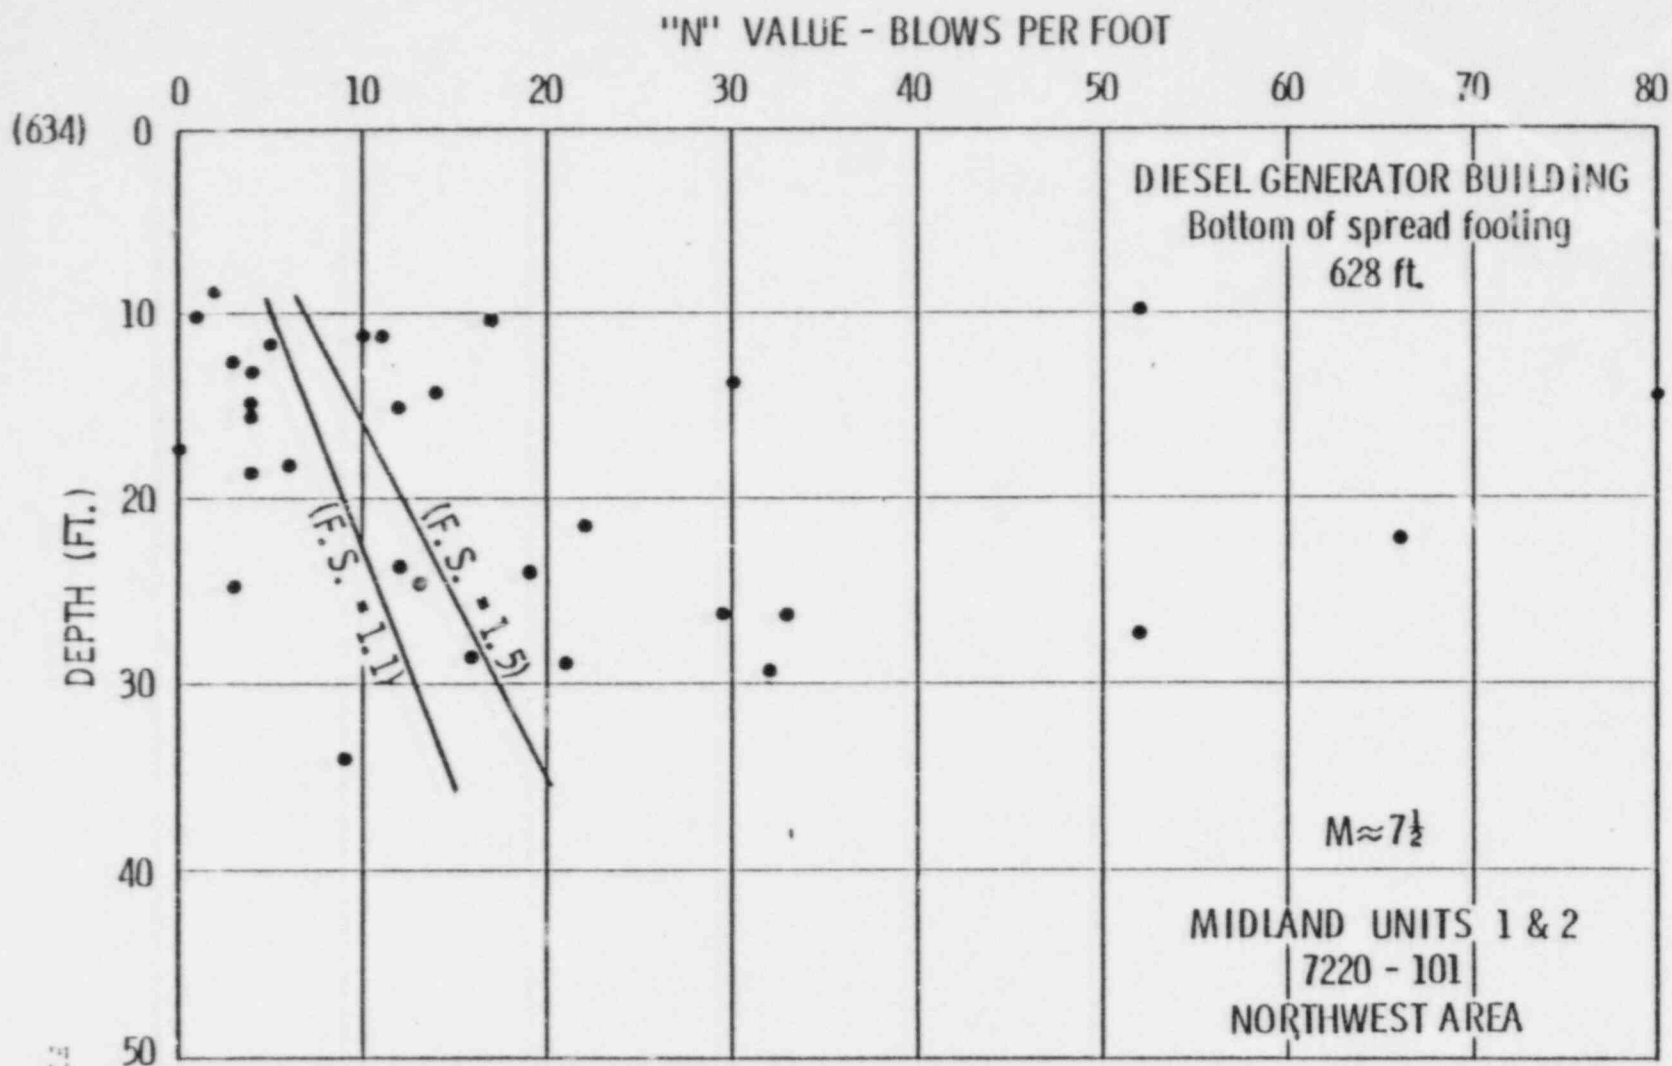
STANDARD PENETRATION RESISTANCE VERSUS  
DEPTH FOR THE NORTHWEST AREA OF THE  
DIESEL GENERATOR BUILDING

Utilizing this information the line representing a safety factor of 1.5 has been calculated and superimposed upon the standard penetration blowcount versus depth for the northwest and northeast areas of the diesel generator building as shown in Figure 36 and 37. The figure also shows the line representing a factor of safety of 1.1. It is seen from Figure 36 that a good number of the standard penetration blowcounts are less than those required for the acceptable factor safety of 1.5. Evaluation of the sands in the northwest area of the building indicates that some of these loose sands may be connected. Figure 37 shows that the great majority of the penetration tests indicate a safety factor well in excess of 1.5 with the exception of three cases below 1.5.

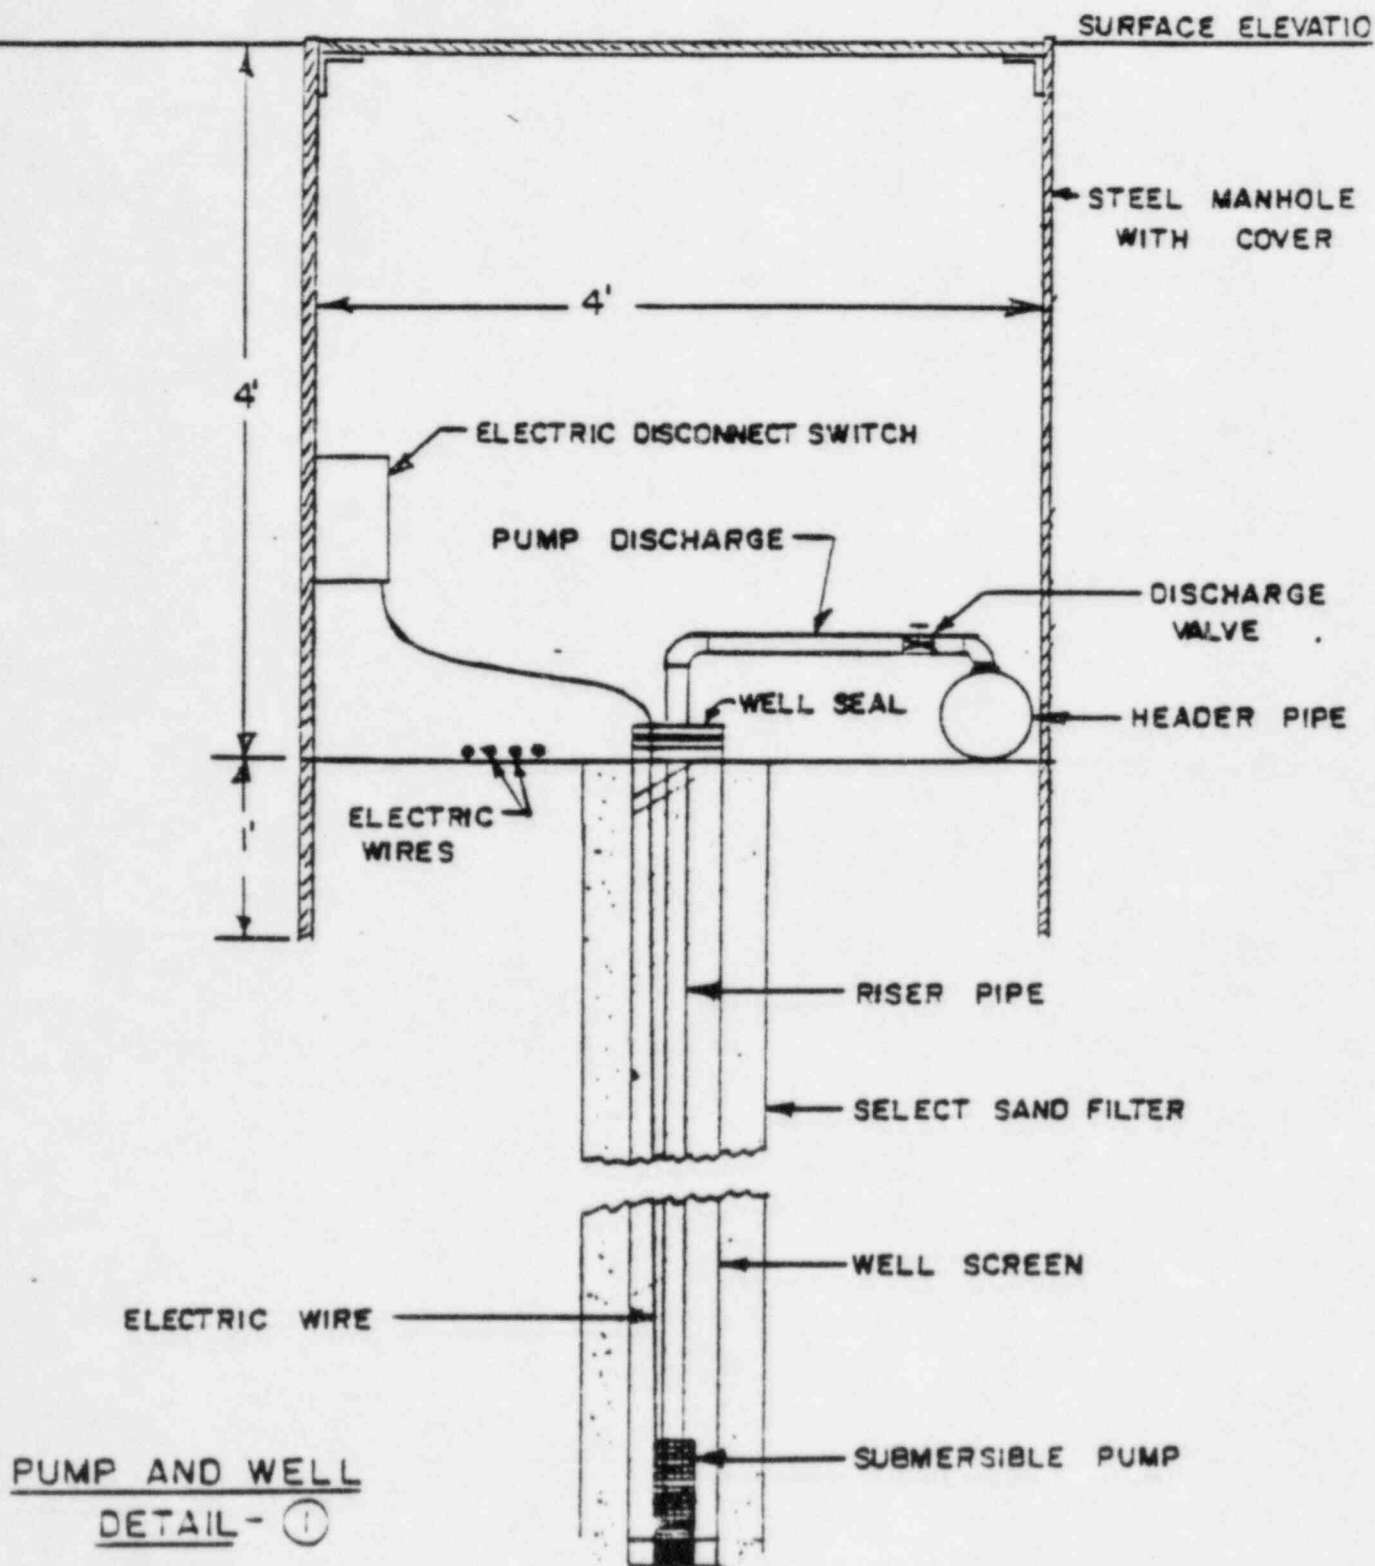
FIGURE 42-

Figure 42 indicates that the dewatering system would be buried below the frost depth. The necessary disconnections would be provided to permit screening the deepwells. In area of heavy traffic a manhole would be provided for access to the deepwells.
