Commonwealth Edison Company
Byron Generating Station
4450 North German Church Road
Byron, IL 61010-9794
Tel 815-234-5441

This report is number 95-005S2; Docket No. 50-454.

Enclosure: Licensee Event Report No. 95-005S2

LICENSEE EVENT REPORT (LER)
TEXT CONTINUATION

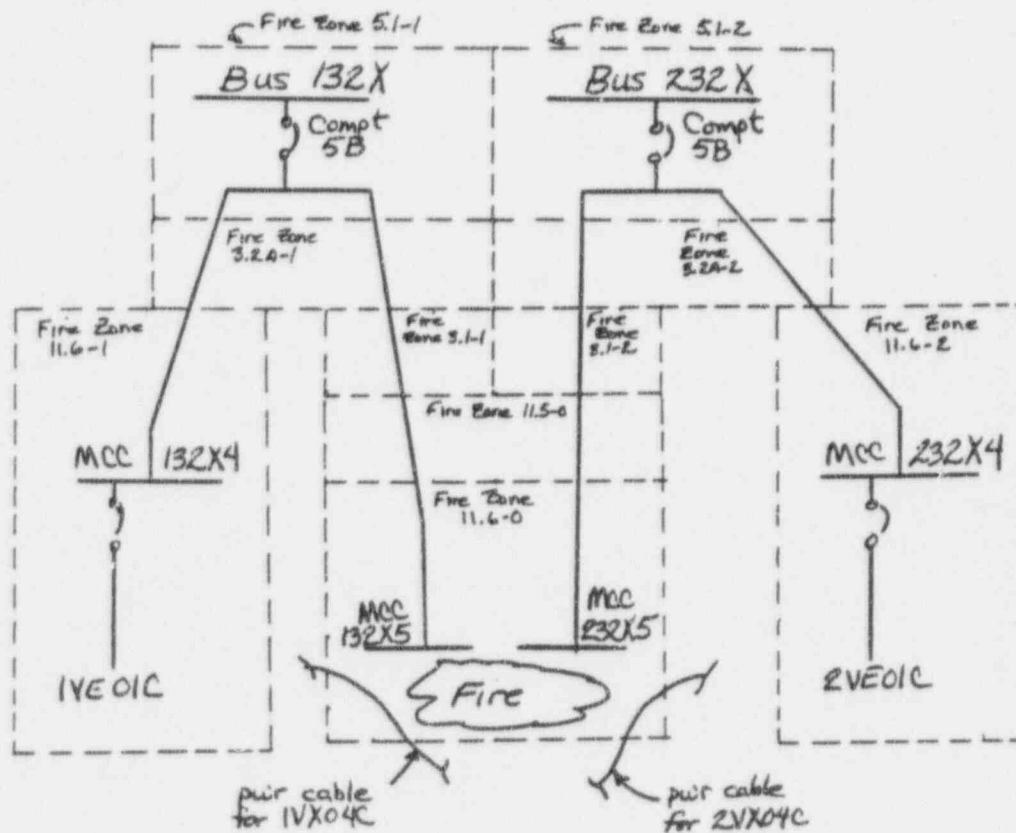
Figure 1: Configuration of Fire Zone 11.6-0

The FPR Safe Shutdown Analysis for Fire Zone 11.6-0 failed to recognize the loss of electric power to the Division 12 and 22 MEER Supply Fans. Although the power cables for these fans are not routed through Fire Zone 11.6-0, they are powered from Motor Control Centers (MCCs) which are affected by a fire in zone 11.6-0. The MCCs supplying power to the Division 12 and 22 MEER Supply Fans are powered from two 480 volt breakers that also power MCCs located in zone 11.6-0. The MCCs located in fire zone 11.6-0 can be damaged by a fire in this zone. A fire induced fault on these MCCs will cause the 480 volt breakers to open which will also de-energize the MEER Supply Fans. See Figure 1 in Attachment A for a diagram of the above configuration.

The cause of the events reported on 10/12/95 and 10/13/95 was a failure of the team of analysts preparing the original Byron Safe Shutdown Analysis to recognize the interconnection between MCCs powered from a single 480 volt Bus breaker. Consequently, the Safe Shutdown Analysis for Fire Zones 11.4-0 and 11.6-0 did not consider the potential loss of some MCCs located outside of the fire zone. The team of analysts considered the equipment and cables located in the fire zone that could be directly affected by a fire. An assumption was implicitly made and the analyses was performed as if the power and control for each component formed an independent circuit and that a failure of cables for one component would not have any impact on any other safe shutdown components. This assumption is based on breaker coordination studies that demonstrate that fire induced faults on a cable will not cause an upstream supply breaker to open before the specific load fuse or breaker for the circuit in question opens. This assumption would not apply if two MCCs are fed from a single bus breaker.

Problem: Appendix R Fire in Zone 11.6-0 (Elev. 426', AB) may cause failure of:

- 1). Power cable for 1VX04C (U-1 Div 11 MEER Supply Fan)
- 2). Power cable for 2VX04C (U-2 Div 21 MEER Supply Fan)
- 3). Fault MCC 132X5 which causes Bus 132 Compt 5B breaker to open when sensing fault current.

- (a) Loss of 1VE01C (U-1 Div 12 MEER Supply Fan)
- 4). Fault MCC 232X5 which causes Bus 232 Compt 5B Breaker to open when sensing fault current.

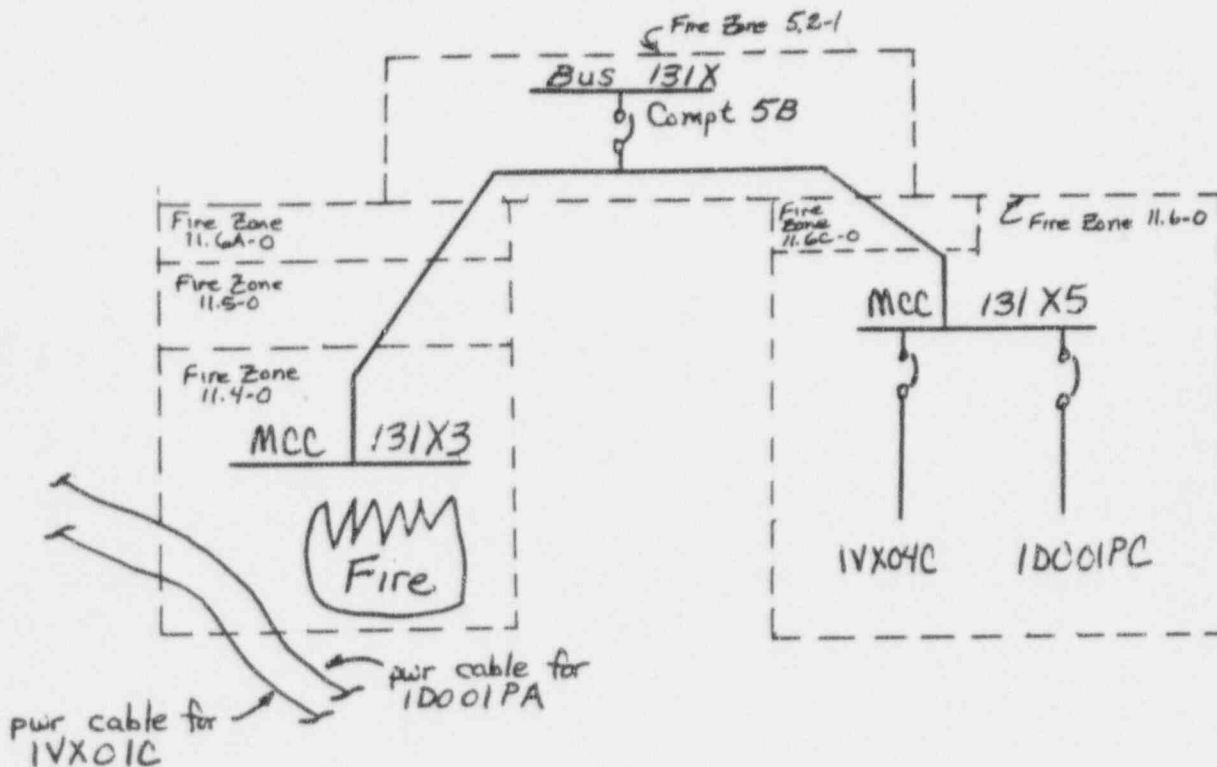
Figure 2: Configuration of Fire Zone 11.4-0

Unit 1 FPR Sections 2.4.2.43 and A5.8.17 state that Division 11 equipment is relied upon for a fire in Fire Zone 11.4-0. The power cable for Diesel Oil Transfer Pump (1DO01PA, Division 11) is routed in this zone and can be damaged by a fire. Redundant pump (1DO01PC, Division 11), its power cable, and MCC power source are located outside of zone 11.4-0. The MCC power source receives power from a common 480 volt bus breaker which also powers an MCC located in Fire Zone 11.4-0. The MCC located in zone 11.4-0 can be damaged by a fire in this zone. Therefore, a fire-induced failure on this MCC will cause the common supply breaker to open and de-energize the MCC supplying power to pump 1DO01PC. With both Diesel Oil Transfer pumps not available, the 1A Emergency Diesel Generator is not available. Additionally, the Division 11 ESF Switchgear Room Supply Fan (1VX04C) is powered by the MCC for pump 1DO01PC. Similarly, fan 1VX04C may not be available for a fire in zone 11.4-0. See Figure 2 in Attachment A for a diagram of the above configuration.

Problem: Appendix R Fire in Zone 11.4-0 (Elev. 383', AB) may cause failure of:

- 1). Pwr cable for 1VX01C (Div 12 ESF Swgr Supply Fan)
- 2). Pwr cable for 1DO01PA (A Diesel Oil pp for 1A D/G)
- 3). Fault MCC 131X3 which causes Bus 131 Compt 5B breaker to open when sensing fault current.
