VIRGINIA ELECTRIC AND POWER COMPANY

Serial Number	96-610
SPSLIC/JDK	R0
Docket Nos.	50-280 50-281
License Nos.	DPR-32 DPR-37

VIRGINIA ELECTRIC AND POWER COMPANY  
SURRY POWER STATION UNITS 1 AND 2  
ALTERNATE AC SOURCE INOPERABLE  
SPECIAL REPORT

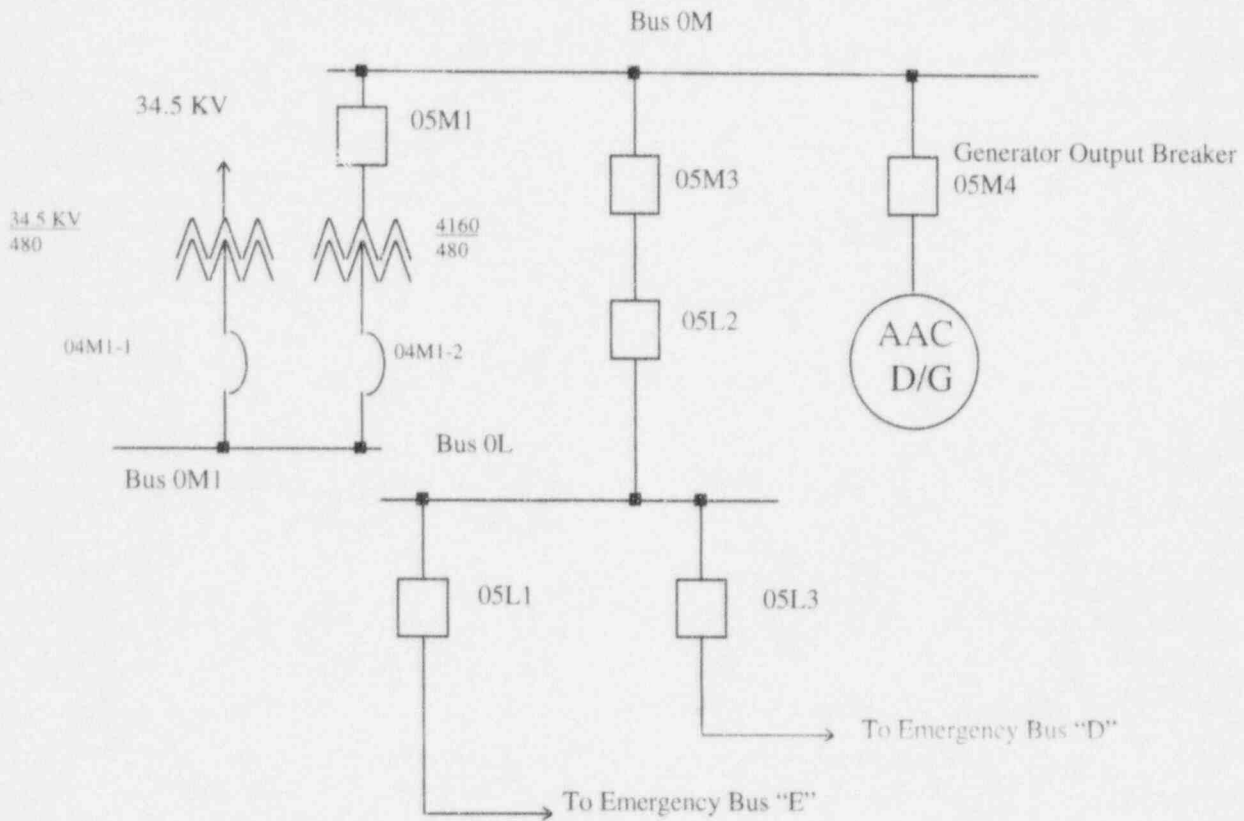
Attachment 1  
Simplified Schematic

With the AAC Diesel Generator output breaker control switch in the Pull-To-Lock position, a control room operator may not have been able to align the AAC Diesel Generator to the transfer busses from the Main Control Room (MCR) within the required time limit. Attachment 1 provides a simplified schematic of this electrical arrangement.
