**United States
Nuclear Regulatory Commission**

**INDEPENDENT SAFETY ASSESSMENT
OF
MAINE YANKEE ATOMIC POWER COMPANY**

October 1996

Licensee: Maine Yankee Atomic Power Company
Facility: Maine Yankee Atomic Power Station
Location: Wiscasset, Maine
Docket No: 50-309
Onsite Evaluation Period: July 15-26, 1996, and
August 12-23, 1996
Team Manager: Edward L. Jordan
Team Leader: Ellis W. Merschoff
Administrative Assistant: Ola B. West
Team Members: Larry Bell
John R. Boardman
Russell L. Bywater, Jr.
Harold O. Christensen
George M. Hausman
John V. Kauffman
Kriss M. Kennedy
G. Norman Lauben
Ronald L. Lloyd
Alan L. Madison
Thomas O. Martin
Peter J. Prescott
Jack E. Rosenthal
State Representatives: David Decrow
Patrick Dostie
Uldis Vanags
Contractors: George Cha
Robert Christie
Cyril Crane
Brian Haagensen
Michael Shlyamberg
Leonard Ward

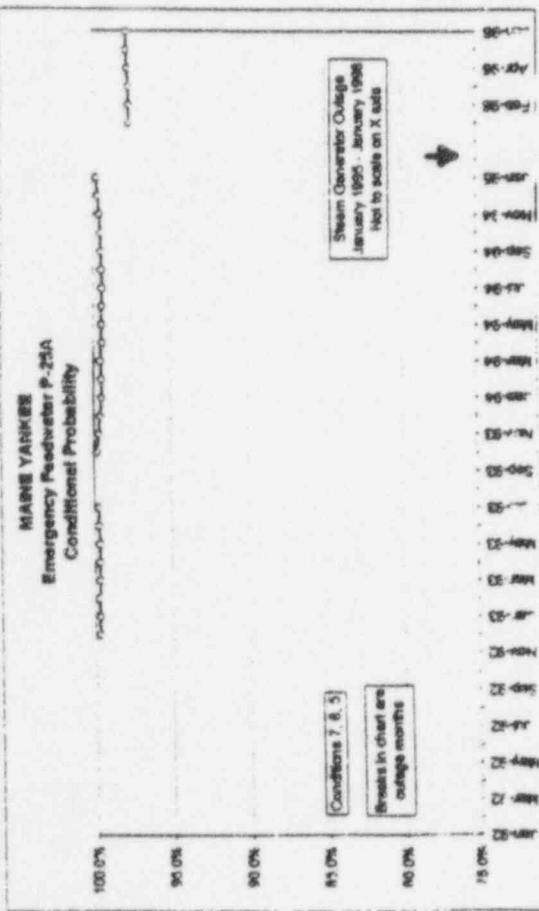
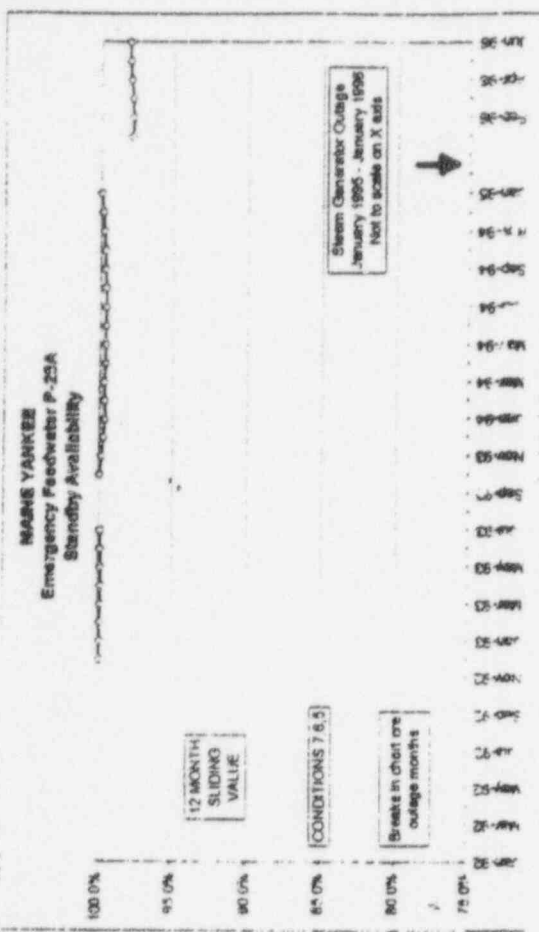
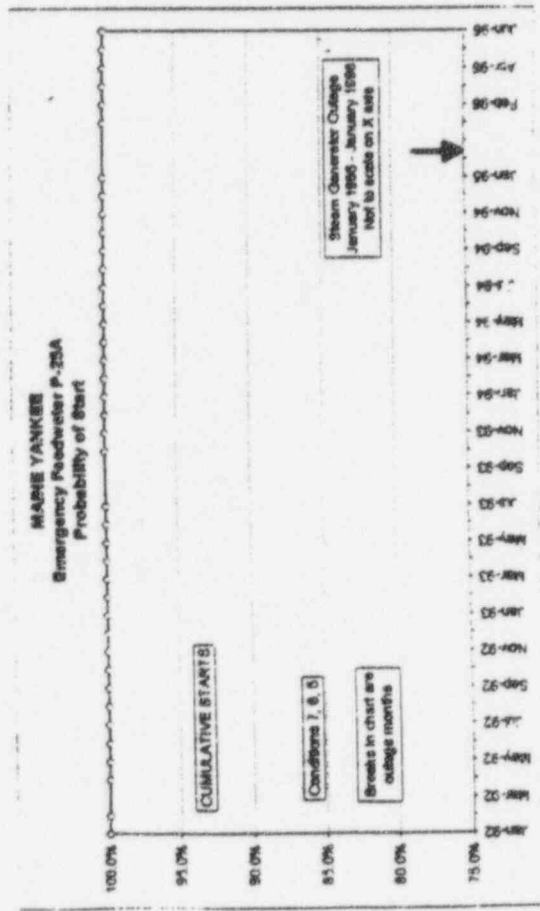
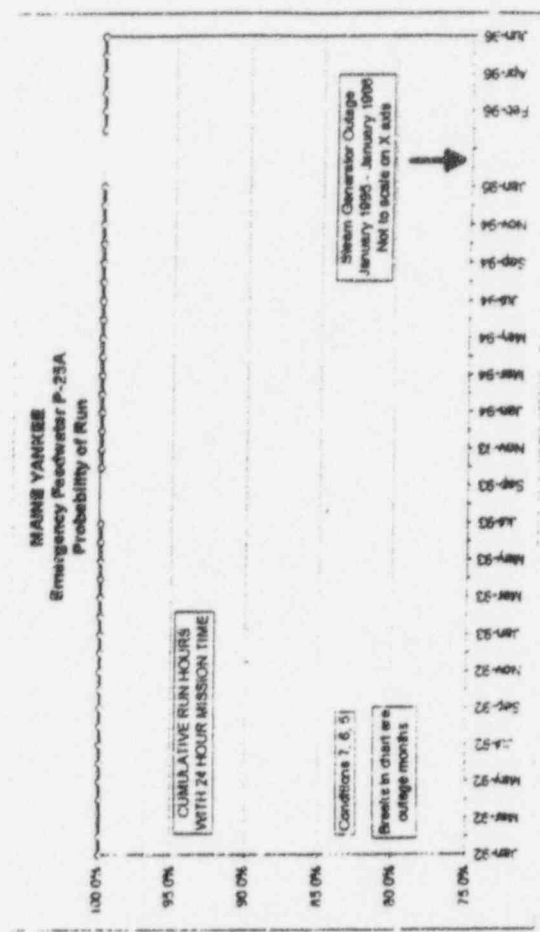
Figure 2

Total Starts	130
Successful Starts	130
Failures to Start	0
Total Run Hours	487
Run Failures	0
Planned Maintenance Hours	44.5
Unplanned Maintenance Hours	143.5

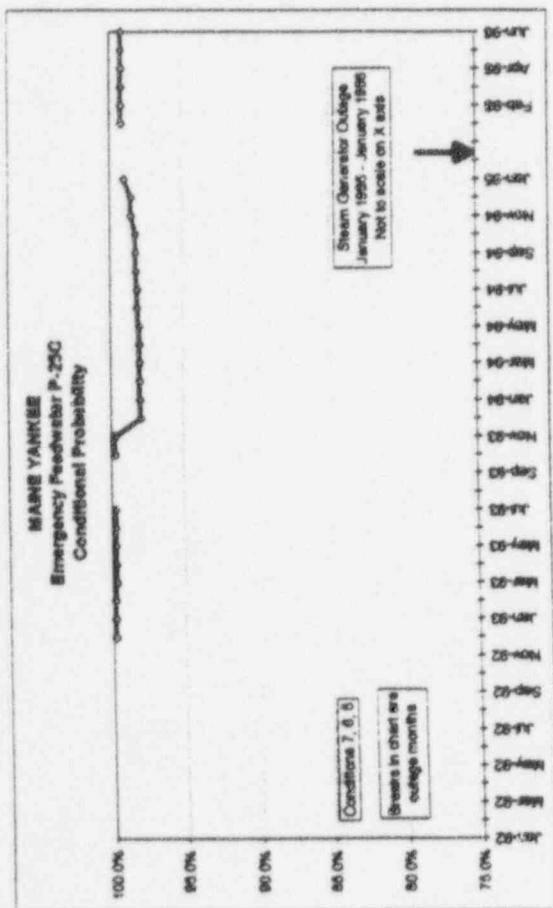
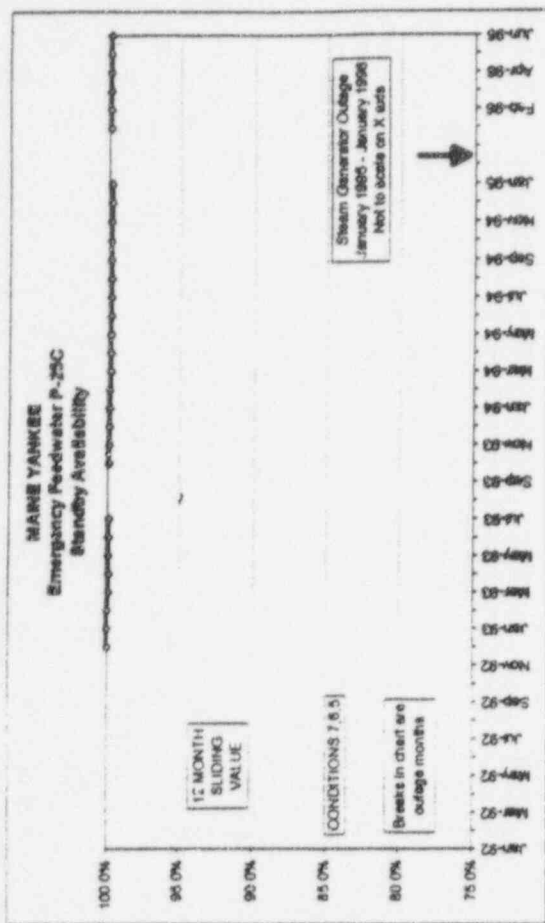
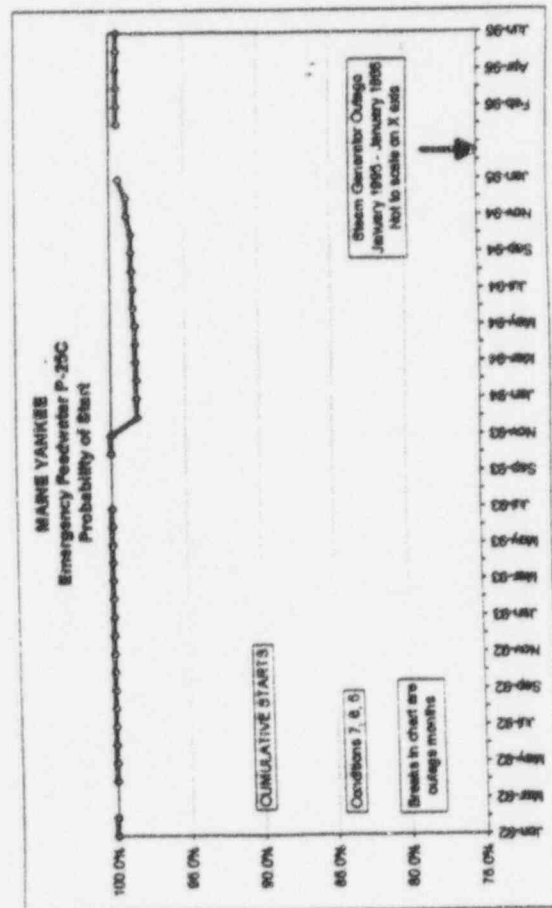
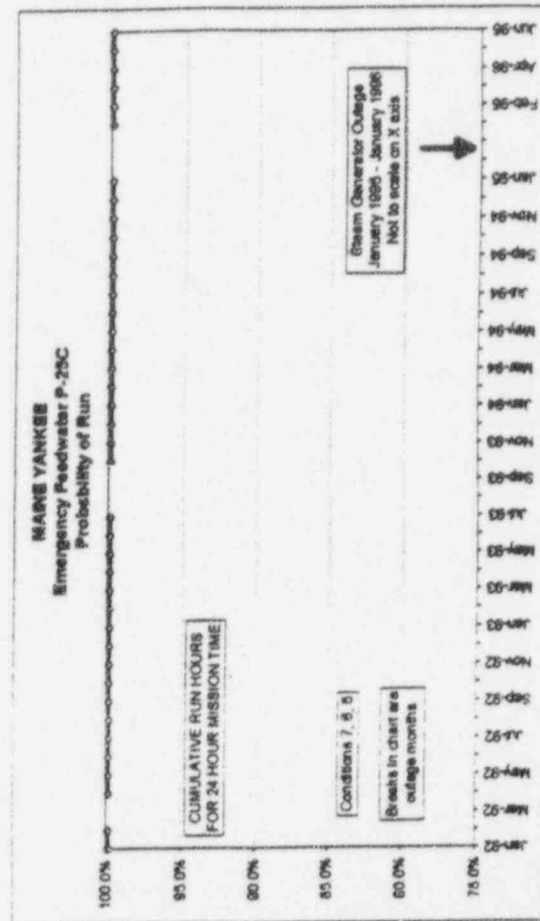
Figure 3

Total Starts	192
Successful Starts	191
Failures to Start	1
Total Run Hours	992
Run Failures	0
Planned Maintenance Hours	29.5
Unplanned Maintenance Hours	1.5

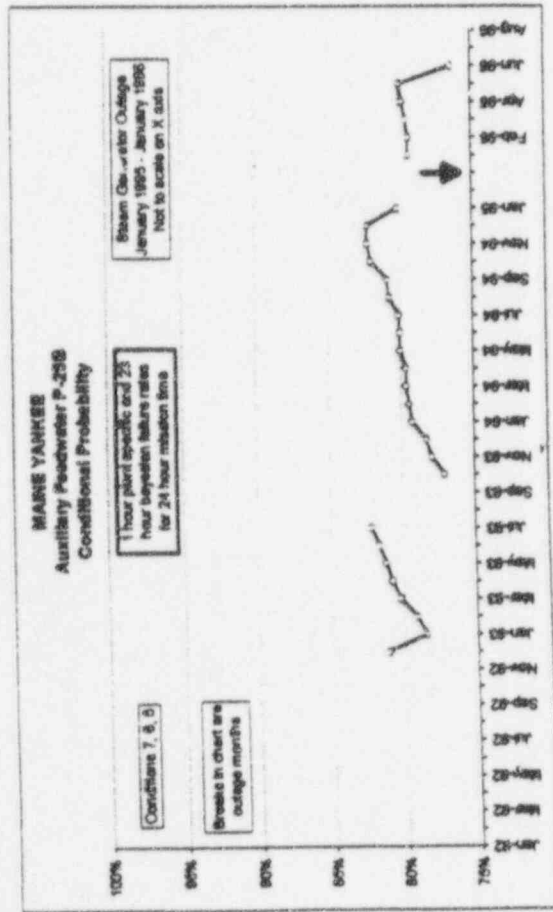
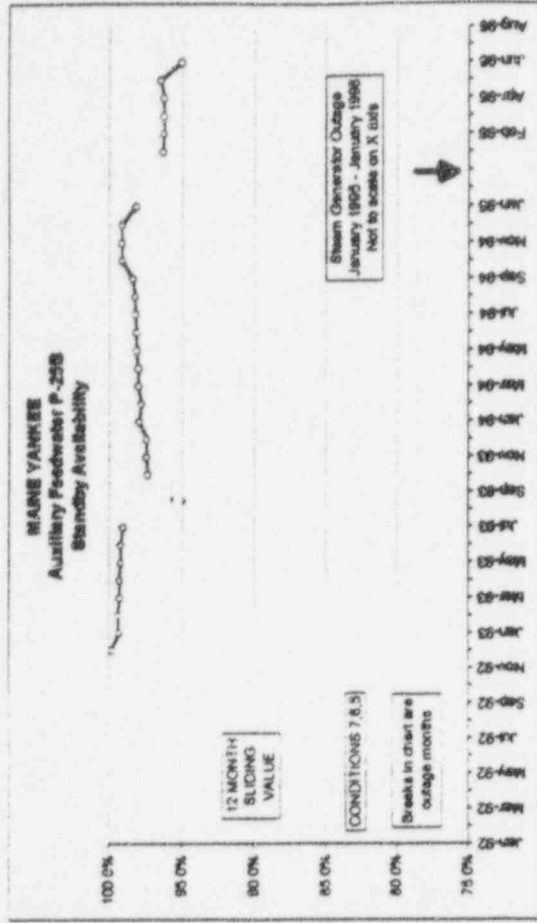
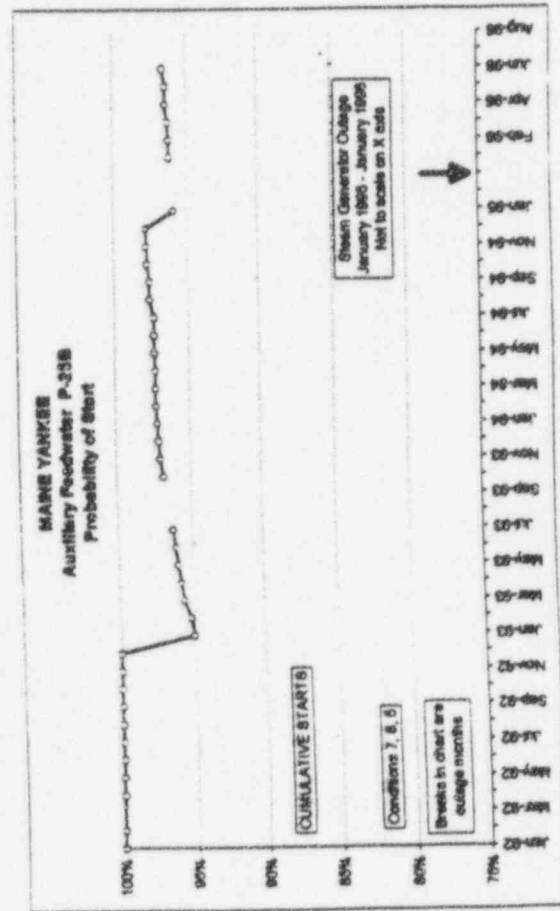
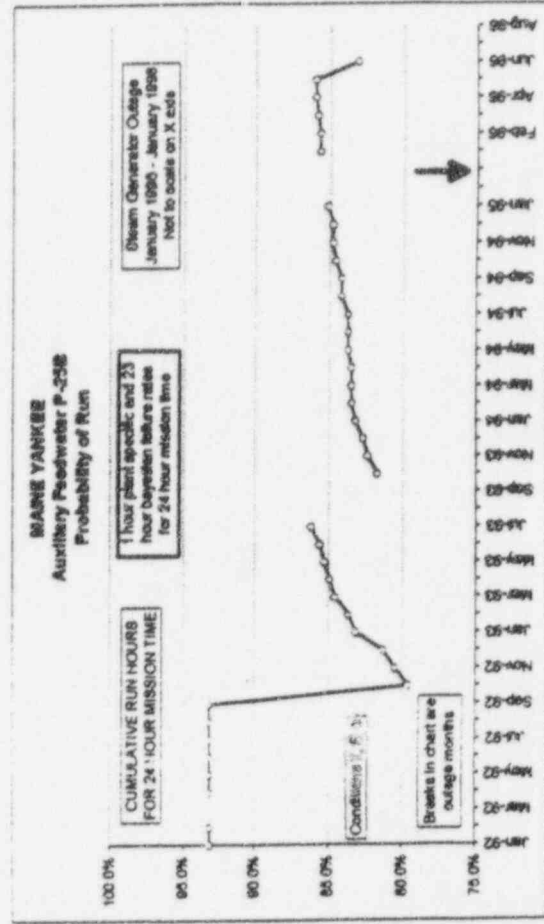
Figure 4

Total Starts	59
Successful Starts	57
Failures to Start	2
Total Run Hours	26.5
Run Failures	3
Planned Maintenance Hours	132.5
Unplanned Maintenance Hours	441.0

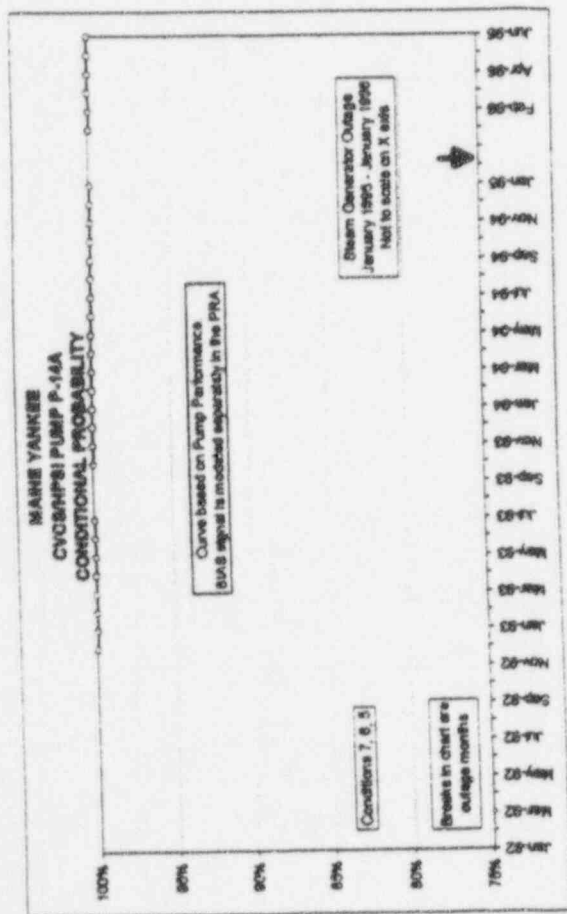
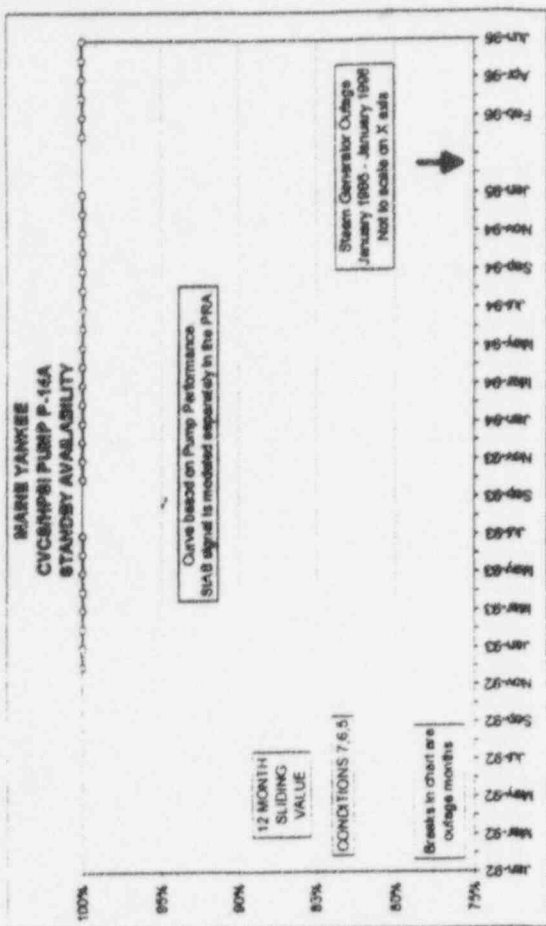
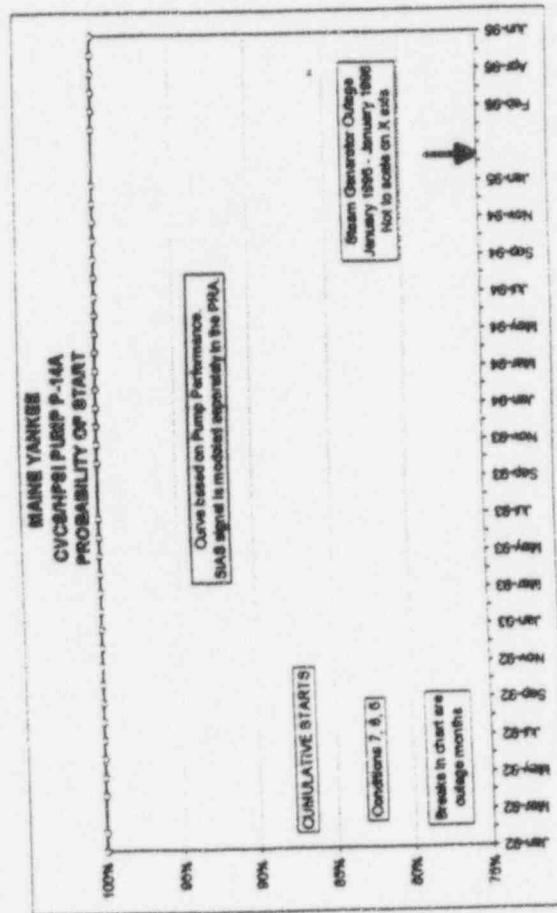
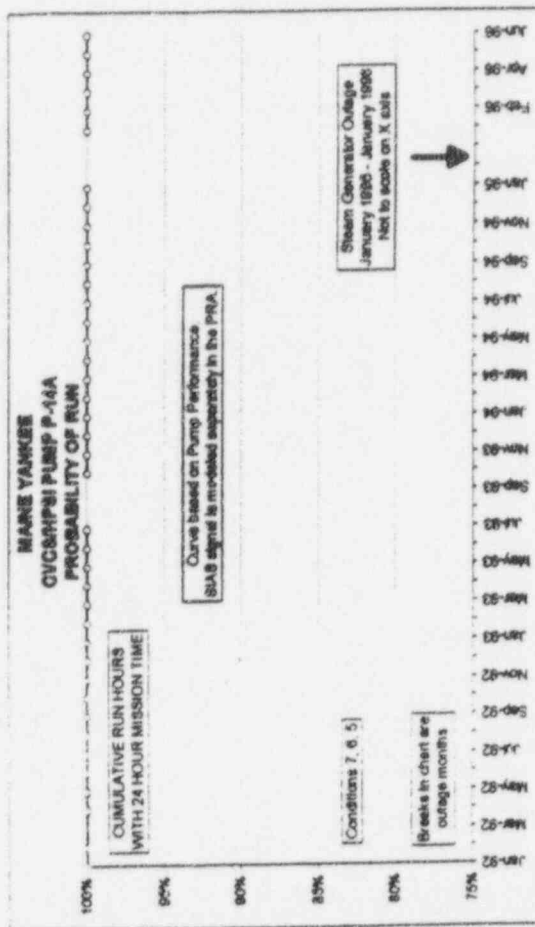
Figure 5

Total Starts	79
Successful Starts	79
Failures to Start	0
Total Run Hours	9.996
Run Failures	0
While aligned	
Planned Maintenance Hours	4.4
Unplanned Maintenance Hours	0.5

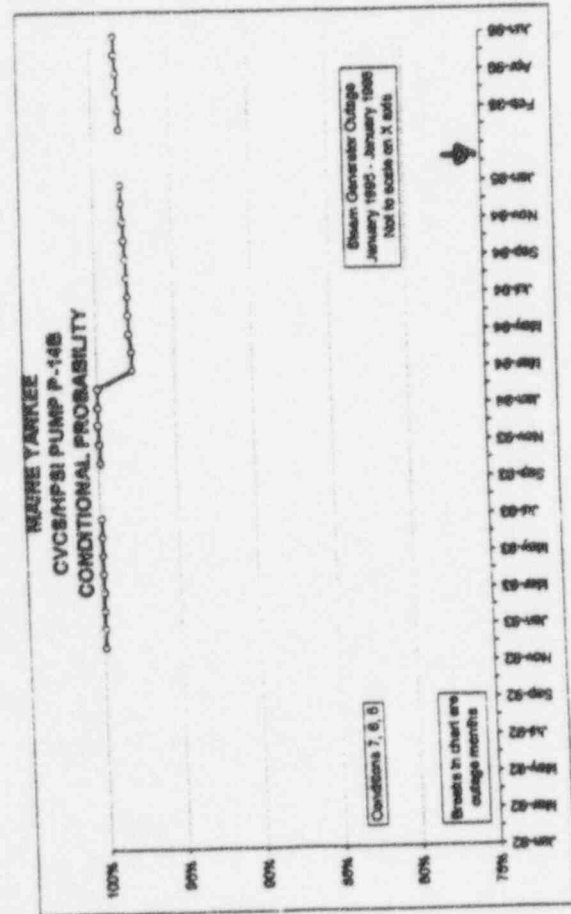
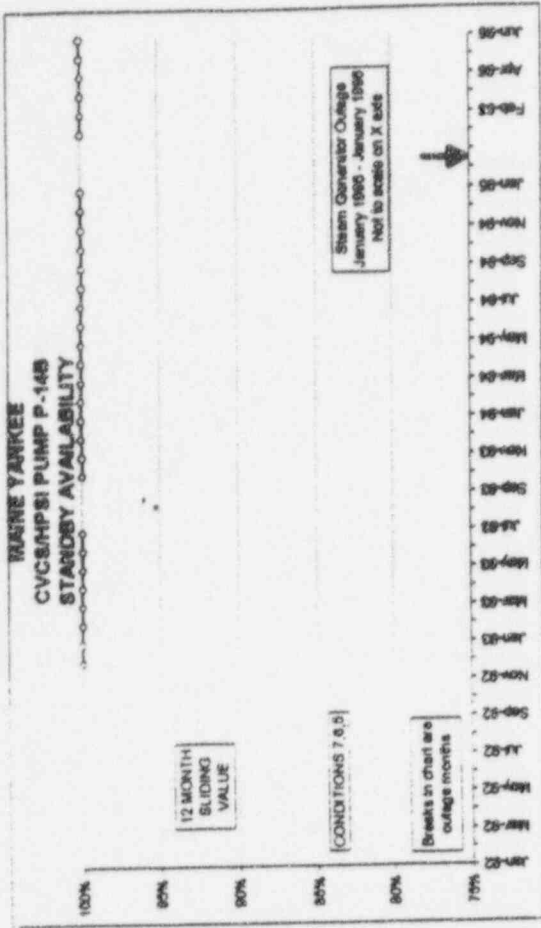
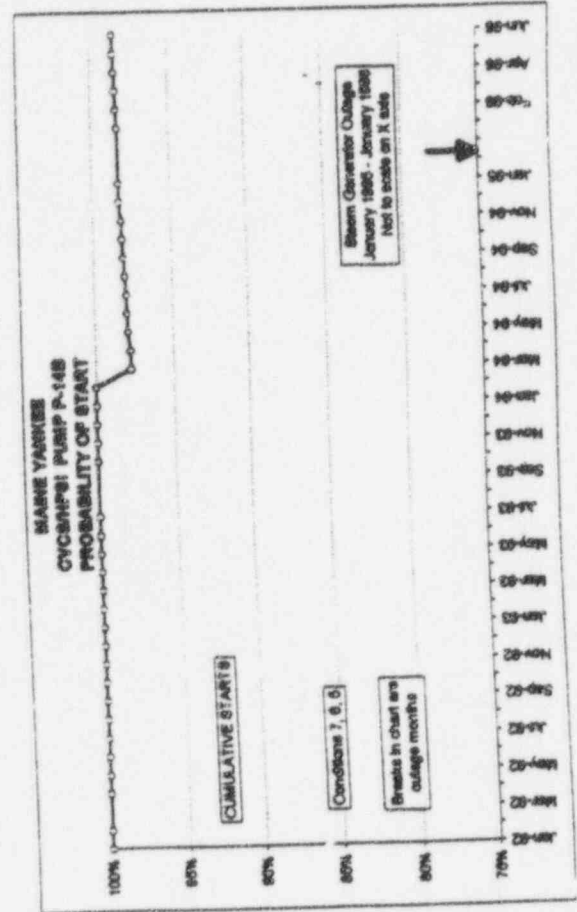
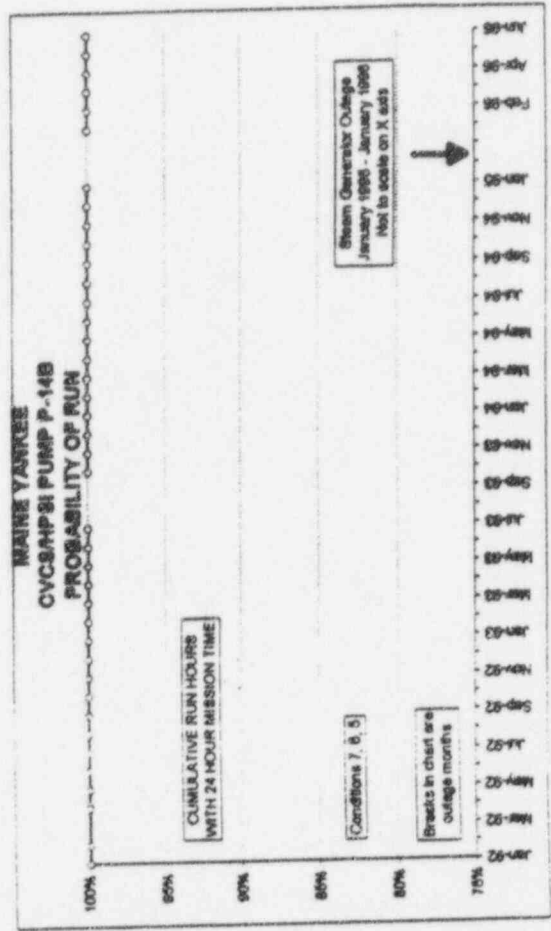
Figure 6

Total Starts	68
Successful Starts	68
Failures to Start	1
Total Run Hours	6,592
Run Failures	0
While aligned	
Planned Maintenance Hours	9.5
Unplanned Maintenance Hours	0.7

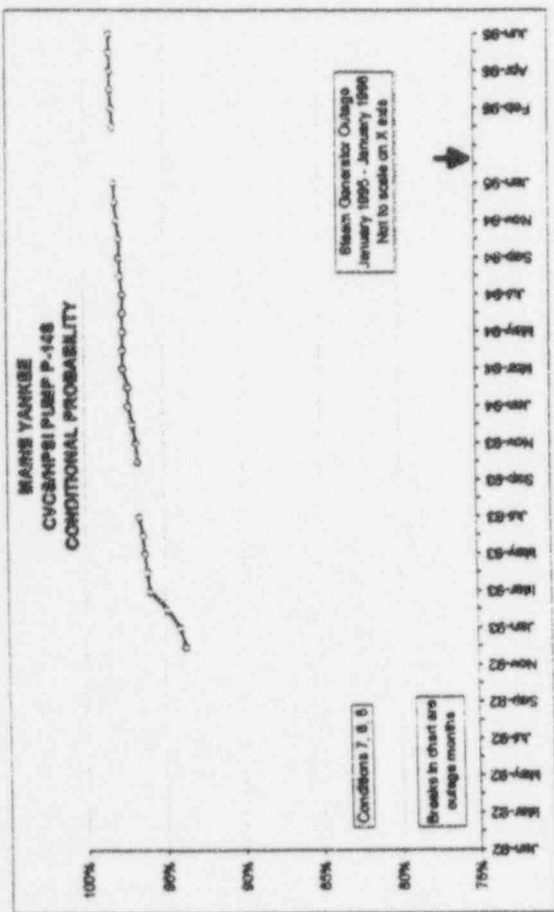
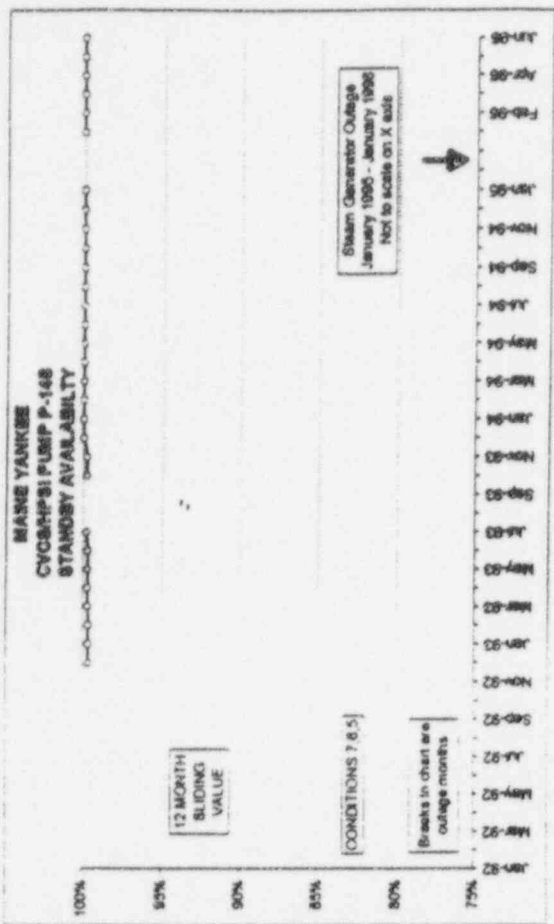
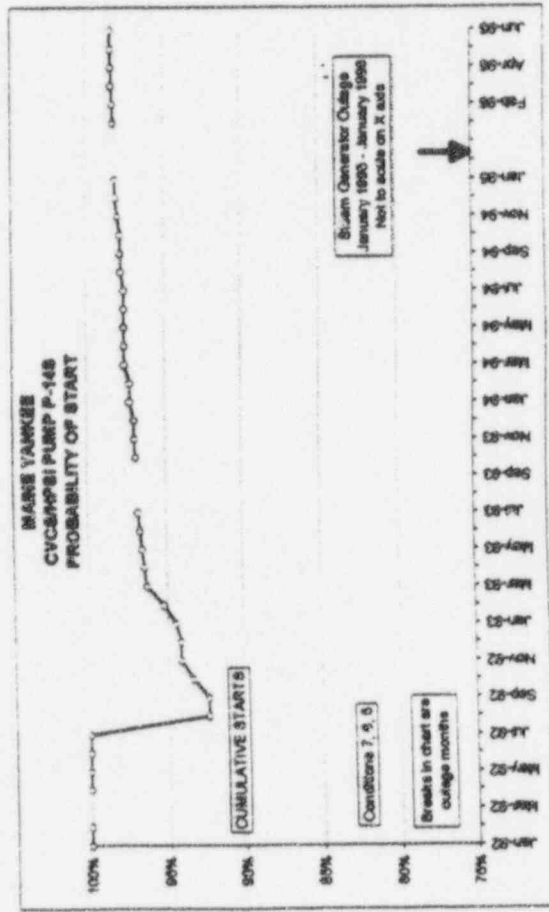
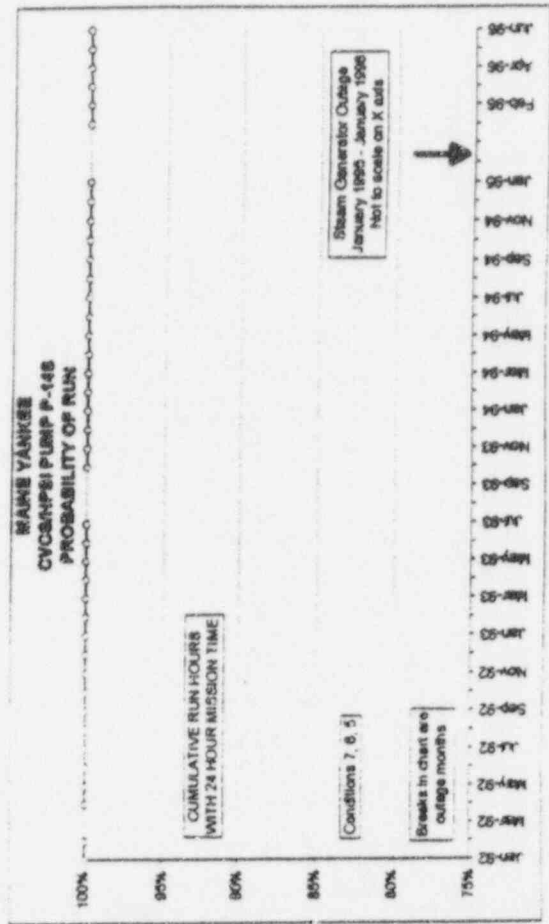
Figure 7

Total Starts	60
Successful Starts	59
Failures to Start	1
Total Run Hours	11,159
Run Failures	0
While aligned	
Planned Maintenance Hours	27.3
Unplanned Maintenance Hours	0.0

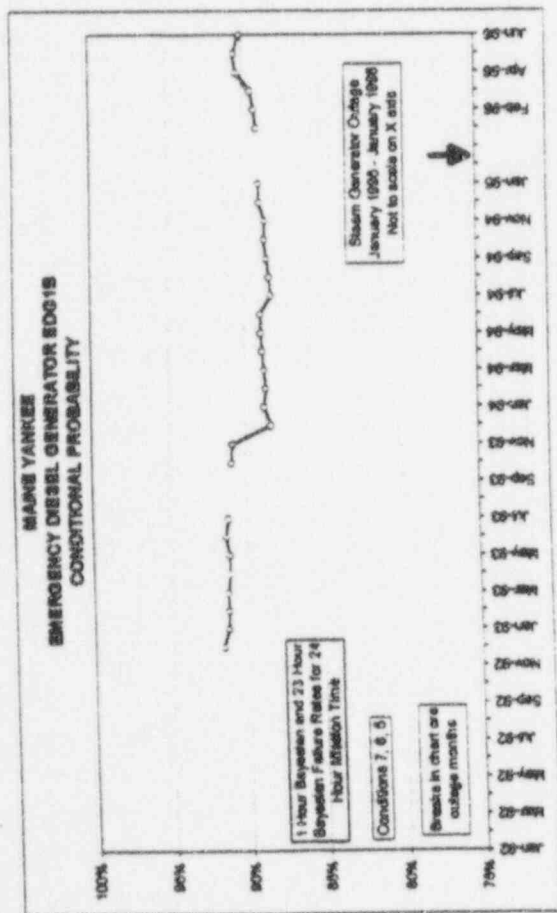
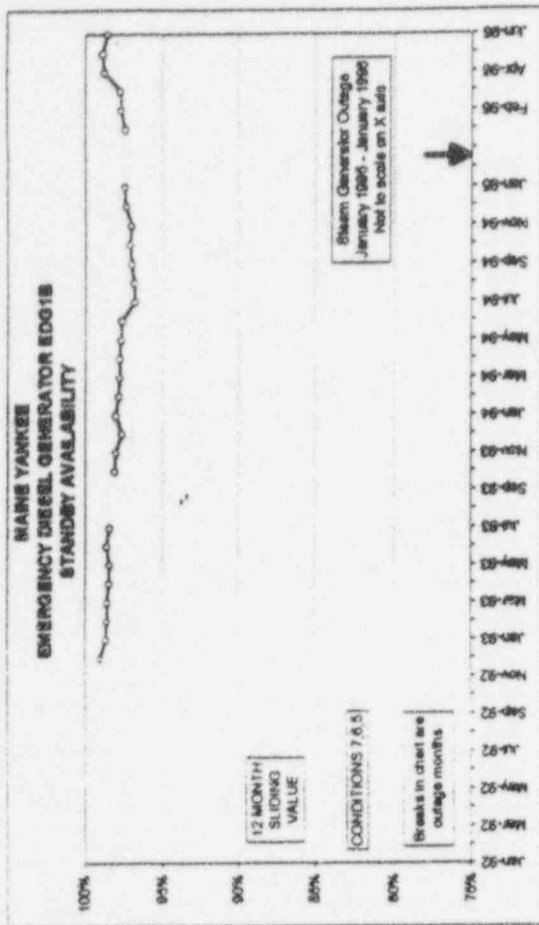
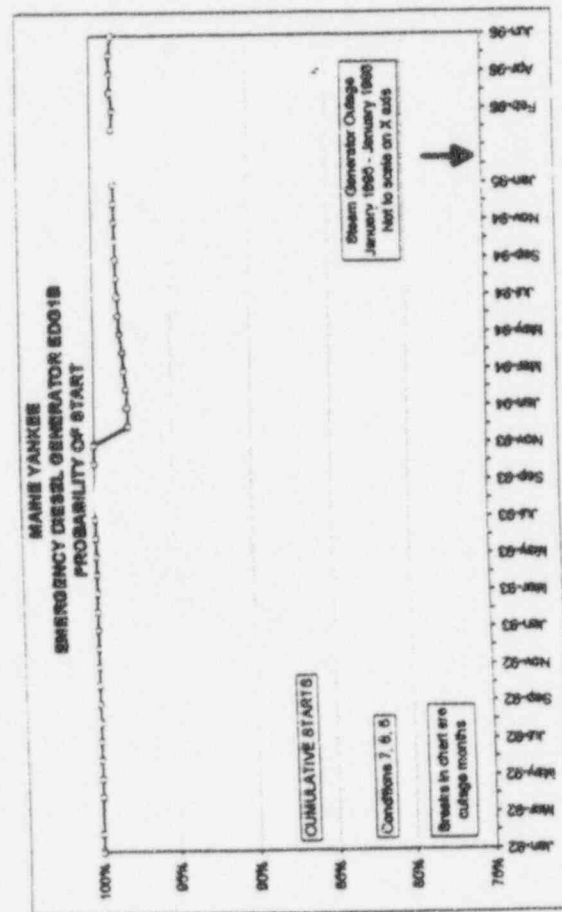
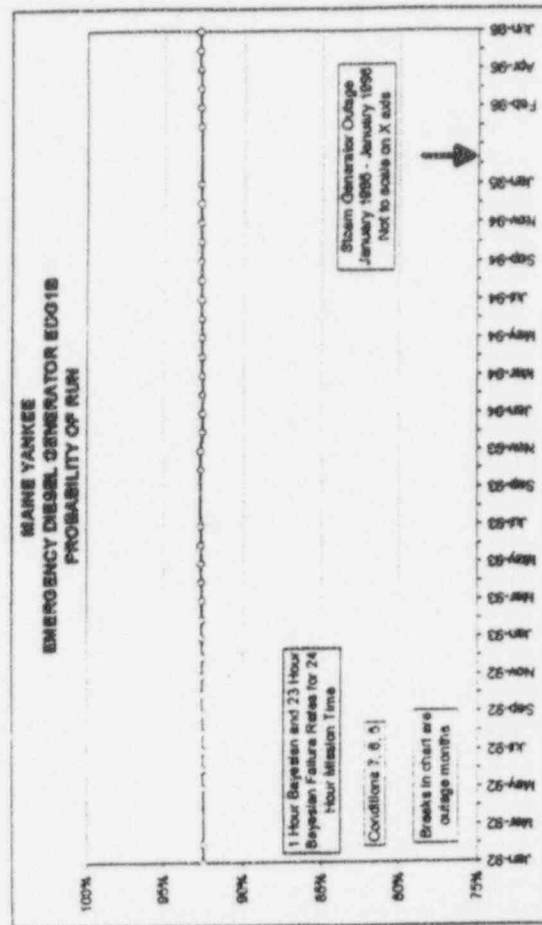
Figure 8

Total Starts	67
Successful Starts	67
Failures to Start	0
Total Run Hours	113
Run Failures	1
Planned Maintenance Hours	367.5
Unplanned Maintenance Hours	86.2

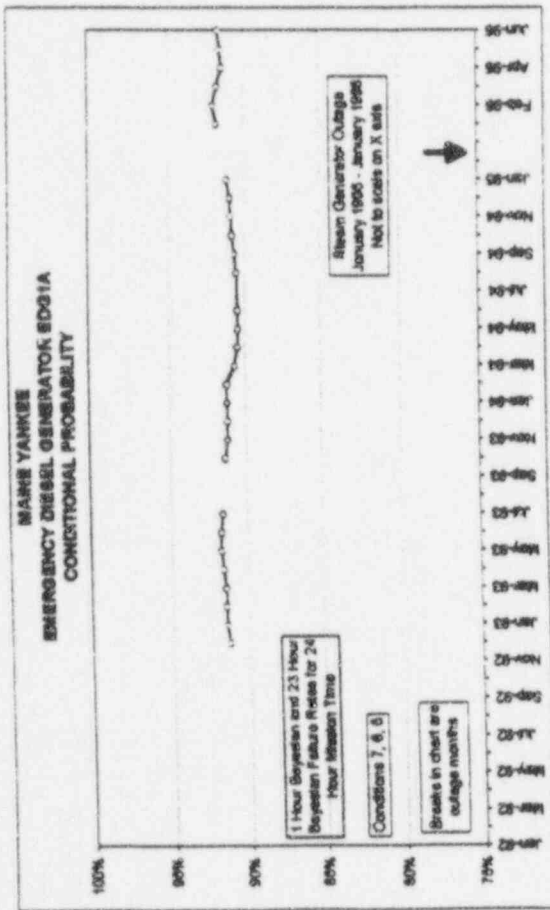
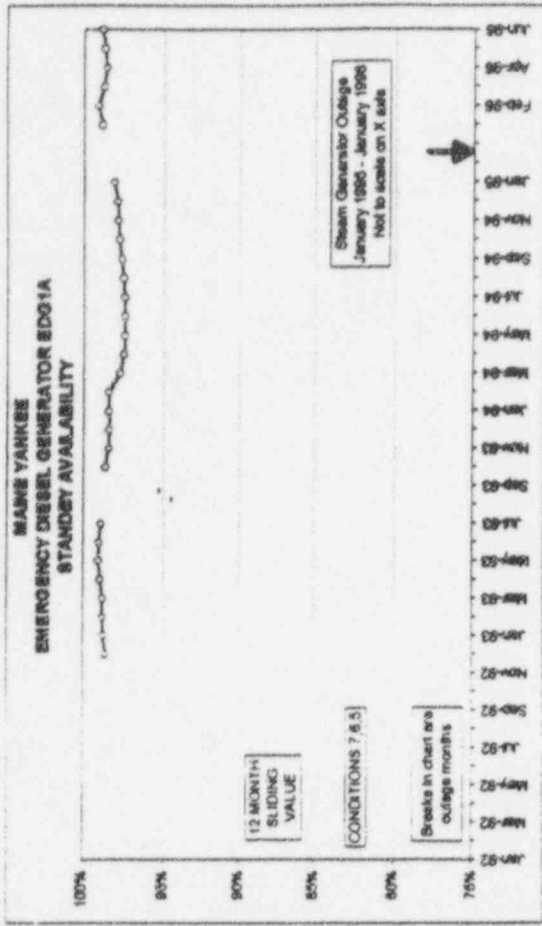
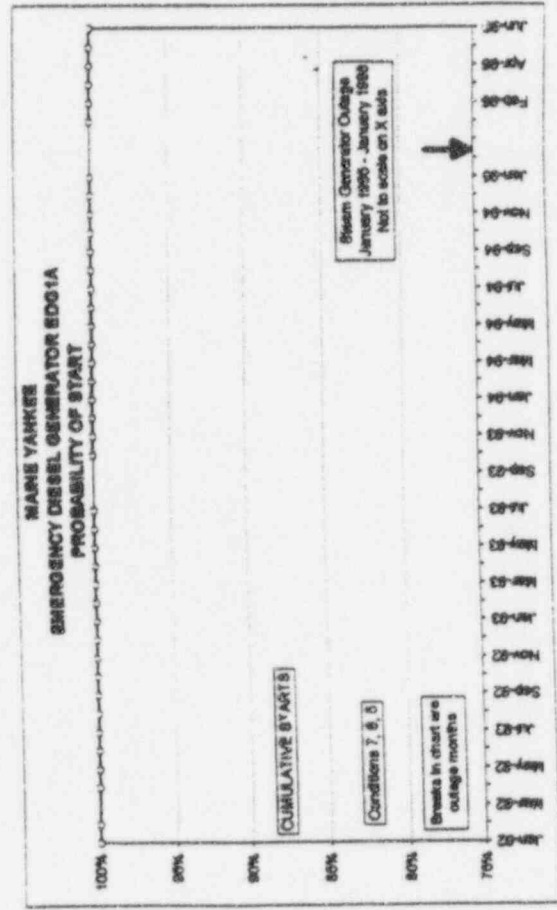
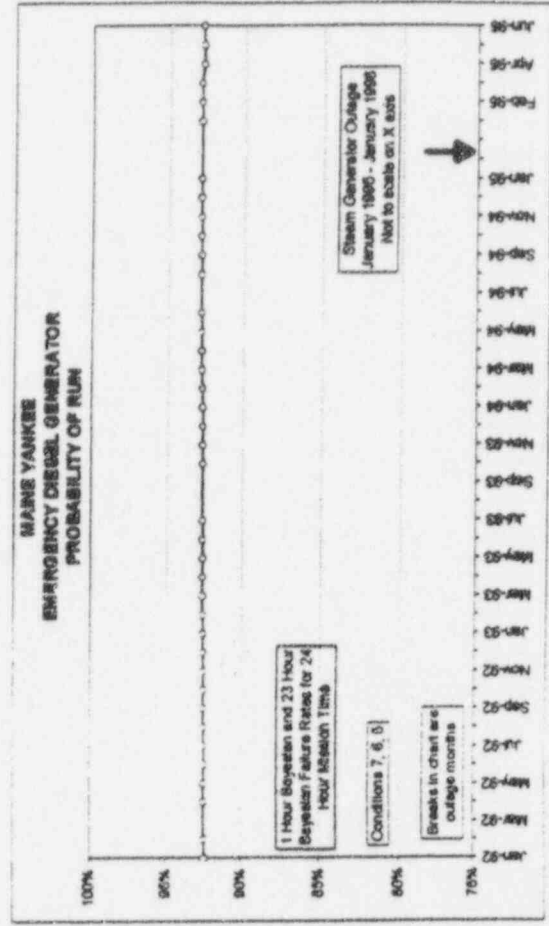
Total Starts	80
Successful Starts	79
Failures to Start	1
Total Run Hours	111
Run Failures	1
Planned Maintenance Hours	396.5
Unplanned Maintenance Hours	132.5
