**VIRGINIA ELECTRIC AND POWER COMPANY**  
**NORTH ANNA POWER STATION UNITS 1 AND 2**  
**SERVICE WATER GROUNDWATER SPECIAL REPORT**

SERVICE WATER GROUNDWATER  
LEVEL EVALUATION

SERVICE WATER RESERVOIR GROUNDWATER  
LEVEL EVALUATION

NORTH ANNA POWER STATION

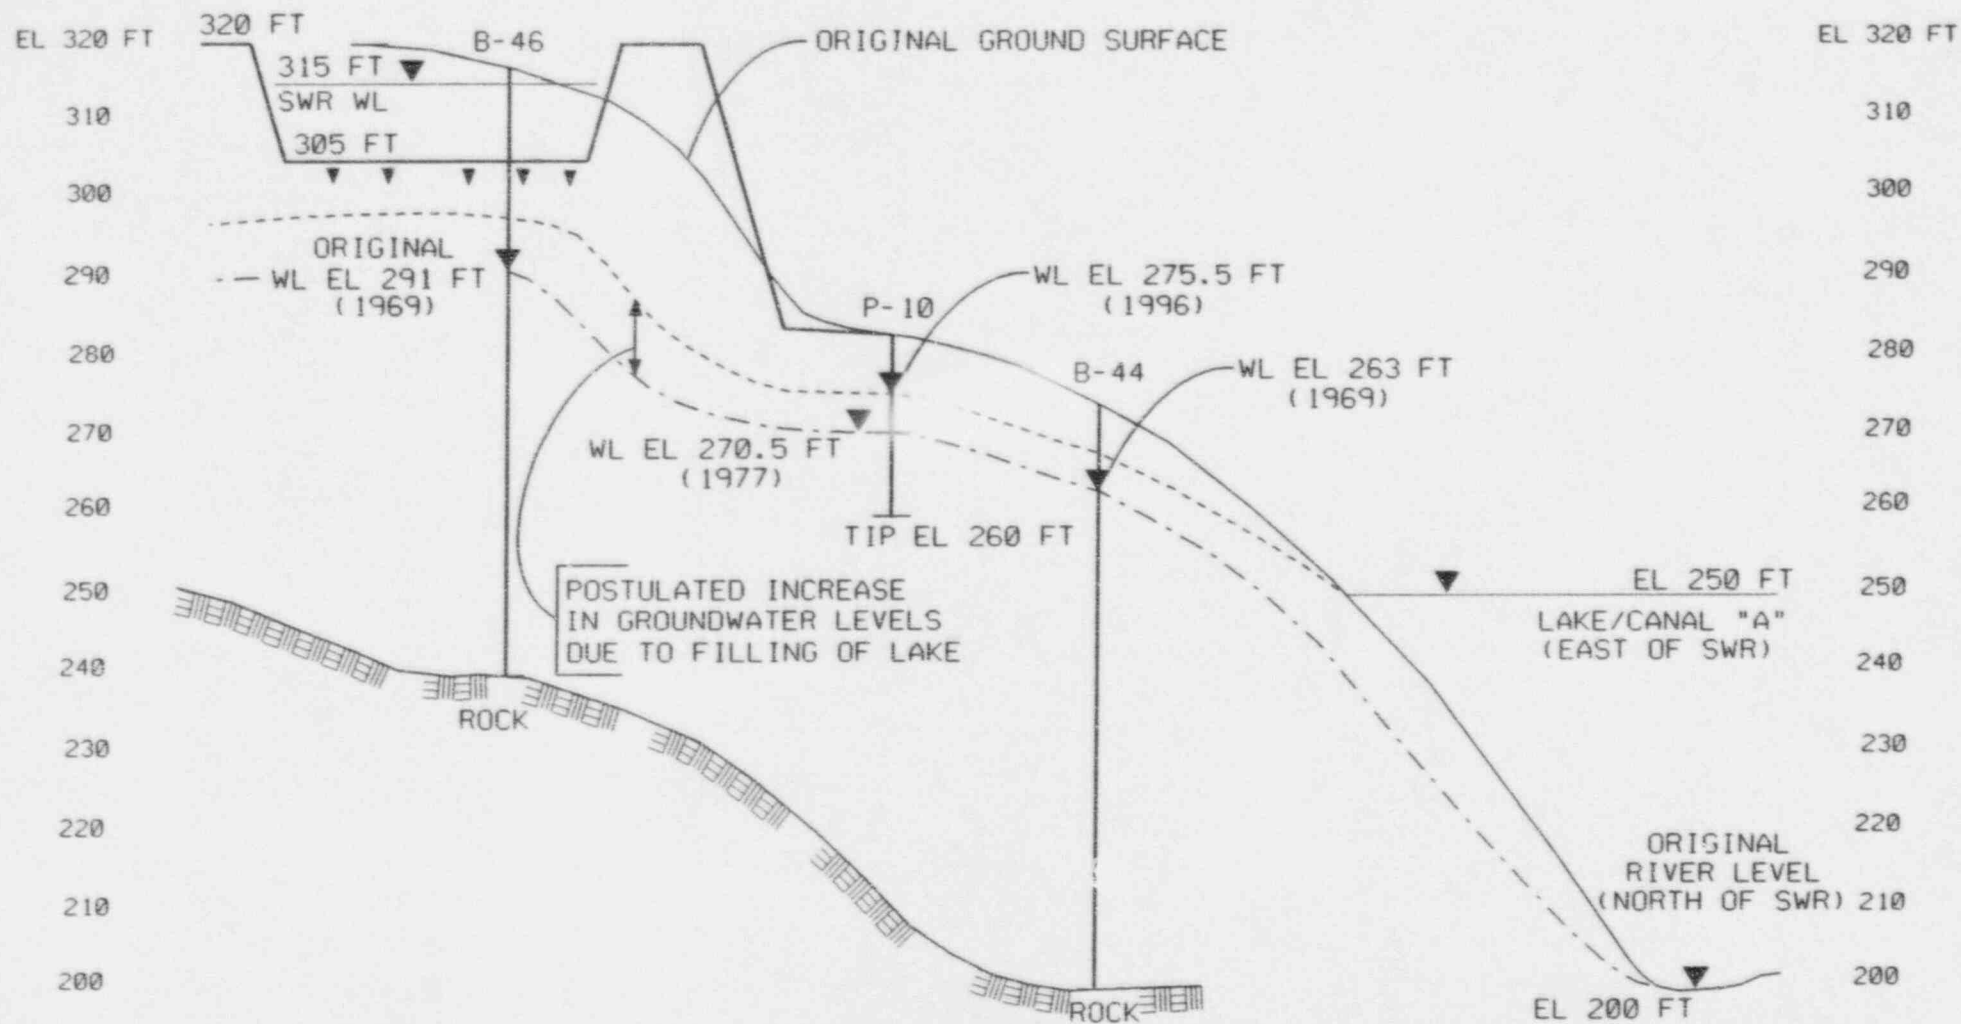
SKETCH 1  
SECTION OF SERVICE WATER RESERVOIR  
AND LAKE WATER LEVEL - SCHEMATIC  
NOT TO SCALE

The groundwater level over the entire area adjacent to the lake is higher than it was prior to filling the lake. Prior to filling of the lake, the North Anna River was the main body of water in the area and the groundwater drained to the river level which was approximately el. 200 ft. The lake is currently maintained at el. 250 ft. thereby gradually increasing the groundwater table in the immediate vicinity of the lake approximately 50 ft. over time. This increase is shown schematically in Sketch 1 which utilizes information from the original borings and current water levels to illustrate the condition. The original water level as depicted in Sketch 1 could exit on the slope as with a spring or dip to the river level. A reduction in the gradient, or the difference in head of water over length, to the discharge canal

would result in less water being discharged from the area near the SWR towards the lake and more water build-up under the SWR. The location of the discharge canal which is a part of the lake and the SWR are shown on Figure 2.

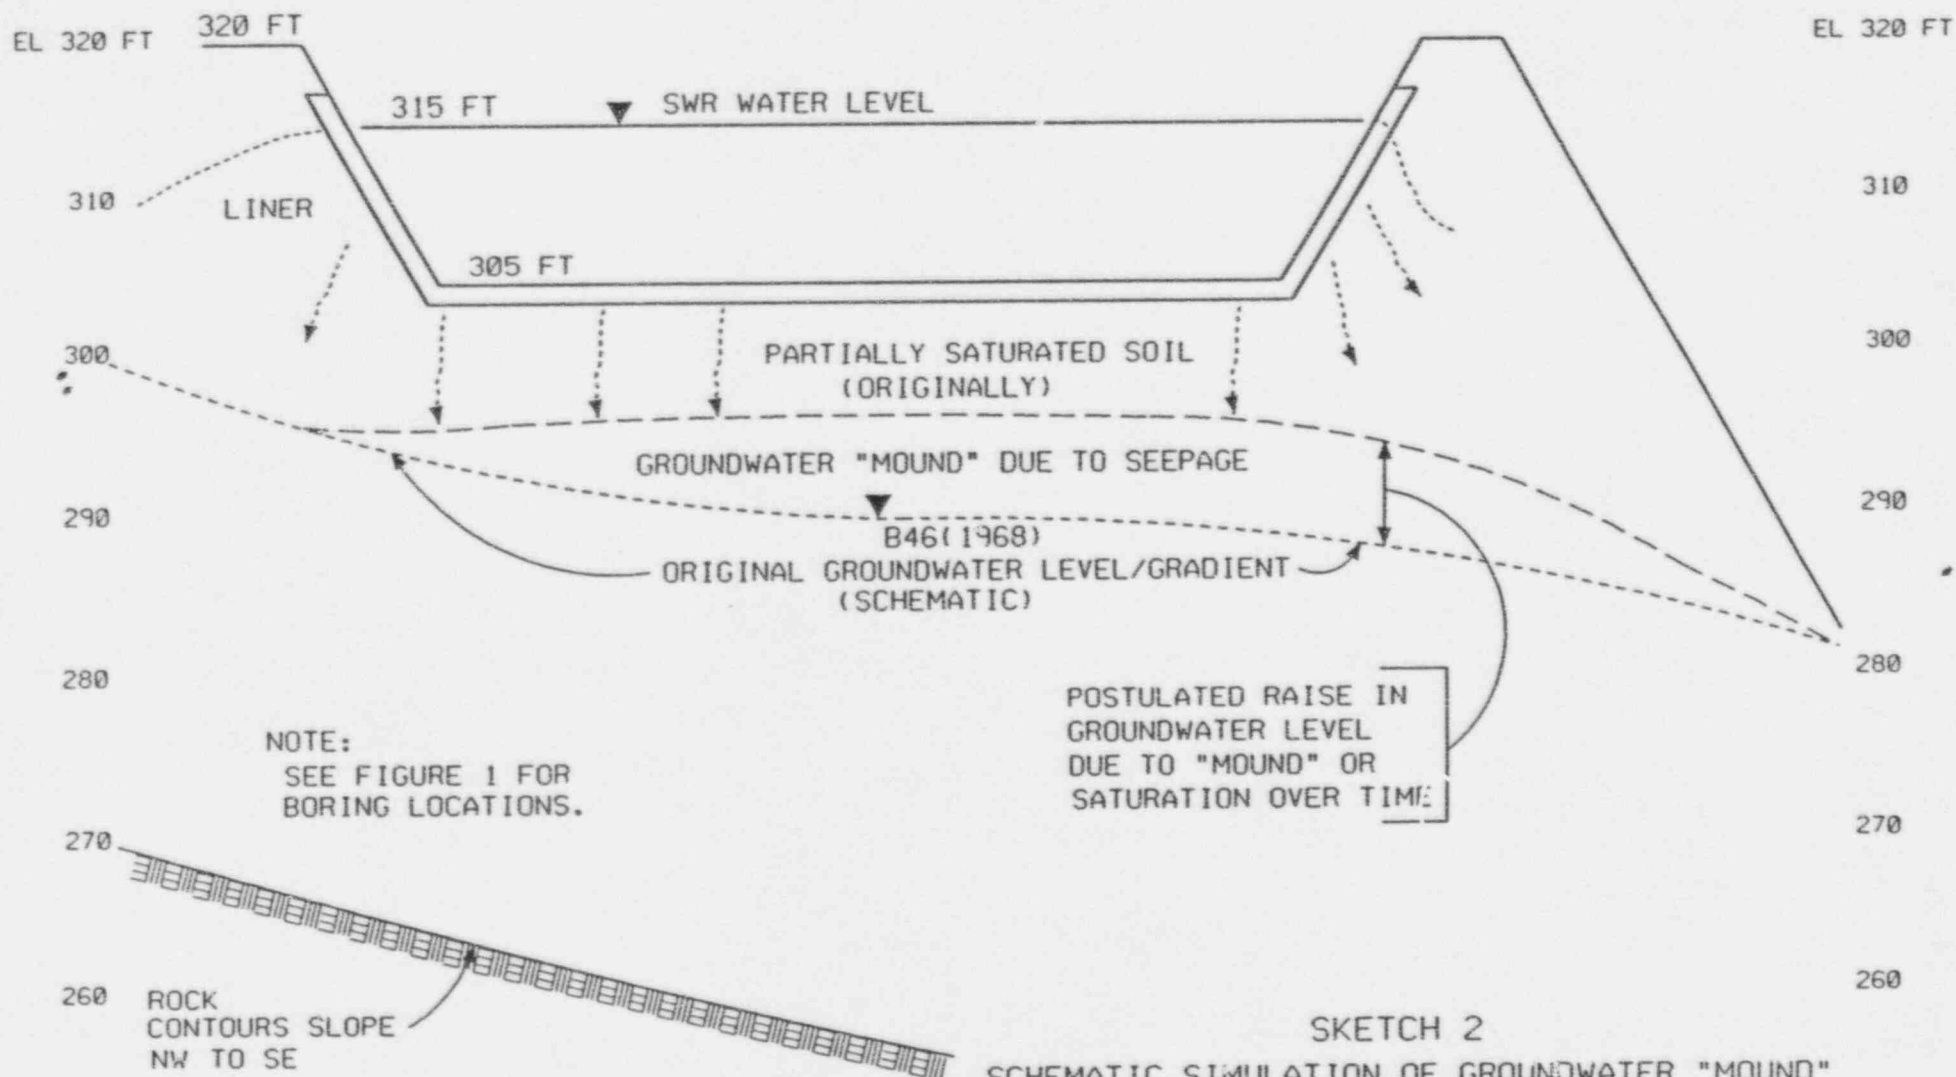
SKETCH 2  
SCHEMATIC SIMULATION OF GROUNDWATER "MOUND"  
SECTION THRU B-46 LOOKING NORTH  
NOT TO SCALE  
HORIZONTAL SCALE GREATLY EXAGGERATED

The SWR also acts as a recharge basin. The reservoir was constructed in a relatively high area above the plant on partially saturated residual soil having a low permeability. The reservoir is lined by two feet of a practically impermeable soil liner. There is a slow seepage of water out of the SWR which percolates down through the partially saturated residual soil to the groundwater table. The original groundwater table was 15 to 25 ft. below the bottom of the SWR (See Sketch 1 and Borings 46 and 48). The SWR recharges the natural groundwater in the area through seepage, although this recharge is very slow due to the low permeability of the soils and the relative low volume of the seepage from the SWR. If the recharge is occurring at a faster rate than the horizontal groundwater movement away from the reservoir, "a mound" in the groundwater table the SWR is created. Estimates of recharge vs. horizontal flow indicate the recharge rate to be greater than the rate of horizontal groundwater movement. A schematic of this phenomena as presented in Sketch 2.

It is also reasonable to expect that the mound or saturation will increase toward the southeast in future years. This could cause water levels in the piezometers along the southeast segment of the dike to show a greater increase in water levels than piezometers on the northeast or up gradient side as is apparently the case.

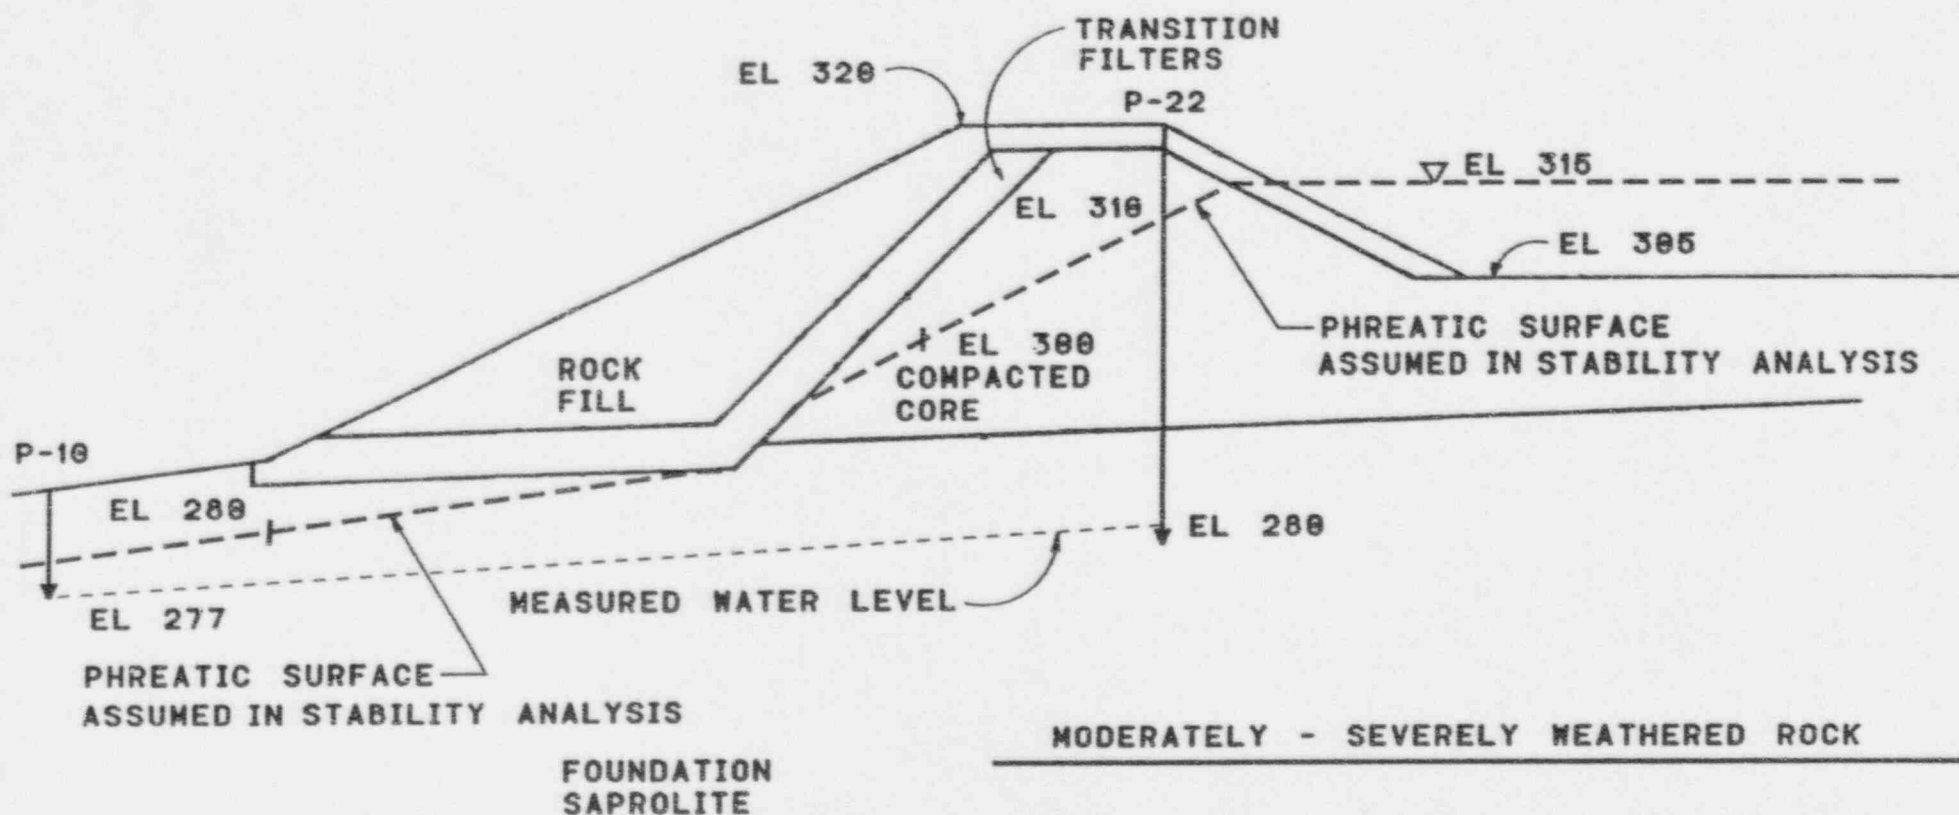
FIGURE 3

A slight increase in piezometric head in the dike and at the toe does not significantly lower the stability of the dike. Calculations 11715-141-"SWR Stability Analysis," Ref. 12, assumes a much higher phreatic surface for the stability analyses than the Technical Specification allowable limits. The calculation assumes a phreatic surface at an approximate elevation 311 ft. at the inboard edge of the slope crest where P-22 is located, elevation 280 ft. at the toe, and elevation 276 ft. at the approximate location of P-10. Figure 3 is a sketch taken from the UFSAR which shows the idealized water levels used in the seismic and static stability analysis. The water levels used in both analyses are the same. The maximum allowable water level as required by the Technical Specifications at P-10 and P-22 are 277 ft. and 280 ft. respectively are superimposed on Figure 3. The minimum factors of safety obtained in the seismic and static stability analysis utilizing the higher water levels shown in Figure 3 were 1.2 and 1.5 respectively (Ref. 13). Current recorded water levels at P-22 are approximately 31 ft. below that assumed in the stability calculation. The calculated factor of safety against failure of the dike would be significantly increased if the actual water levels were used in the stability calculations. Therefore, the stability of the dike is not decreased by the small increase in water levels indicated in P-10 and

P-22, and a significant margin remains to the safety factor against a stability failure.

- 5.1 The piezometers along the southeast portion of the dike (P-10, 21, and 22) be monitored on a quarterly frequency for approximately one additional year and the results be evaluated at that time.
- 5.2 Since P-10 and P-11 are the last operative pneumatic piezometers, additional standpipe piezometers should be installed at the toe of the slope along the SE section near P-21 and near P-22. P-10 is presently located at the toe of the slope approximately midway between the two piezometers.
