MILLSTONE NUCLEAR POWER STATION, UNIT NO. 3  
CONTAINMENT RECIRCULATION SPRAY (RSS)  
SYSTEM

TUBECO RADIOGRAPHY ISSUE

AUGUST 12, 1985

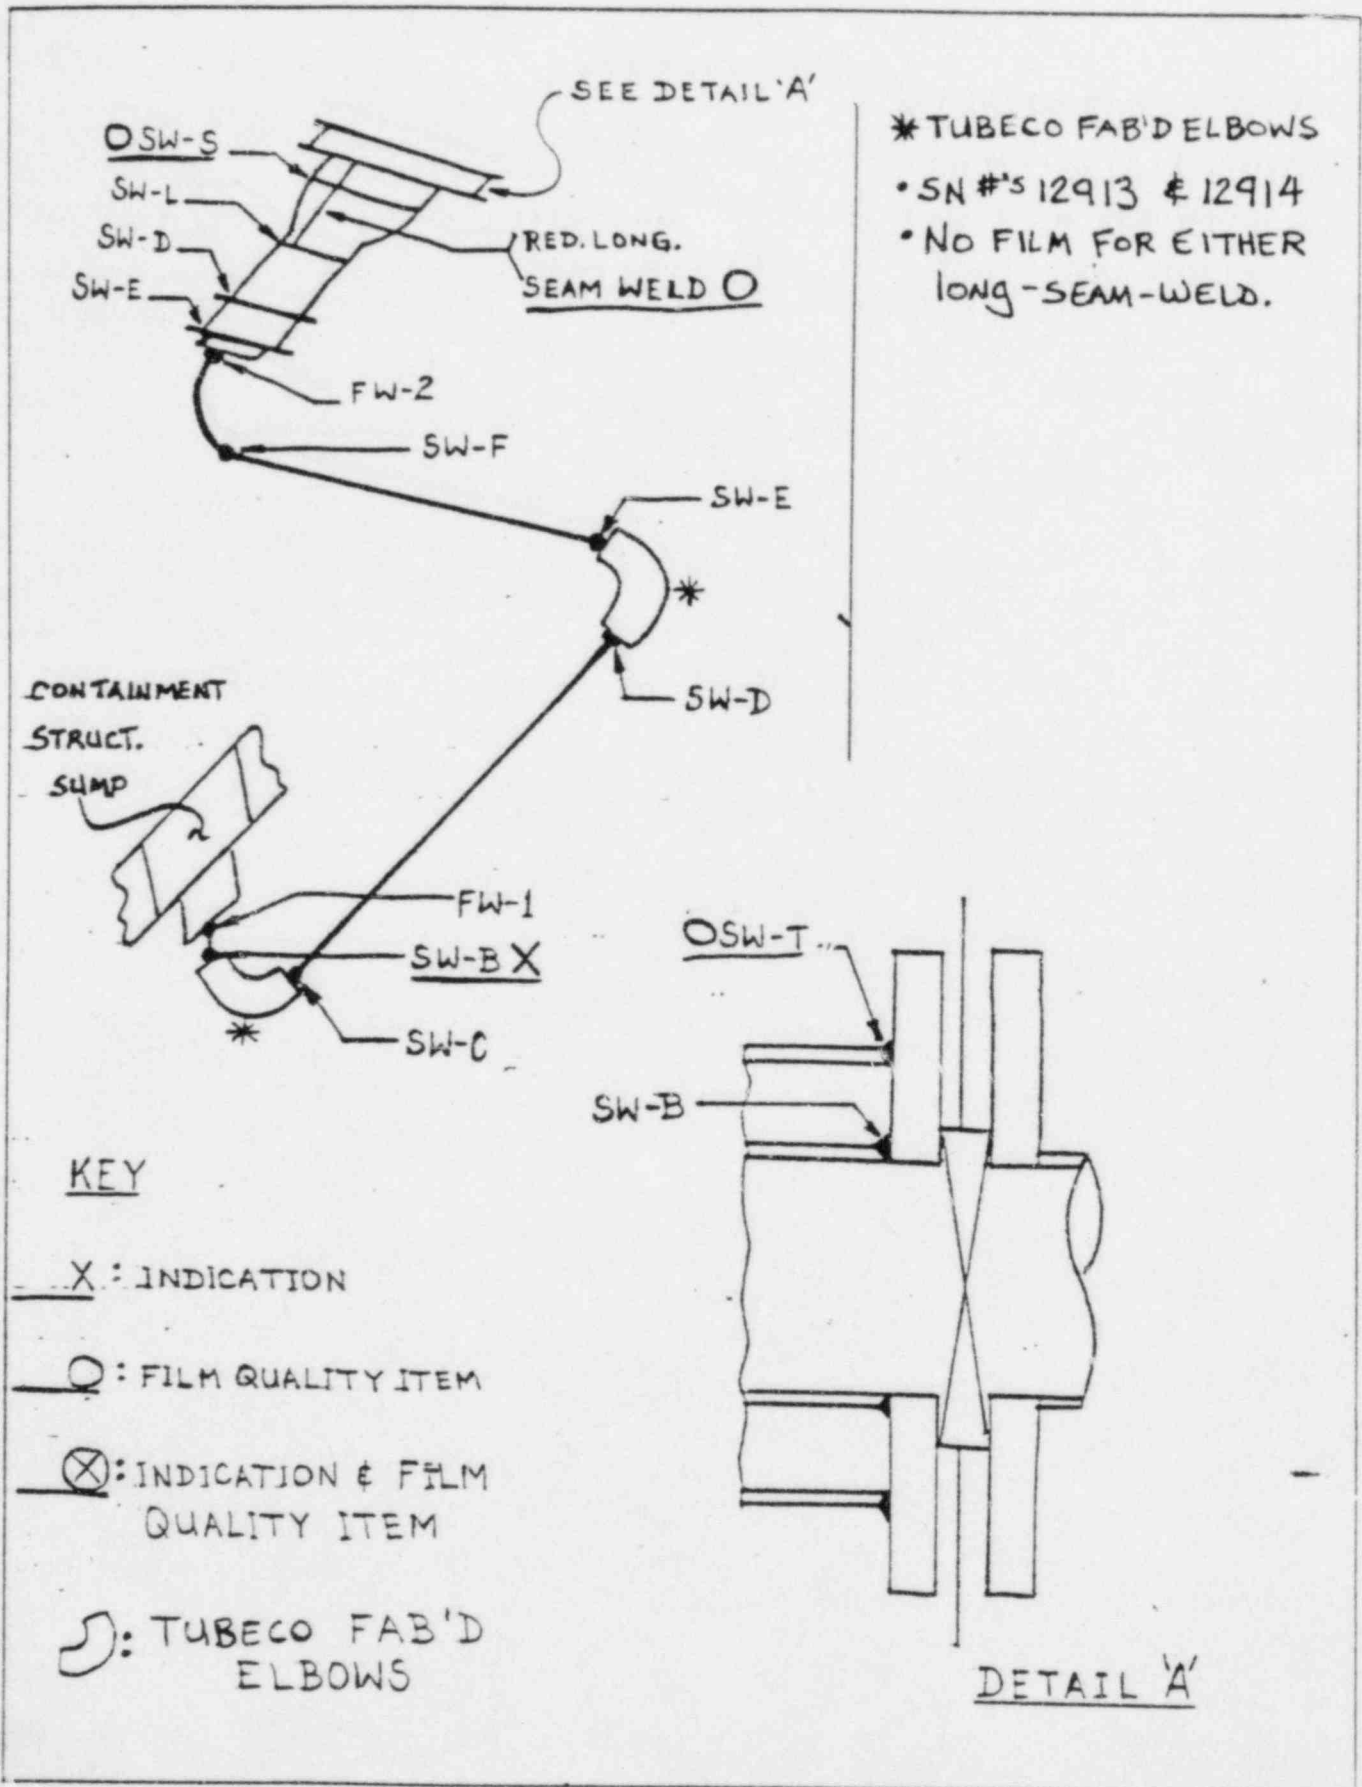
FIGURE 1

Visual examination was performed on SW-E, SW-D, SW-C, SW-B and the elbow long seams (S/N Nos. 12913 and 12914). No visible flaws were found in the areas inspected. The extrados long seam from SW-C to SW-B was partially obscured (approximately 10% of length) due to residual water and dirt film.

Weld radiograph SW-B had an indication at the intersect area of the circumferential weld to long seam. This was not detected on the pipe I.D. by visual examination. The remaining weld radiographs were acceptable; however, the radiographs of the long seam welds were misplaced and not available for review. Visual examination of these long seams revealed no apparent defects at the I.D. root area.

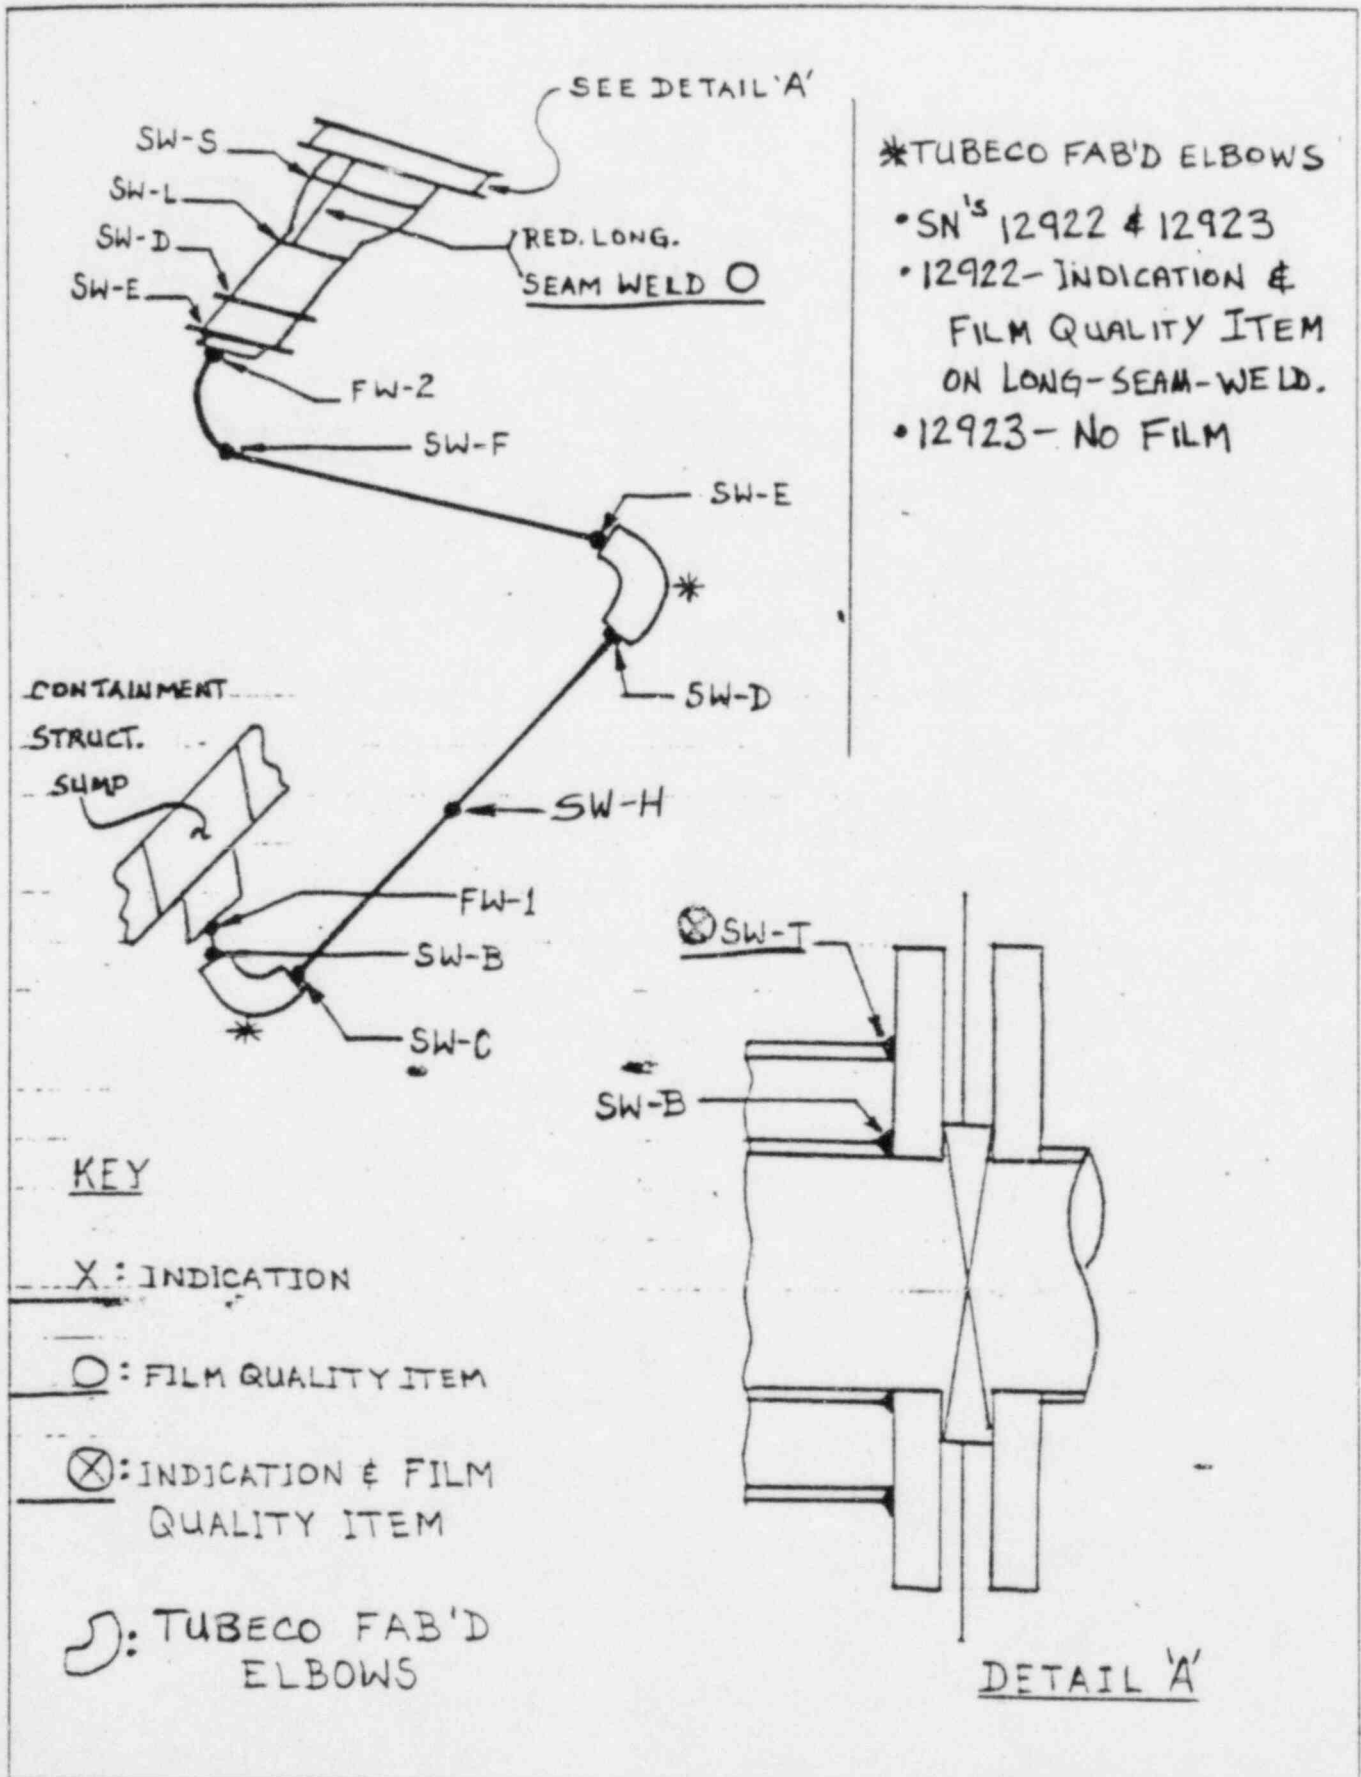
FIGURE 2

The radiograph review for this line identified no apparent defects. Film quality for radiographs taken of the elbow seams for elbow S/N 12922 were not acceptable to ASME standards. Radiographs of elbow seams S/N 12923 were misplaced and not reviewed. These radiographs were initially accepted.

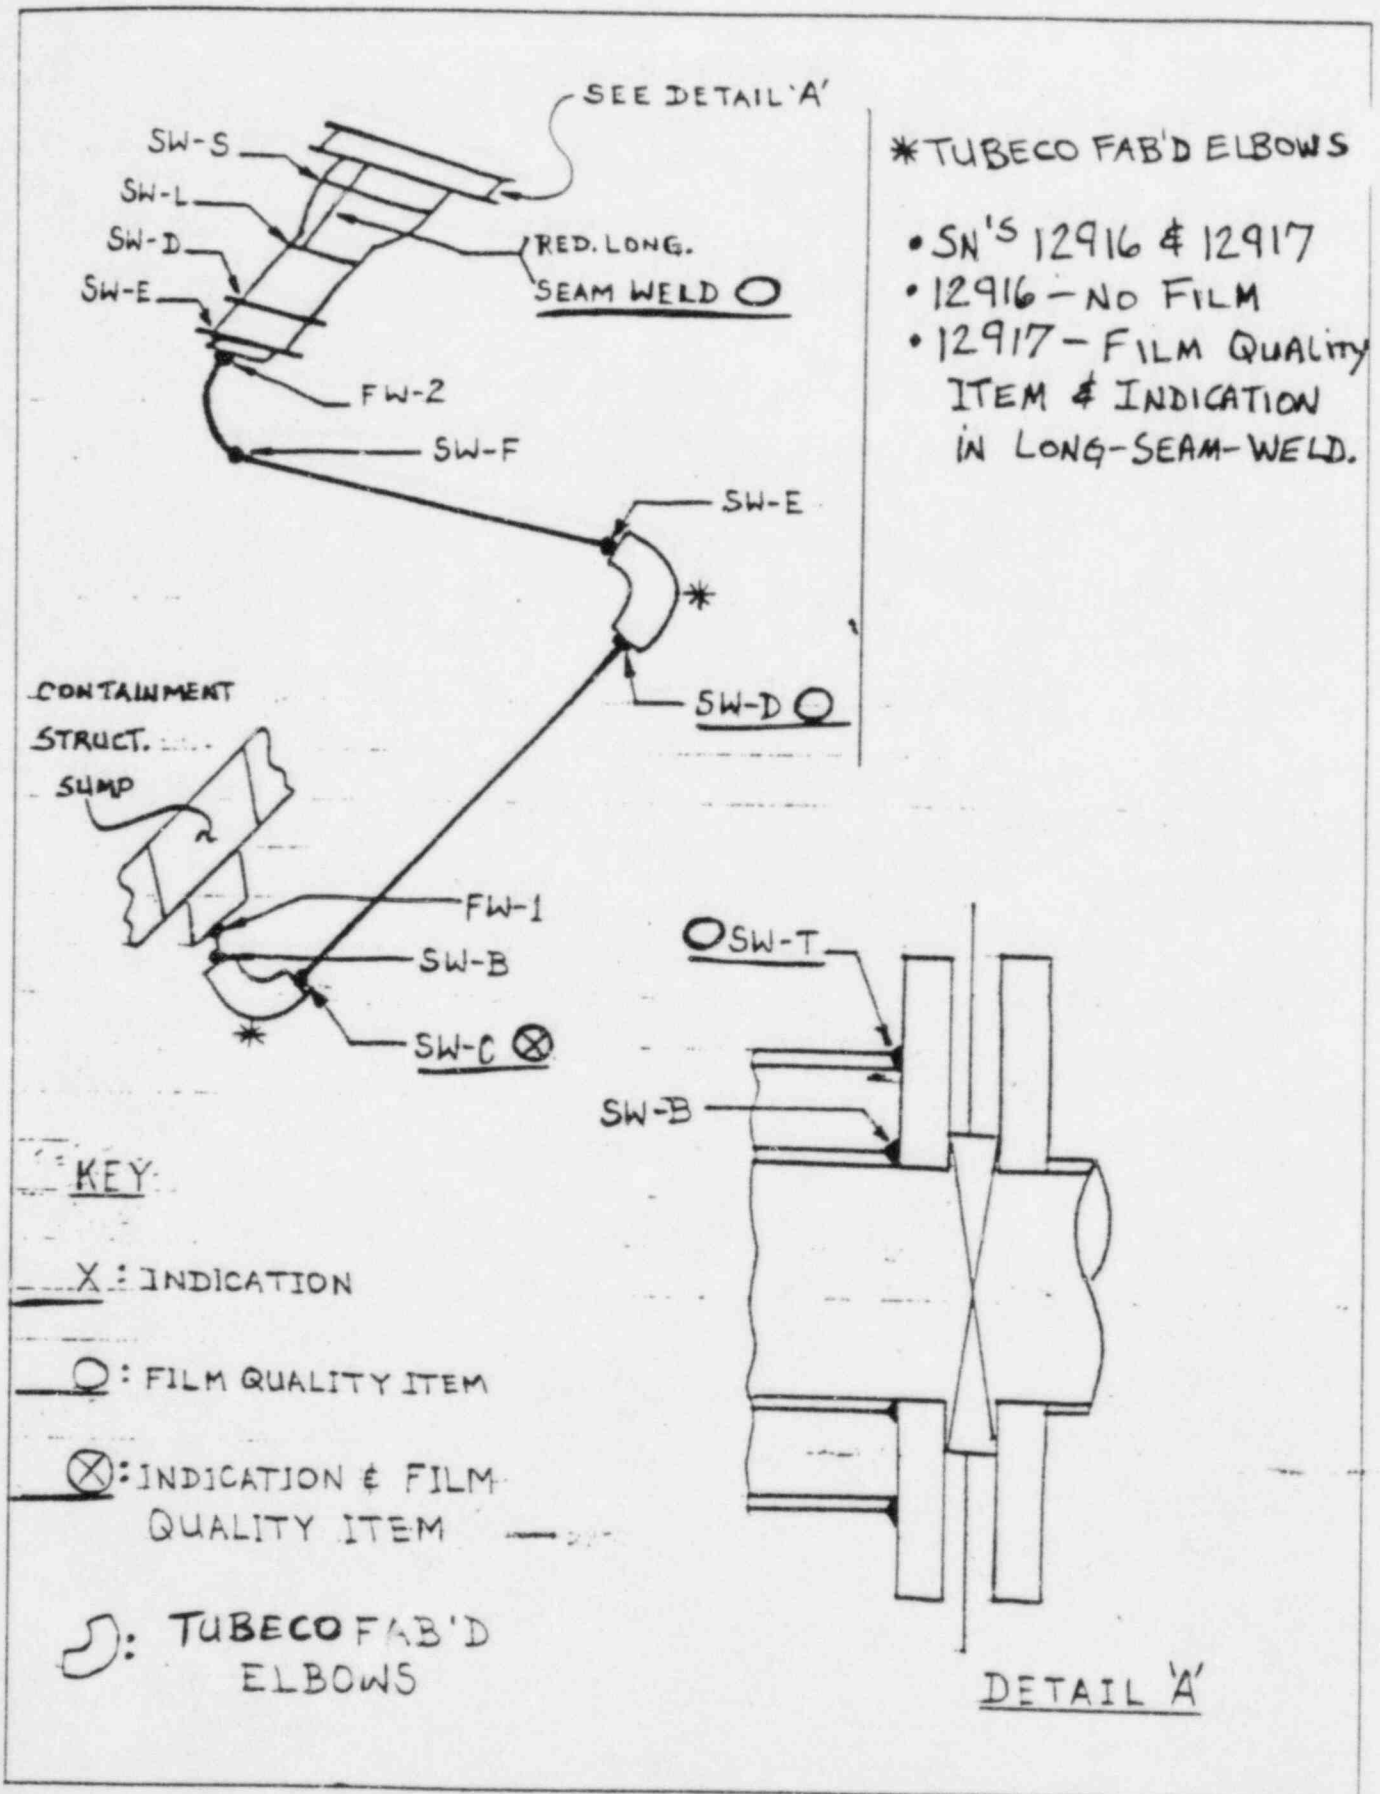
FIGURE 4

Radiograph review of SW-B and SW-E found these welds acceptable. Film quality problems were identified for SW-D, SW-C and elbow seam welds S/N 12917. The seam weld radiographs for elbow S/N 12916 were misplaced and not available for review. Weld SW-C and elbow seam weld S/N 12917 radiographs revealed suspect indications which could not be located visually on the I.D. surface.
