MONTICELLO NUCLEAR GENERATING PLANT
Docket No. 50-263 License No. DPR-22

LER 96-011

Jumper Placement Error During Surveillance Procedure Causes
Dual Recirc Pump Trip, Requiring a Manual Scram

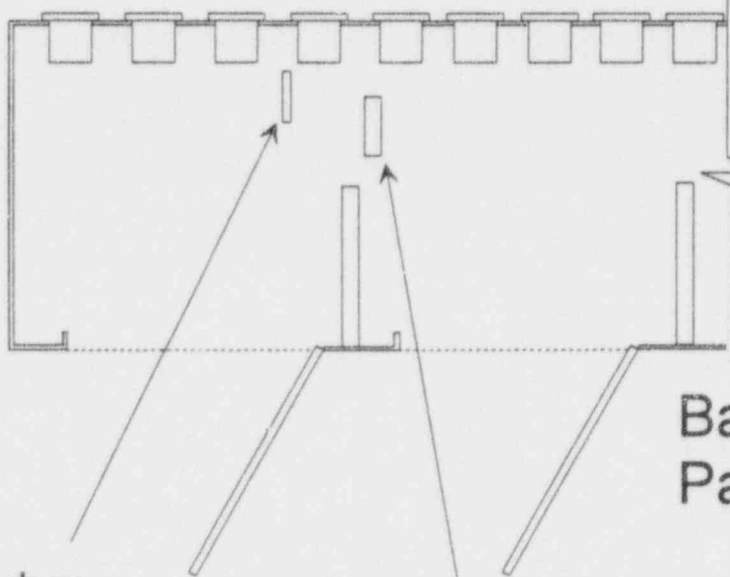
Top View of Relay Cabinet in the Cable Spreading Room

The relay to be jumpered is located in Panel C32 in the cable spreading room (see attached figure). Relays on C32 are mounted on the front vertical surface of the panel. Electrical

connections are accessed through the back panel doors. The relays are all labeled on the front of the panel and some relays are labeled inside the panel. Neither the relay that was identified in the procedure nor the relay that was jumpered were labeled inside the panel.

The relay was correctly identified from the front of the panel as the fourth relay from the end of the panel. In order to apply the jumpers, the personnel needed to go inside the panel from the back and locate the fourth relay from the end. They went to the first panel door from the end of the panel and found a structural member located next to the fourth relay, which would have made it difficult to install the jumper. They then went to the adjacent panel door and located what they thought was the same structural member and jumpered the relay next to it. Later investigation identified that there were two structural members and the fifth relay was actually jumpered. The licensed operator and the engineer independently selected the same wrong relay to jumper.

Desired Relay
to be jumpered
(Fourth Relay
From the End)

Relay that
was jumpered

This structural member
made it difficult to
apply the jumper to
the fourth relay

This member obscured
the fourth relay and was
confused with the other
structural member.

The surveillance procedure was changed to jumper parallel contacts on a more accessible relay.

The plant has an existing project to improve plant labeling. Quality Services personnel had identified labeling concerns with C32 during the last refueling outage. The priority on improving the labeling of C32 will be increased. Furthermore, no non-emergency jumpers will be applied to similar relays in C32, C33, C30, C39, C15 or C17 until the back of the relays are properly labeled.
