Edwin I. Hatch Nuclear Plant - Unit 1
Licensee Event Report
Incorrect Circuit Breaker Setting Results in
Emergency Diesel Generator Being Inoperable - Rev. 1

Edwin I. Hatch Nuclear Plant - Unit 1

Incorrect Circuit Breaker Setting Results in Emergency Diesel Generator Being Inoperable - Rev. 1

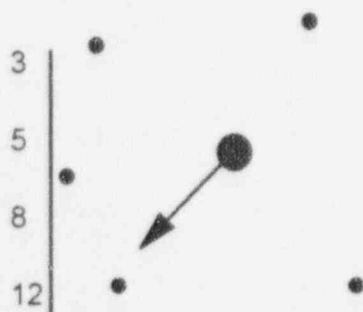
Figure 1, Actual Appearance of
Selector Switch Face

This event occurred as the result of a failure to incorporate information developed in a design calculation into the appropriate electrical single line drawing and plant maintenance procedure. A second error occurred due to a labeling problem which resulted in the installed trip device having a setting which differed even from the incorrect single line diagram.

In 1987, procedure 52PM-R24-002-0S, "Air Circuit Breaker Type LA-600 Maintenance" was developed to perform periodic maintenance on this breaker. The procedure writer appears to have relied on the erroneous technical information from the electrical single line diagram and listed the long time delay pickup as 300 amps and the instantaneous trip multiplier set at 12. In October 1988, the procedure was used to service the subject breaker and trip device. Per the maintenance work order, the breaker instantaneous trip setting was to have been set at 12. At this point, a labeling problem resulted in the individual who performed the work adjusting the setting to a multiplier of 8. The labels on the face of the trip device selector switch are misleading. An individual setting the trip device to point to the numeral 12 on the face of the selector switch would actually be setting it on a reference dot corresponding to 8x. Comparing Figure 1 with Figure 2 shows the labeling problem which led to the breaker trip device being set incorrectly.
