Public Service
Company of Colorado

July 5, 1985
Fort St. Vrain
Unit No. 1
P-85226

SUBJECT: Licensee Event Report
84-005, Final Report

TITLE (4)
Corrosion of PCRV Tendon Wires (Voluntary LER)

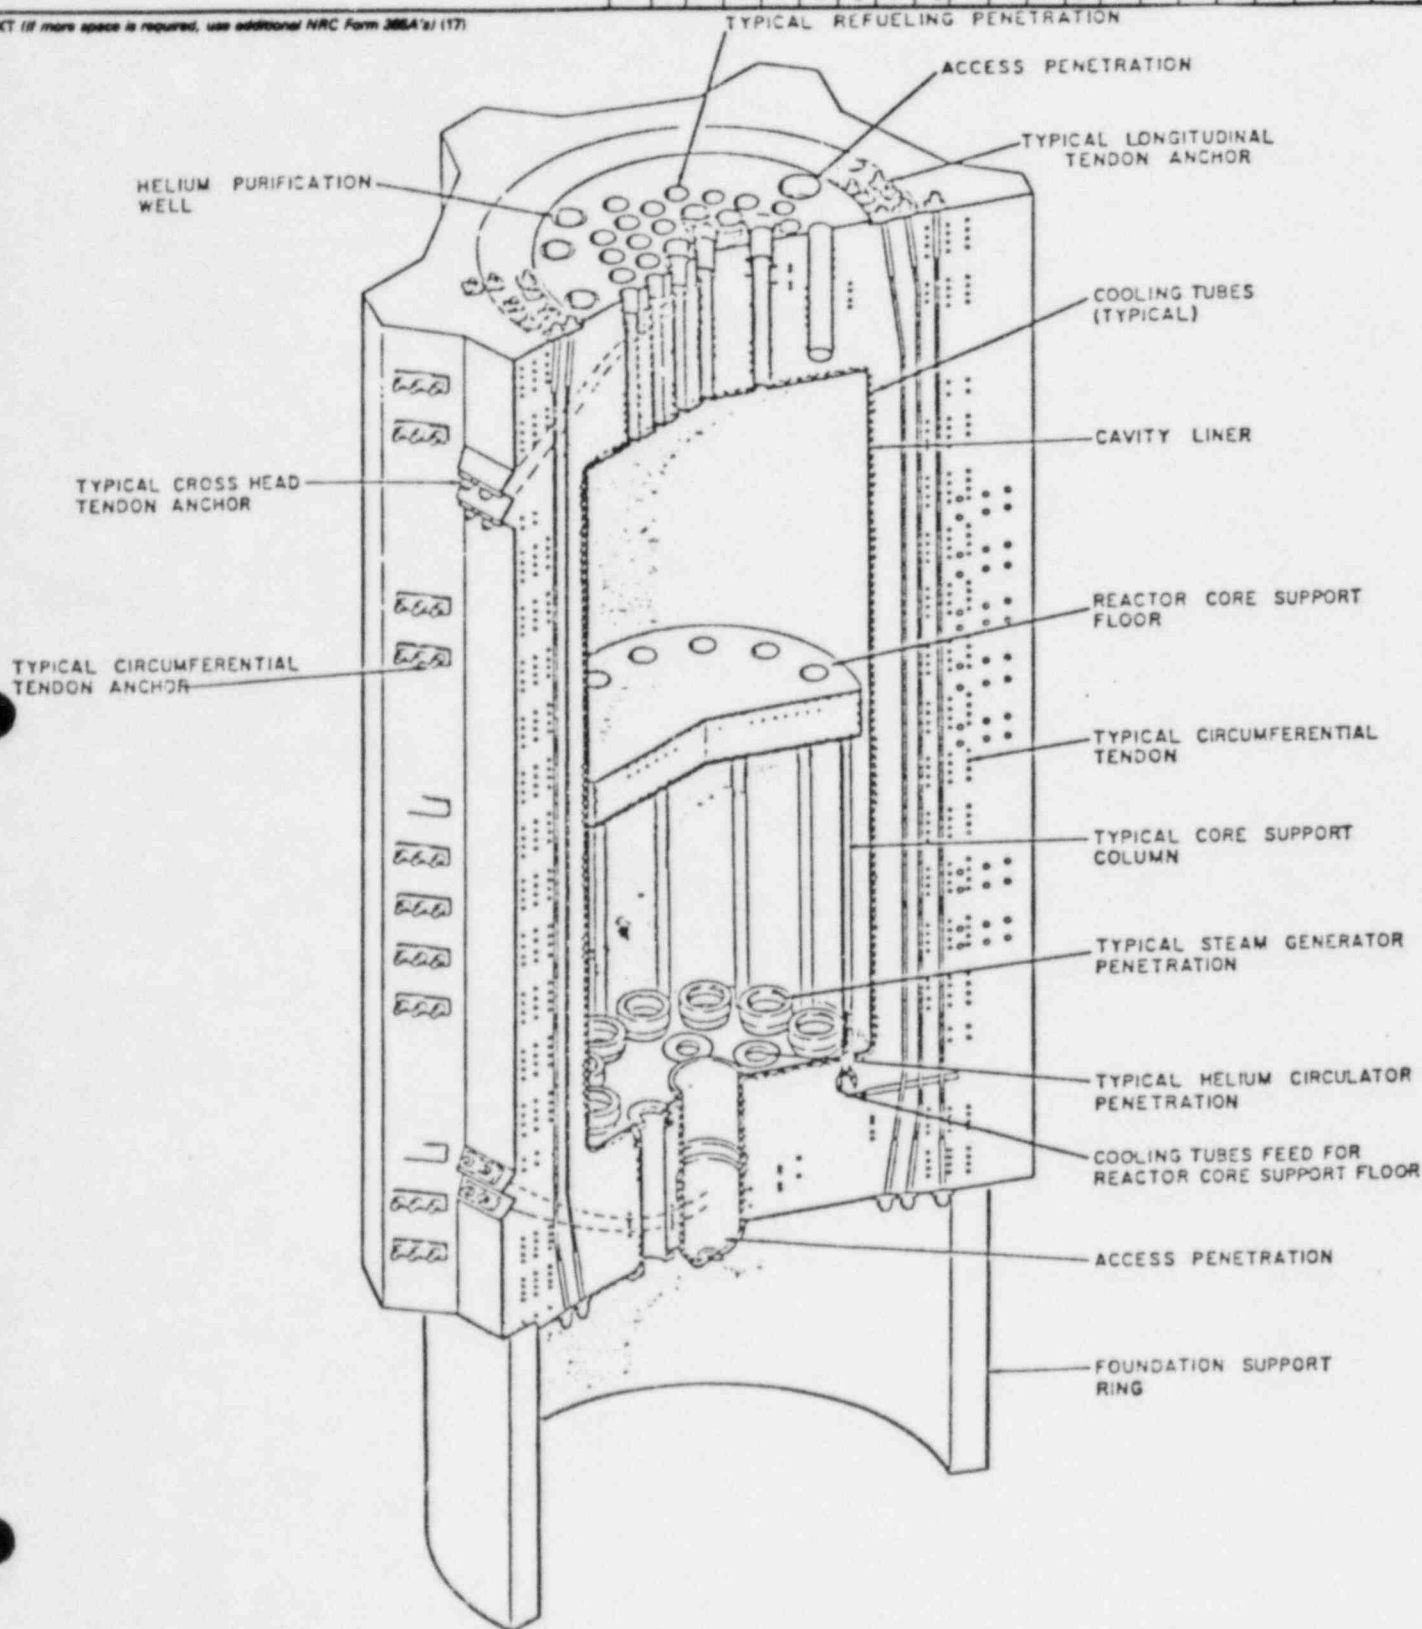
FIGURE 2

The Prestressed Concrete Reactor Vessel (PCRV) utilizes a system consisting of 448 prestressing tendons in two basic configurations consisting of 152 or 169 1/4 inch diameter wires. Each wire terminates at a buttonhead supported by an anchor (buttonhead) washer which seats through a split shim onto a bearing plate on the PCRV surface (see Figure 1). The tendons may be delineated into four different types according to the following table (also see Figure 2).
