Subject: Arkansas Nuclear One - Units 1 and 2
Docket Nos. 50-313 and 50-368
License Nos. DPR-51 and NPF-6
Response To Inspection Report
50-313/96-06; 50-368/96-06

NOTICE OF VIOLATION

Response to Notice Of Violation 313/9606-01

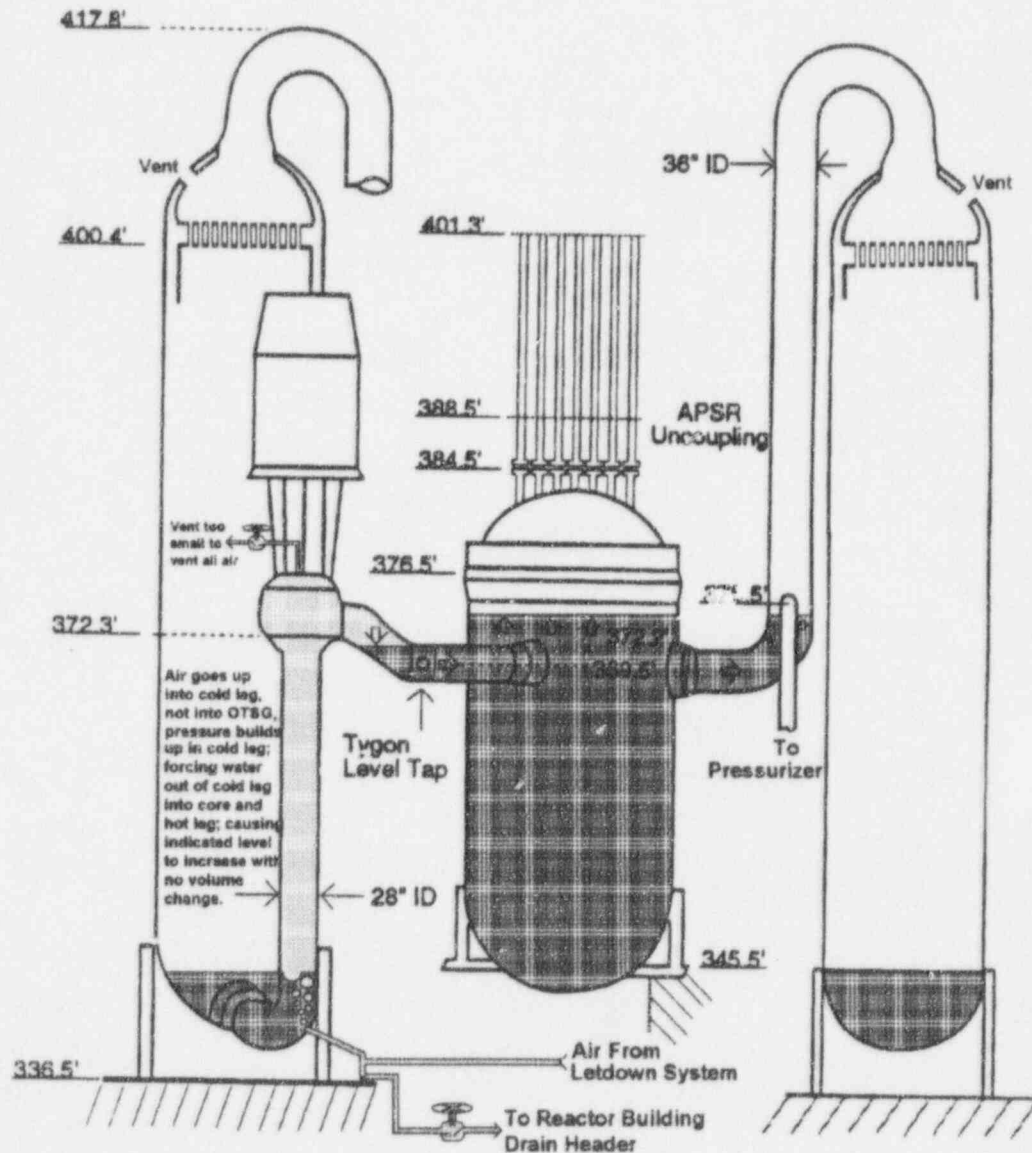
In order to ensure complete venting and draining of the letdown penetration, pressurized service air was used as a motive force. During the evolution, control room operators observed an unexpected RCS level increase of approximately 0.7 feet. When the operations personnel draining the letdown line became aware of the RCS level increase, they immediately secured service air and informed the control room. The RCS level rise stopped when the service air was secured and quickly returned to its previous value. The elapsed time from the start of the RCS level rise to RCS level stable at its previous value of 371.5 feet was approximately ten minutes.

Air introduced into the cold leg from the letdown line collected in the air volume between the top of the water level and the Reactor Coolant Pump (RCP) seal. Water in the cold leg between the RCP and the reactor vessel acted as a seal between the RCP and the head vents. This allowed for venting of the introduced air to occur only from the RCP seal vent. The volume of air that this vent path could pass was insufficient in comparison to the amount of air being introduced into the system; therefore, the buildup of air pressure below the RCP seal vent displaced a small amount of water from the cold leg into the reactor vessel. This displaced water caused the reactor vessel level indication to increase approximately 0.7 feet. (See attached drawing 2)

The cause of this event was that an adequate assessment of the vent capabilities of the RCS cold legs in association with the high volumes of service air being introduced into the RCS via the letdown system was not performed. Additionally, the lack of a procedure for draining systems connected to the RCS contributed to this event.

Drawing 2 Drain down in progress; air assisted draining of letdown system in progress; air goes into cold leg RCP area; RCP seal vent can not vent all the air, and pressure builds up in this area; water level rises in reactor core to 372.2'.

Service air was secured immediately upon identification of it as the cause of the RCS level increase.

A procedure for draining systems that are or may be interconnected to the RCS will be developed by February 28, 1998.
