CONNECTICUT YANKEE ATOMIC POWER COMPANY

September 20, 1985

Haddam Neck Plant  
Auxiliary Feedwater System Status

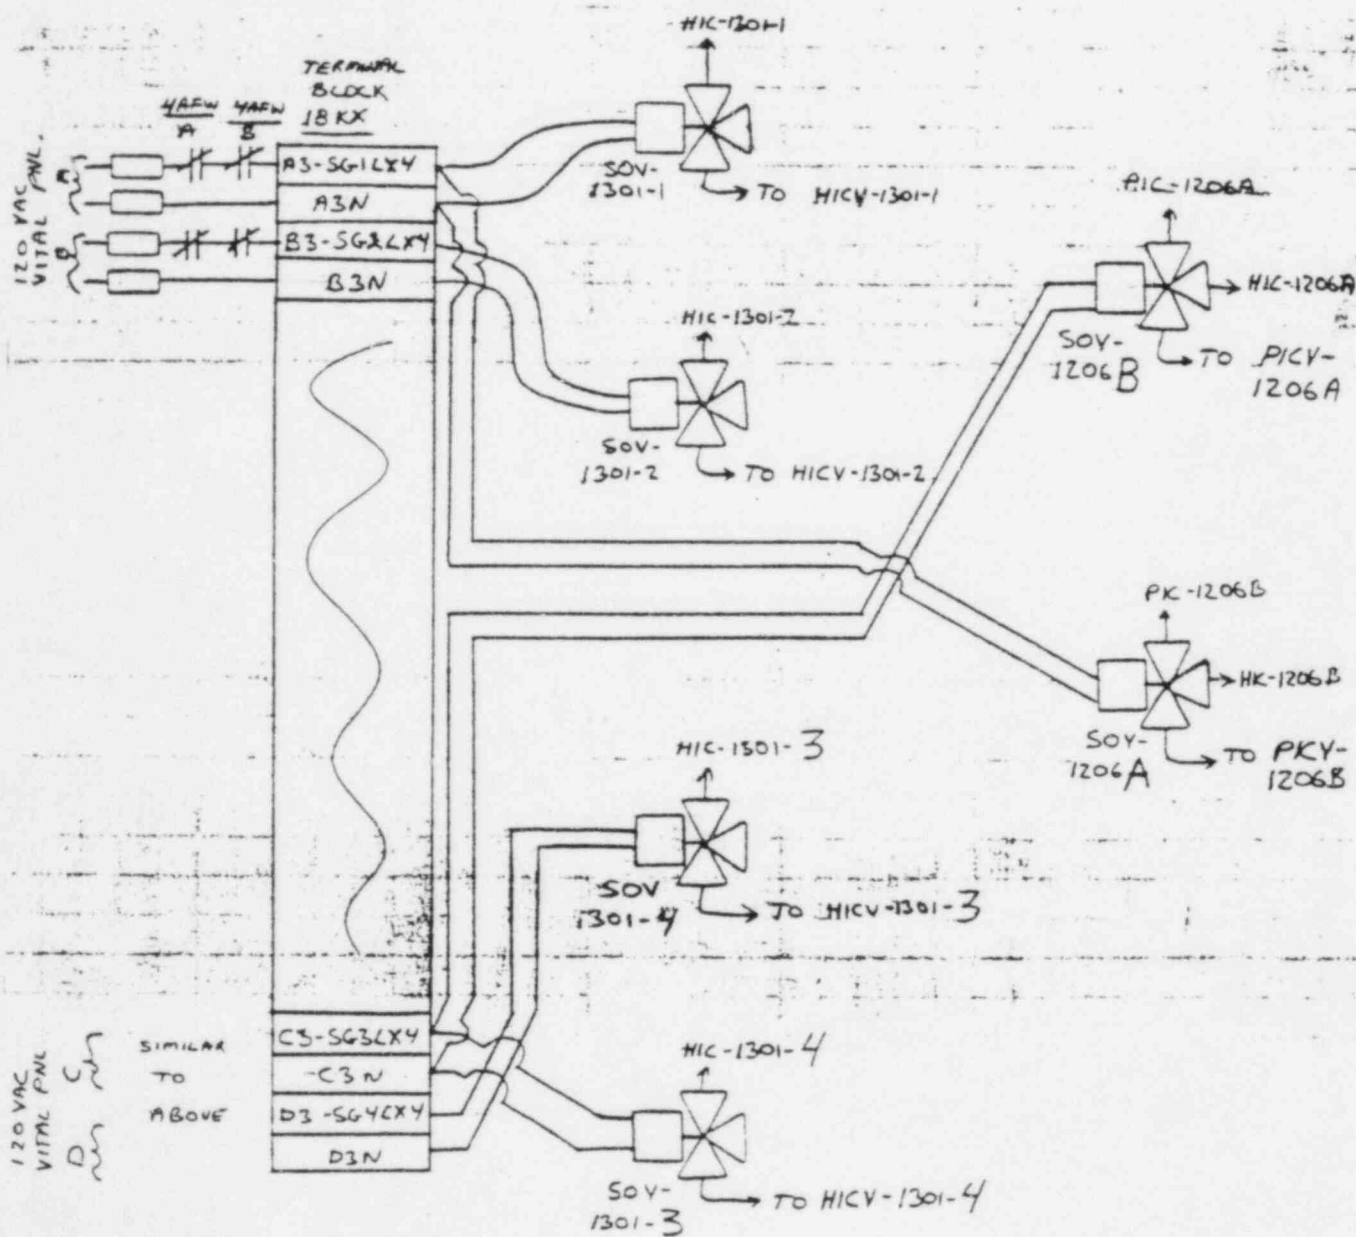
# Wiring Diagram Auxiliary Feedwater Automatic Initiation Solenoids

During the performance of this preventative maintenance procedure, fuses protecting circuits which actuate the SOV's for the feedwater bypass valves and AFW Terry Turbine system steam admission valves were individually removed to deenergize the circuits and cause a change in position of the SOV's and corresponding opening of the feedwater bypass valves and steam admission valves. An error was discovered when a fuse thought to be associated with the (A) Terry Turbine steam admission valve was pulled resulting in startup of the (B) Terry Turbine. Further investigation revealed that a similar cross-connection problem existed in two of the four AFW system bypass valves. Additionally, during the performance of the procedure, one of the four solenoid

operated valves (SOV's) for the feedwater bypass valves failed to change position and allow the bypass valve to open. This later problem is related to our LER #85-005 described event. The attached wiring diagram (sketch) illustrates the details of the error which caused the improper valve operations.

- o During the 1983 refueling outage, final disposition with respect to the spliced-in sections of wiring was accomplished by a rewiring of the SOV's. It is our postulation that the wiring error occurred at this time as a result of the complete unwiring, and then, rewiring of the SOV's to facilitate splice elimination. At this time, as at present, the SOV ID tags were in the improper position in 4 of 6 instances. Wiring was done to the improperly tagged valves in accordance with design drawings resulting in the cross-connections being incorporated.

Based on the above, we believe the design was correctly incorporated initially. A review of the design drawings show they accurately reflect the intended design. A surveillance test performed on the auxiliary feedwater system did not detect the error because overall system operability was not and is not affected. No divisional separation was violated by the wiring error since it occurred in the wiring between main control board terminal blocks and the adjacently mounted SOV's. Rewiring and relabeling of the solenoids will be corrected during the upcoming refueling outage to be consistent with the original design intent.

Additional efforts are in progress to identify any appropriate corrective actions necessary to prevent recurrence. We will be providing additional details on these efforts directly to the Resident Inspector as they become available.
