U. S. NUCLEAR REGULATORY COMMISSION

Report No. 50-461/85032(DRP)

Facility Name: Clinton Power Station

Inspection Conducted: May 29 through July 9, 1985

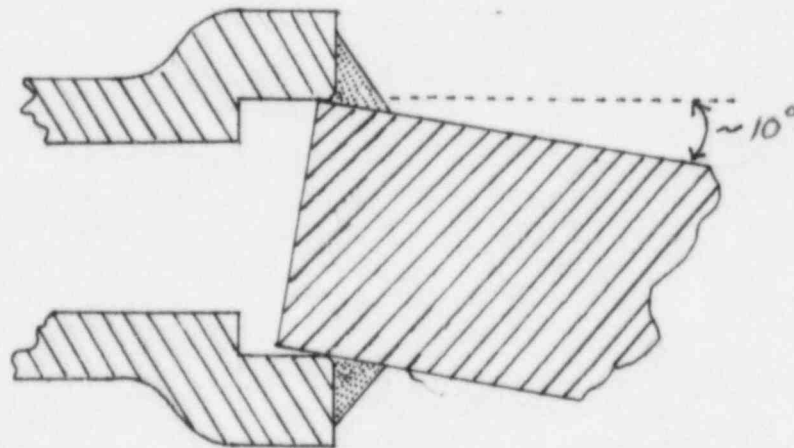
FIGURE 1b

The inspector observed approximately 150 instrumentation piping installations. The piping had various angularities to eliminate the need to bend the piping for fit up. In one case, the angularity was approximately 10 degrees (Figure 1-B attached).

At the request of the inspector, the fitting in Figure 1-B (see attached) was radiographed and full piping engagement into the socket was verified. The inspector questioned whether piping with an angularity of 10 degrees or greater could bind within the socket and thereby induce excessive stresses on the weld resulting in cracking, a condition similar to weld cracking if the piping is fully engaged at the socket bottom when welded.

- (1) Will socket weld fit up with angularity approaching 10 degrees compromise the integrity of the socket weld by "bottoming out" the pipe in the socket (similar to a fully engaged socket) thereby resulting in potential cracking of the weld during the weldment cooling/solidification process? The inspector noted that the socket welds in question were generally ASME Class 3 which do not require nondestructive examination (other than a final visual inspection).
- (2) What is the source document (code or standard) which permits angularity greater than the normal tolerances of piping inserted into the socket?
