RADIOLOGIC AND ENGINEERING ASSESSMENT

DOE ID NO.: GJ-03089-RS  
ADDRESS: 1745 ORCHARD AVENUE

SEPTEMBER 1985

URANIUM MILL TAILINGS REMEDIAL ACTION PROJECT OFFICE

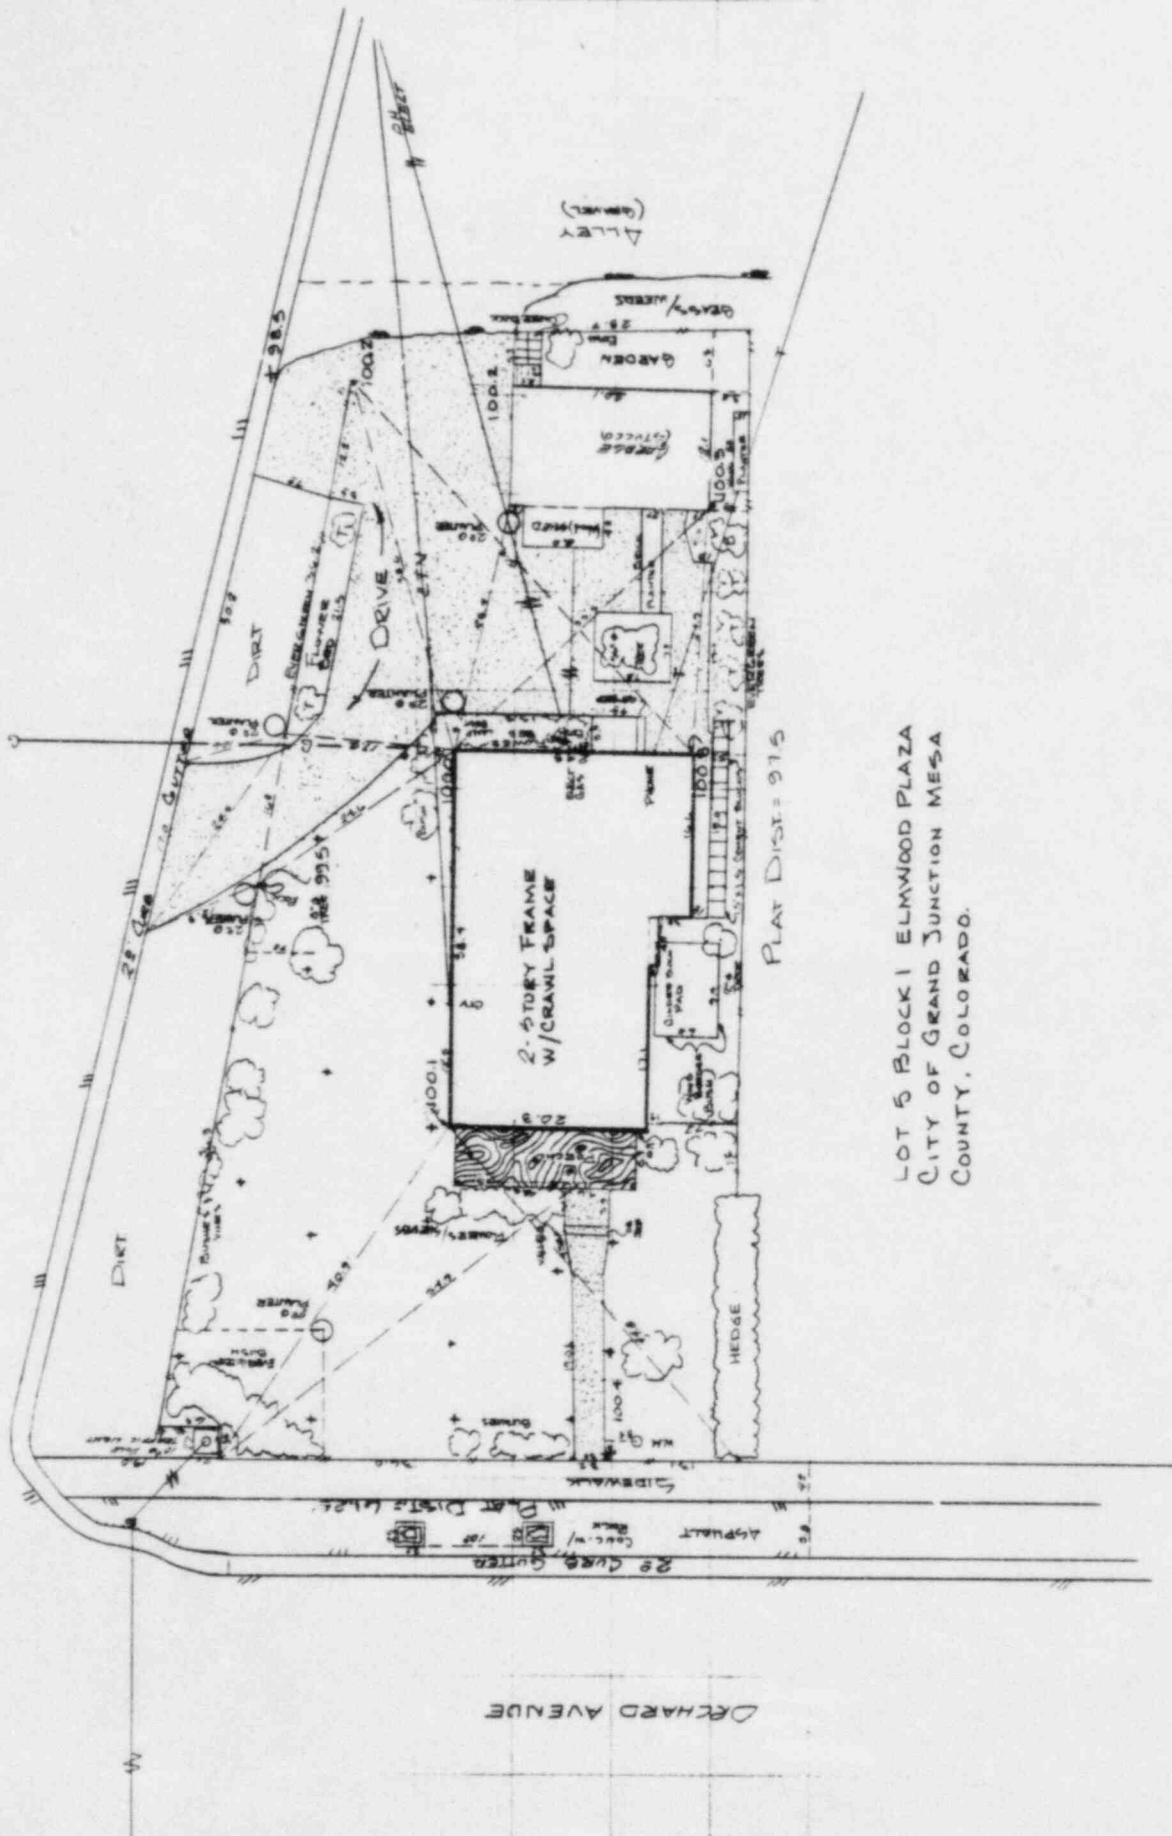
FIGURE 2.2 SITE PLAN

Structures, utilities, landscaping, and other special features of this property are included in Appendix Figure 2.2.

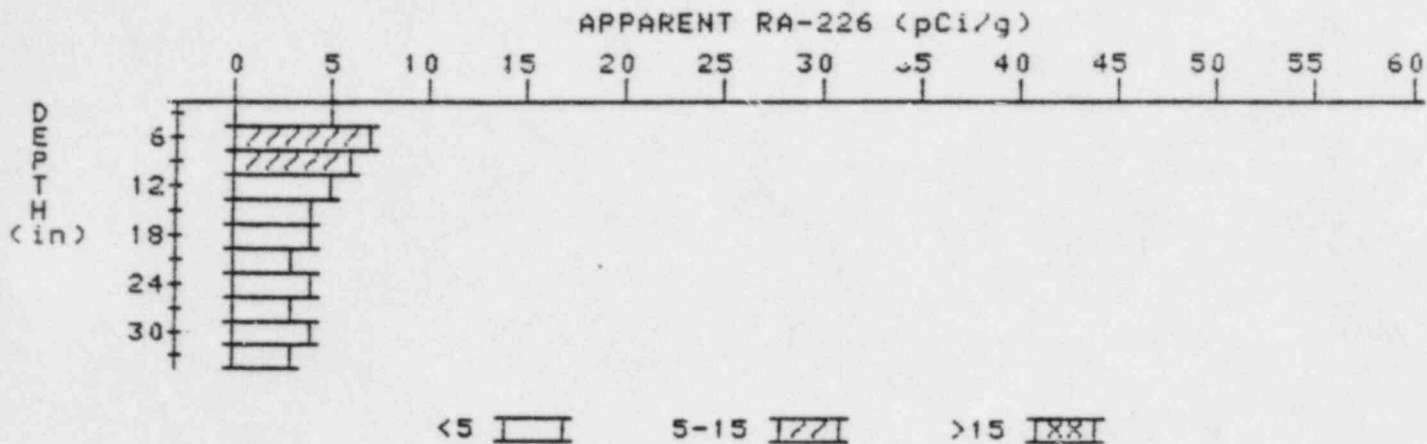
HOLE NUMBER: 9

Depth (in)	Apparent Radium-226 (pCi/g) Undeconvolved	Apparent Radium-226 (pCi/g) Deconvolved
3	4.7	4.7
6	5.5	7.1
9	5.4	6.5
12	4.7	4.5
15	4.1	3.6
18	3.8	3.8
21	3.5	3.0
24	3.5	3.7
27	3.4	3.2
30	3.4	3.6
33	3.3	3.3

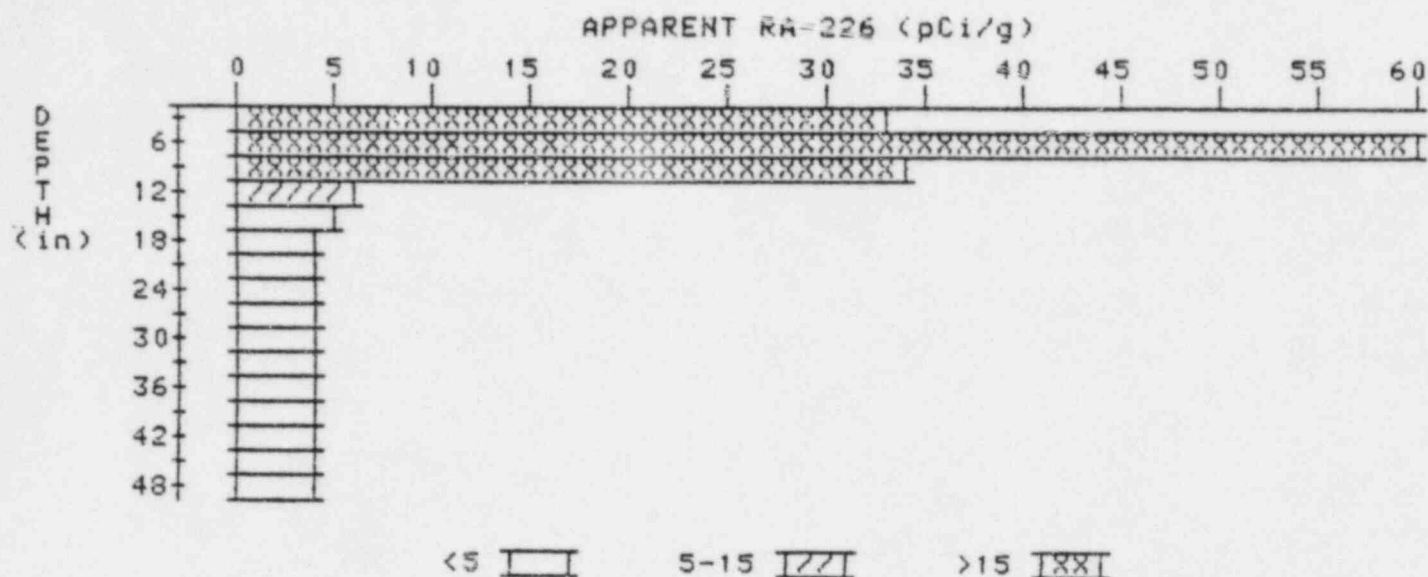
HOLE NUMBER: 17

Depth (in)	Apparent Radium-226 (pCi/g) Undeconvolved	Apparent Radium-226 (pCi/g) Deconvolved
3	32.7	32.7
6	39.4	68.9
9	29.5	34.3
12	16.9	6.1
15	10.4	4.5
18	7.2	4.4
21	5.6	4.0
24	4.9	4.4
27	4.5	4.1
30	4.3	4.3
33	4.1	3.9
36	4.0	3.8
39	4.0	4.4
42	3.8	3.6
45	3.7	3.5
48	3.7	3.7

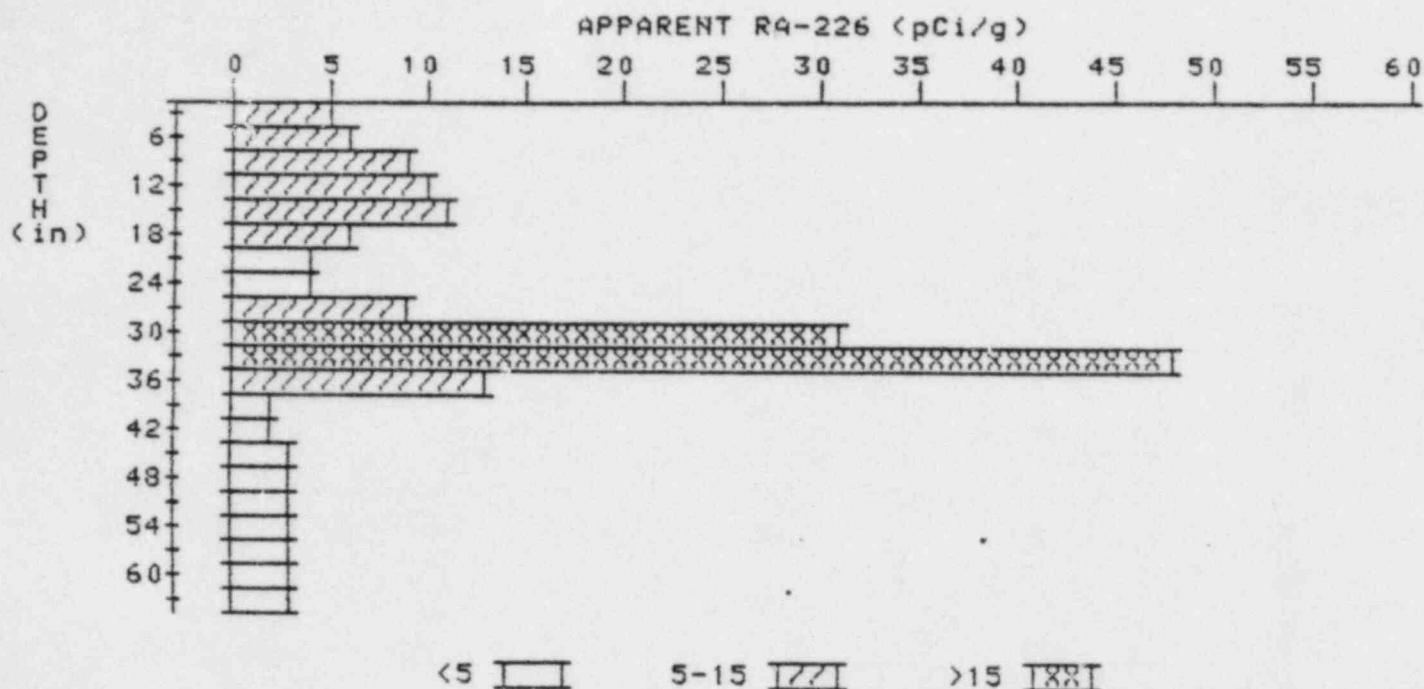
HOLE NUMBER: 24

Depth (in)	Apparent Radium-226 (pCi/g) Undeconvolved	Apparent Radium-226 (pCi/g) Deconvolved
3	5.0	5.0
6	6.4	6.4
9	7.8	9.0
12	8.5	9.6
15	8.6	10.7
18	7.5	5.9
21	7.3	3.6
24	9.2	3.7
27	14.2	8.7
30	22.3	30.8
33	25.6	48.0
36	16.3	12.9
39	8.9	1.6
42	5.6	2.0
45	4.3	3.1
48	3.7	3.3
51	3.3	2.6

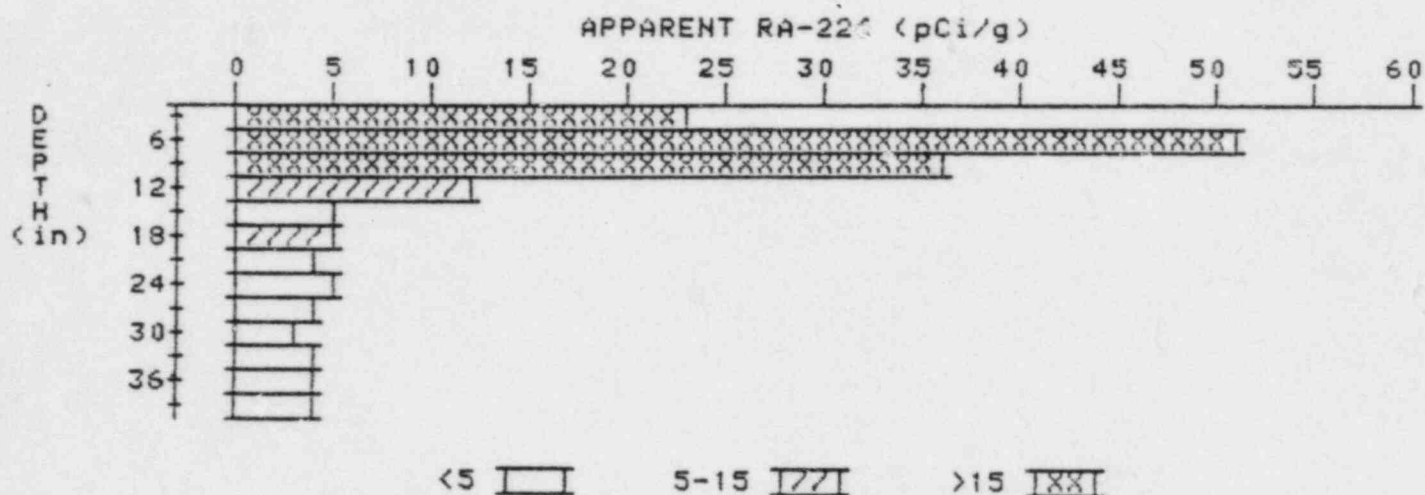
HOLE NUMBER: 26

Depth (in)	Apparent Radium-226 (pCi/g) Undeconvolved	Apparent Radium-226 (pCi/g) Deconvolved
3	22.8	22.8
6	30.3	50.6
9	26.4	35.8
12	17.2	12.4
15	10.7	4.8
18	7.5	5.0
21	5.7	3.7
24	5.0	4.8
27	4.4	4.2
30	3.9	3.2
33	3.8	3.8
36	3.7	3.5
39	3.7	3.7
