RADIOLOGIC AND ENGINEERING ASSESSMENT

DOE ID NO.: GJ-01354-CS
ADDRESS: 1710 NORTH 12TH STREET

SEPTEMBER 1985

BENDIX FIELD ENGINEERING CORPORATION
P.O. Box 1569
Grand Junction, Colorado 81502

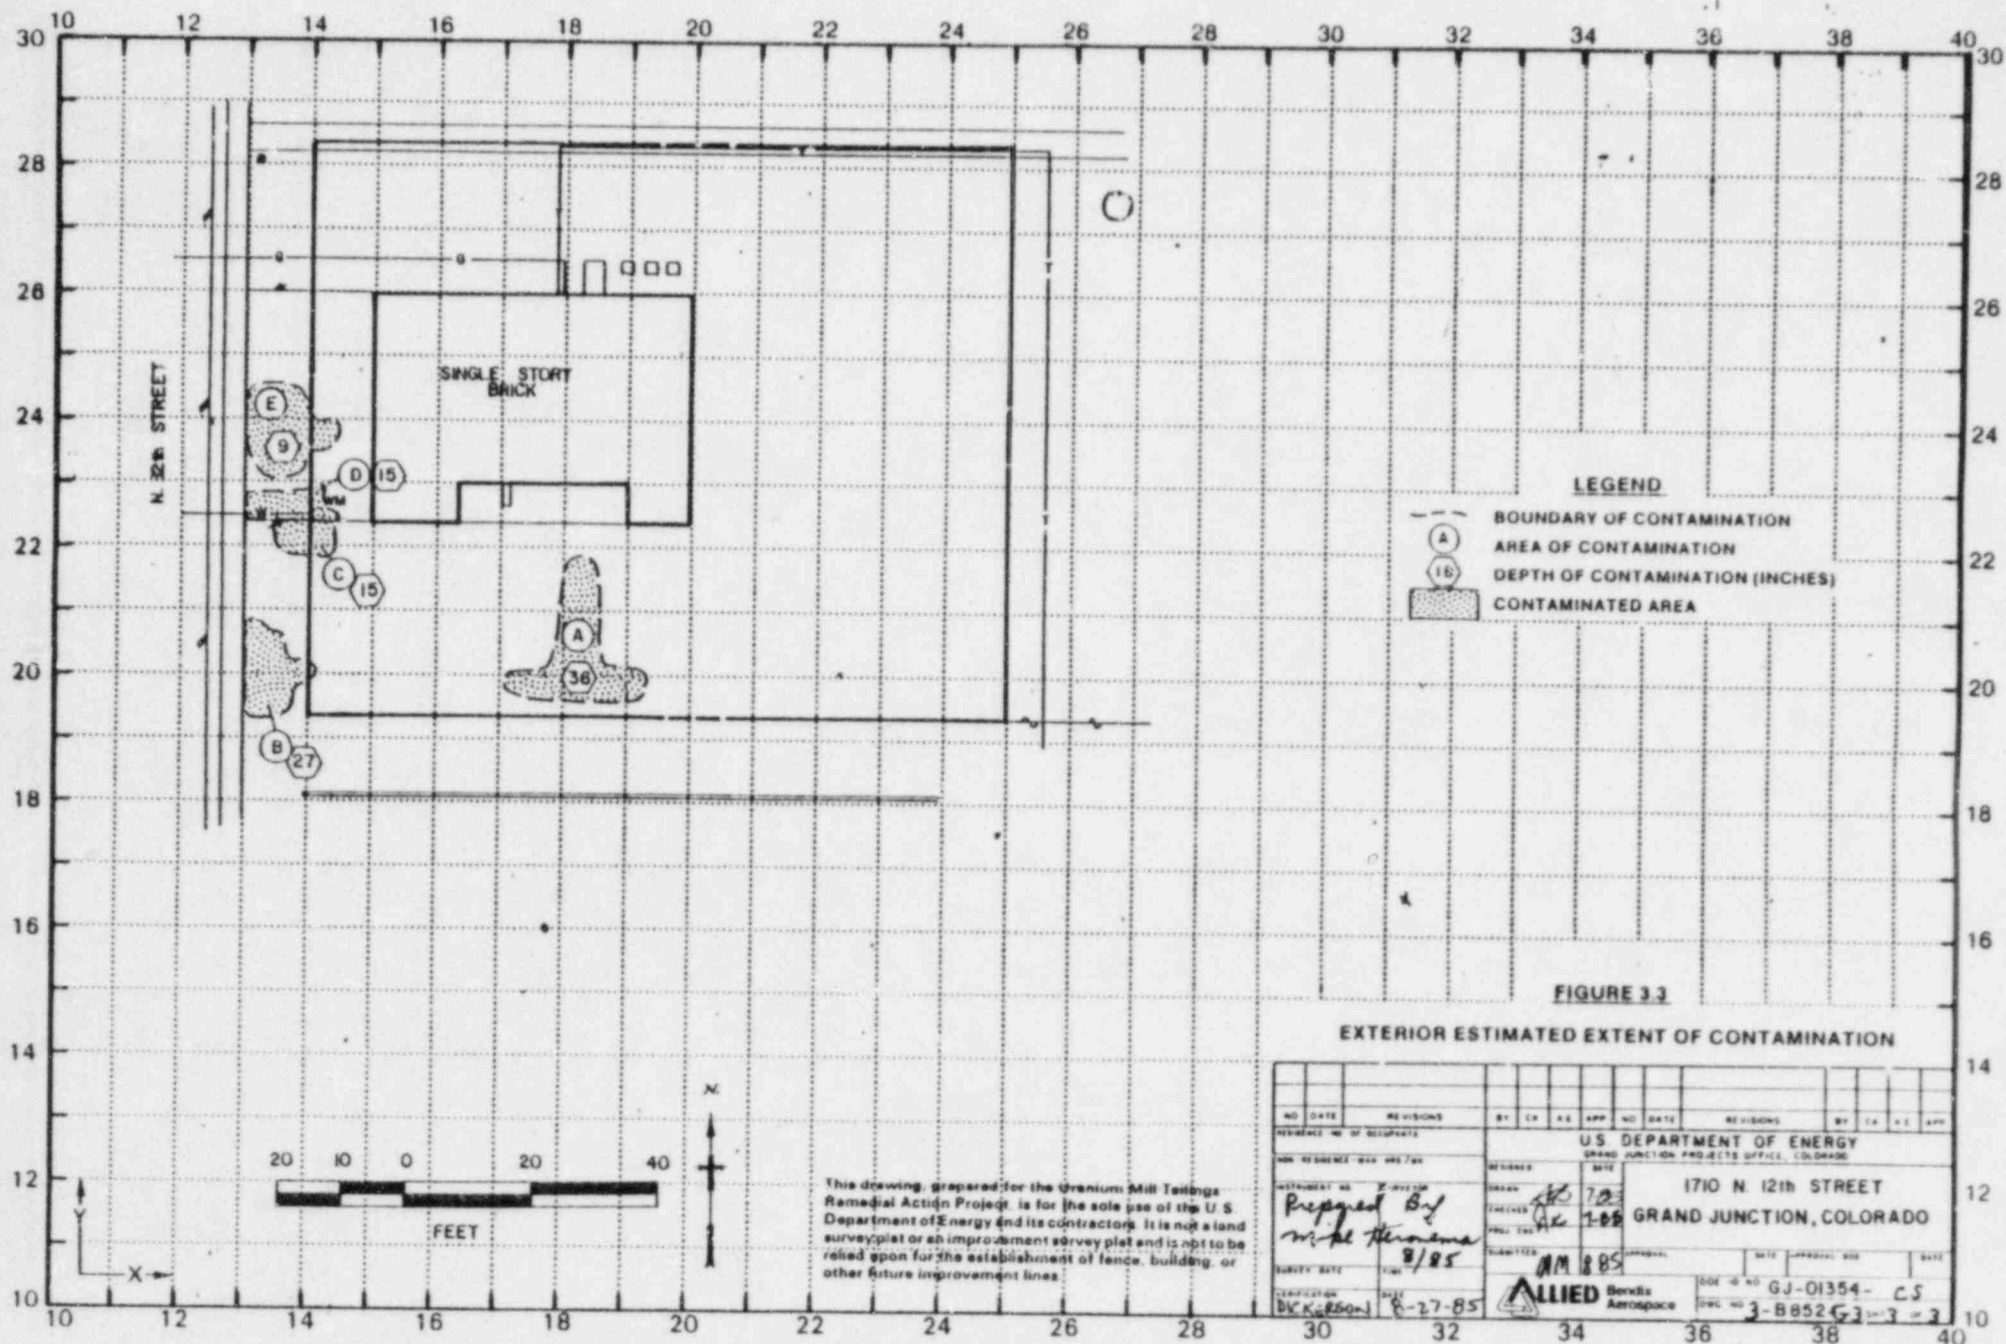
FIGURE 3.3

Appendix Figure 3.3 shows identified areas and estimated depths of contamination on this property, based on assessments of all measurements taken. As noted in this figure, areas recommended for remedial action that contain identified residual radioactive materials are:

- (Area A) Surface Material: Asphalt
 Direction From Primary Structure: South
 Other Directions: South parking area
 Total Depth of Contamination: 36 inches
 Other (height or thickness): 3-inch-thick asphalt
 Comments: Area contains large pit run and the
 contamination could extend deeper than indicated.
 Approximate Square Footage: 239

- (Area B) Surface Material: Asphalt
 Direction From Primary Structure: Southwest
 Other Directions: Adjacent to the west property line
 Total Depth of Contamination: 27 inches
 Other (height or thickness): 3-inch-thick asphalt
 Comments: Area contains large pit run.
 Approximate Square Footage: 120

- (Area C) Surface Material: Asphalt
 Direction From Primary Structure: West
 Total Depth of Contamination: 15 inches
 Other (height or thickness): 3-inch-thick asphalt
 Approximate Square Footage: 60

- (Area D) Surface Material: Decorative rock
 Direction From Primary Structure: West
 Other Directions: Adjacent to the west property line
 Total Depth of Contamination: 15 inches
 Comments: Depth of contamination is based on all
 available data.
 Approximate Square Footage: 84

- (Area E) Surface Material: Decorative rock
 Direction From Primary Structure: West
 Other Directions: Adjacent to the west property line
 Total Depth of Contamination: 9 inches
 Comments: Depth of contamination is based on all
 available data.
 Approximate Square Footage: 165

The recommended remedial action for this property, DOE ID No. GJ-01354-CS, includes removal of all areas identified as containing radioactive material (as discussed in Section 3.5 and shown in Appendix Figure 3.3) and transport of removed material to the disposal site.
