RADIOLOGIC AND ENGINEERING ASSESSMENT

DOE ID NO.: GJ-02193-RS
ADDRESS: 443 NORTH 18TH STREET

SEPTEMBER 1985

BENDIX FIELD ENGINEERING CORPORATION
P.O. Box 1569
Grand Junction, Colorado 81502

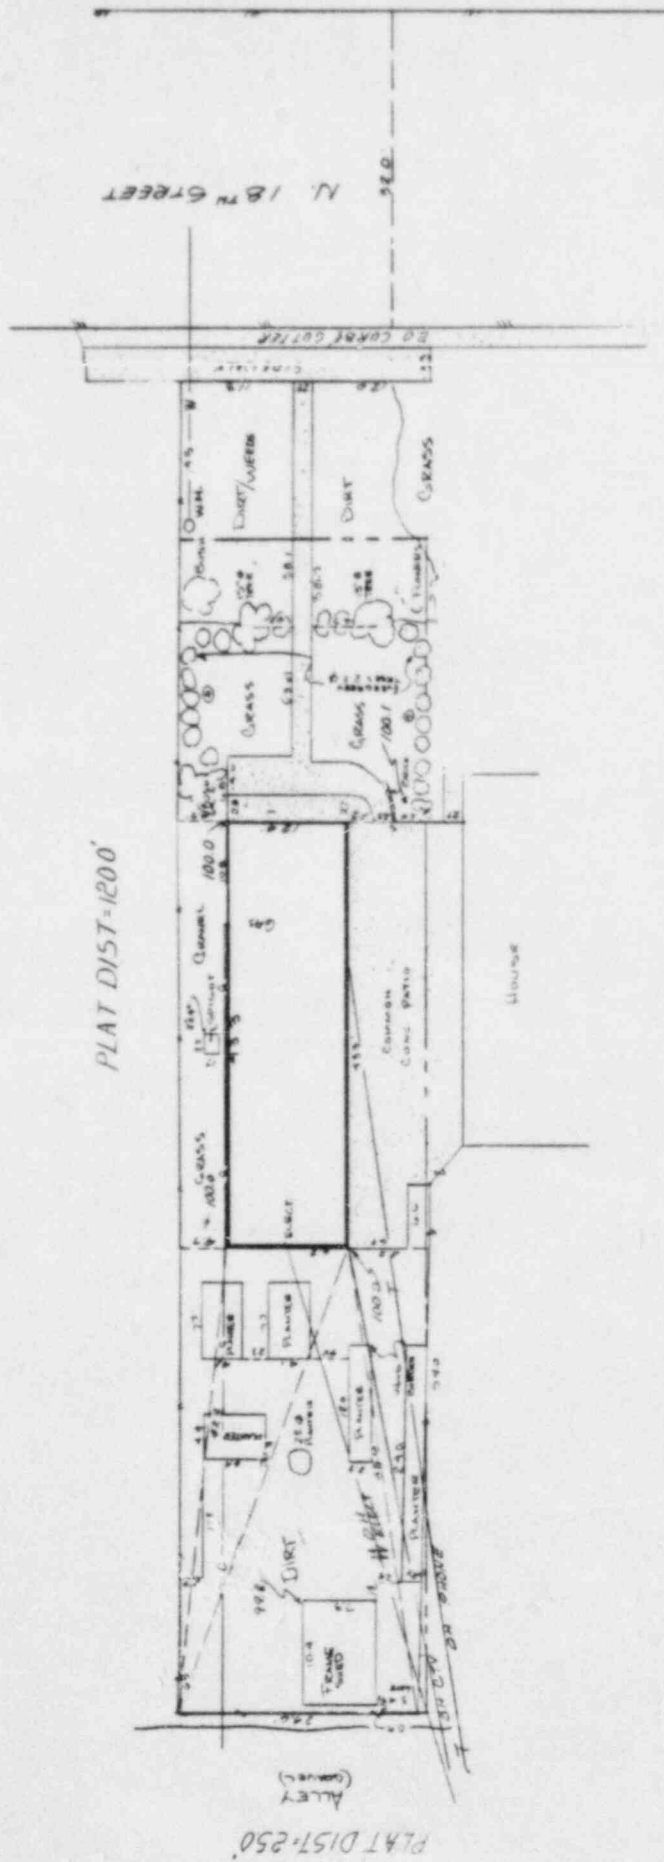
FIGURE 2.2 SITE PLAN

Structures, utilities, landscaping, and other special features of this property are included in Appendix Figure 2.2.

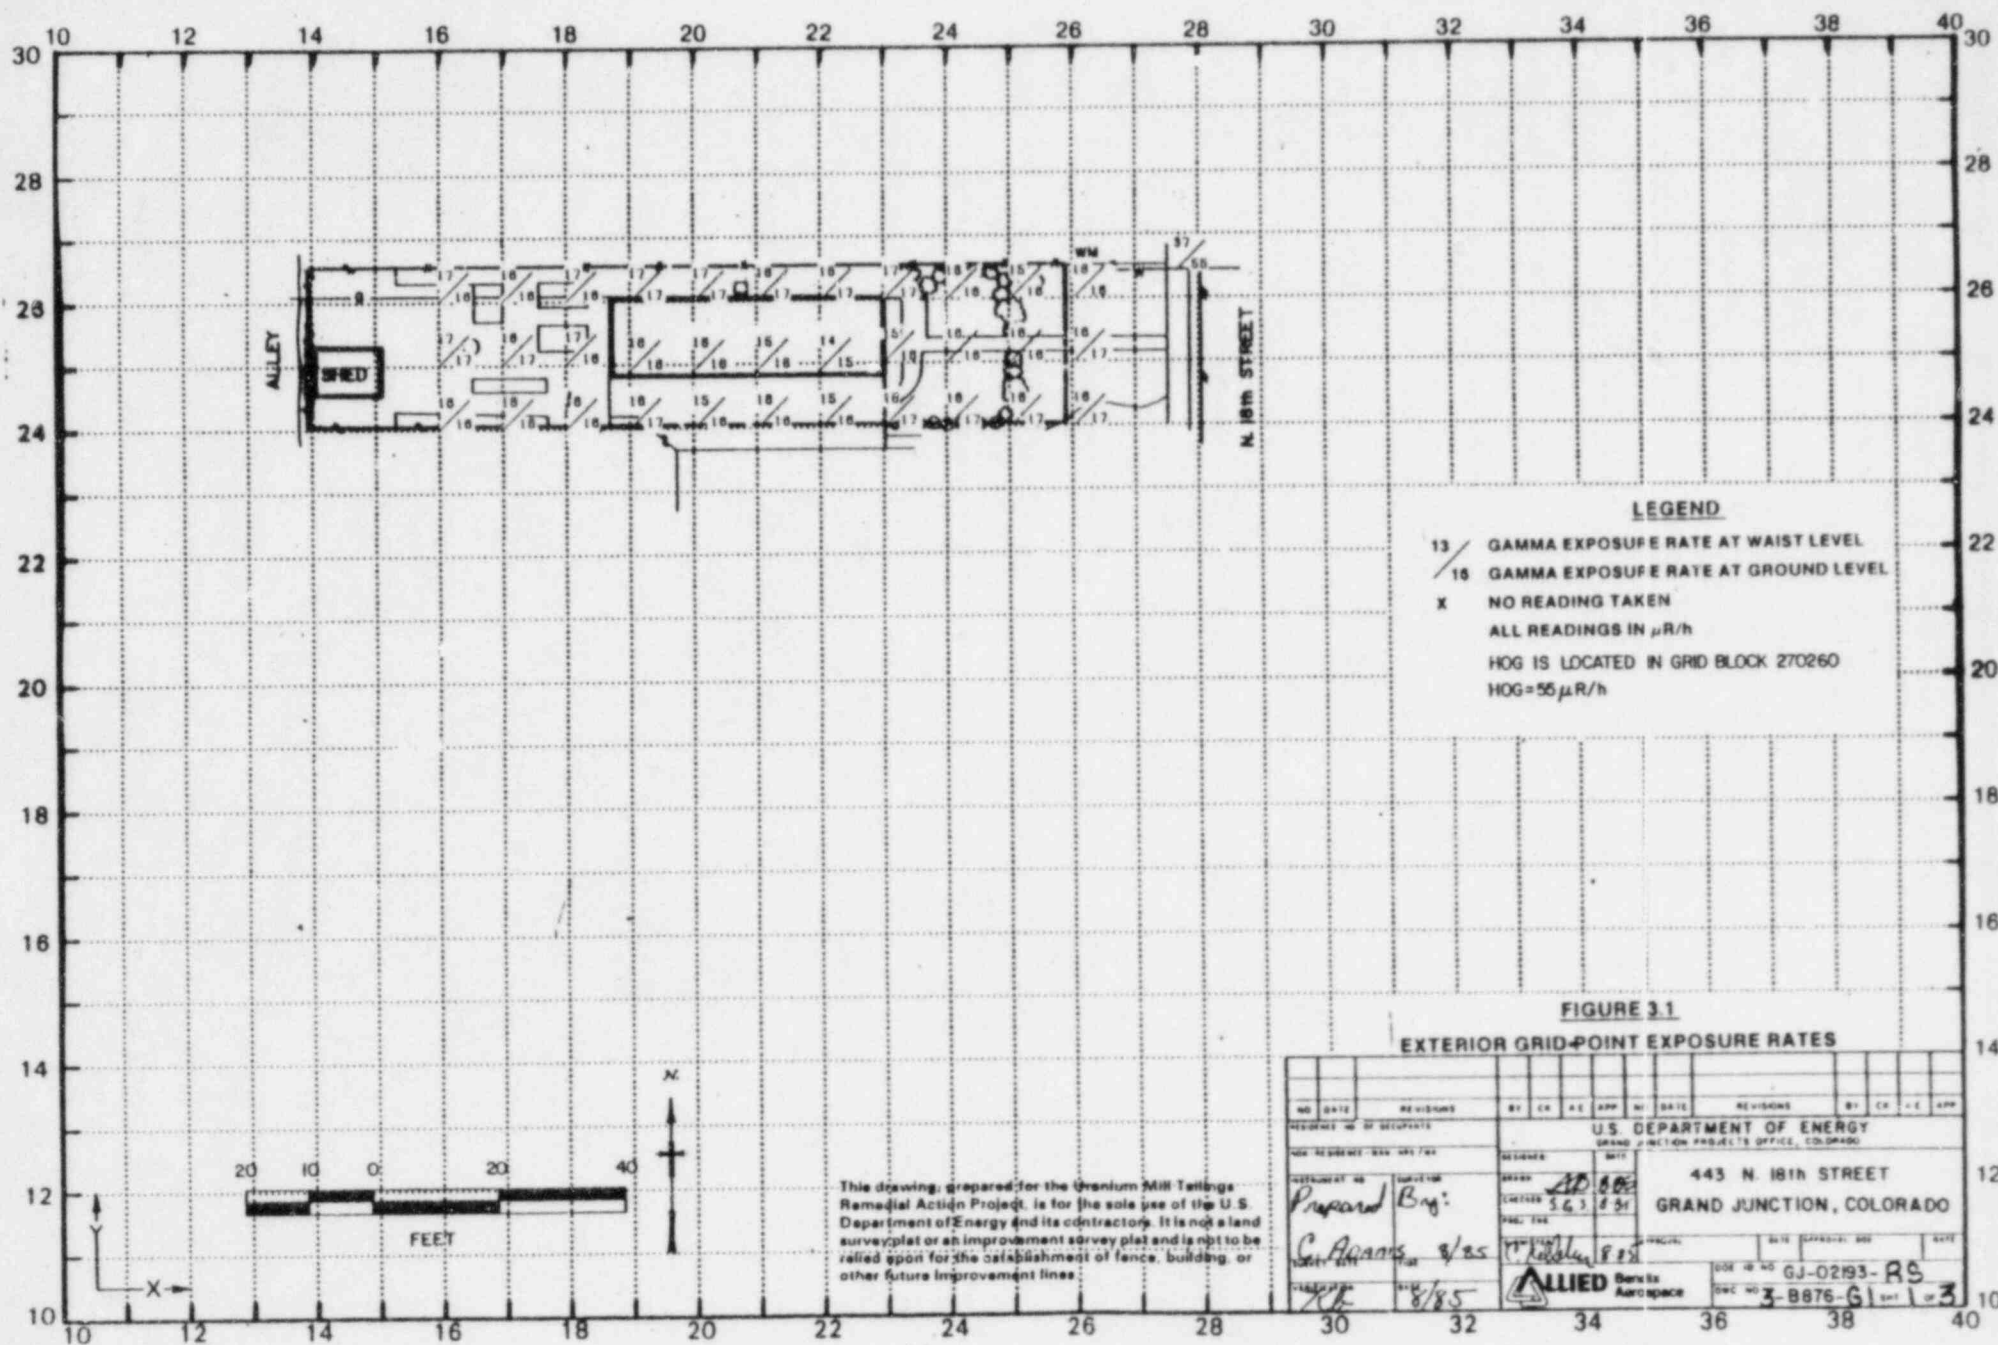
Exterior radium-concentration measurements are presented in Appendix Table 3.1. Exterior exposure-rate survey results are shown in Appendix Figure 3.1.

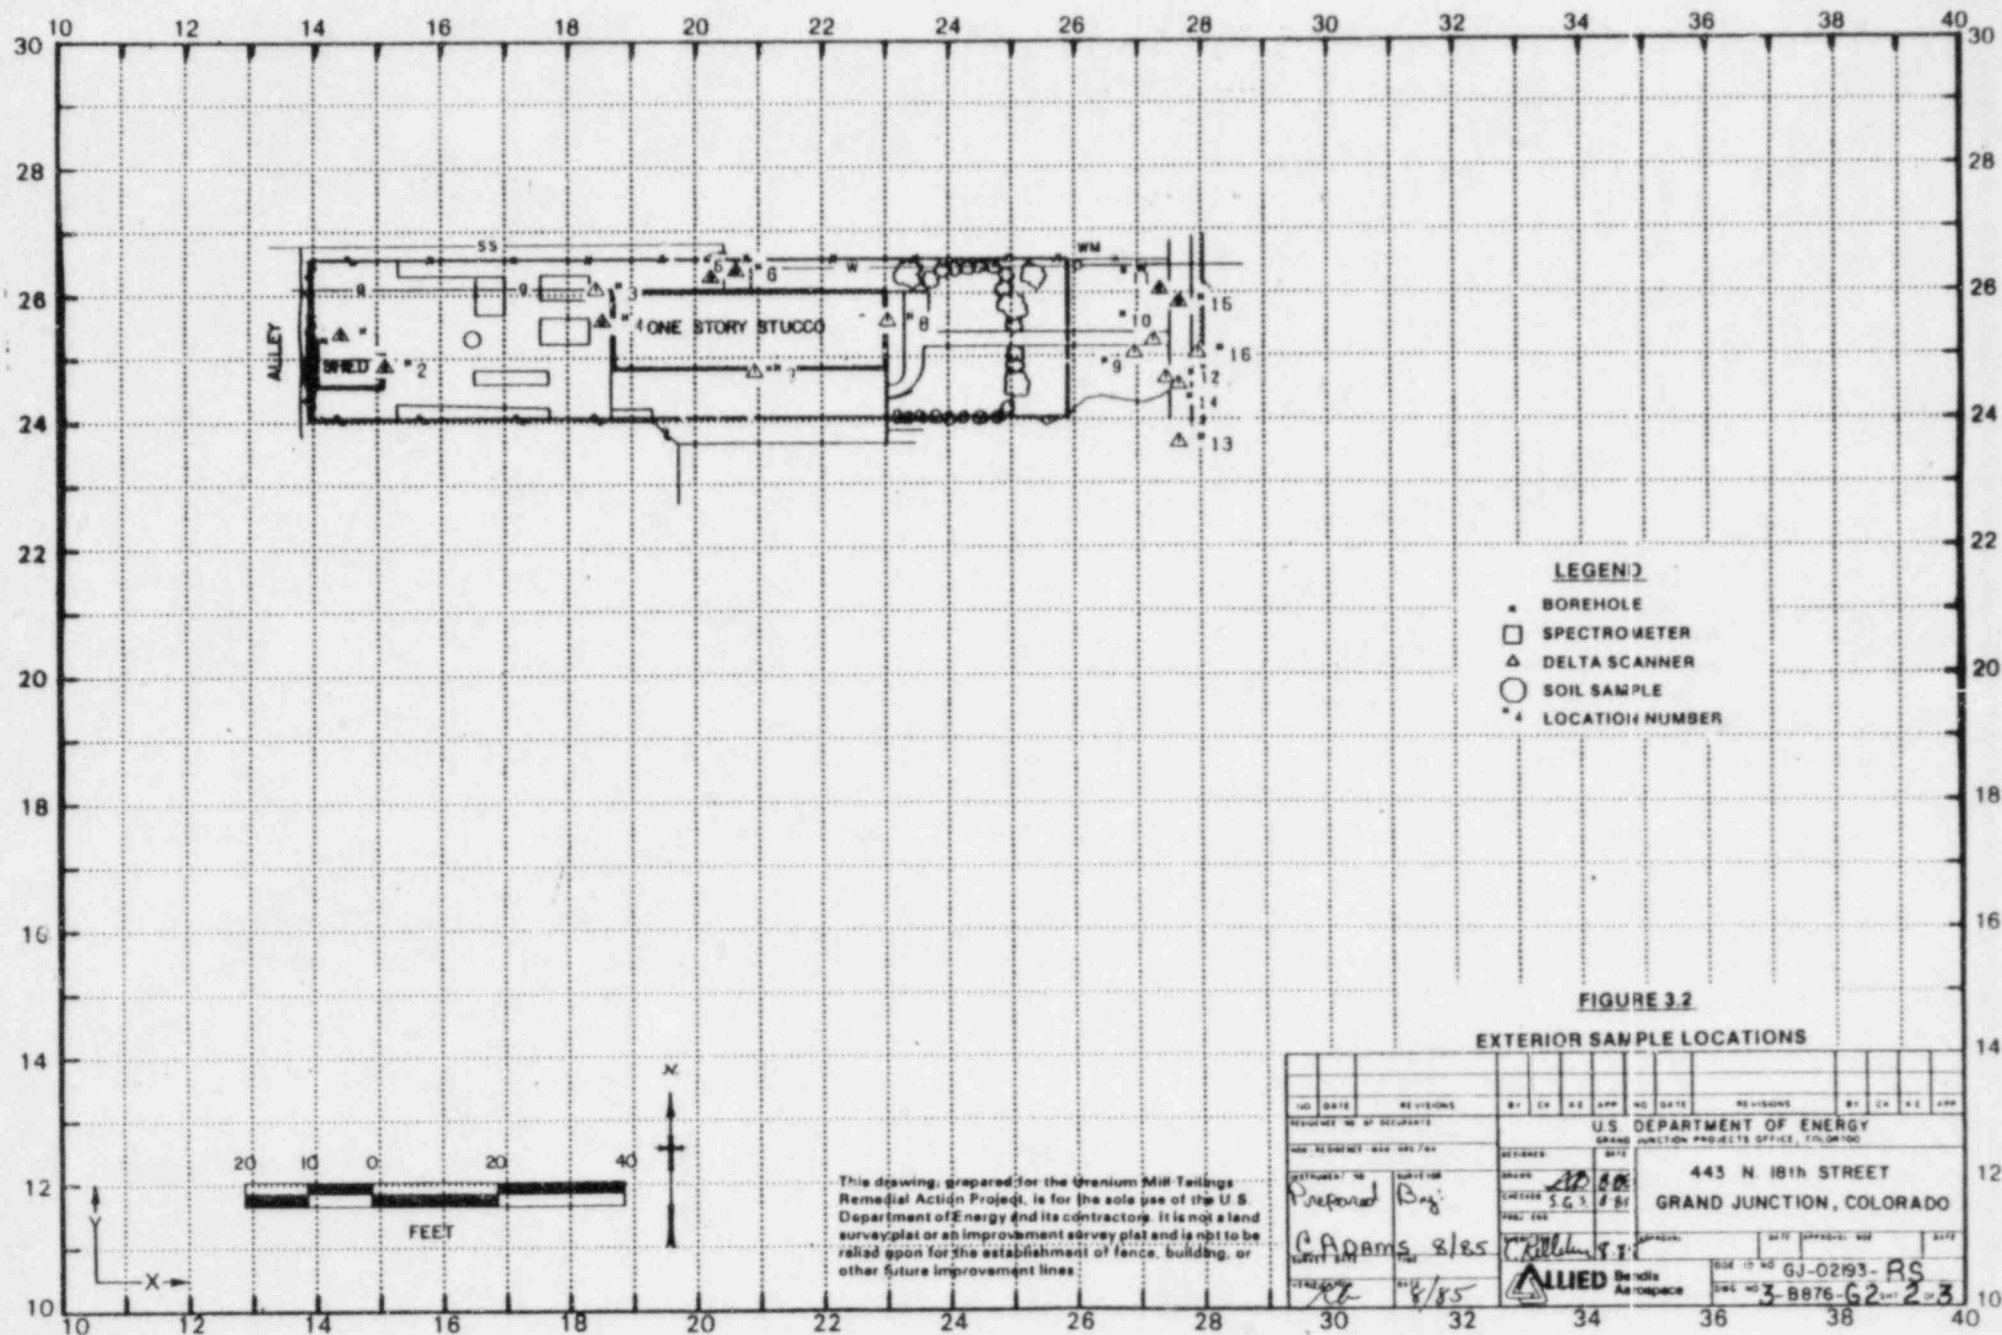
Areas which displayed elevated gamma levels were further investigated; the locations and types of these investigations are shown in Appendix Figure 3.2. Data from these investigations are included in Appendix Table 3.1.

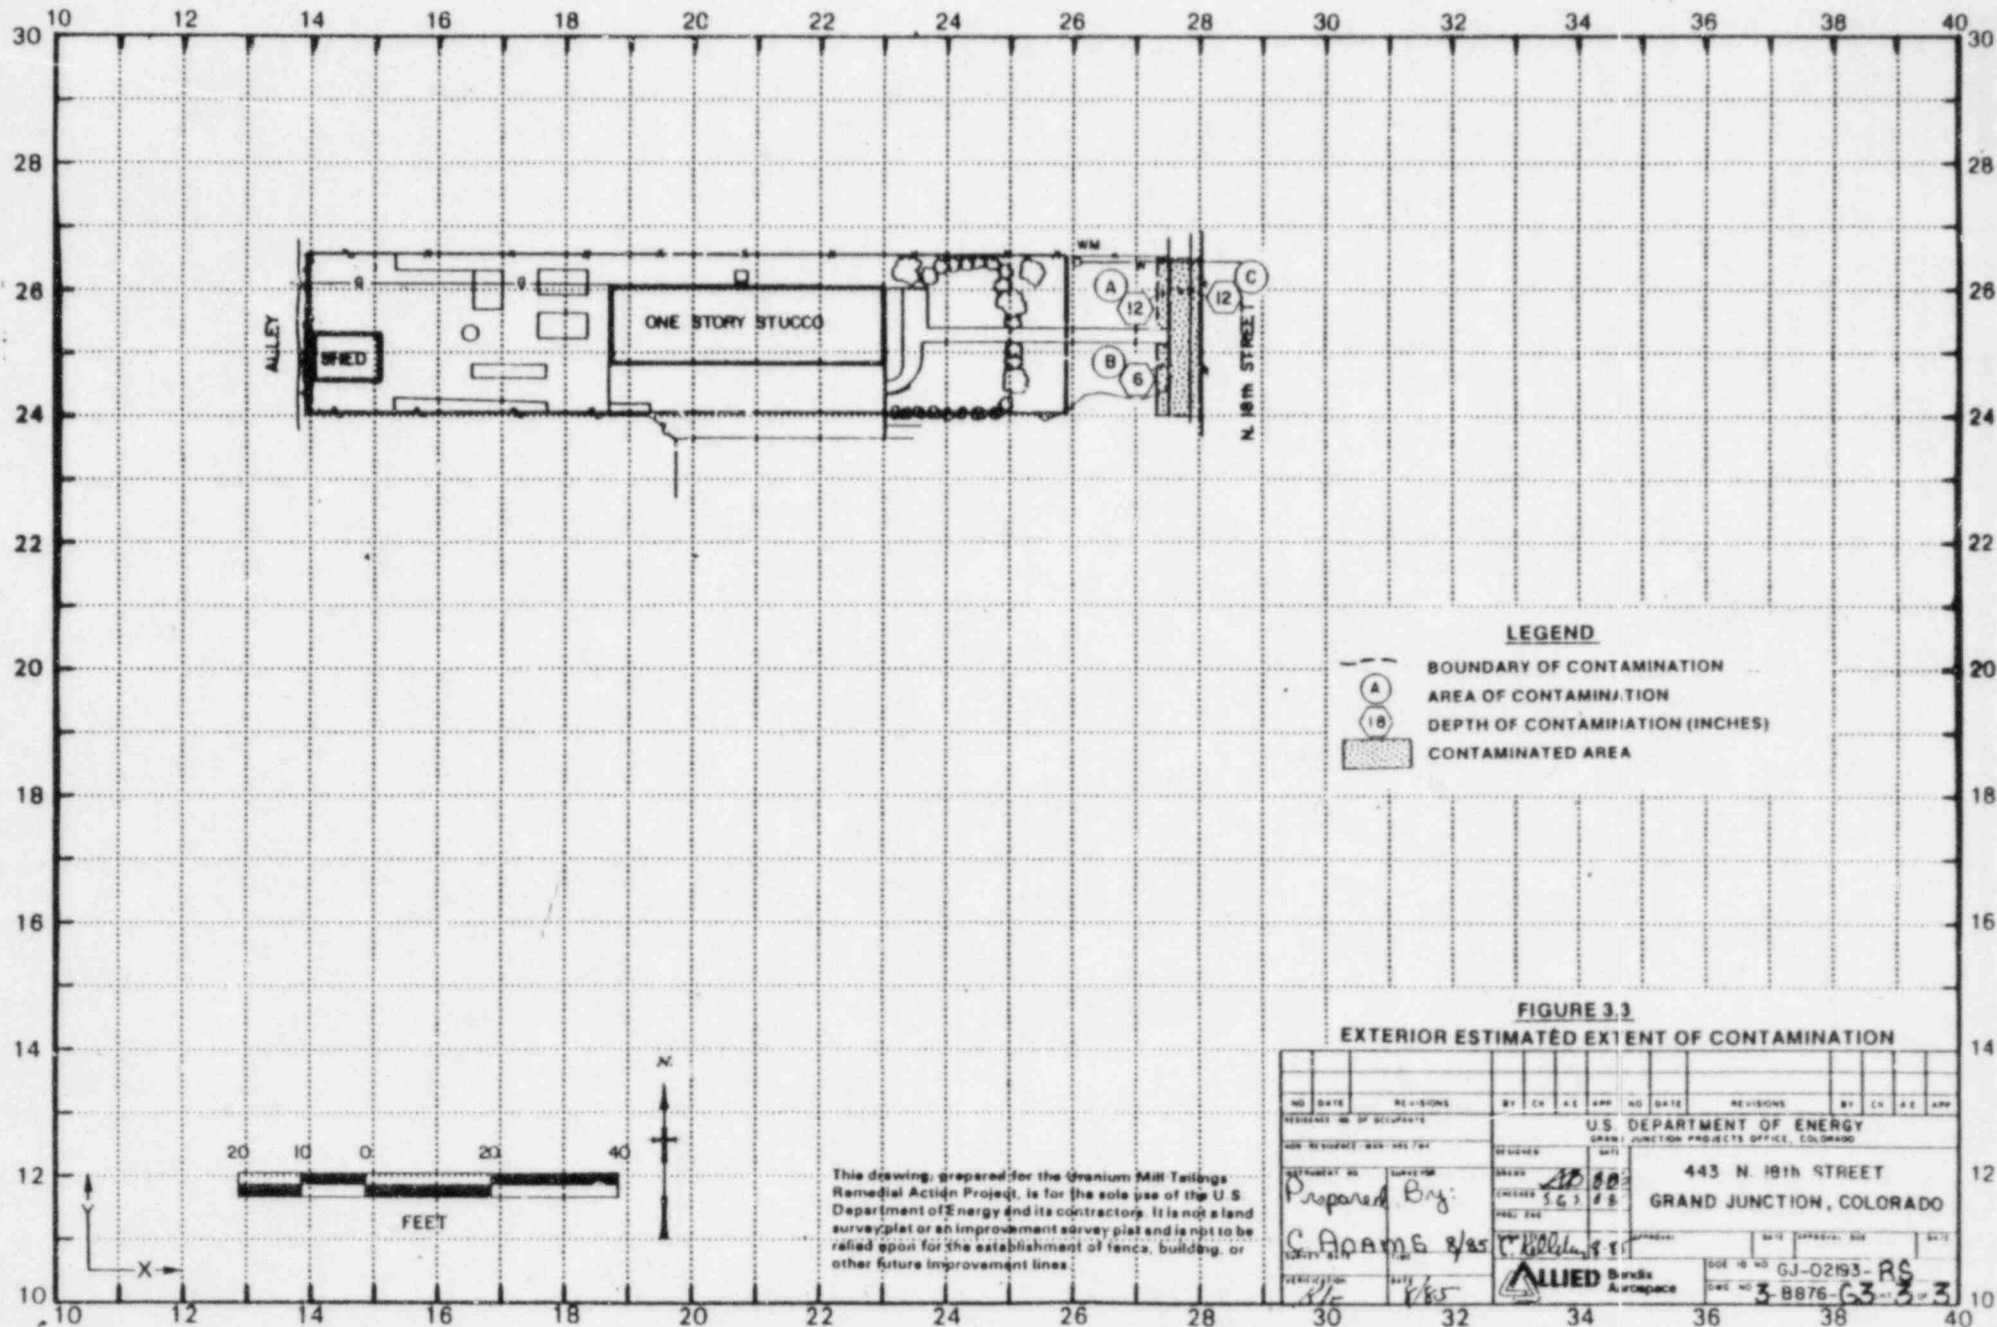
Appendix Figure 3.3 shows identified areas and estimated depths of contamination on this property, based on assessments of all measurements taken. As noted in this figure, areas that contain identified residual radioactive materials are:

- (Area A) Surface Material: Sparse grass
Direction From Primary Structure: East
Other Directions: Lies next to city sidewalk
Total Depth of Contamination: 12 inches
Approximate Square Footage: 24
- (Area B) Surface Material: Sparse grass
Direction From Primary Structure: East
Other Directions: Lies next to city sidewalk
Total Depth of Contamination: 6 inches
Approximate Square Footage: 22
- (Area C) Surface Material: Concrete
Direction From Primary Structure: East
Total Depth of Contamination: 12 inches
Other (height or thickness): 4-inch-thick concrete sidewalk
Comments: This area consists of the city sidewalk, curb, and gutter.
Approximate Square Footage: 83 - under sidewalk;
50 - under curb and gutter (This portion of Area C is excluded from remedial action.)

The recommended remedial action for this property, DOE ID No. GJ-02193-RS, includes removal of all areas identified as containing radioactive material (as discussed in Section 3.5 and shown in Appendix Figure 3.3) and transport of removed material to the disposal site.

Remedial action will not be performed under the curb and gutter found in Area C because we do not perform remedial action in street right-of-ways where paved streets or curb and gutters will be disturbed.

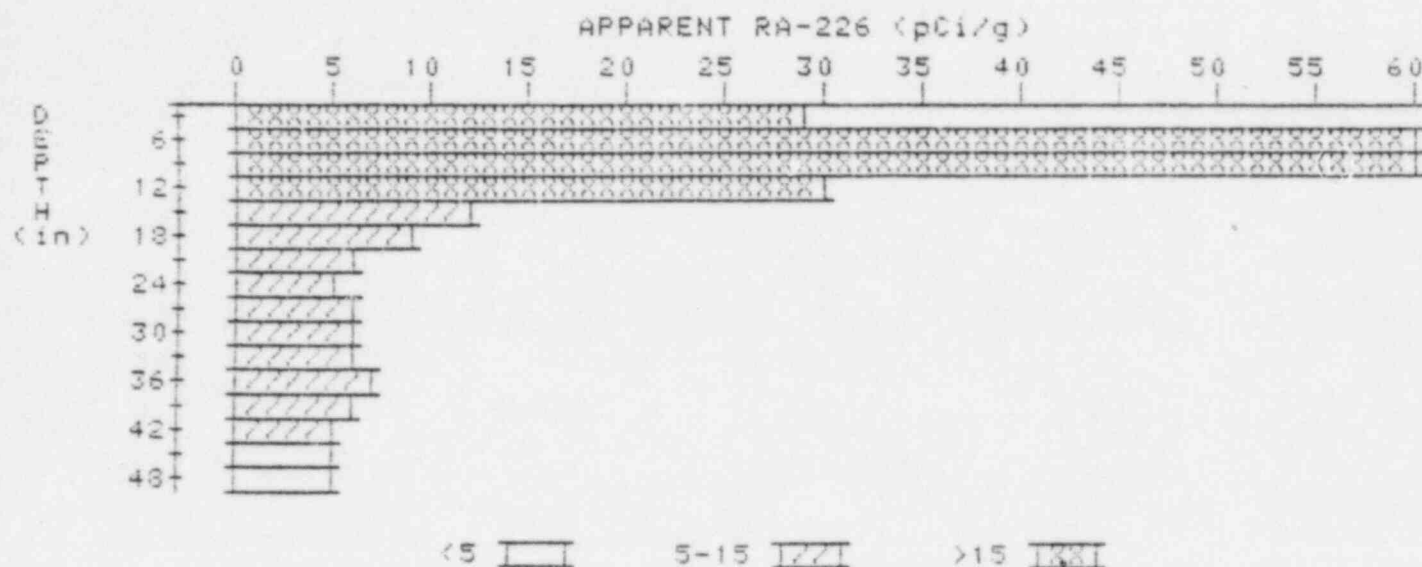
APPARENT RADIUM-226 CONCENTRATION 11 DECONVOLUTION GRAPH

Depth (in)	Apparent Radium-226 (pCi/g) Undeconvolved	Apparent Radium-226 (pCi/g) Deconvolved
3	28.5	28.5
6	40.6	61.6
9	40.9	60.3
12	30.3	30.5
15	19.6	11.6
18	13.4	9.3
21	9.5	6.1
24	7.5	5.4
27	6.7	6.2
30	6.2	5.7
33	6.0	5.6
36	6.0	6.7
39	5.6	5.6
42	5.2	5.2
45	4.8	4.6
48	4.5	4.5

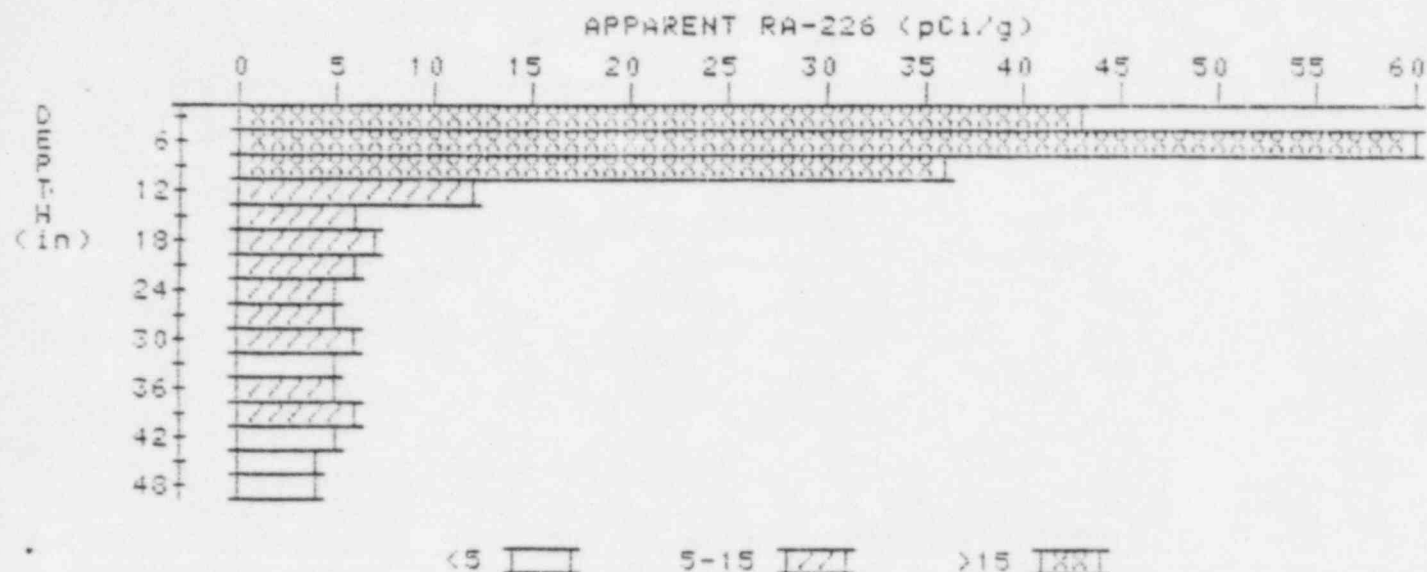
APPARENT RADIUM-226 CONCENTRATION DECONVOLUTION GRAPH

Depth (in)	Apparent Radium-226 (pCi/g) Undeconvolved	Apparent Radium-226 (pCi/g) Deconvolved
3	42.7	42.7
6	52.2	96.1
9	37.0	35.6
12	22.6	12.3
15	14.0	5.6
18	10.1	7.4
21	7.7	5.6
24	6.5	5.4
27	5.9	5.4
30	5.6	5.6
33	5.3	4.9
36	5.2	5.0
39	5.2	5.9
42	4.9	5.0
45	4.3	5.6
48	4.2	4.2
