Subject: GE Services Information Letter on Jet Pump Riser Pipe Cracking

## ***Jet pump riser pipe cracking***

**SIL No. 605**

December 6, 1996

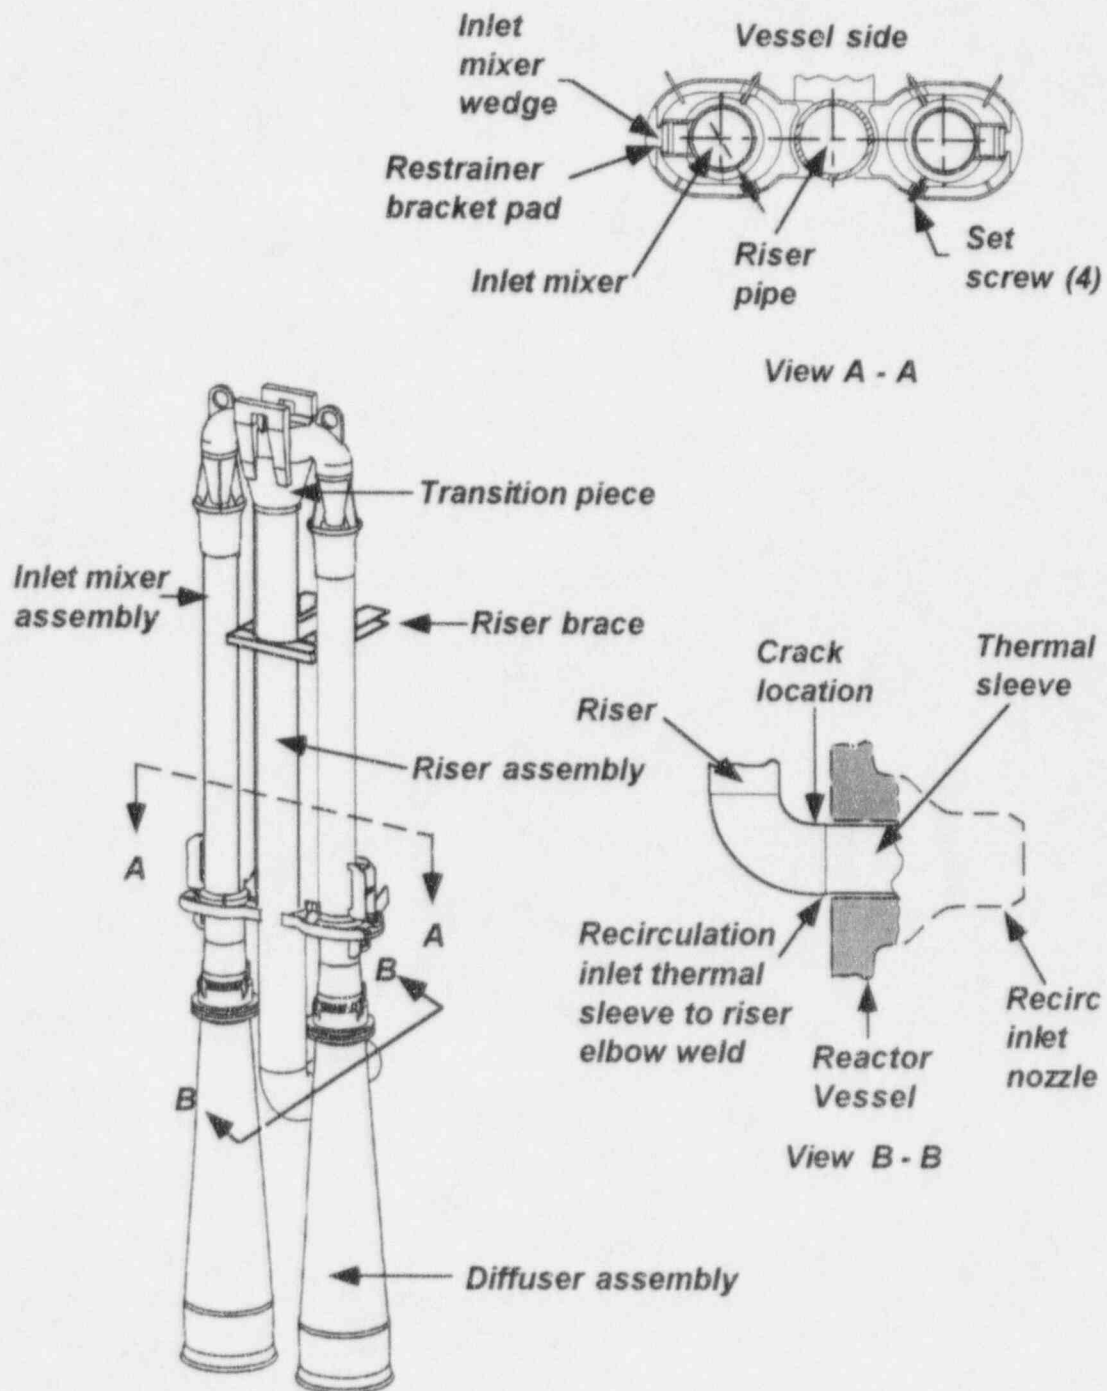
**Figure 1 - Typical jet pump assembly**

Jet pumps are used as part of the reactor recirculation system in BWR/3, 4, 5, and 6 plants. They are installed in the annulus between the core shroud and the reactor pressure vessel (RPV), and each vessel contains between 12 and 24 jet pumps. There are several BWR jet pump designs, however the basic jet pump configuration is the same for all jet pump plants (Figure 1).

The cracks were detected by visual inspection in two jet pump riser pipe elbows located inside the reactor vessel in the vicinity of the field-fabricated circumferential weld joining the riser

elbow to the recirculation inlet thermal sleeve. The root cause of the cracking has not yet been determined, however, the indications are characteristic of Intergranular Stress Corrosion Cracking (IGSCC), in that they show evidence of branching. The evaluation into the cause of the cracking is still in progress.

1. Jet pump monitoring should include an evaluation of the ratio of total loop jet pump suction flow to total loop jet pump drive flow. This ratio should not differ by more than 10% from its characteristic value. Failure to meet this criteria is indication of a possible jet pump malfunction.
2. GE BWRs currently in a refueling outage should consider a visual inspection of the jet pump riser pipe welds to assess the integrity of the pipe welds. Inspection during the current

3. GE BWRs should consider a visual inspection of the jet pump riser welds as a part of future outage inspection activities. Based on currently available information, a visual inspection is adequate for detection of cracking.
