RADIOLOGIC AND ENGINEERING ASSESSMENT

DOE ID NO.: GJ-00715-RS
ADDRESS: 1614 ELM AVENUE

AUGUST 1985

BENDIX FIELD ENGINEERING CORPORATION
P.O. Box 1569
Grand Junction, Colorado 81502

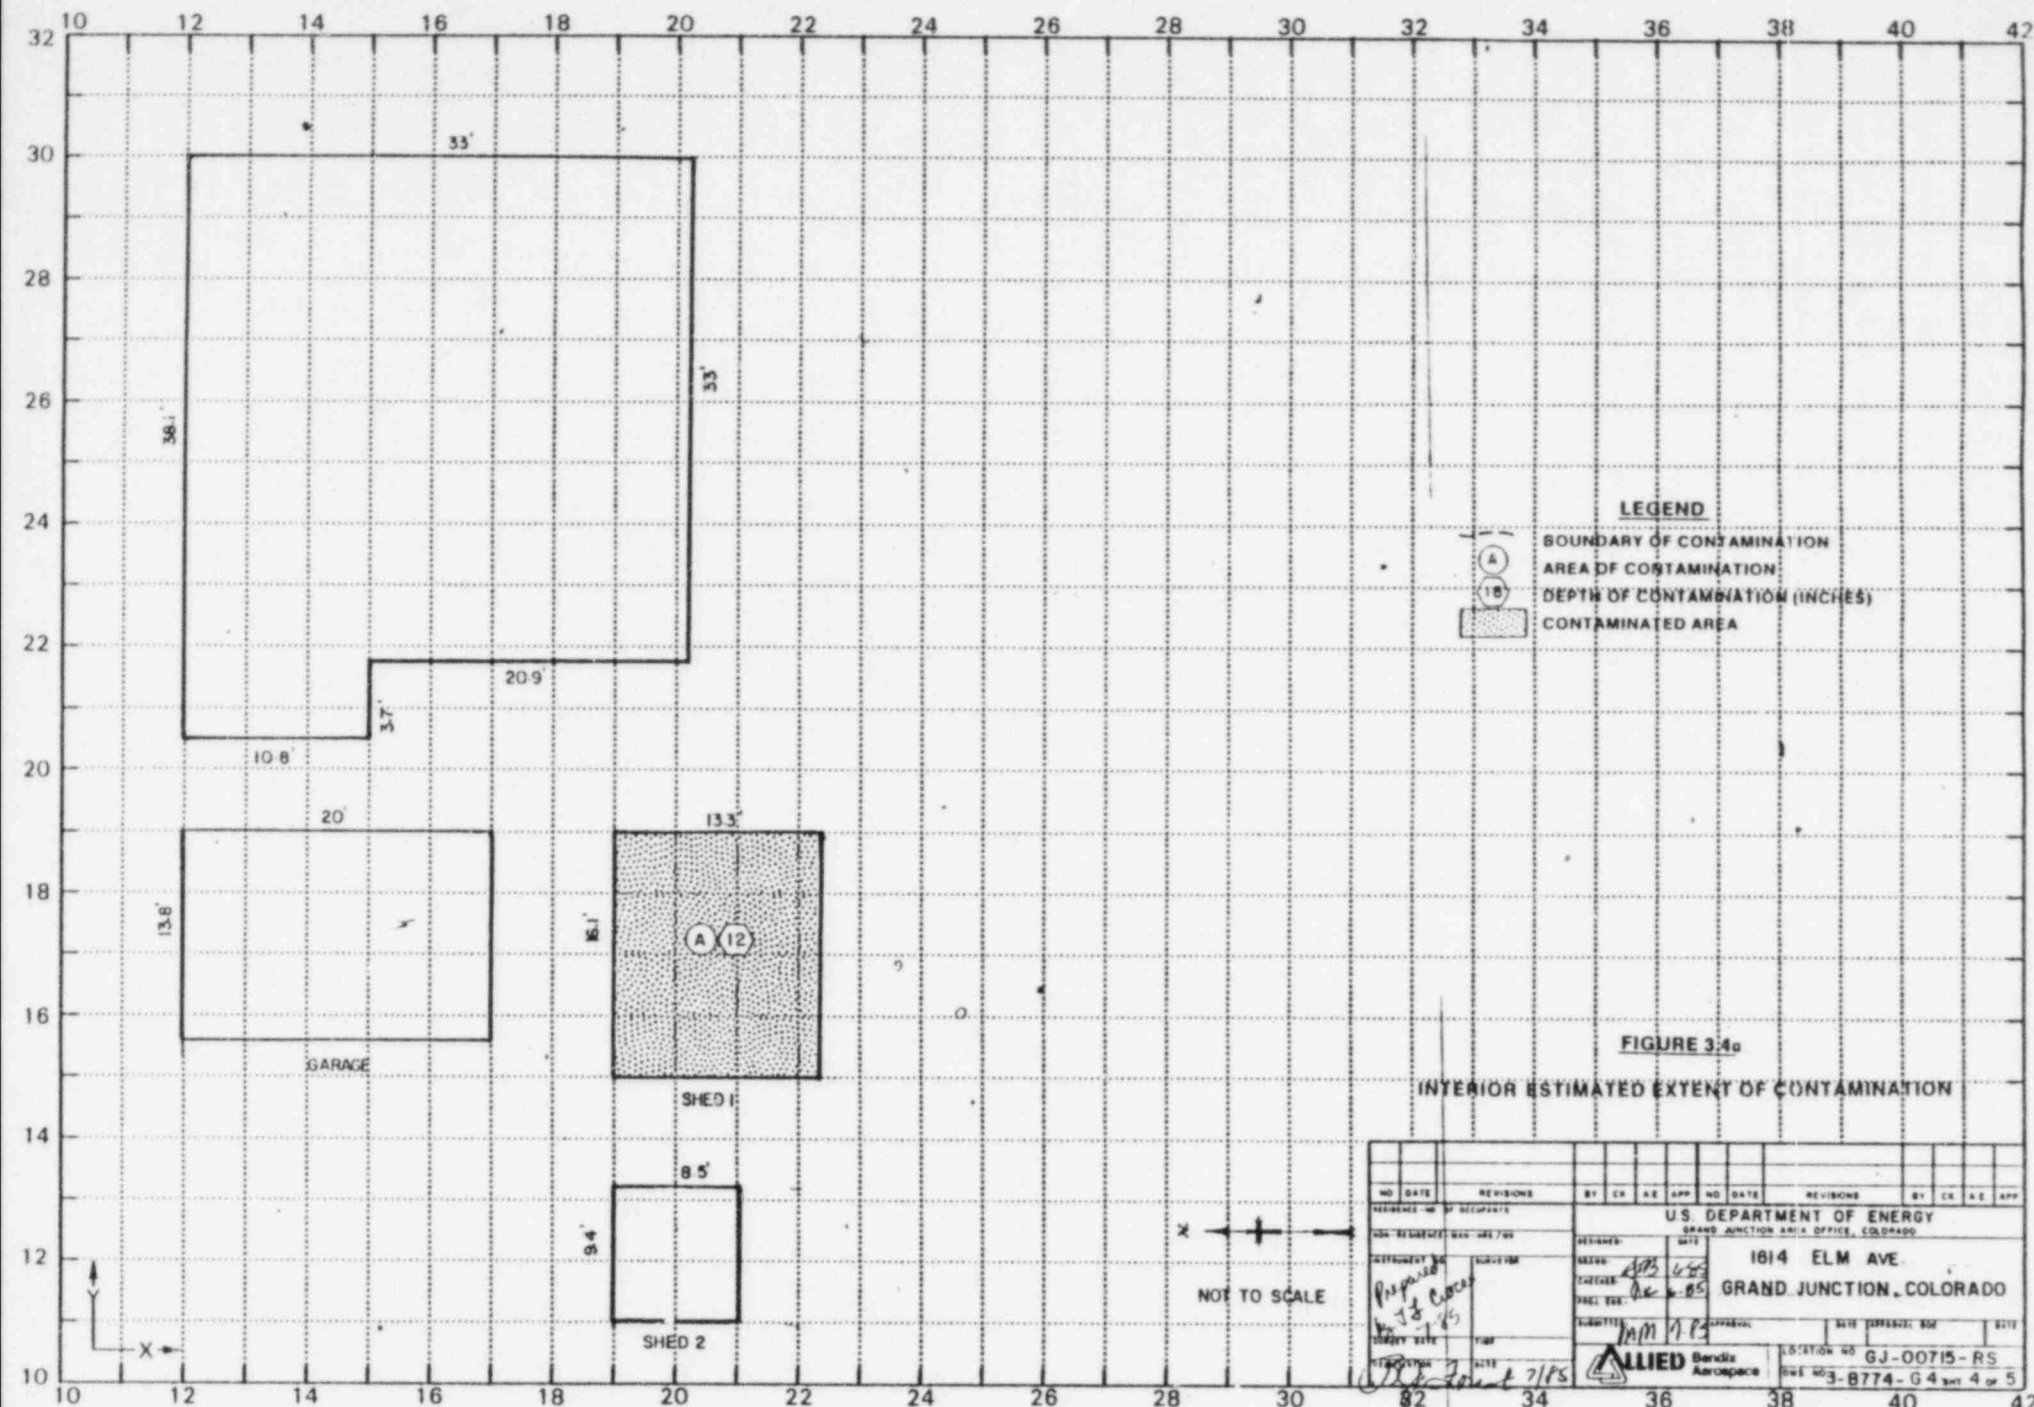
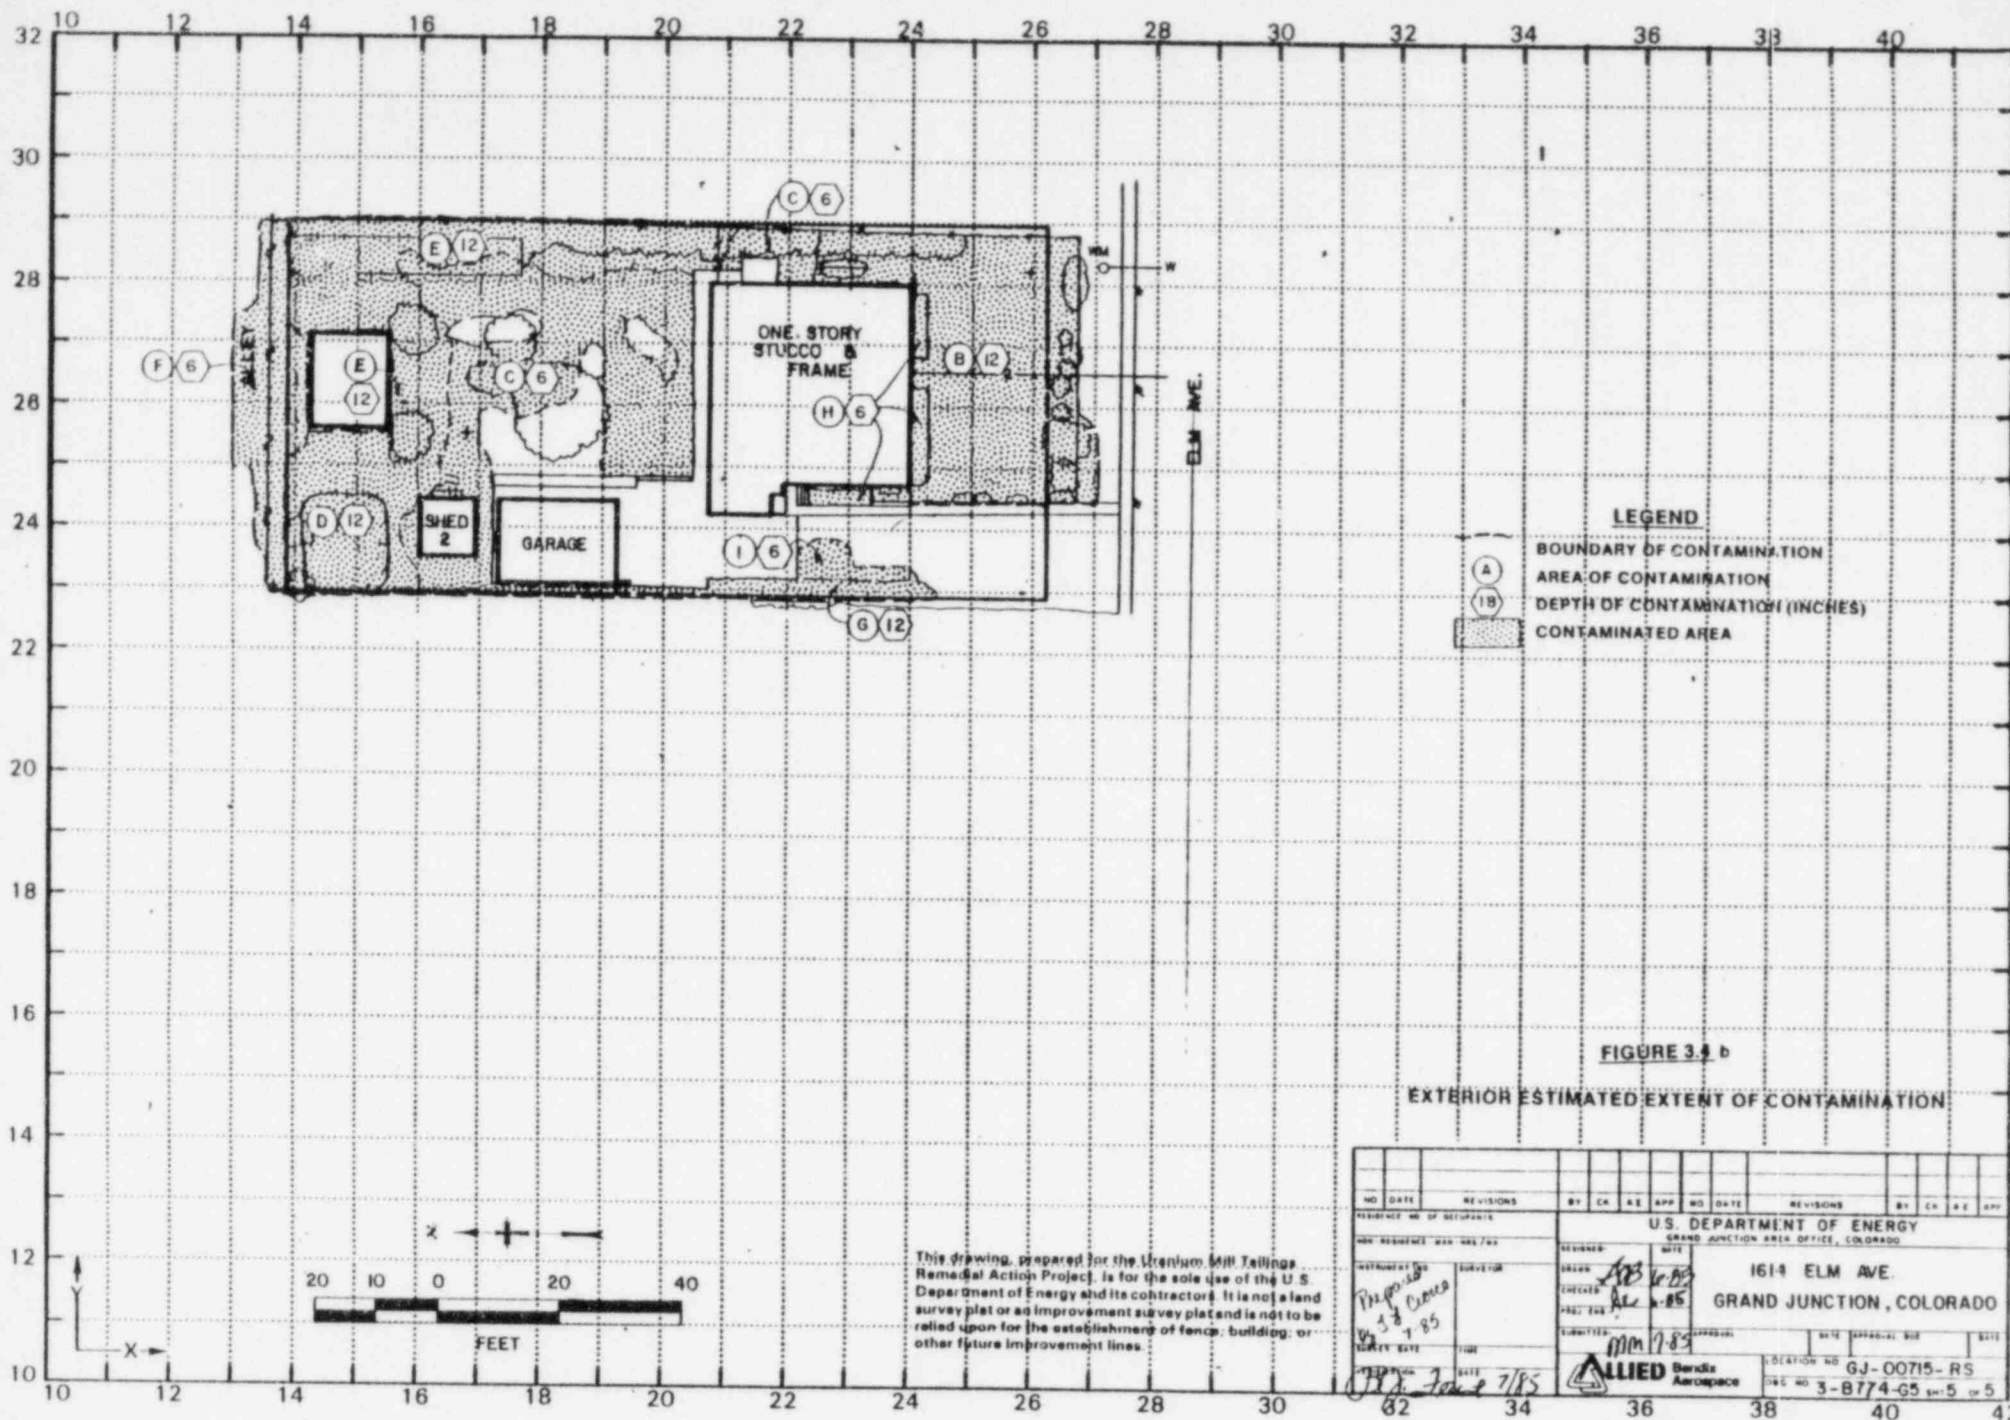
Appendix Figures 3.4a and 3.4b show identified areas and estimated depths of contamination on this property, based on assessments of all measurements taken. As noted in these figures, areas recommended for remedial action that contain identified residual radioactive materials are:

- (Area A) Surface Material: Wood
Direction From Primary Structure: North
Other Directions: Near north property line, beneath Shed 1
Total Depth of Contamination: Estimated at 12 inches
Comments: Shed 1 has a wood floor that is 3 inches above the soil. The depth of contamination is measured from the soil surface and is based on data collected in Area E.
Approximate Square Footage: 208

- (Area B) Surface Material: Lawn
Direction From Primary Structure: South and east
Total Depth of Contamination: 12 inches
Approximate Square Footage: 1,332

- (Area C) Surface Material: Lawn
Direction From Primary Structure: North and east
Total Depth of Contamination: 6 inches
Comments: Shed 2 should be checked for contamination after remedial action is performed on the exterior.
Approximate Square Footage: 960

- (Area D) Surface Material: Lawn
Direction From Primary Structure: Northwest
Total Depth of Contamination: 12 inches
Comments: Several large rose bushes are planted in this area.
Approximate Square Footage: 208

- (Area E) Surface Material: Lawn
Direction From Primary Structure: North
Total Depth of Contamination: 12 inches
Comments: There is a sprinkler system throughout the entire north yard.
Approximate Square Footage: 1,358

- (Area F) Surface Material: Road base
Direction From Primary Structure: North
Other Directions: In north alley
Total Depth of Contamination: 6 inches
Approximate Square Footage: 480

- (Area G) Surface Material: Soil
Direction From Primary Structure: West
Other Directions: Along west property line
Total Depth of Contamination: 12 inches
Comments: Several large vines and bushes are planted
in this area.
Approximate Square Footage: 144
- (Area H) Surface Material: Soil
Direction From Primary Structure: South and west
Other Directions: Inside brick and concrete planter
Total Depth of Contamination: Estimated at 6 inches
Comments: The brick planters have a concrete base that is
not contaminated. The depth of contamination is based
on the depth of the soil in the planters.
Approximate Square Footage: 95
- (Area I) Surface Material: Road base
Direction From Primary Structure: West
Other Directions: Driveway leading to carport
Total Depth of Contamination: 6 inches
Approximate Square Footage: 60

The recommended remedial action for this property, DOE ID No. GJ-00715-RS, includes removal of all areas identified as containing radioactive material (as discussed in Section 3.5 and shown in Appendix Figures 3.4a and 3.4b) and transport of removed material to the disposal site.

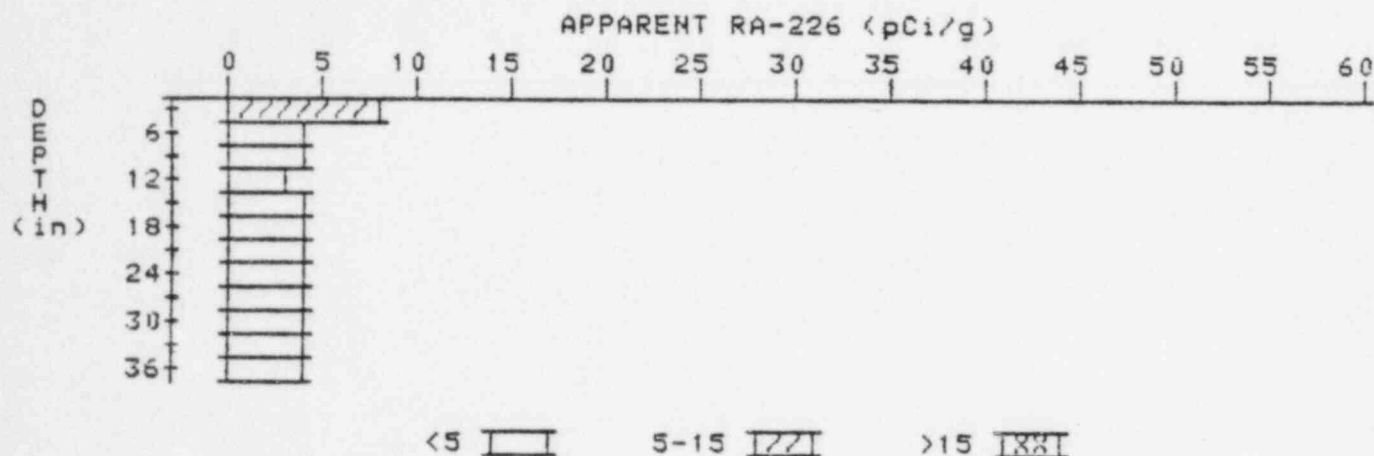
HOLE NUMBER: 1

Depth (in)	Apparent Radium-226 (pCi/g) Undeconvolved	Apparent Radium-226 (pCi/g) Deconvolved
3	8.1	8.1
6	6.0	4.2
9	4.9	4.2
12	4.2	3.5
15	3.9	3.5
18	3.8	3.6
21	3.8	4.0
24	3.7	3.5
27	3.7	3.7
30	3.7	3.9
33	3.6	3.6
36	3.5	3.5

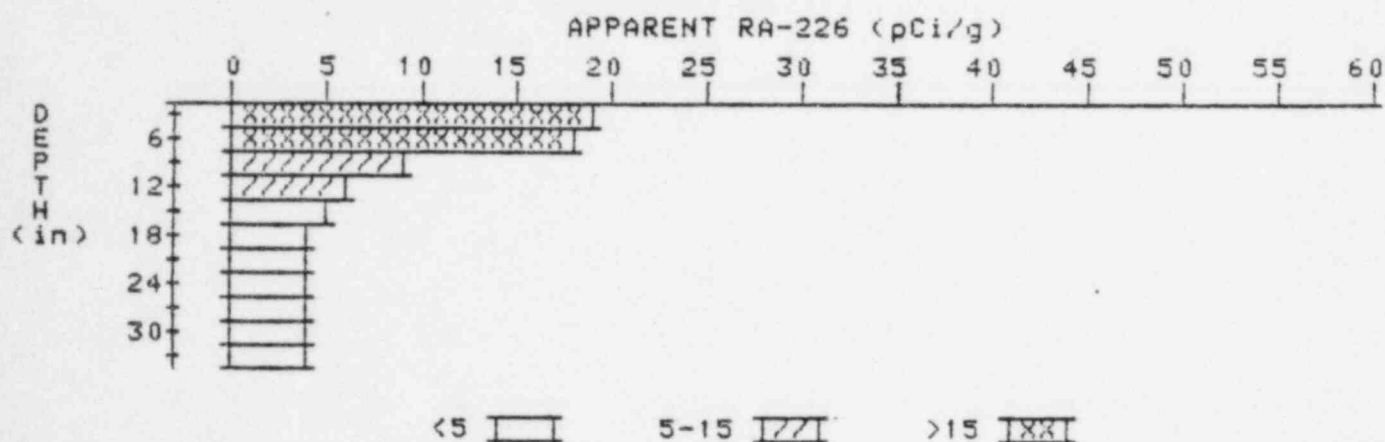
HOLE NUMBER: 2

Depth (in)	Apparent Radium-226 (pCi/g) Undeconvolved	Apparent Radium-226 (pCi/g) Deconvolved
3	18.7	18.7
6	15.6	17.7
9	11.3	9.2
12	8.2	6.1
15	6.3	4.9
18	5.2	4.3
21	4.6	4.1
24	4.3	3.9
27	4.2	4.4
30	4.0	3.8
33	3.9	3.9

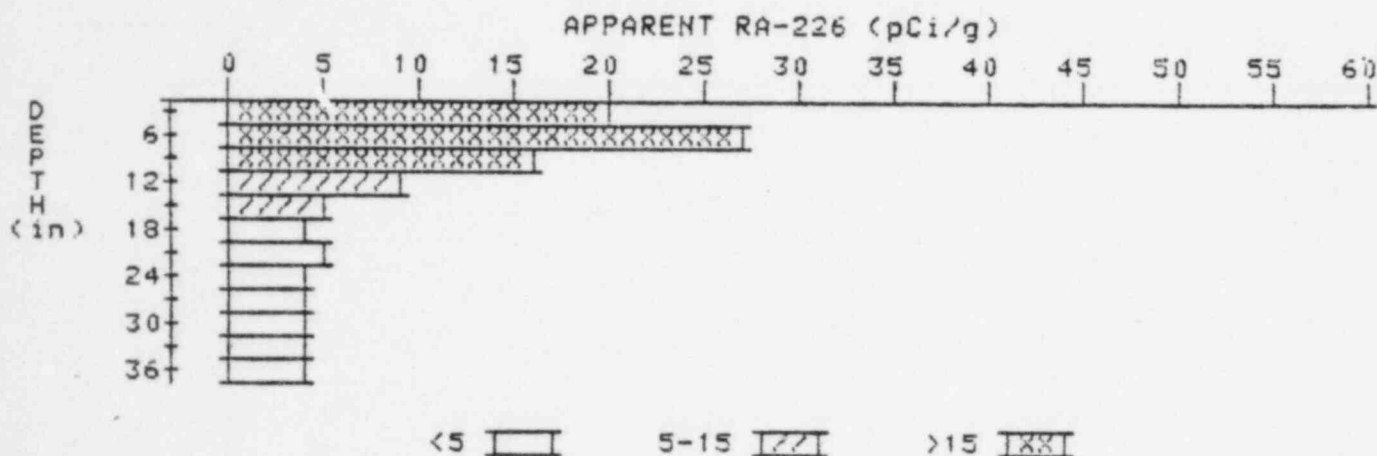
HOLE NUMBER: 4

Depth (in)	Apparent Radium-226 (pCi/g) Undeconvolved	Apparent Radium-226 (pCi/g) Deconvolved
3	19.7	19.7
6	19.8	27.4
9	15.6	16.3
12	11.0	9.5
15	7.8	5.3
18	6.0	4.2
21	5.2	4.8
24	4.6	4.1
27	4.3	4.1
30	4.1	3.7
33	4.1	4.1
36	4.1	4.1

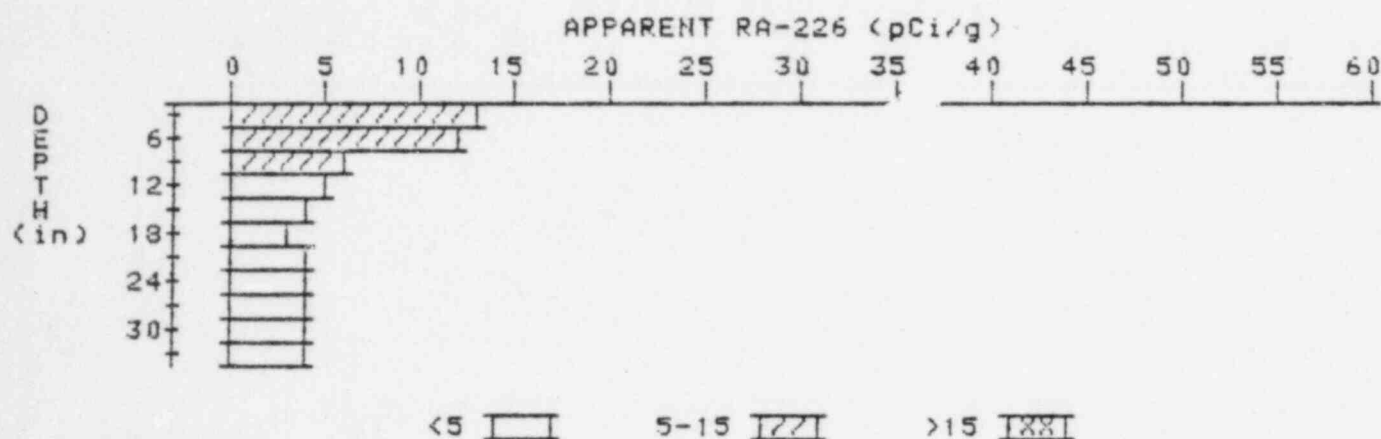
PROPERTY NUMBER: GJ-00715-RS
HOLE NUMBER: 11
LOCATION: 182294

Depth (in)	Apparent Radium-226 (pCi/g)	Apparent Radium-226 (pCi/g)
	Undeconvolved	Deconvolved
3	12.6	12.6
6	10.6	11.8
9	7.9	6.3
12	6.1	4.9
15	5.0	4.3
18	4.3	3.4
21	4.1	4.1
24	3.9	3.5
27	3.9	3.9
30	3.9	4.1
33	3.8	3.8

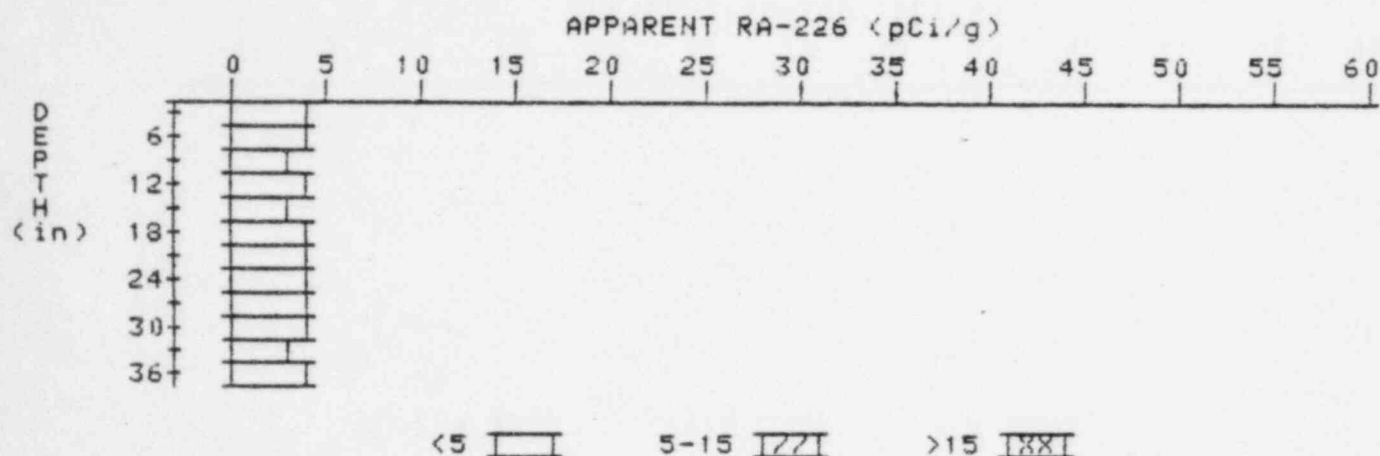
PROPERTY NUMBER: GJ-00715-RS
HOLE NUMBER: 13
LOCATION: 189259

Depth (in)	Apparent Radium-226 (pCi/g) Undeconvolved	Apparent Radium-226 (pCi/g) Deconvolved
3	3.6	3.6
6	3.7	4.1
9	3.6	3.4
12	3.6	3.6
15	3.6	3.4
18	3.7	3.7
21	3.8	4.0
24	3.8	4.0
27	3.7	3.5
30	3.7	3.9
33	3.6	3.4
36	3.6	3.6

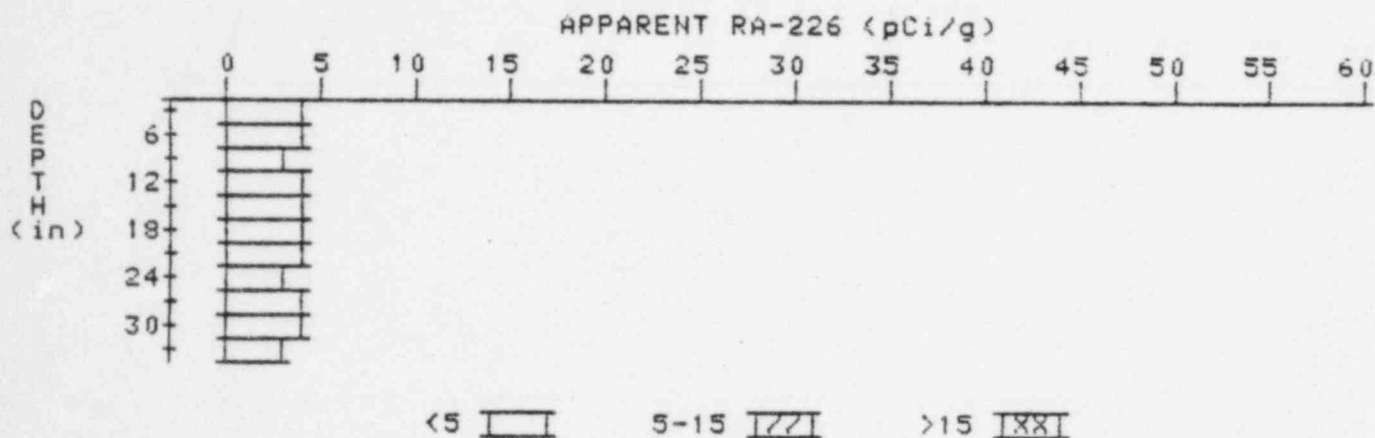
PROPERTY NUMBER: GJ-00715-RS
HOLE NUMBER: 21
LOCATION: 223235

Depth (in)	Apparent Radium-226 (pCi/g) Undeconvolved	Apparent Radium-226 (pCi/g) Deconvolved
3	3.6	3.6
6	3.6	3.8
9	3.5	3.1
12	3.6	3.8
15	3.6	3.6
18	3.6	3.6
21	3.6	3.8
24	3.5	3.1
27	3.6	4.0
30	3.5	3.5
33	3.4	3.4

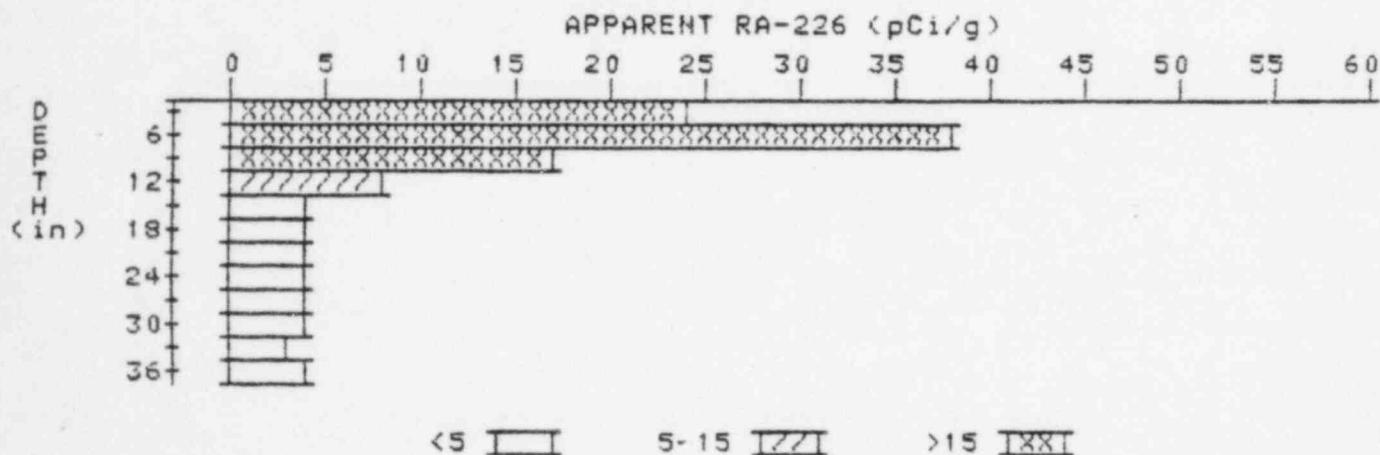
PROPERTY NUMBER: GJ-00715-RS
HOLE NUMBER: 24
LOCATION: 232281

Depth (in)	Apparent Radium-226 (pCi/g) Undeconvolved	Apparent Radium-226 (pCi/g) Deconvolved
3	23.8	23.8
6	24.8	38.3
9	18.2	17.5
12	12.0	8.4
15	7.8	3.9
18	5.8	4.2
21	4.7	3.6
24	4.2	3.8
27	3.9	3.5
30	3.8	4.0
33	3.6	3.1
36	3.7	3.7

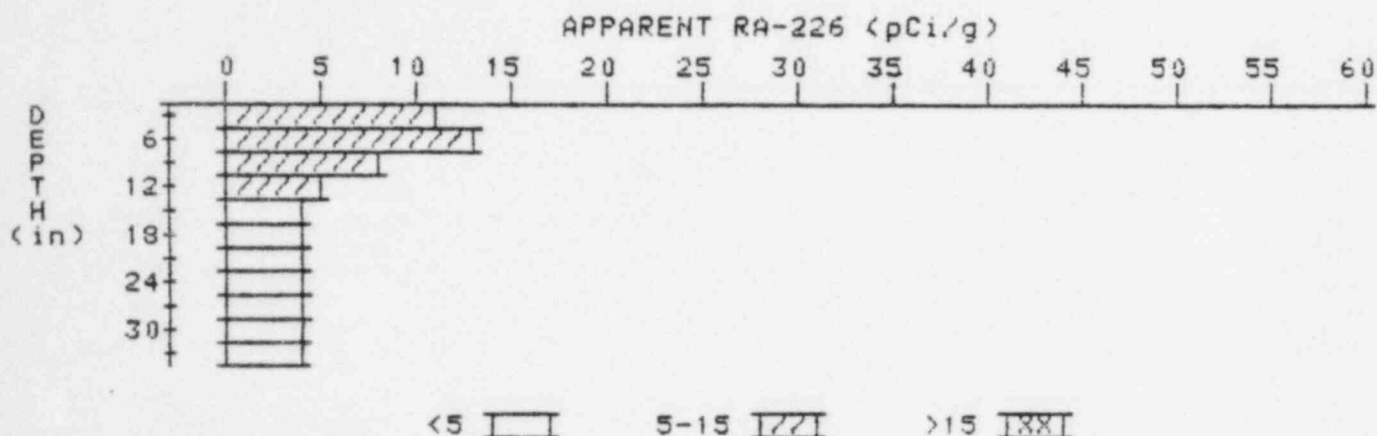
PROPERTY NUMBER: GJ-00715-RS
HOLE NUMBER: 25
LOCATION: 234230

Depth (in)	Apparent Radium-226 (pCi/g) Undeconvolved	Apparent Radium-226 (pCi/g) Deconvolved
3	10.6	10.6
6	10.3	13.5
9	8.2	7.8
12	6.3	5.2
15	5.0	3.6
18	4.5	4.1
21	4.2	4.0
24	4.0	3.8
27	3.9	3.9
30	3.8	3.6
33	3.8	3.8

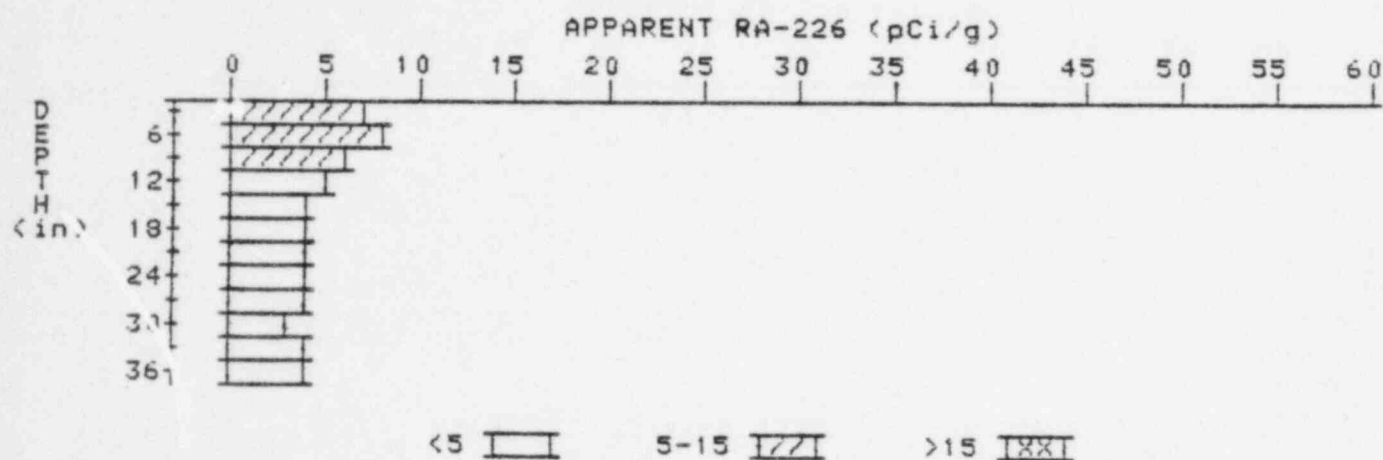
PROPERTY NUMBER: GJ-00715-RS
HOLE NUMBER: 29
LOCATION: 250270

Depth (in)	Apparent Radium-226 (pCi/g) Undeconvolved	Apparent Radium-226 (pCi/g) Deconvolved
3	7.2	7.2
6	7.0	6.4
9	6.0	5.8
12	5.1	4.7
15	4.4	3.7
18	4.1	3.9
21	3.9	3.9
24	3.7	3.5
27	3.6	3.6
30	3.5	3.3
33	3.5	3.5
36	3.5	3.5
