RADIOLOGIC AND ENGINEERING ASSESSMENT

DOE ID NO.: GJ-13359-RS
ADDRESS: 713 CENTAURI DRIVE

AUGUST 1985

URANIUM MILL TAILINGS REMEDIAL ACTION PROJECT OFFICE

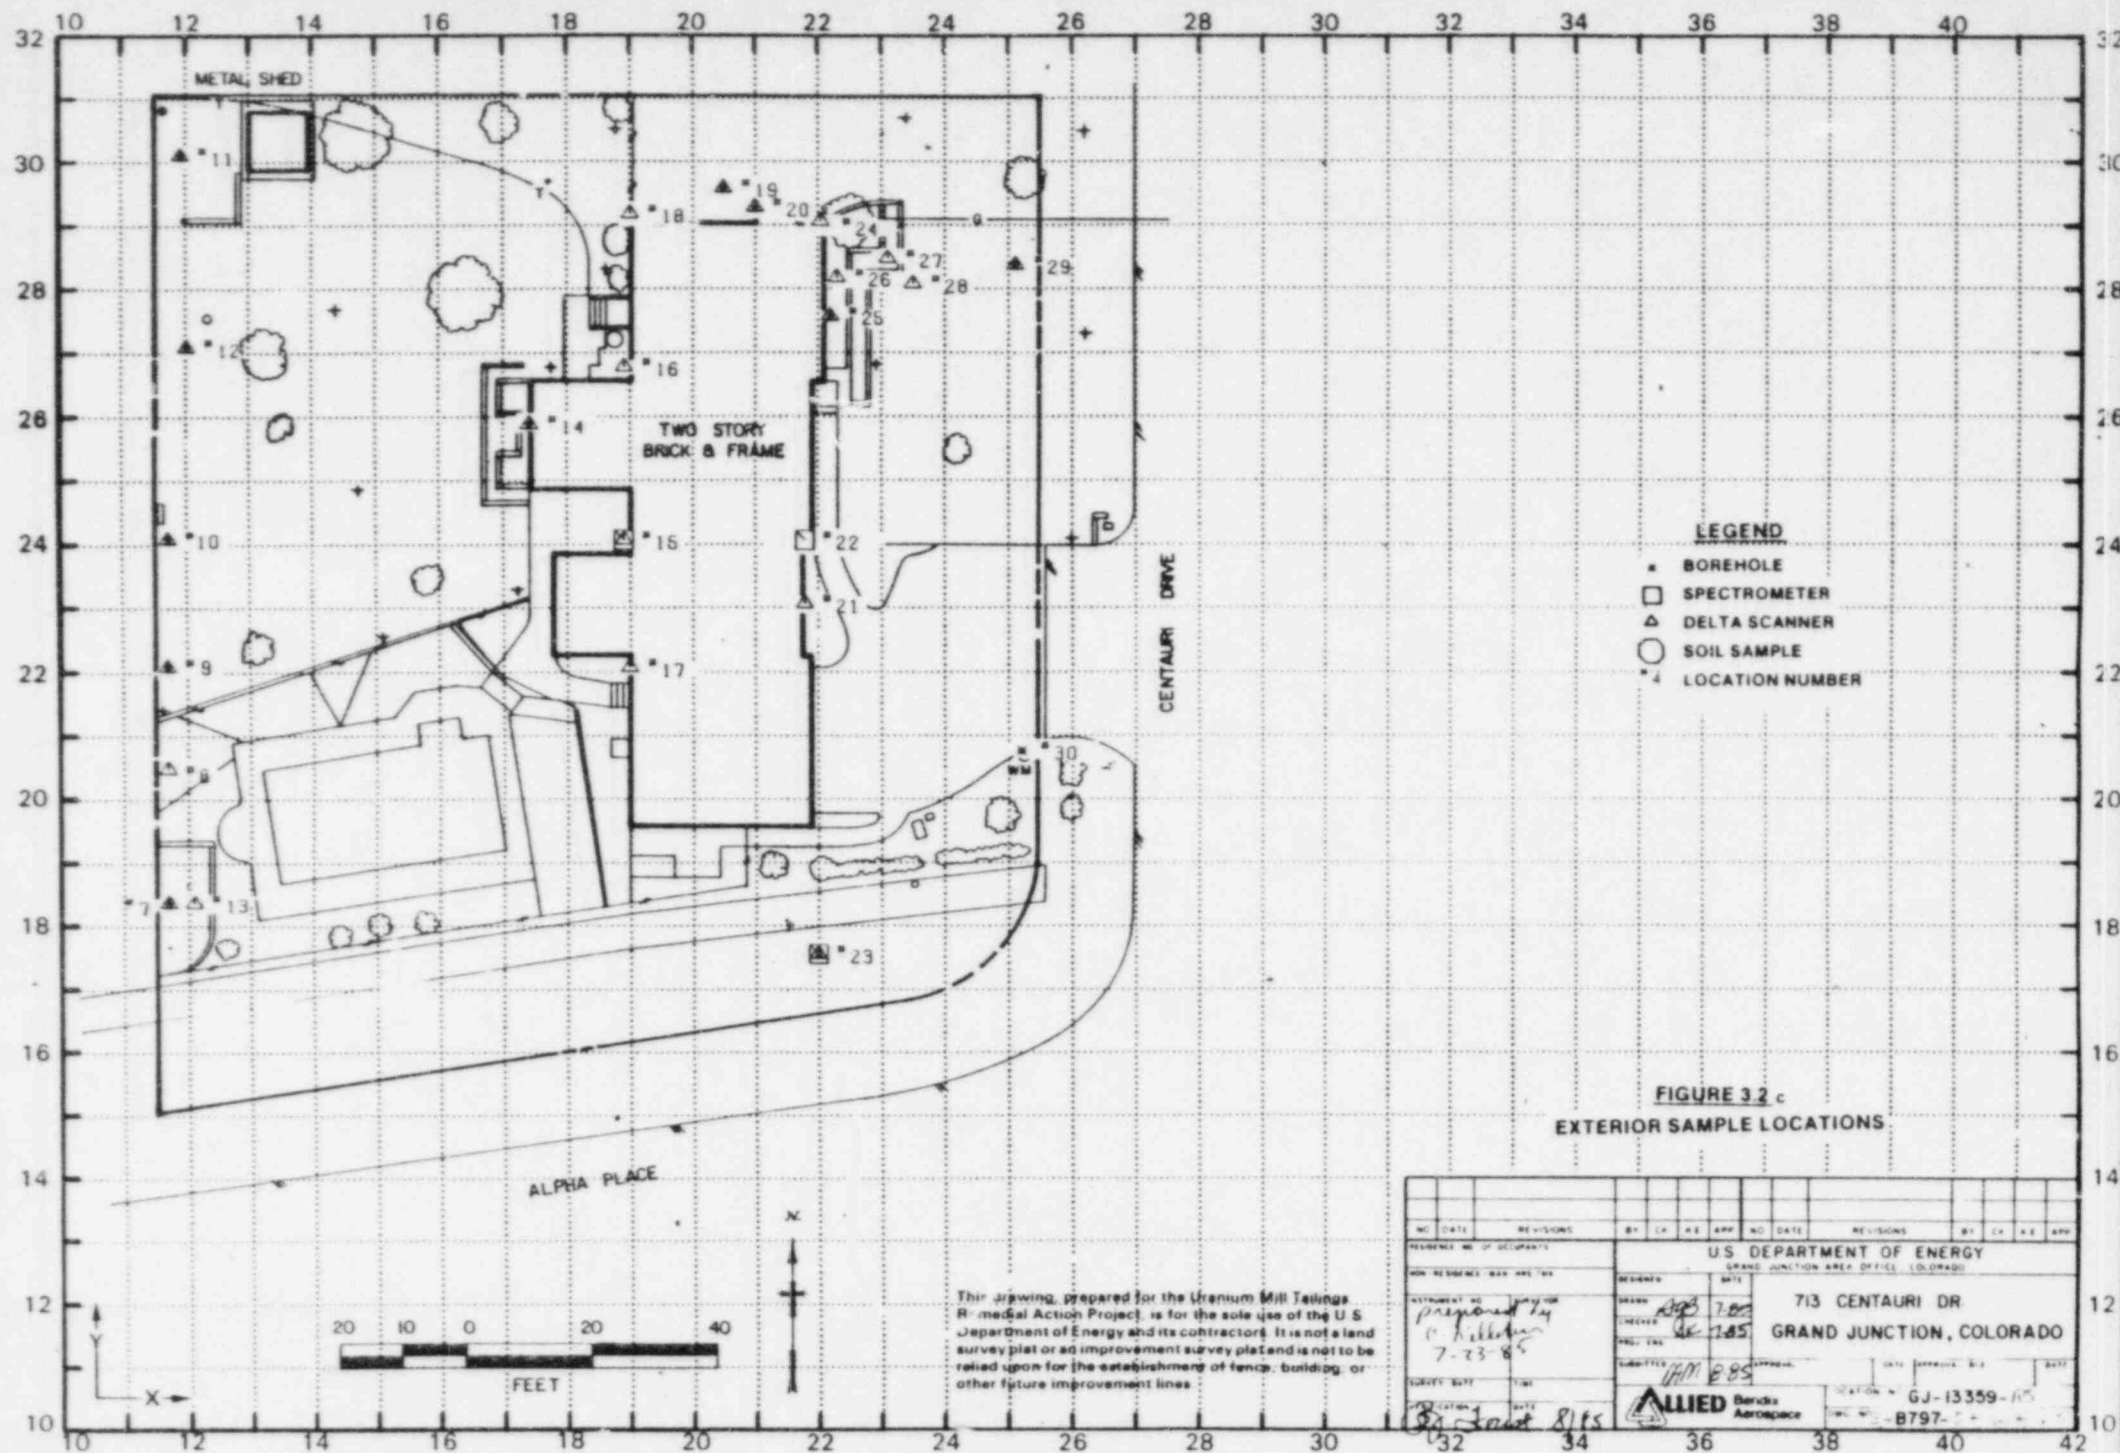
FIGURE 3.2 c
EXTERIOR SAMPLE LOCATIONS

Areas which displayed elevated gamma levels were further investigated; these areas are shown in Appendix Figures 3.2a, 3.2b, and 3.2c. These investigations are included in Appendix Tables 3.1 and 3.2.
